ADDRESS OF PROPERTY: 424 East Tremont Avenue, *Dilworth Local Historic District* *HDC 2013-060*

SUMMARY OF REQUEST: Demolition

Verna Engineering, P.C.

RE: 424 E. Tremont Avenue

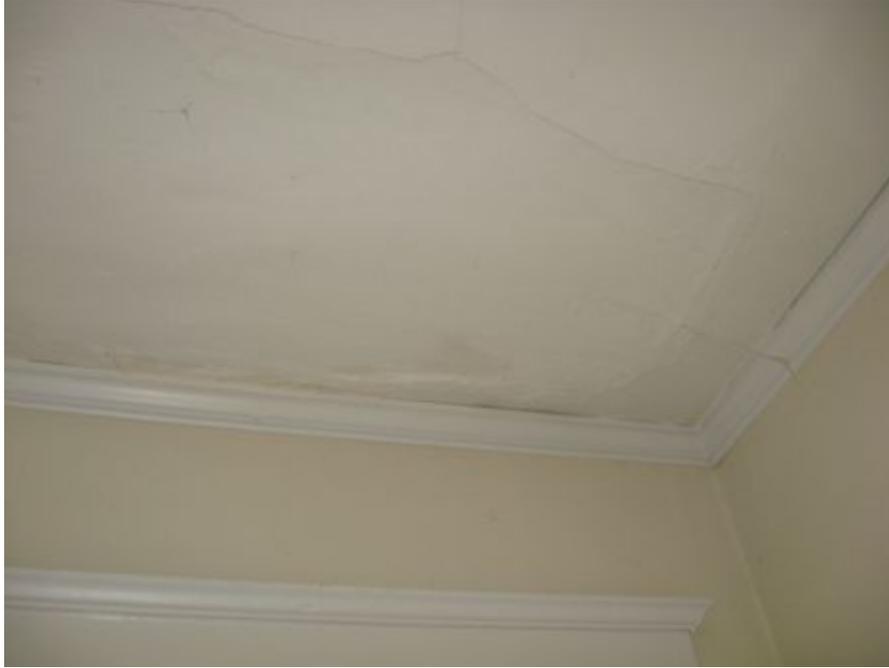
Investigation of the interior showed numerous cracks in the plaster walls and ceiling with racking of several doors also being noted. (see Photos #1 through #8) These cracks appear predominantly at intersections and around doors and windows. We recommend that these cracks be routed out to approximately ¼" in depth. Once this has been done, apply a 6" wide fiber-mesh reinforcing tape, "battered in" with joint compound and sanded out for painting. There were also two noted areas where the walls have the plaster falling off and signs of minor deterioration (see Photos #12 and #13). These cosmetic repairs should be addressed once the repairs to the foundation have been completed. There are signs of unevenness in the floors throughout the house, which is related to the framing methods used (see Photos #9 through #11). However, several areas do show signs of significant foundation issues, as noted below.

Above: Cracked Plaster, Photo 4
Below: Cracked Plaster, Photo 6

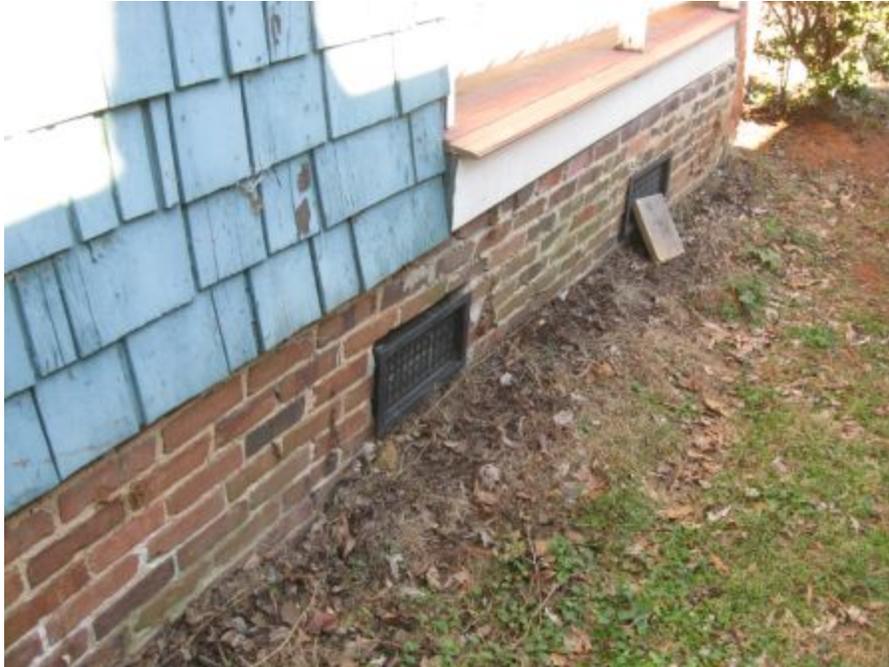
During the inspection of the exterior, significant bowing of the masonry curtain wall was noted at several locations around the perimeter of the house. (see Photos #17 through #20) Investigation of the crawlspace revealed that the curtain wall around the perimeter had a reveal above grade of approximately one foot. However, there are varying depths below grade, with the front foundation wall of the house retaining approximately four feet of soil. Throughout the crawlspace, there are signs of failure in the masonry curtain wall, due to these lateral pressures. (see Photos #21 through #29) This has resulted in lateral displacement of these walls and created apparent outward rotation at the top. It is recommended that the entire curtain wall be removed and replaced with an 8" masonry foundation wall per Code. The footing is to be a minimum 8"x16" concrete footing with two #4 reinforcing bars continuous around the perimeter. This should be investigated further if the renovation desired includes a second floor addition. The footing size is based on 2,000 pounds per square foot allowable soil bearing capacity.

Above: Bowed Masonry Curtain Wall, Photo 18
Below: Failed Masonry Curtain Wall, Photo 27

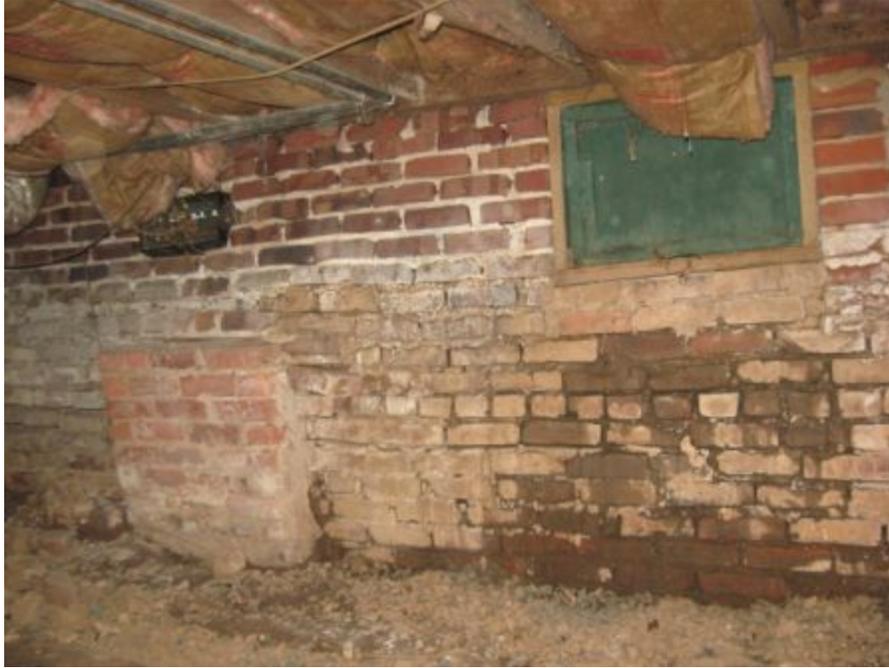
Above: Failed Masonry Curtain Wall, Photo 29

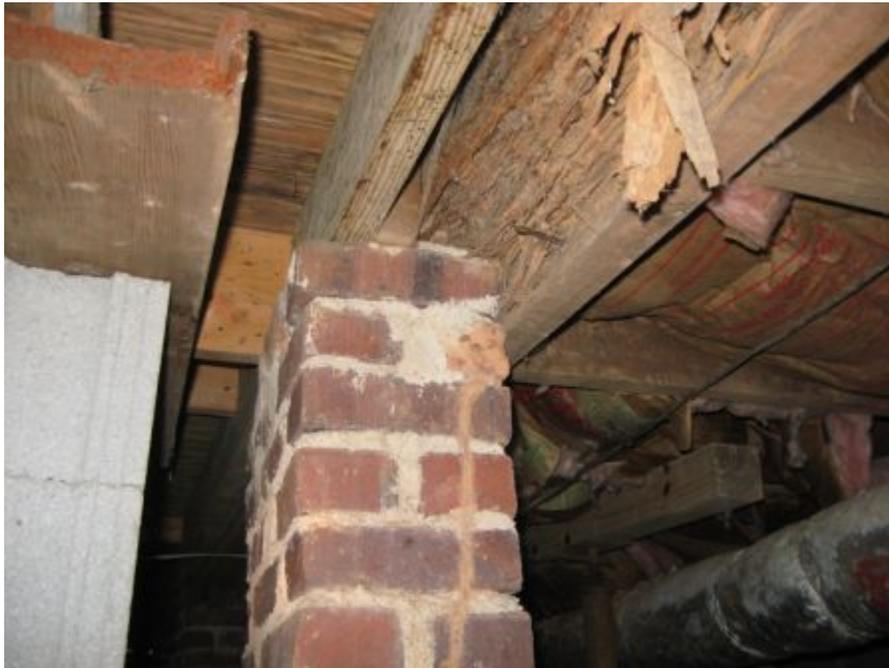
It was also noted during inspection of the crawlspace and as viewed from the exterior, that the front porch is sloping toward the house. (see Photos #30 through #32) Inspection of the crawlspace showed that the framing was constructed on the curtain wall at varying heights, which has induced the slope toward the girder supporting the front wall of the house. (see Photo #33) This main girder has in turn experienced water damage and deterioration. (see Photos #34 through #36). The front porch should be reconstructed so as to slope any runoff water away from the house at a slope of $\frac{1}{8}$ " per foot. Proper flashing per Code should be verified or installed at this intersection. There were other signs of notable deterioration throughout the crawlspace in the girders and exterior band. (see Photos #37 through #41) All damaged or rotted wood members should be removed and replaced with new lumber of equivalent dimensions and species.

Below: Water Damaged Girder, Photo 34

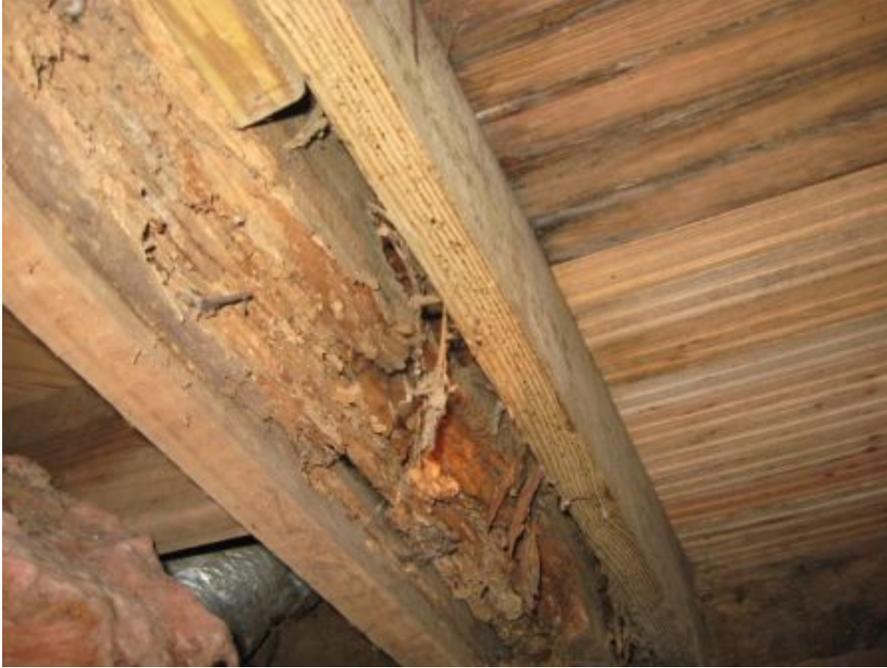
Above: Water Damaged Girder, Photo 35

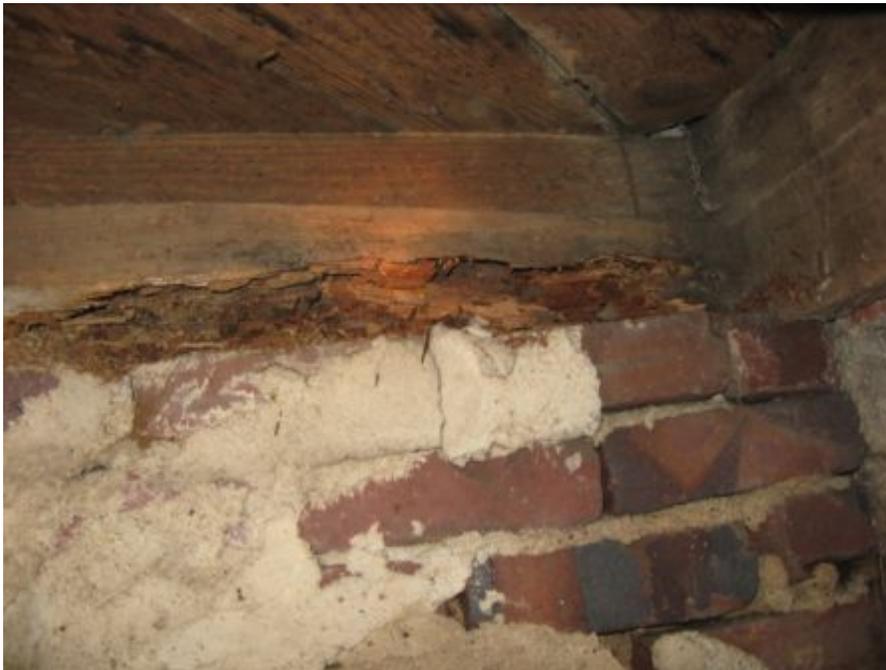
Below: Deteriorated Girder, Photo 41
