LOCAL HISTORIC DISTRICT: Wesley Heights

PROPERTY ADDRESS: 421 Grandin Road

SUMMARY OF REQUEST: Demolition

Charlotte Historic District Commission - Case 2016-180
HISTORIC DISTRICT: WESLEY HEIGHTS
DEMOLITION

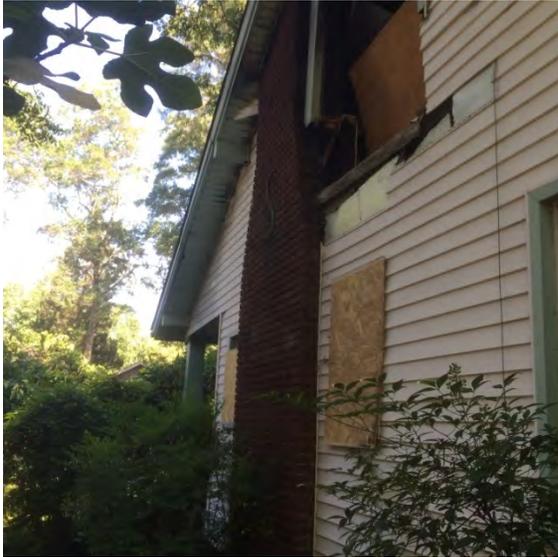
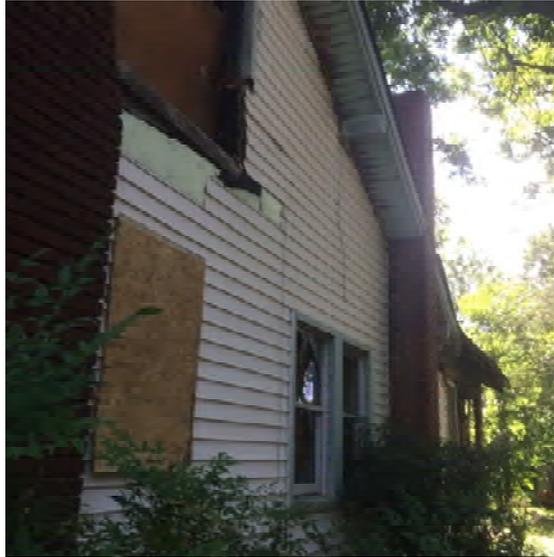
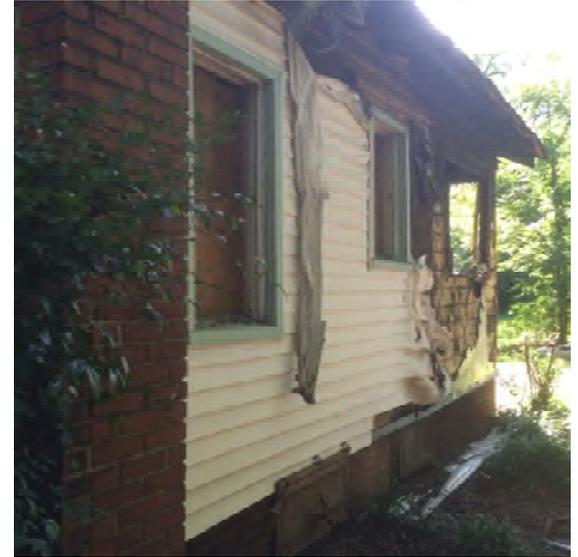
ABOVE: Right side of house showing unsalvageable melted/charred siding, broken windows and demolished 2nd floor & roof

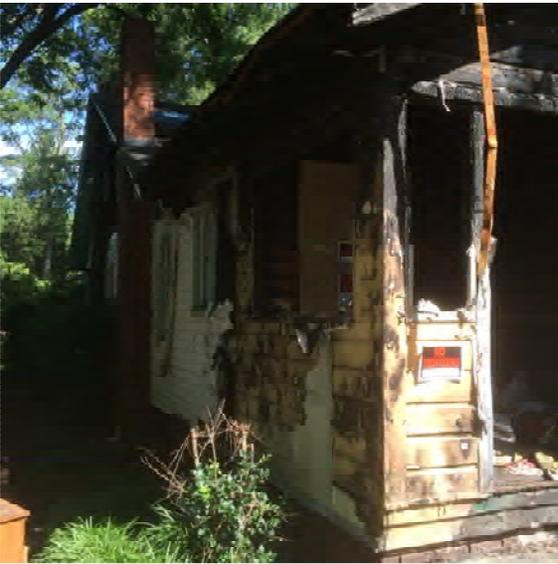
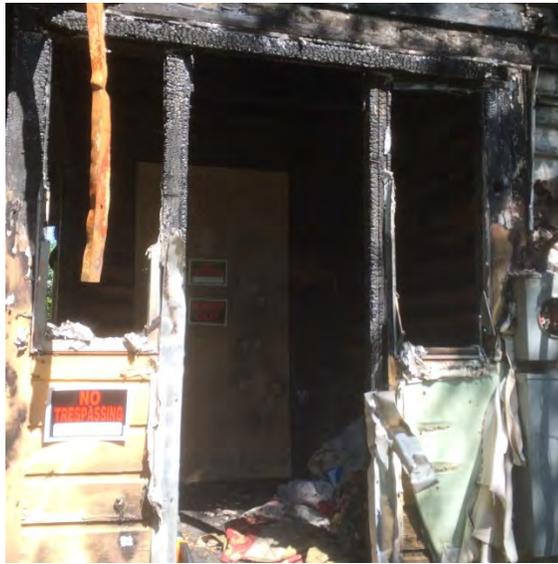
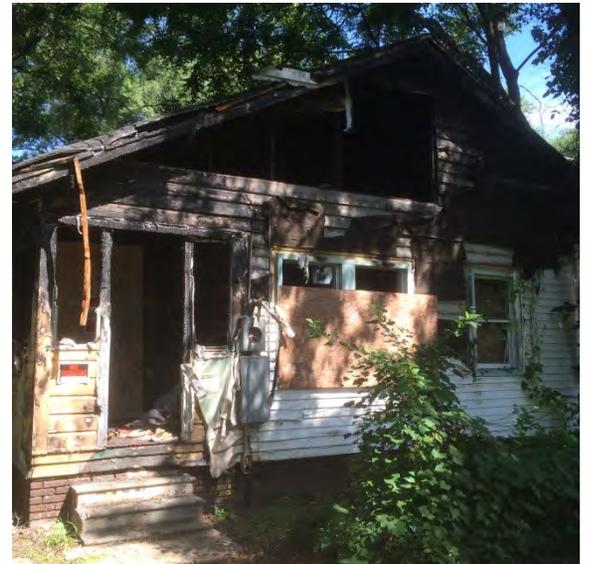
BELOW: Rear including Roof and Kitchen area. Unsalvageable structure from top to bottom.

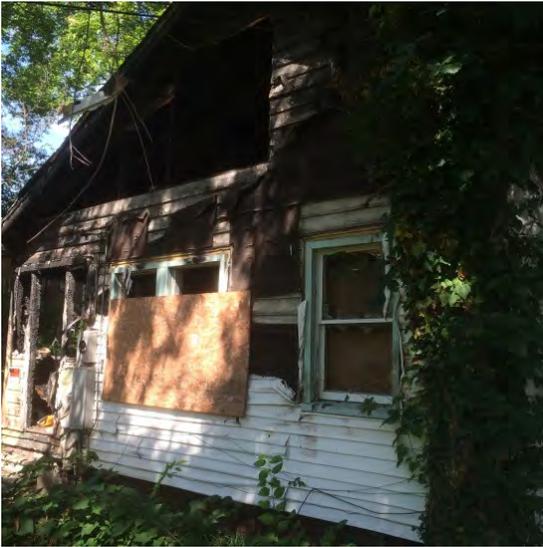
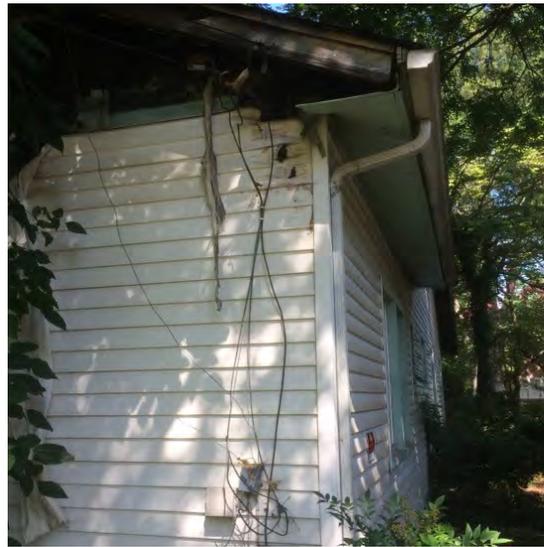
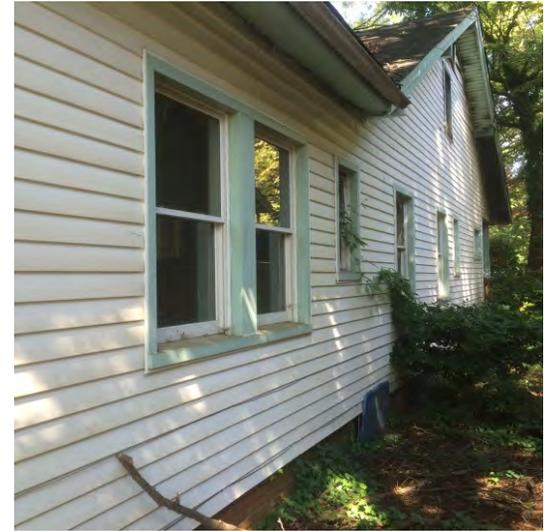
ABOVE: Rear/Left of house showing melted/charred siding, broken windows, and demolished 2nd floor & roof

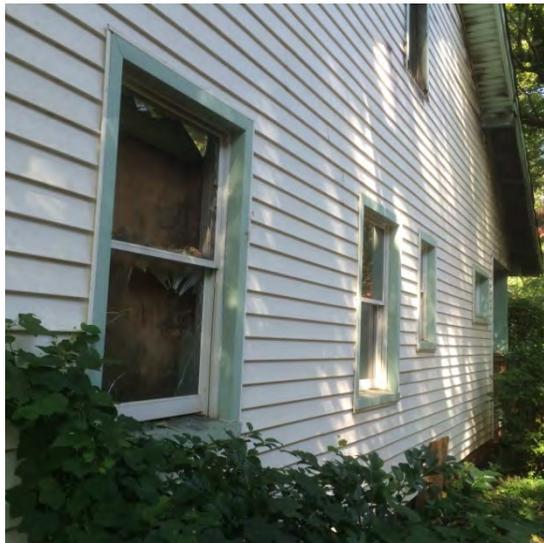
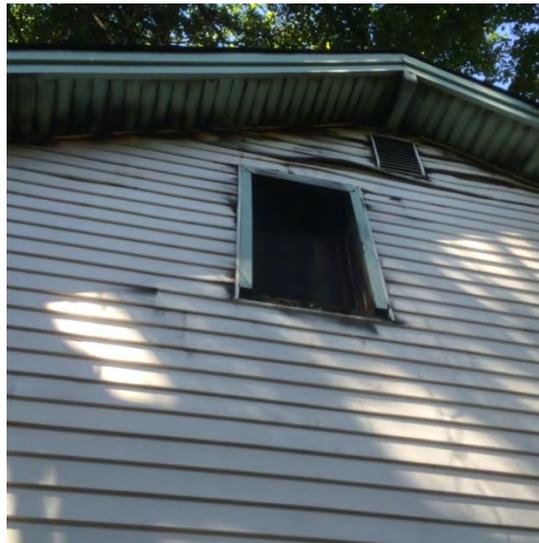
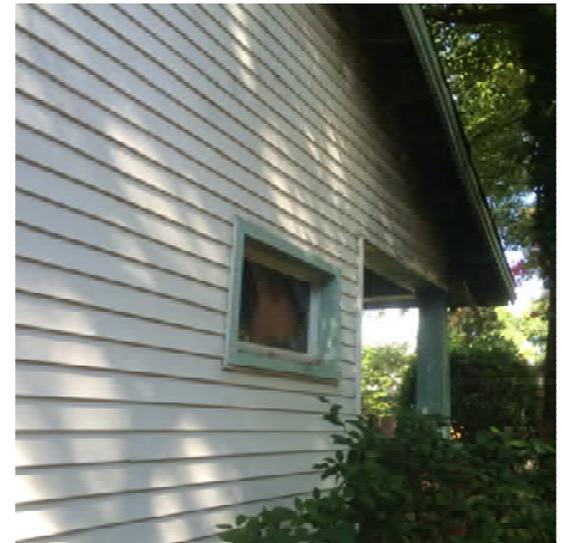
BELOW:: Left of house showing melted/charred siding, broken windows, and demolished 2nd floor & roof. Damage goes from rear to front, top to bottom.

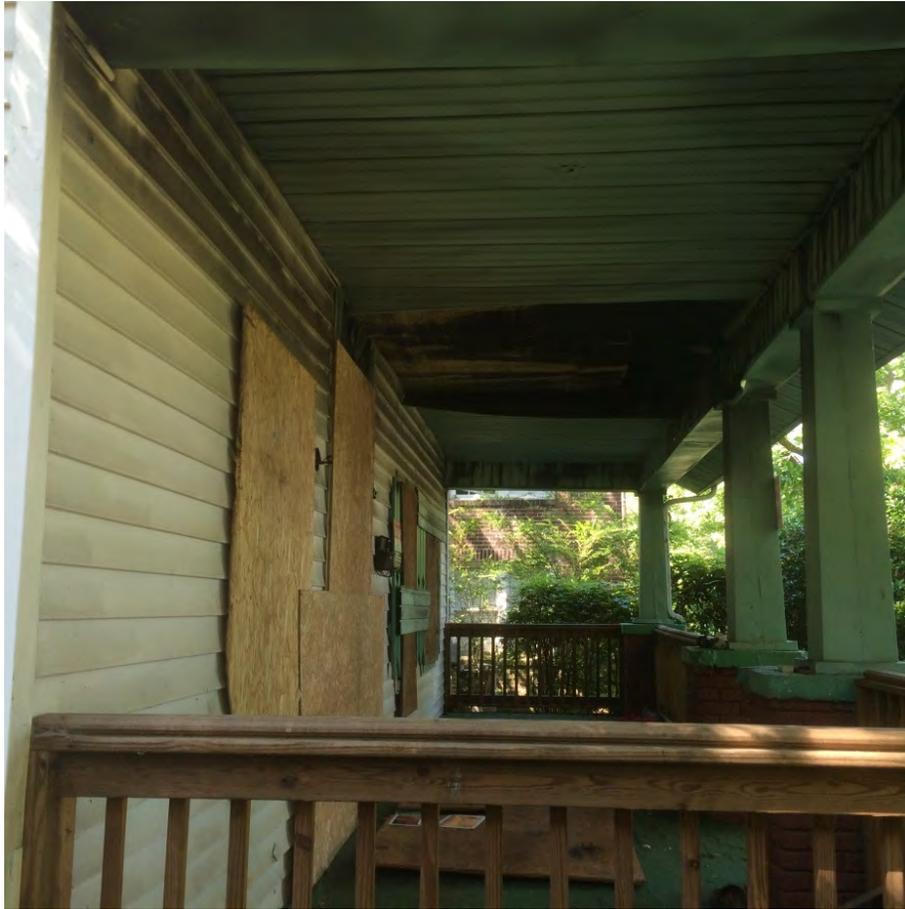
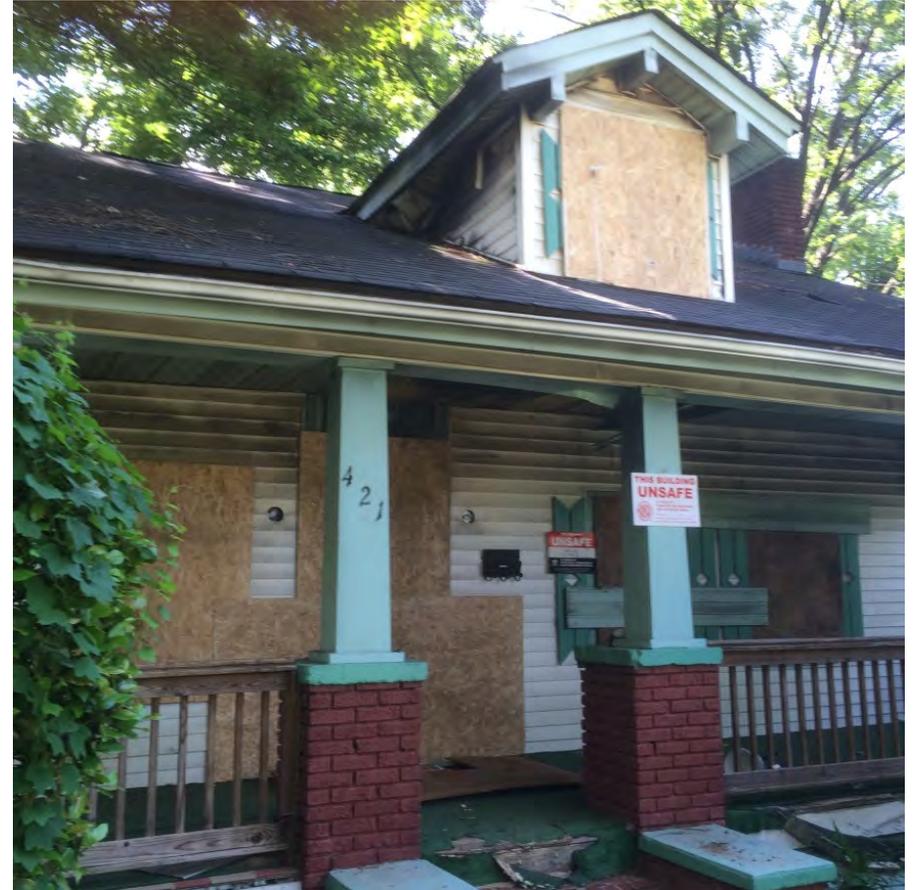
ABOVE: Front Porch. Furthest point from fire source and still damaged. All windows are demolished and heat/smoke damage throughout.

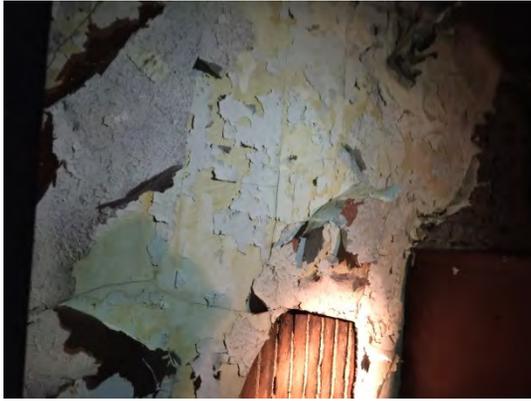
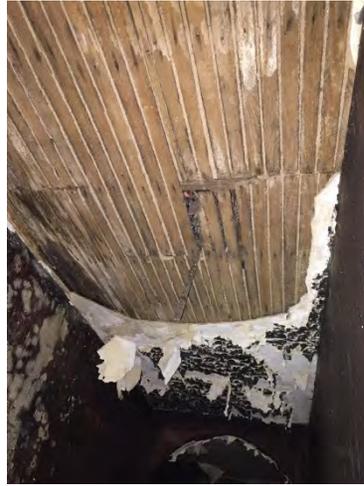
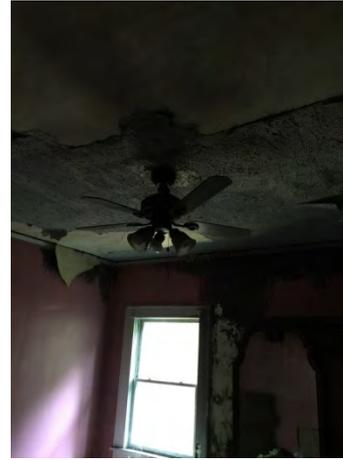
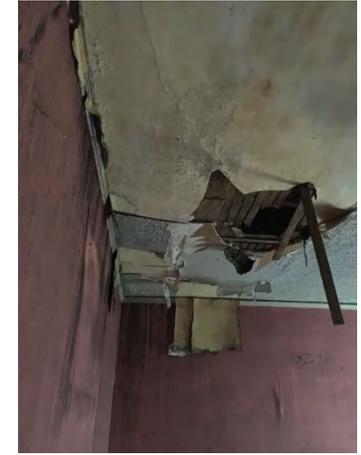
ABOVE: Indoor Ceiling showing melted coverings, mold, axe and water damage. Unsalvageable.

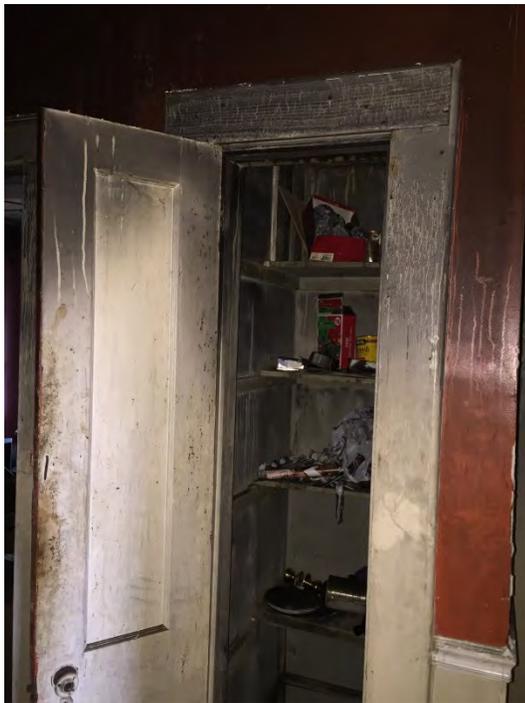
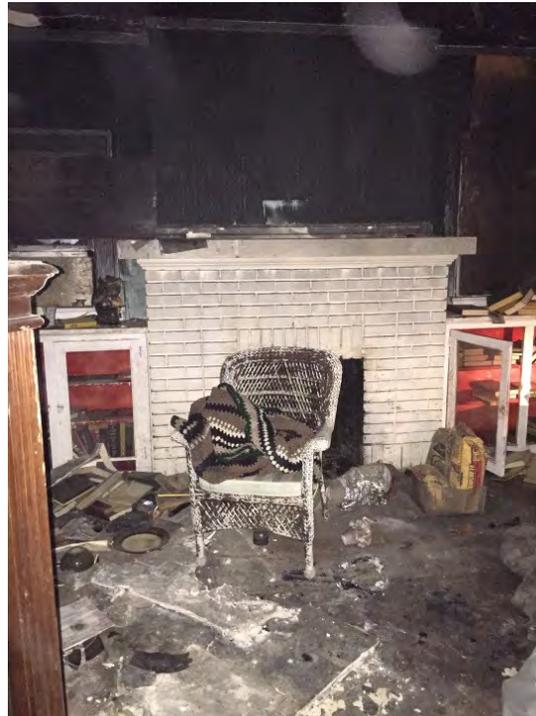
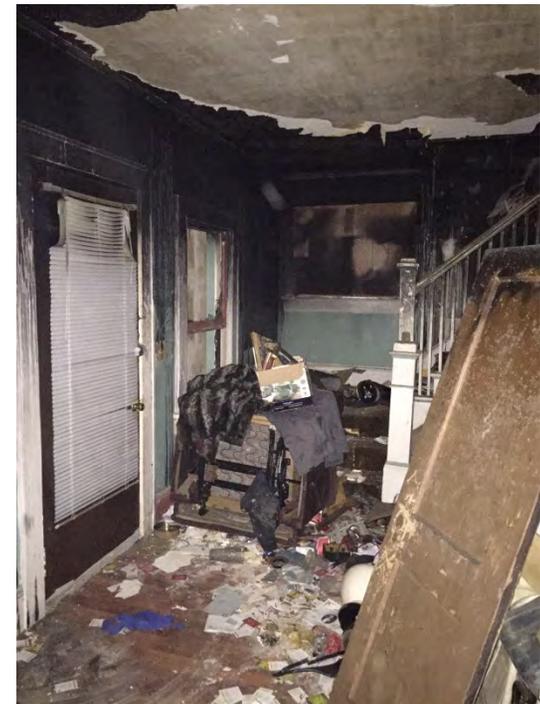
BELOW: Once colored walls now black, charred and unsalvageable all the way to the front of the house

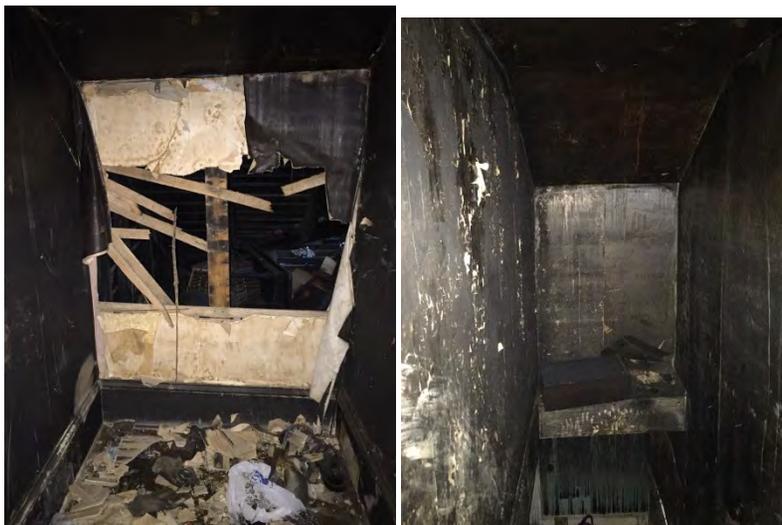
ABOVE: Stairwell damage. Unsalvageable.

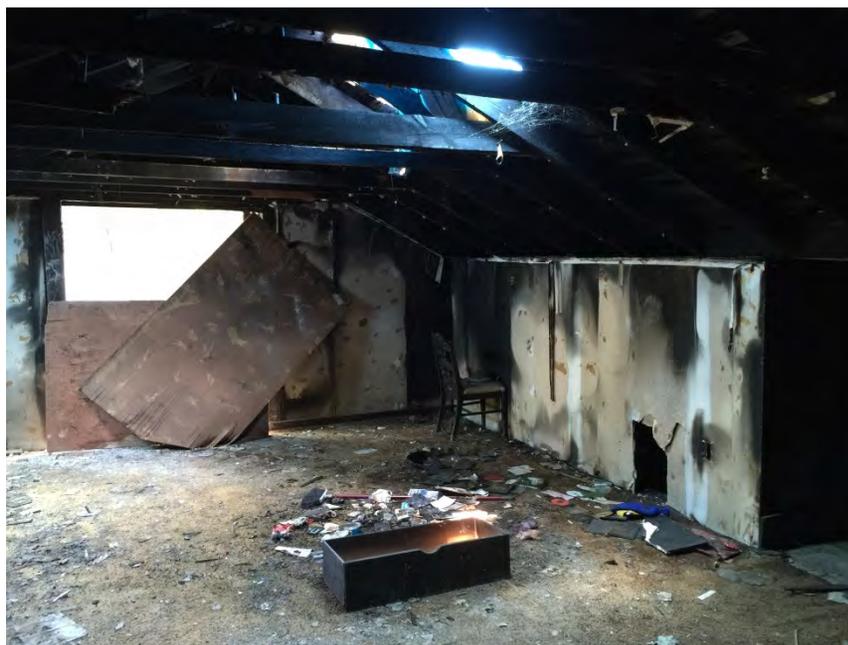
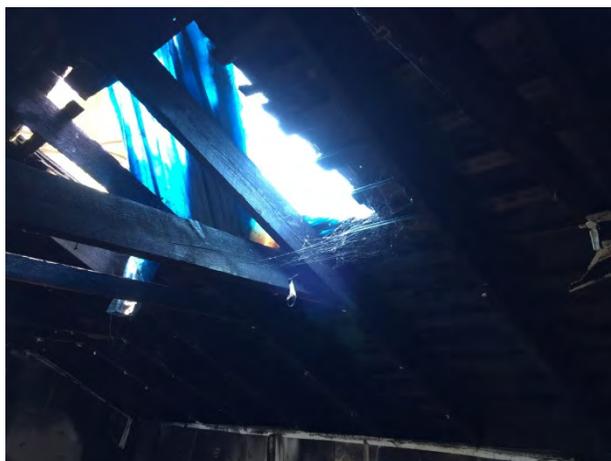
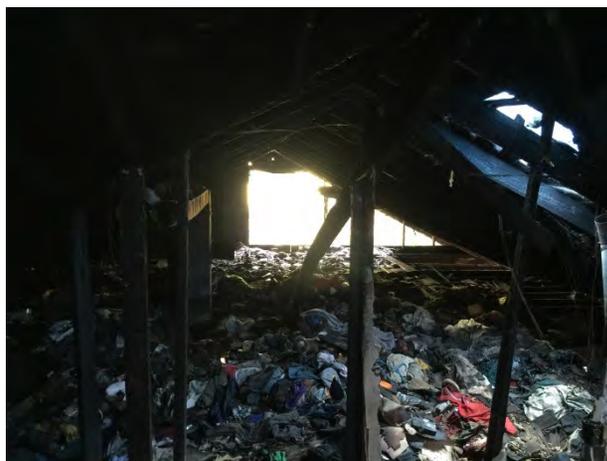
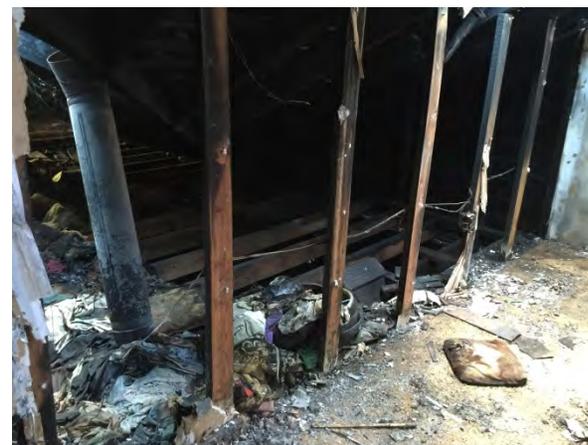
BELOW: 2nd Floor. Holes in roof, fire damage to the studs, exposed interior, unsalvageable from front to rear. Dangerous to walk on failing floor. Failed weatherproofing.

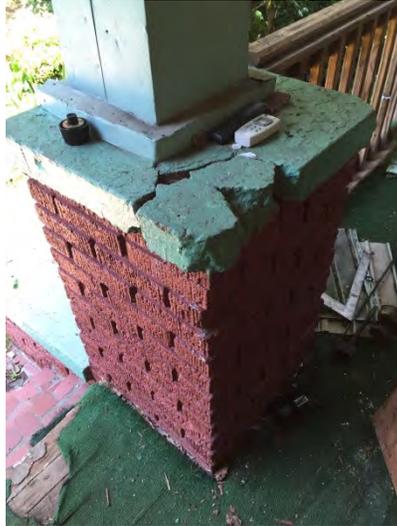
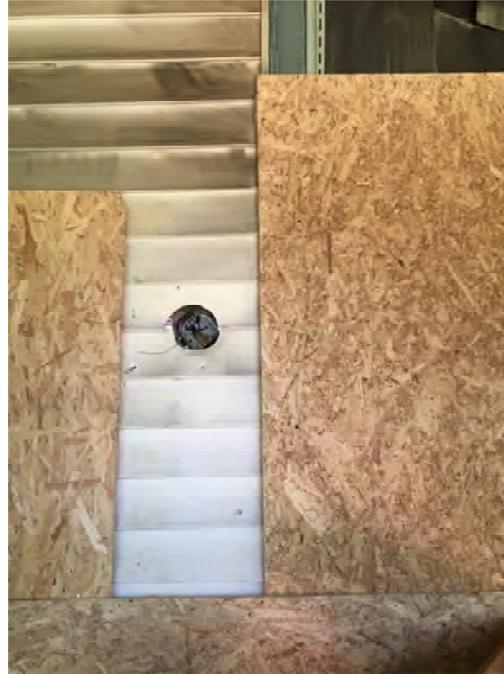
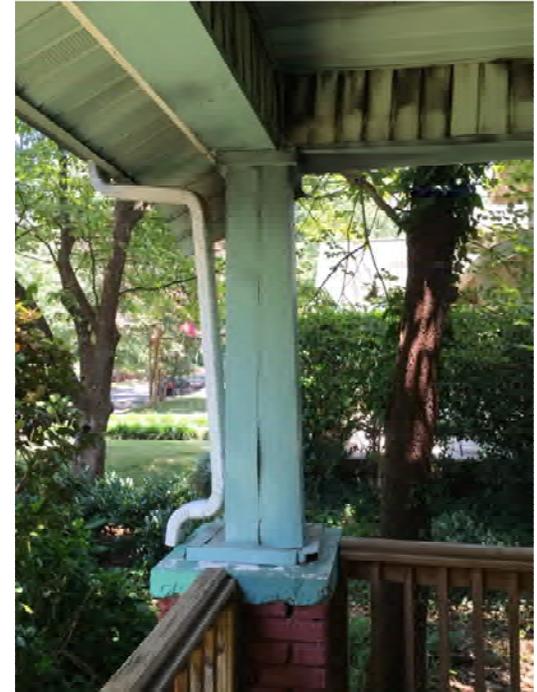
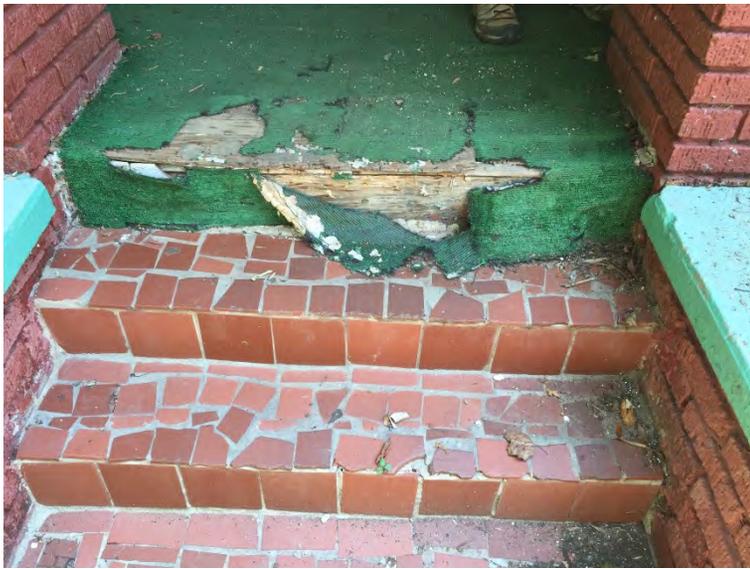
BELOW: Current structure contains failing items such as deteriorated columns, ripped artificial turf surface, exposed electrical system, and failed vinyl siding.

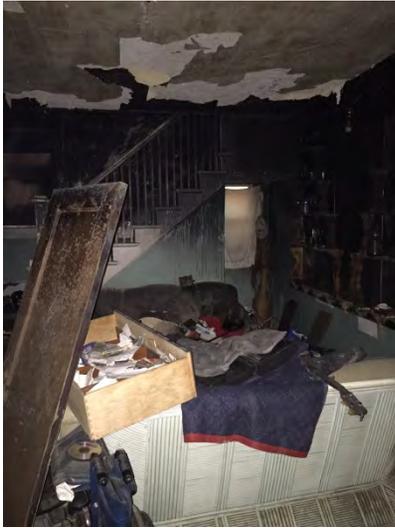
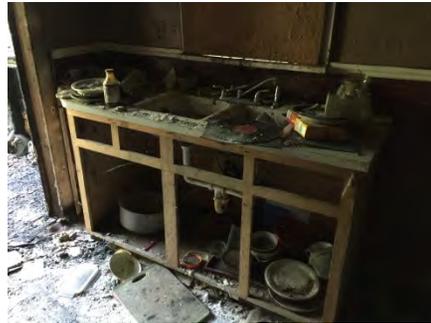
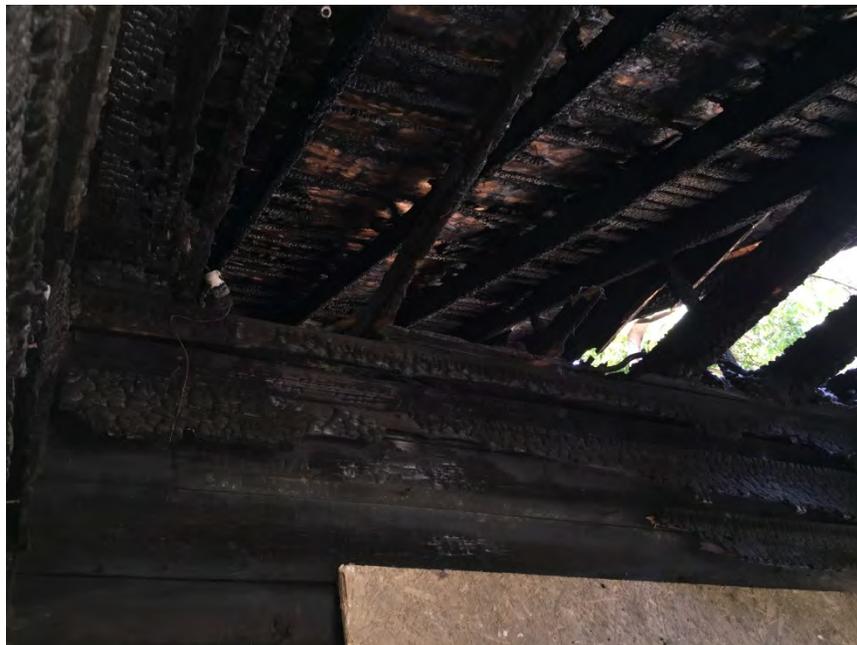
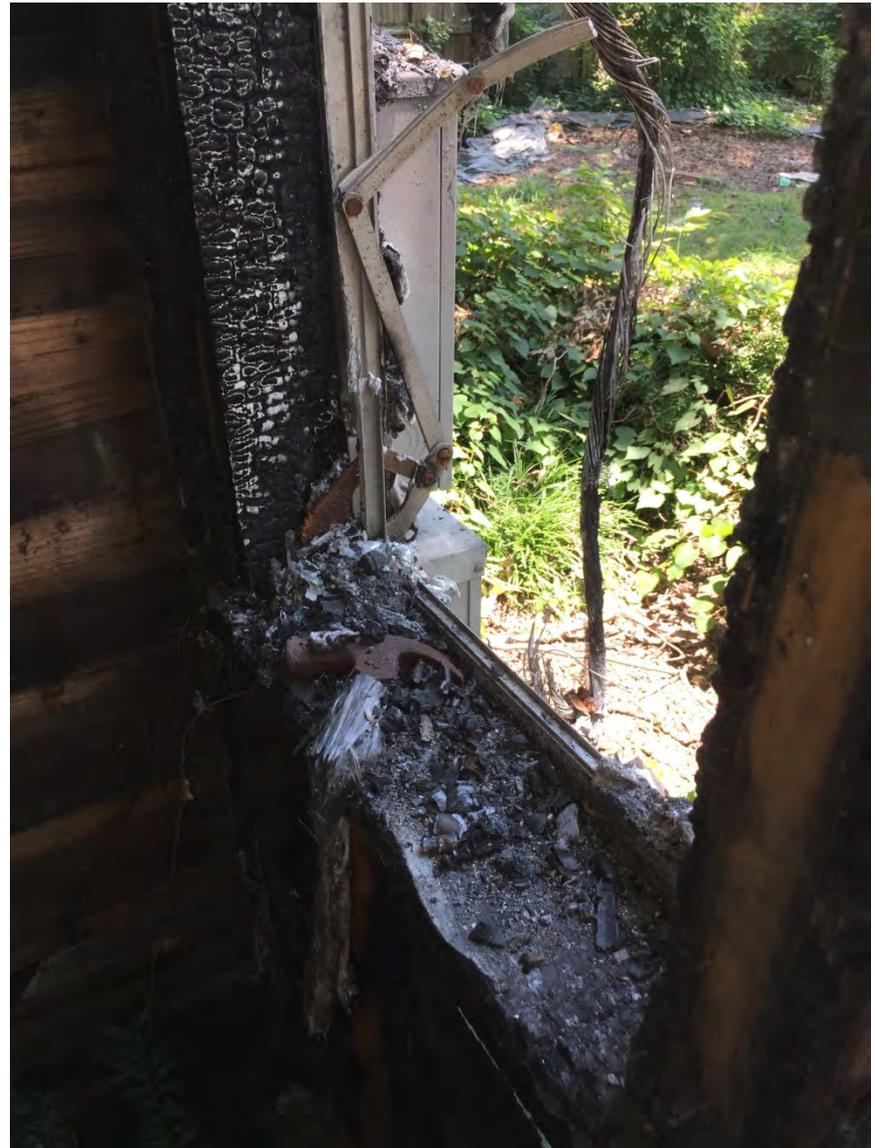
BELOW: Miscellaneous pictures showing typical unsalvageable structure. Roof, living room, kitchen, windows.
