PROPERTY ADDRESS: 1913 Cleveland Avenue

SUMMARY OF REQUEST: Demolition

Charlotte Historic District Commission - Case 2016-234
Demolition
HISTORIC DISTRICT: DILWORTH

Inspection Report

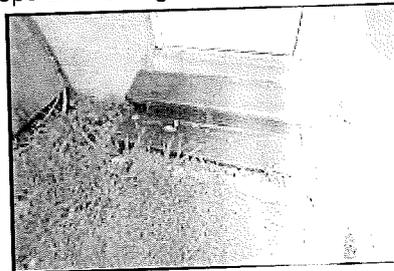
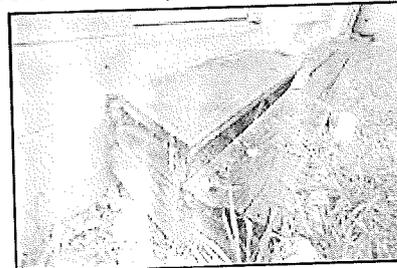
- 2.1 (2) Rear: The steps are damaged and deteriorated, recommend replacement for safety.

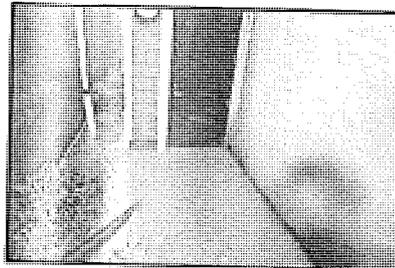
☑ (4) Evidence suggests that the landscaping at right side (facing front) directs water toward and allows surface water to stand and or puddle. Landscaping should be adjusted to direct water away from the structure/foundation area.

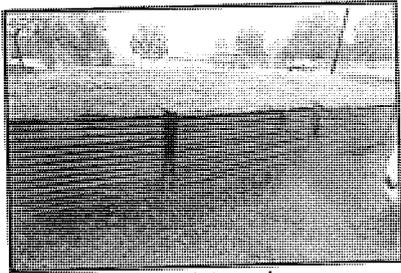
☑ **2.5** Areas of deterioration noted in front retaining wall. This condition will likely continue to get worse and this may lead to failure in the future. Recommend repairs as deemed necessary by a qualified landscaping contractor.

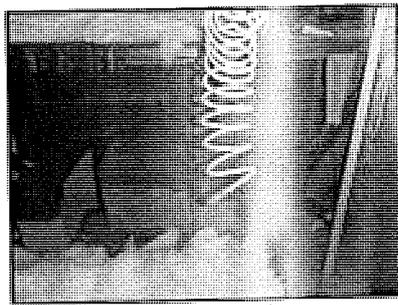
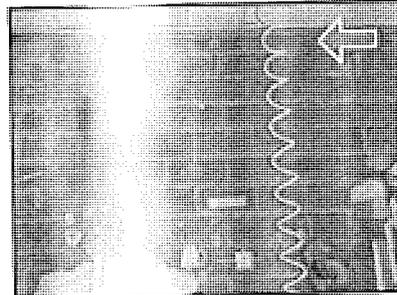
3.1 The following roofing concerns were noted during the inspection. Recommend review and repair as deemed appropriate by a qualified roofing contractor: The roof covering/flashings are past their normal life span, Evidence suggests that the roof covering/flashings should be replaced. Water noted leaking in at right side interior wall.

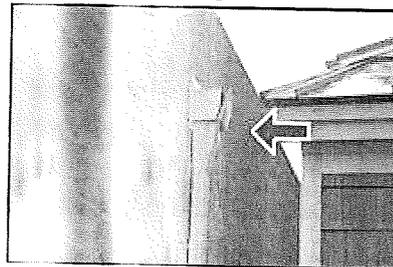
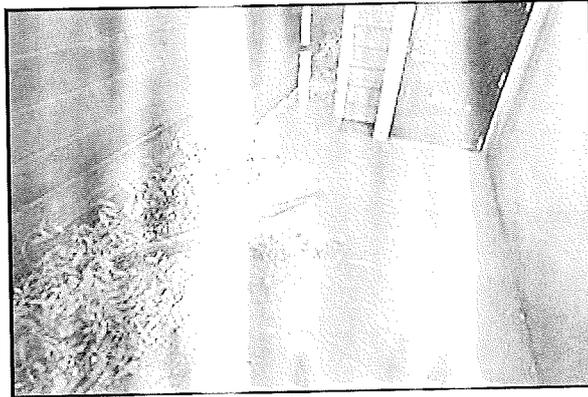
☒ (2) There are at least two damaged scuppers at right side where water leaks/spills at foundation. At right side there is standing water at foundation and blocking neighboring building service door.

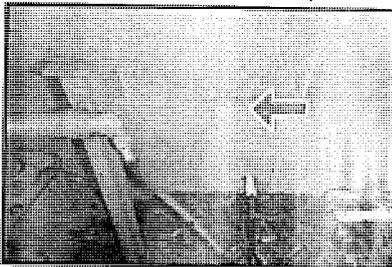
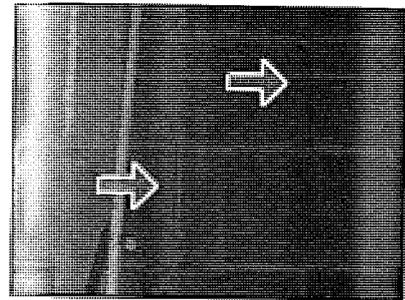
4.0 There are step cracks in the exterior masonry at left side to rear of has pak, under the left side 2nd from front window and to the upper right corner of the left side warehouse entry door (interior). Cracks of this type are typical in this age of building and this type of construction requires monitoring cracks for changes in size and or direction. If changes are noted consult a qualified contractor. Recommend repairs by a qualified contractor to prevent possible moisture penetration which can lead to deterioration of building components.

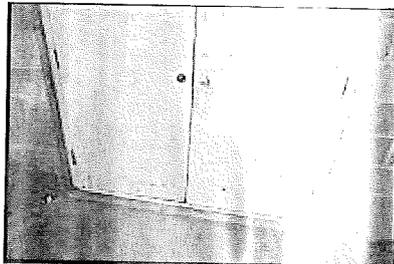
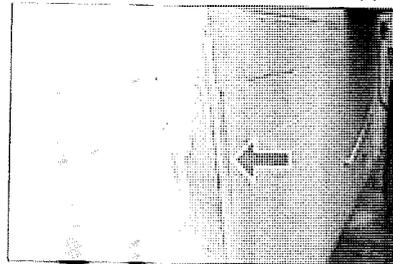
4.1 (1) Maintenance: The metal and wooden exterior trim needs to be scraped, primed and painted and re-caulked in the near future, some areas of bare wood and rusted metal showing, this is typical maintenance.

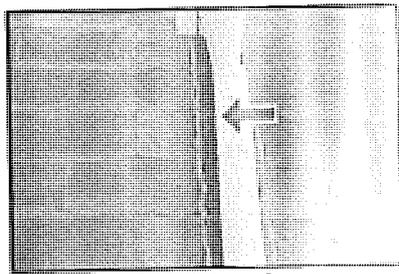
(2) Maintenance: The caulking around components such as but not limited to windows, doors and control joint/penetrations (interior & exterior) at various areas around the building need to be caulked/sealed, open voids and or missing caulking observed.

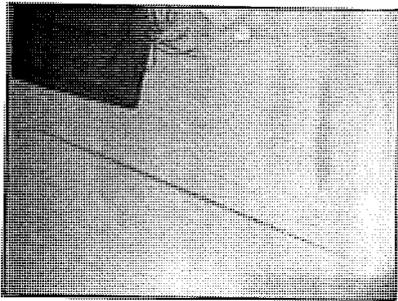
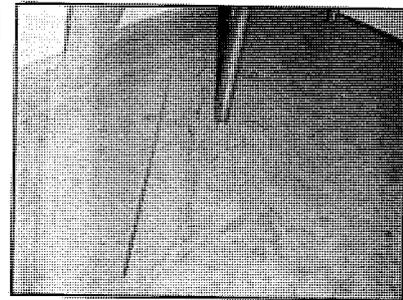
5.0 Large settlement cracks noted towards the right side of the center and left side near the front of the warehouse in the concrete slab. Recommend a qualified structural engineer evaluate to determine appropriate actions.

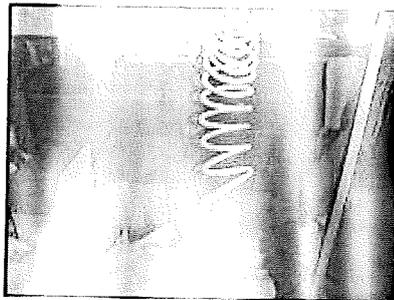
5.3 Water penetration, moisture staining and or efflorescence was observed throughout the warehouse. Recommend further evaluation by a foundation and/or crawl space moisture control contractor to eliminate any and all possibilities for water intrusion.
