LOCAL HISTORIC DISTRICT: Dilworth

PROPERTY ADDRESS: 300 East Worthington Avenue

SUMMARY OF REQUEST: Demolition

Charlotte Historic District Commission - Case 2016-235
Demolition
HISTORIC DISTRICT: DILWORTH

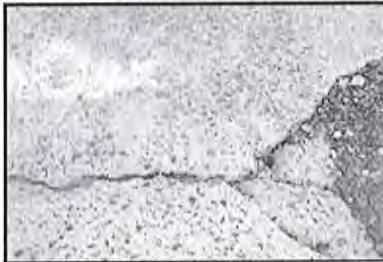
2.0 Picture 1

2.0 Maintenance: Cracks present in driveway surfaces, these cracks are common and in need of repairs and or sealant. We recommend caulking/sealing to help prevent possible future deterioration.

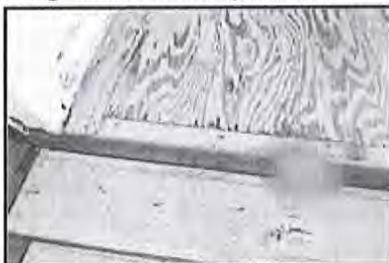
2.1 Picture 1

2.1 Front porch: There are areas of damage to flooring and the front right post is/has settled into the wood flooring. This is a safety hazard, recommend repair by a qualified contractor.

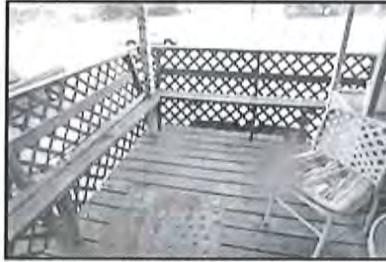
2.2 Picture 1

2.2 The rear deck steps and deck handrail pickets are missing and or are spaced too far apart. Pickets need to be installed at all railings with maximum space between pickets to be four inches or less (where platform exceeds 30 inches from ground).

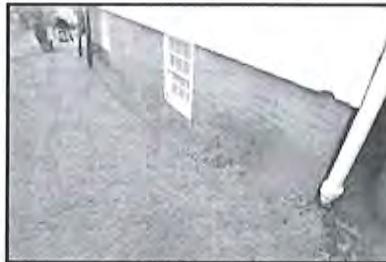
2.3 Picture 1

2.3 The grading is flat and or sloped towards the front and left side of foundation. These areas do not allow water to drain freely away from building/foundation. The grading needs to promote positive drainage away from the structure so as to direct surface water away from the foundation. It is suggested that the grading slope down away from the foundation.

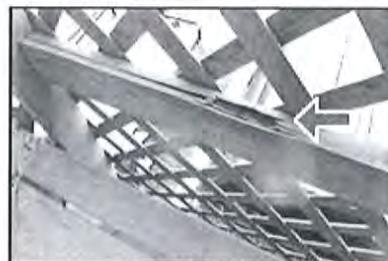
2.4 Picture 5

Areas of deterioration noted in step stringers and railings. (Picture 4,5)

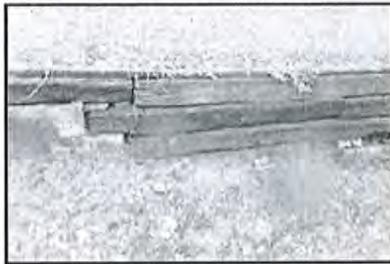
2.5 Picture 1

2.5 (1) Retaining wall at rear of site has areas of deterioration in wood, has been non typically

patched/repared over the years. There are pieces missing in the wall at rear. At left side there are loose block and metal bands/anchors in wall.

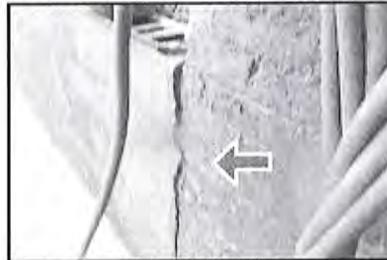
2.5 Picture 7

(3) Retaining wall at rear right of the building leans and has separated from the homes foundation. This condition may continue to get worse, recommend repairs by a licensed contractor.

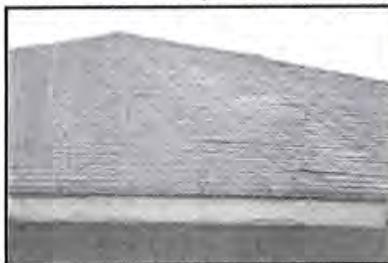
3.0 Picture 1

3.0 The roof shows typical wear for its age. The roofing shingles are 20 year type roof shingles, these roof shingles usually last between 15 to 18 years. The roof covering/flashings are past their normal life span, Evidence suggests that the roof covering/flashings should be replaced. The old roof covering and flashing should be removed prior to the installation of the new materials.

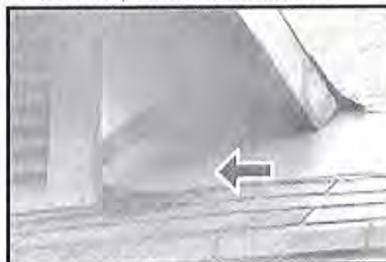
3.2 Picture 1

3.2 (1) The following roof flashing/penetration concerns were noted during the inspection. Further review and repair as deemed appropriate: At front dormer shingles have been used as flashing, these can crack (no designed to bend) and lead to premature failure.

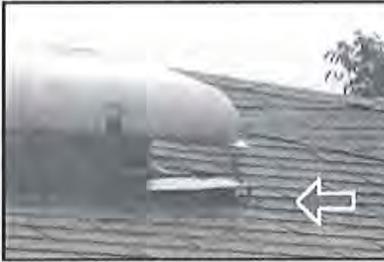
3.2 Picture 3

(2) Metal and or rubber vent flashing at roof has raised bottom edges. At some locations the nails have backed out of the flashing. Recommend flashing be secured flat to the roof to prevent possible water intrusion or damage in high winds.

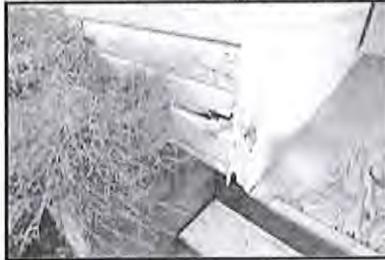
4.0 Picture 1

**4.0 (1)** The siding shows signs of moisture damage, softness and or deterioration at various areas along various areas including: front left of the front porch. This can lead to deterioration of interior framing, possible hidden damage noted in this area. Recommend repairs by a qualified contractor.

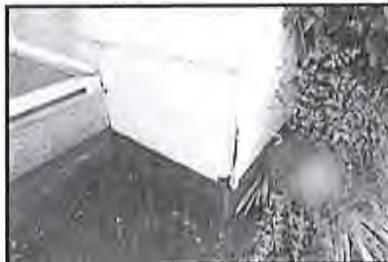
4.0 Picture 2

**(2)** Portions of the home appear to be clad with asbestos slate type shingles. Noted multiple damaged tiles around the home, this may be a health hazard. Recommend proper testing prior to repairs and or removal of damaged tile.

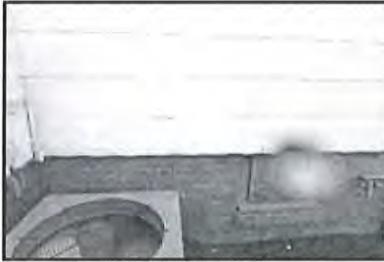
4.0 Picture 4

**(3) Maintenance:** Siding and trim needs to be scraped, primed, painted/sealed and caulked at various areas around the entire building, this is typical maintenance. Minor moisture penetration and surface deterioration noted at some areas. Due to age there is possible presence of lead based paints, recommend proper testing prior to any work for safety.

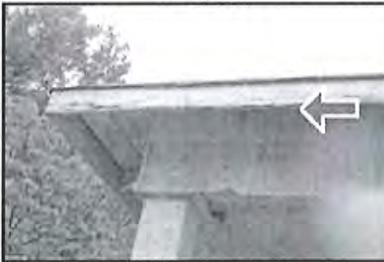
4.1 Picture 1

4.1 Maintenance: The wooden exterior trim needs to be scraped, primed and painted and re-caulked in the near future, some areas of bare wood showing, this is typical maintenance. Due to age there is possible presence of lead based paints, recommend proper testing prior to any work for safety.

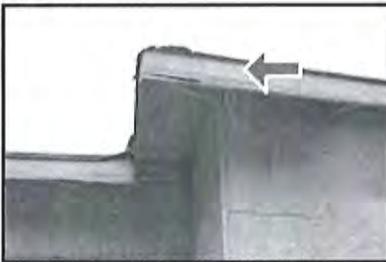
4.2 Picture 1 right side

4.2 Moisture damage visible at fascia at multiple areas including: right side and left side. Continued deterioration may lead to moisture intrusion into wood structural components, there is possible hidden in roof/wall framing damage. Recommend further investigation and repairs as deemed necessary by a licensed contractor.

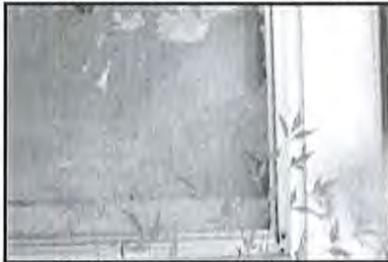
4.5 Picture 1 Right Side

4.5 (1) Window(s) has cracked/broken glass at several windows including: right side front, left side 2nd from rear, left side front of basement, rear sunroom/addition wall and left rear room at rear wall. Evaluation/correction by qualified contractor recommended.

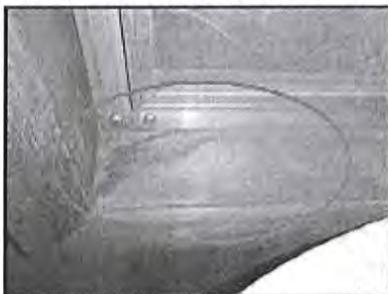
4.5 Picture 6

4.5 (2) Moisture stains noted at interior window sills in the left front sunroom/addition.

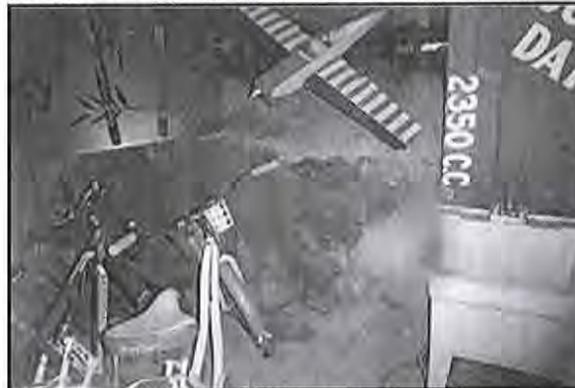
5.0 Picture 1

**5.0** A section of the front foundation is missing at front right of the basement. Only a dirt wall is present at front of the basement to the crawl space under the front porch. Recommend further investigation and repair recommendation by a qualified engineer to ensure proper structural support.

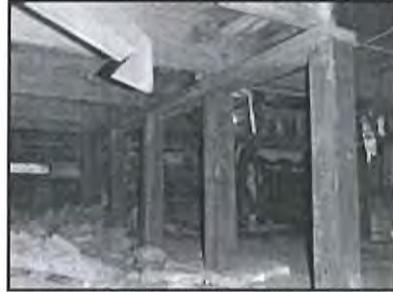
5.2 Picture 2

Non typical wood column/framing support noted at front porch area. (Picture 2)

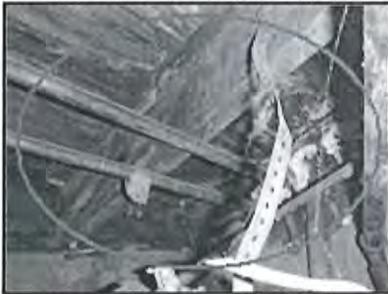
5.2 Picture 3

🏠 (2) Evidence of moisture stains and or moisture damaged at floor joists and or the sub-structure in the basement underneath the hall bathroom and kitchen. Recommend further investigation of all floor framing and repair recommendation by a qualified engineer.

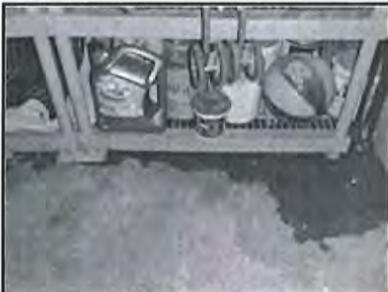
5.4 Picture 1

🏠 5.4 (1) Evidence of water/moisture present inside the basement foundation area. The basement ground was wet at the time of inspection. The basement is open to the crawl space under the front porch, this is a least one water entry point. This water/moisture entry needs to be eliminated to reduce dampness in the structure/foundation that may lead to deterioration of the building components.

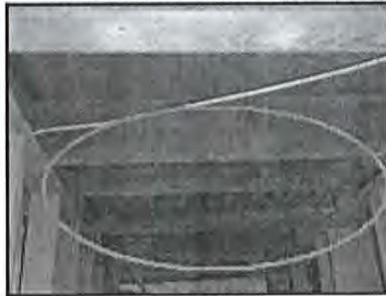
5.4 Picture 6

☒ (2) Discoloration and small amounts of fungal type growth is present on floor system in various areas throughout the basement. Evidence suggests that this condition is from past and or present elevated moisture/humidity conditions. Recommend review and repair by properly qualified/licensed specialists.

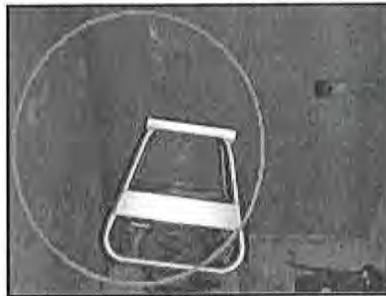
5.4 Picture 7

☒ (3) Water penetration, moisture staining and or efflorescence was observed in the basement at the front and right side walls. Recommend further evaluation by a foundation and or crawl space moisture control contractor to eliminate any and all possibilities for water intrusion.

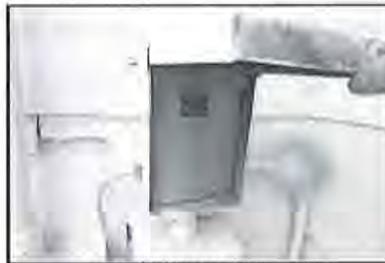
6.2 Picture 1

6.2 (1) Investigate Further - The electric sub panel installed in the subject house is a Federal Pacific, the panel and equipment has had a higher than normal failure/defect rate and is known for having many adverse problems/concerns.

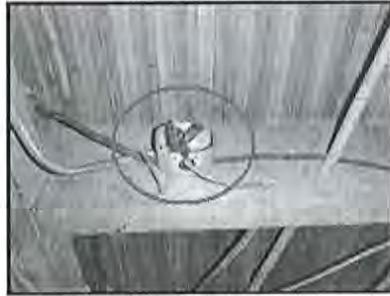
6.3 Picture 1

6.3 Open wire splices/junction boxes were observed at basement. All wiring connections should be protected in a enclosed approved electric junction box. Recommend review and repair by properly qualified contractor.

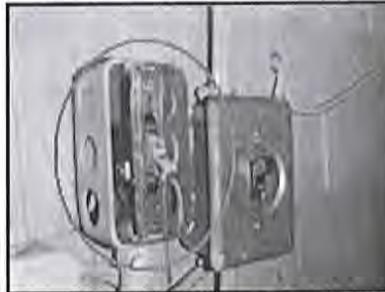
6.4 Picture 1

(3) Electric switch cover plate is missing at basement entry from the second floor. Recommend replacement for safety.

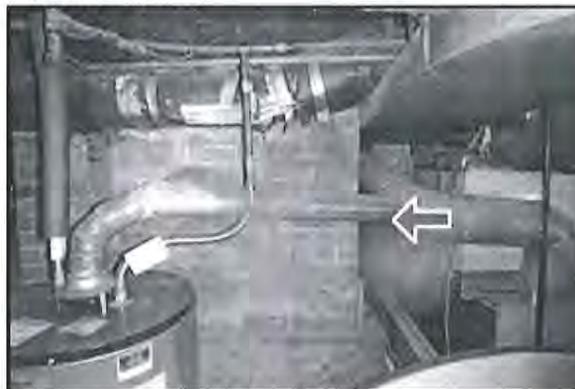
7.2 Picture 2

7.2 (2) Vent pipe for gas water heater fails to rise 1/4 inch per foot and may need re-locating or a power vent installed. This can allow combustion products to leak out into the home. Recommend a licensed heat contractor inspect further and repair as needed.

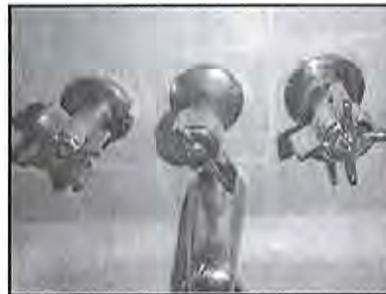
7.4 Picture 1

Evidence of previous repairs and cracked tile at tile wall at/around the tub faucets in the second floor hall bathroom. This can be a moisture entry point behind the tub enclosure. Recommend repair and or replacement of cracked tile.

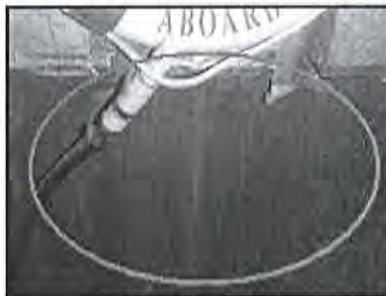
8.1 Picture 1

8.1 The following HVAC system concerns were noted during the inspection. Recommend review and repair as deemed appropriate: Evidence of past and or present moisture conditions (water, rust and water stains) present on top of air handler unit located in the basement. This is a typical past and or present indication of the air handler, A-coil and or refrigerant lines leaking and or not draining properly, also the condensation drain piping maybe clogged.

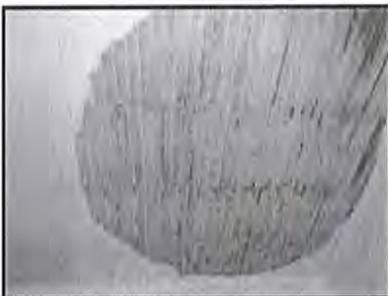
9.0 Picture 1

9.0 Damaged/missing plaster at right front room ceiling.

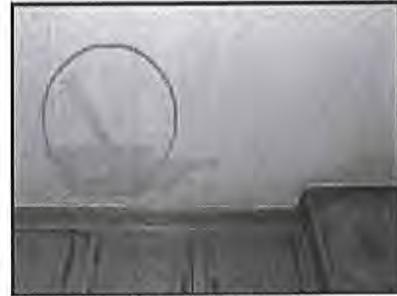
9.0 Picture 3

Evidence of plaster cracks noted in the kitchen.

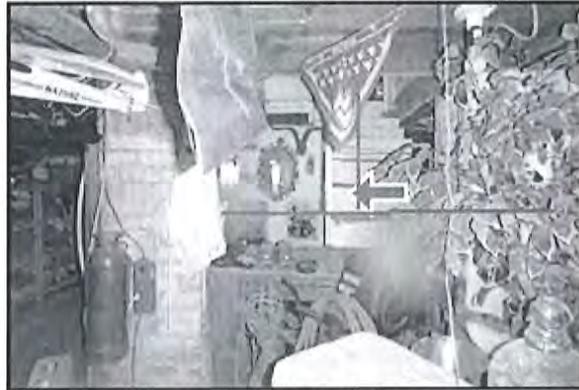
9.4 Picture 1

9.4 The stairs/hall handrail pickets are missing and or are spaced too far apart. Pickets need to be installed at all railings with maximum space between pickets to be four inches or less (where landing extends over the steps). This is a fall hazard, recommend repairs by a licensed contractor.

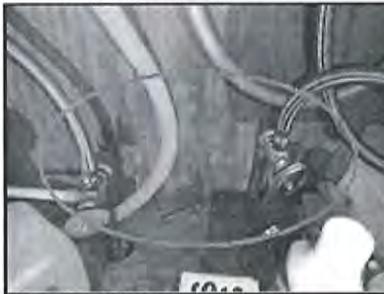
9.5 Picture 1

9.5 Water/moisture stains and small amounts of fungi type growth is visible in the kitchen sink base cabinet. Evidence suggests that this condition is possibly from a past and or present plumbing leak and or stored items. Recommend review and repair by a properly qualified person.
