PROPERTY ADDRESS: 804 East Kingston Avenue

SUMMARY OF REQUEST: Tree removal

Charlotte Historic District Commission Case 2017-429
HISTORIC DISTRICT: DILWORTH
TREE REMOVAL

RE: Risk Assessment of 42" Willow Oak (*Quercus phellos*)

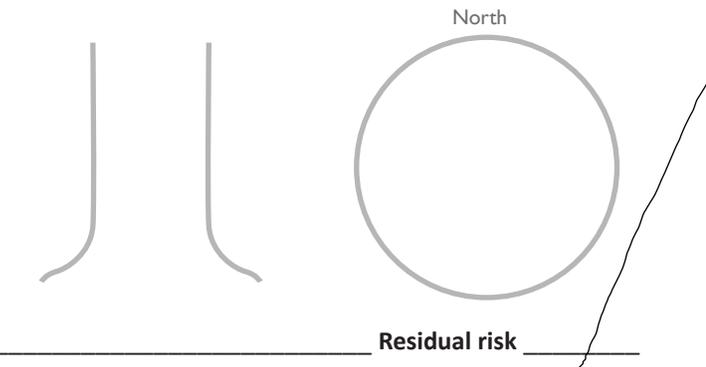
Notes, explanations, descriptions _____
 2 cavities at 30' In right lead
 Diam. 28", cavity total 16", Opening total 14"
 Total strength loss... 32% In right lead
 Drilling results... Less than 5% S.L. In lower trunk

Mitigation options Removal is recommended Residual risk _____
 _____ Residual risk _____
 _____ Residual risk _____
 _____ Residual risk _____
