Charlotte Historic District Commission Case 2017-702
HISTORIC DISTRICT: FOURTH WARD
TREE REMOVAL

December 6, 2017

Re: Greene Residence Maple Tree

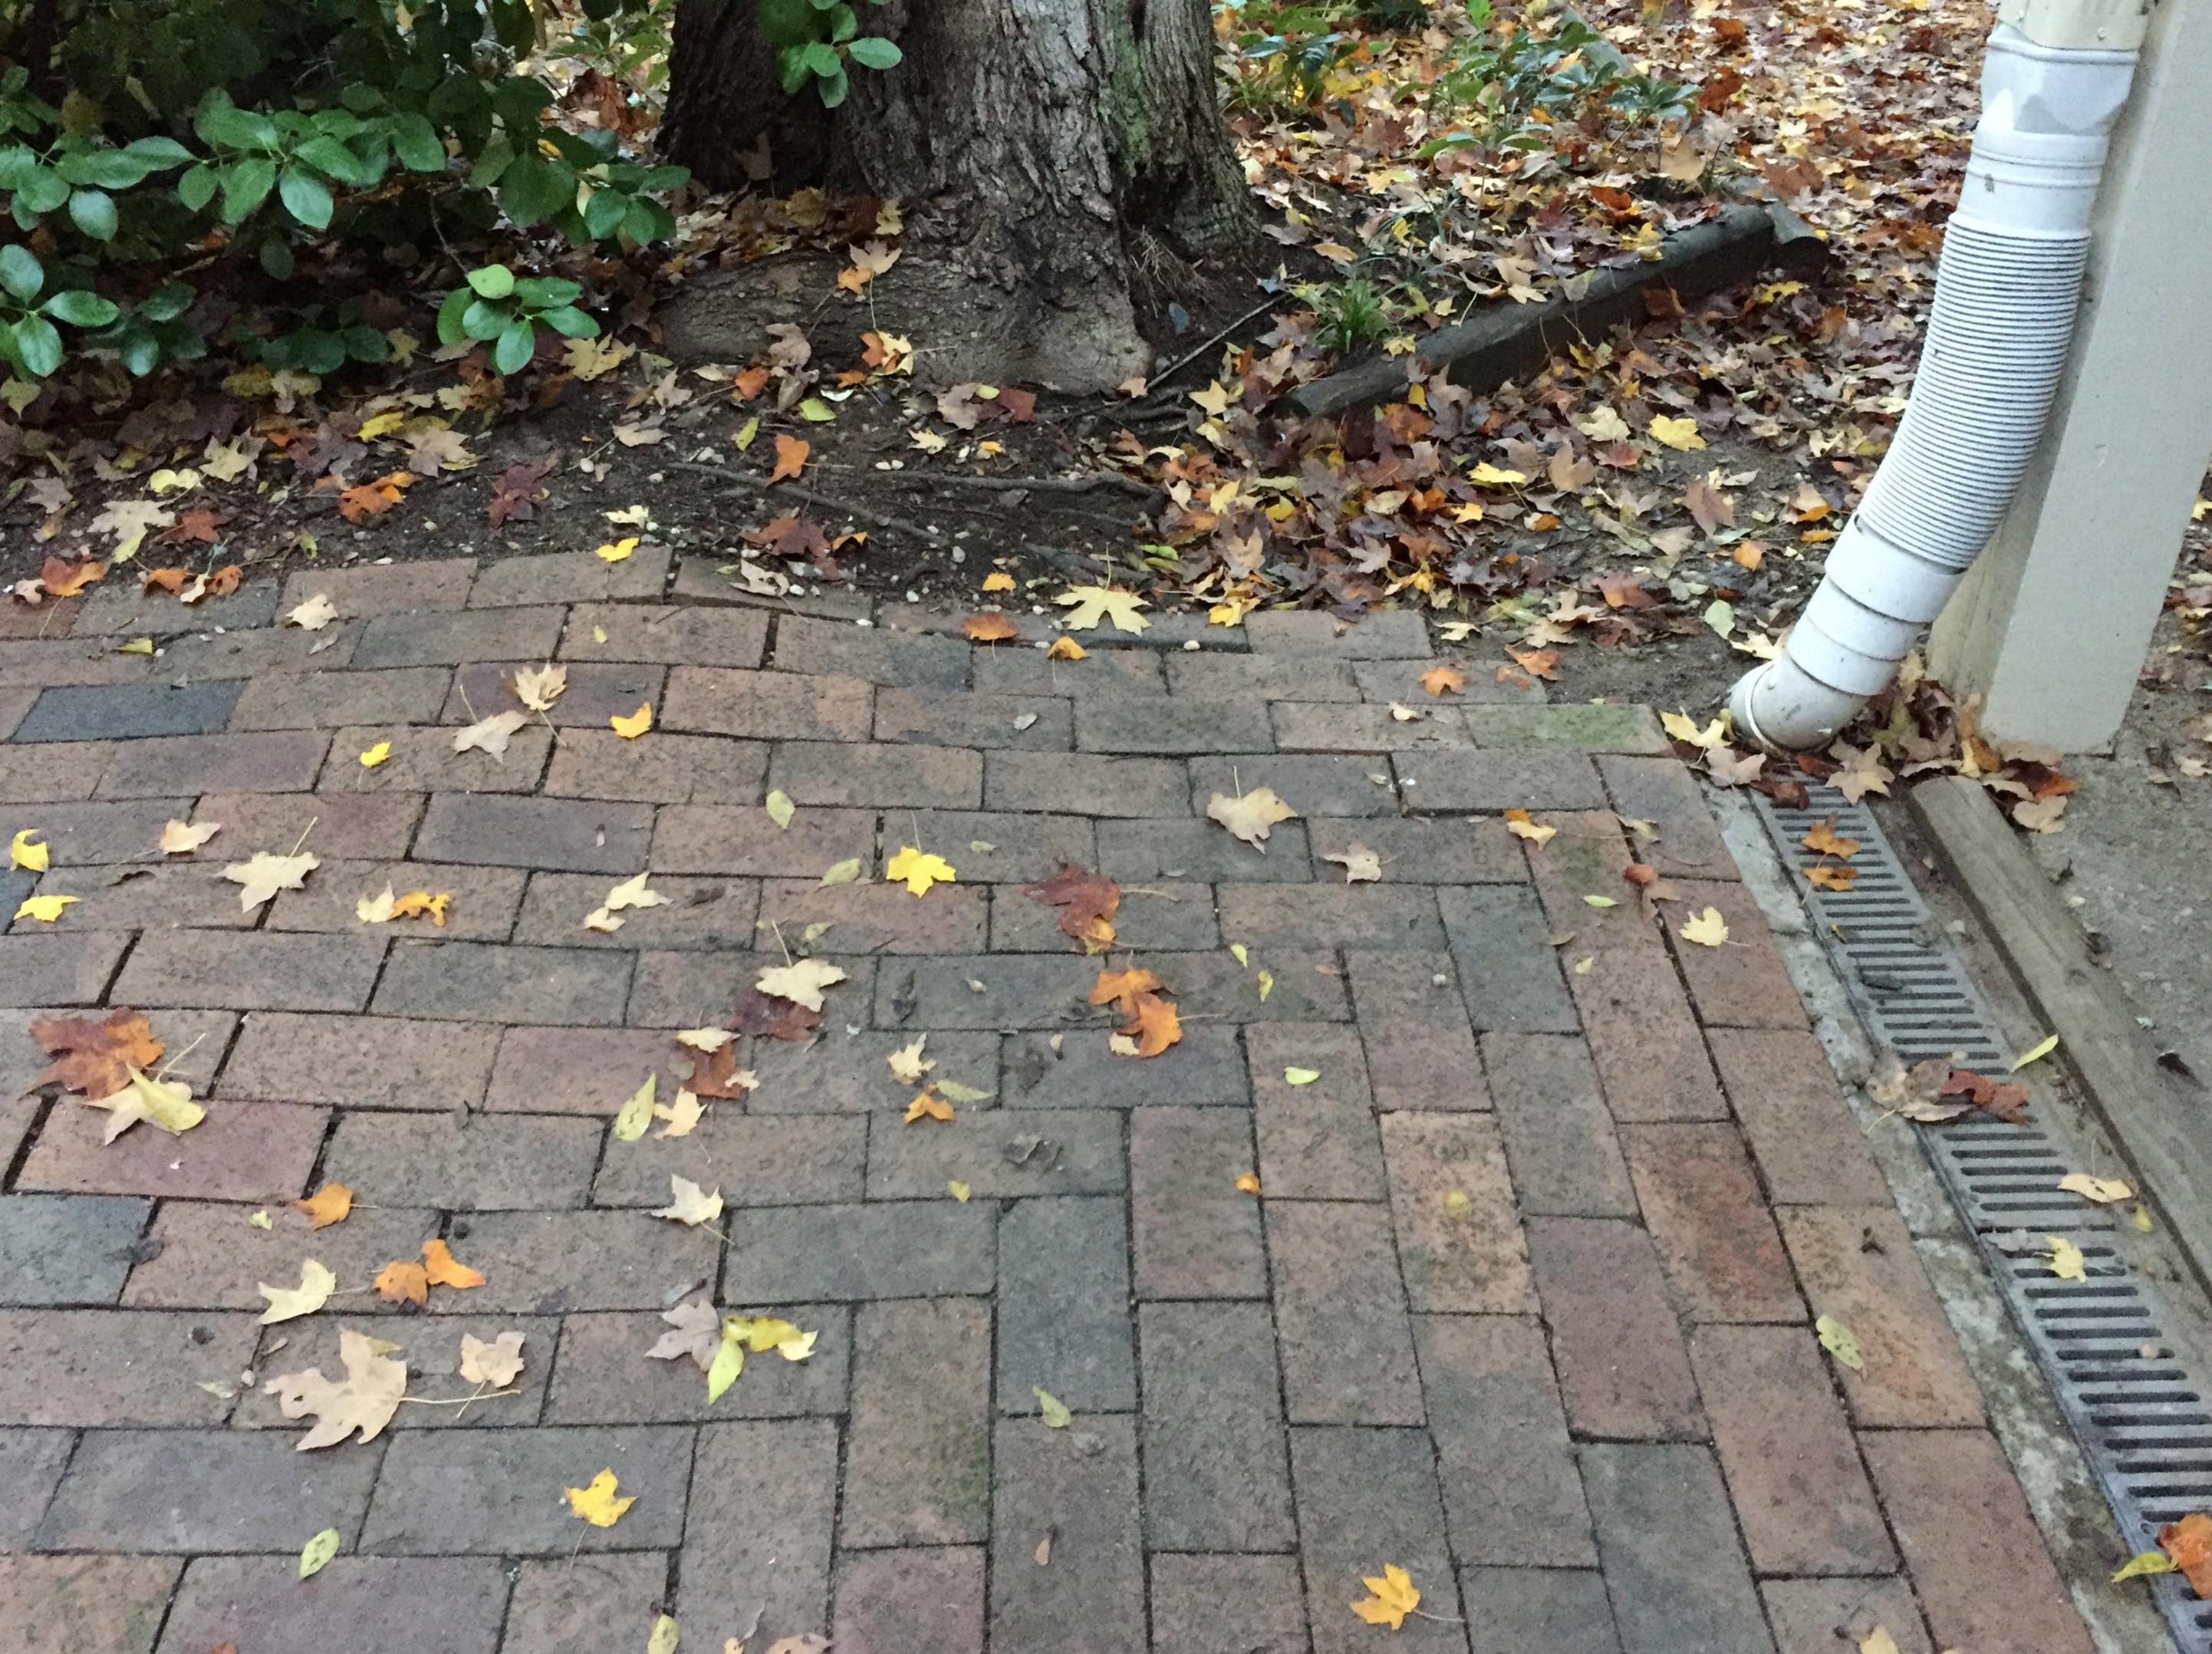
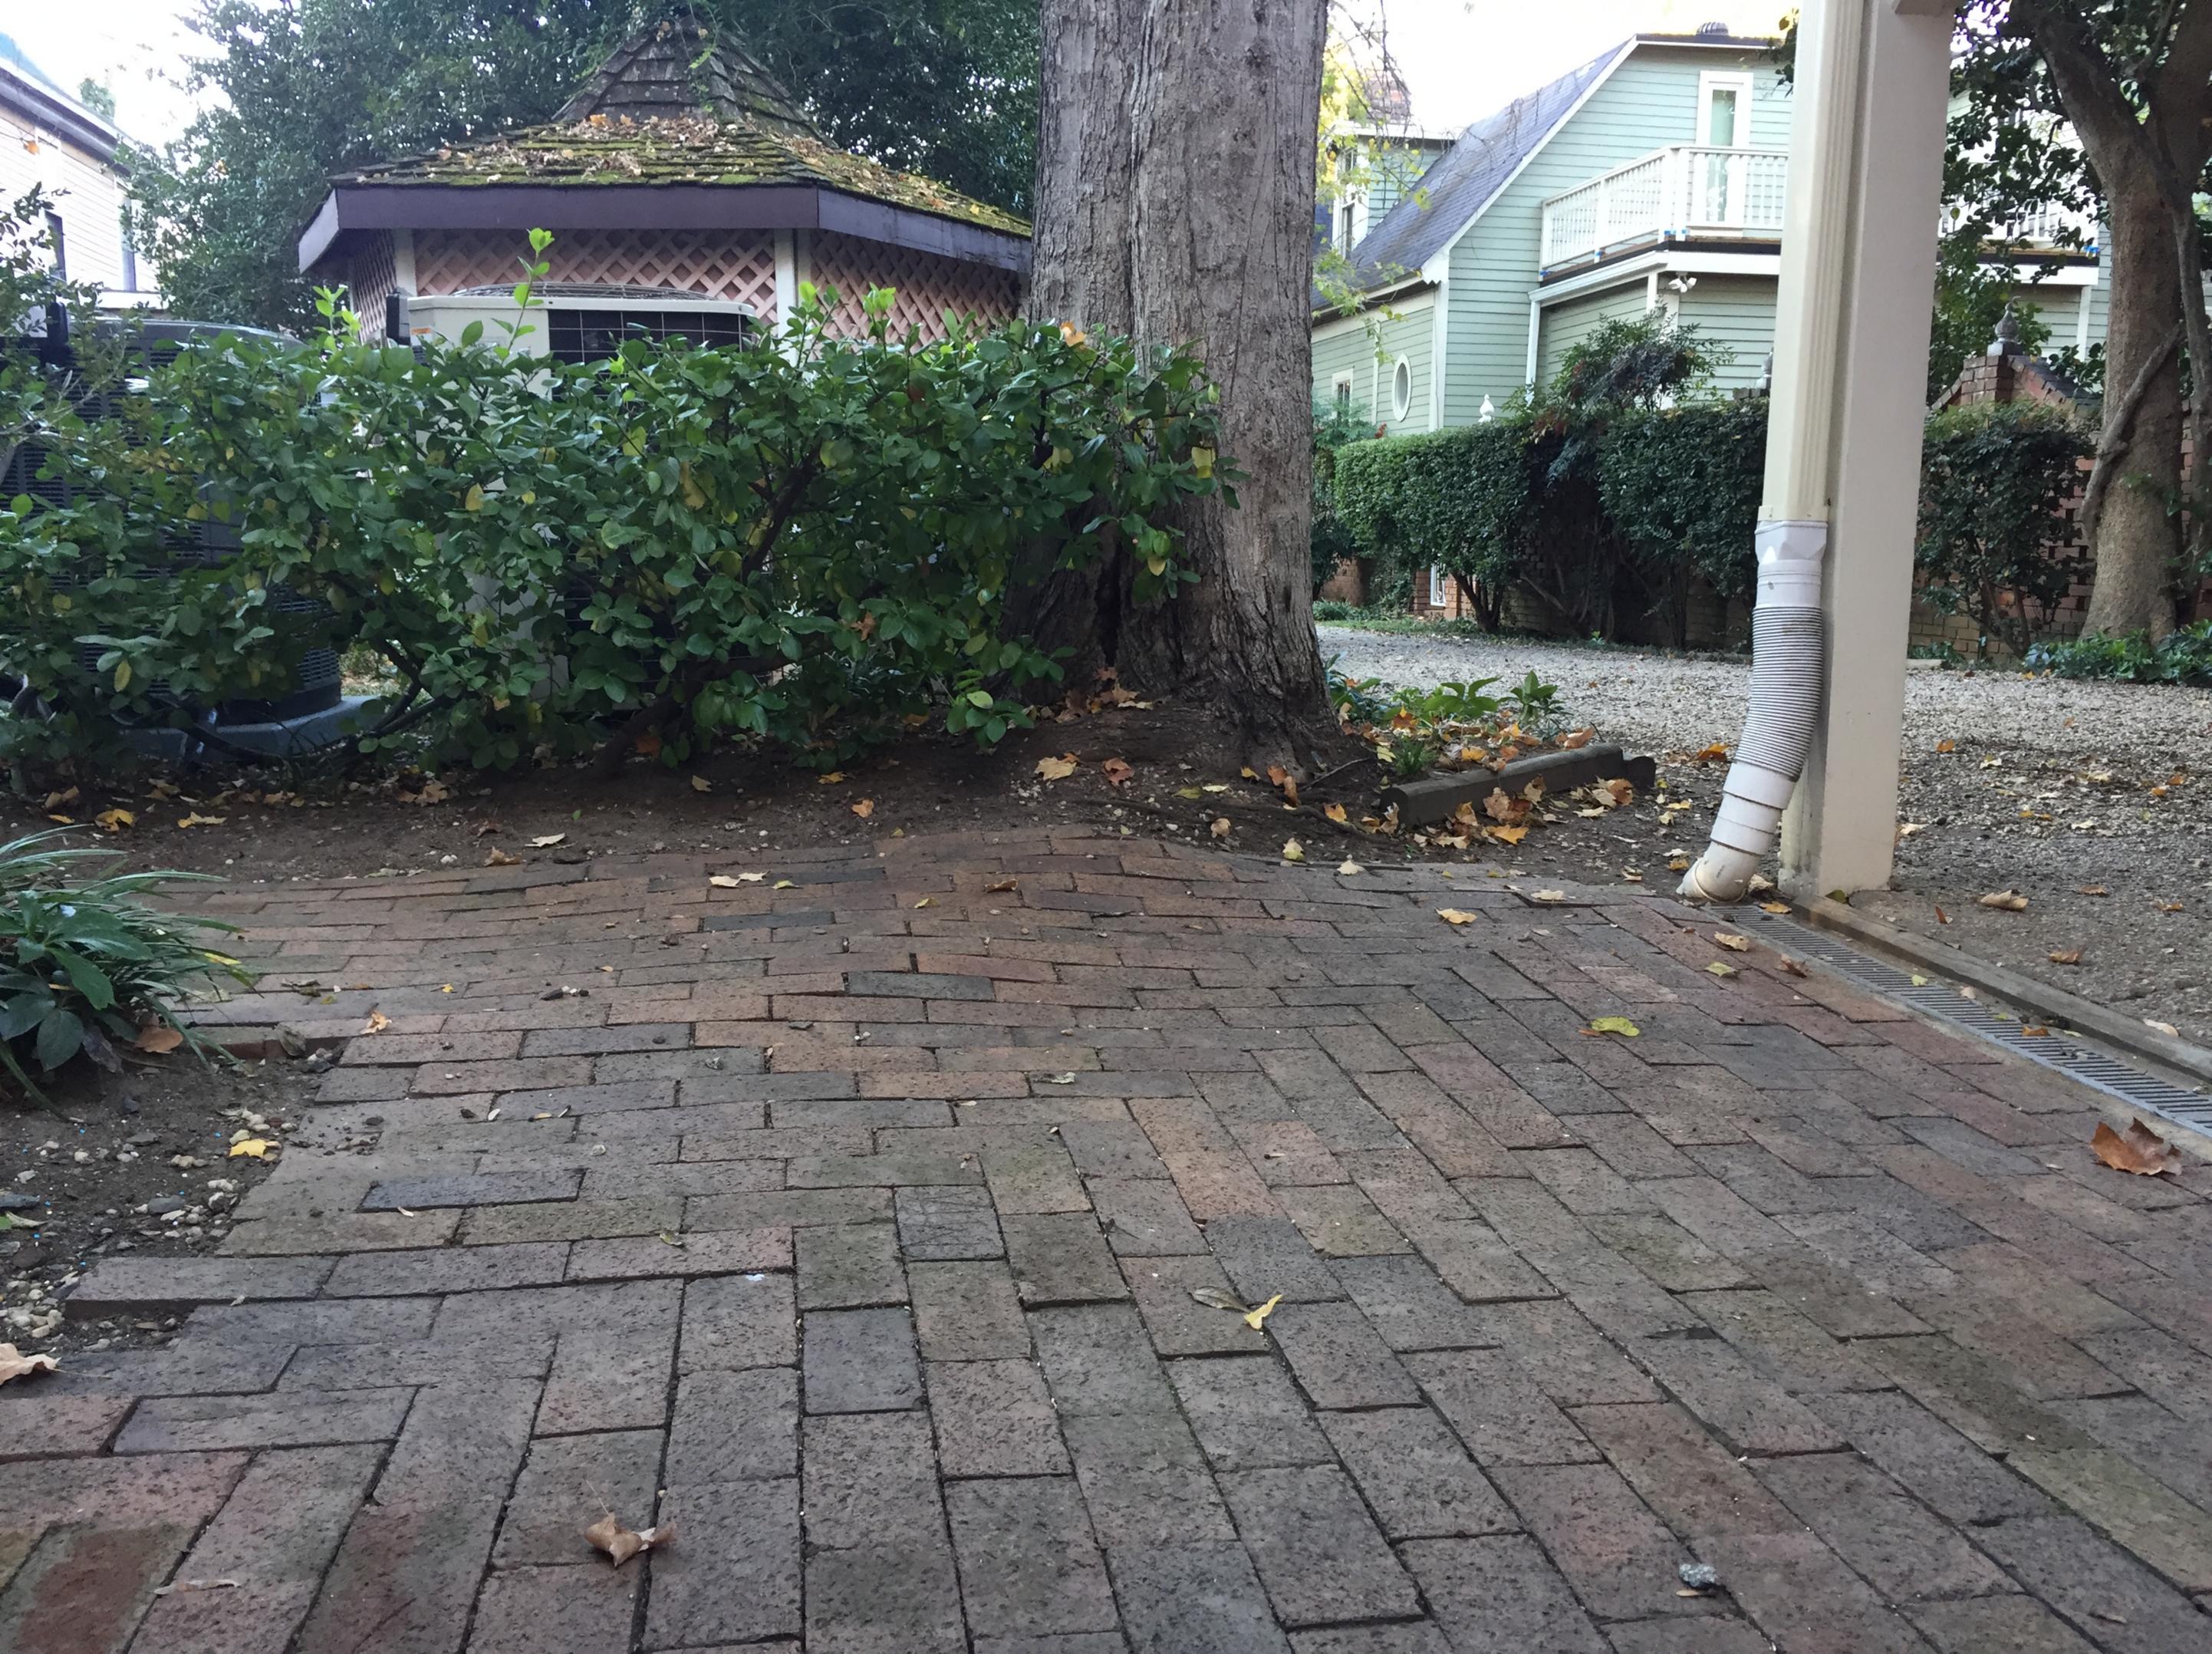
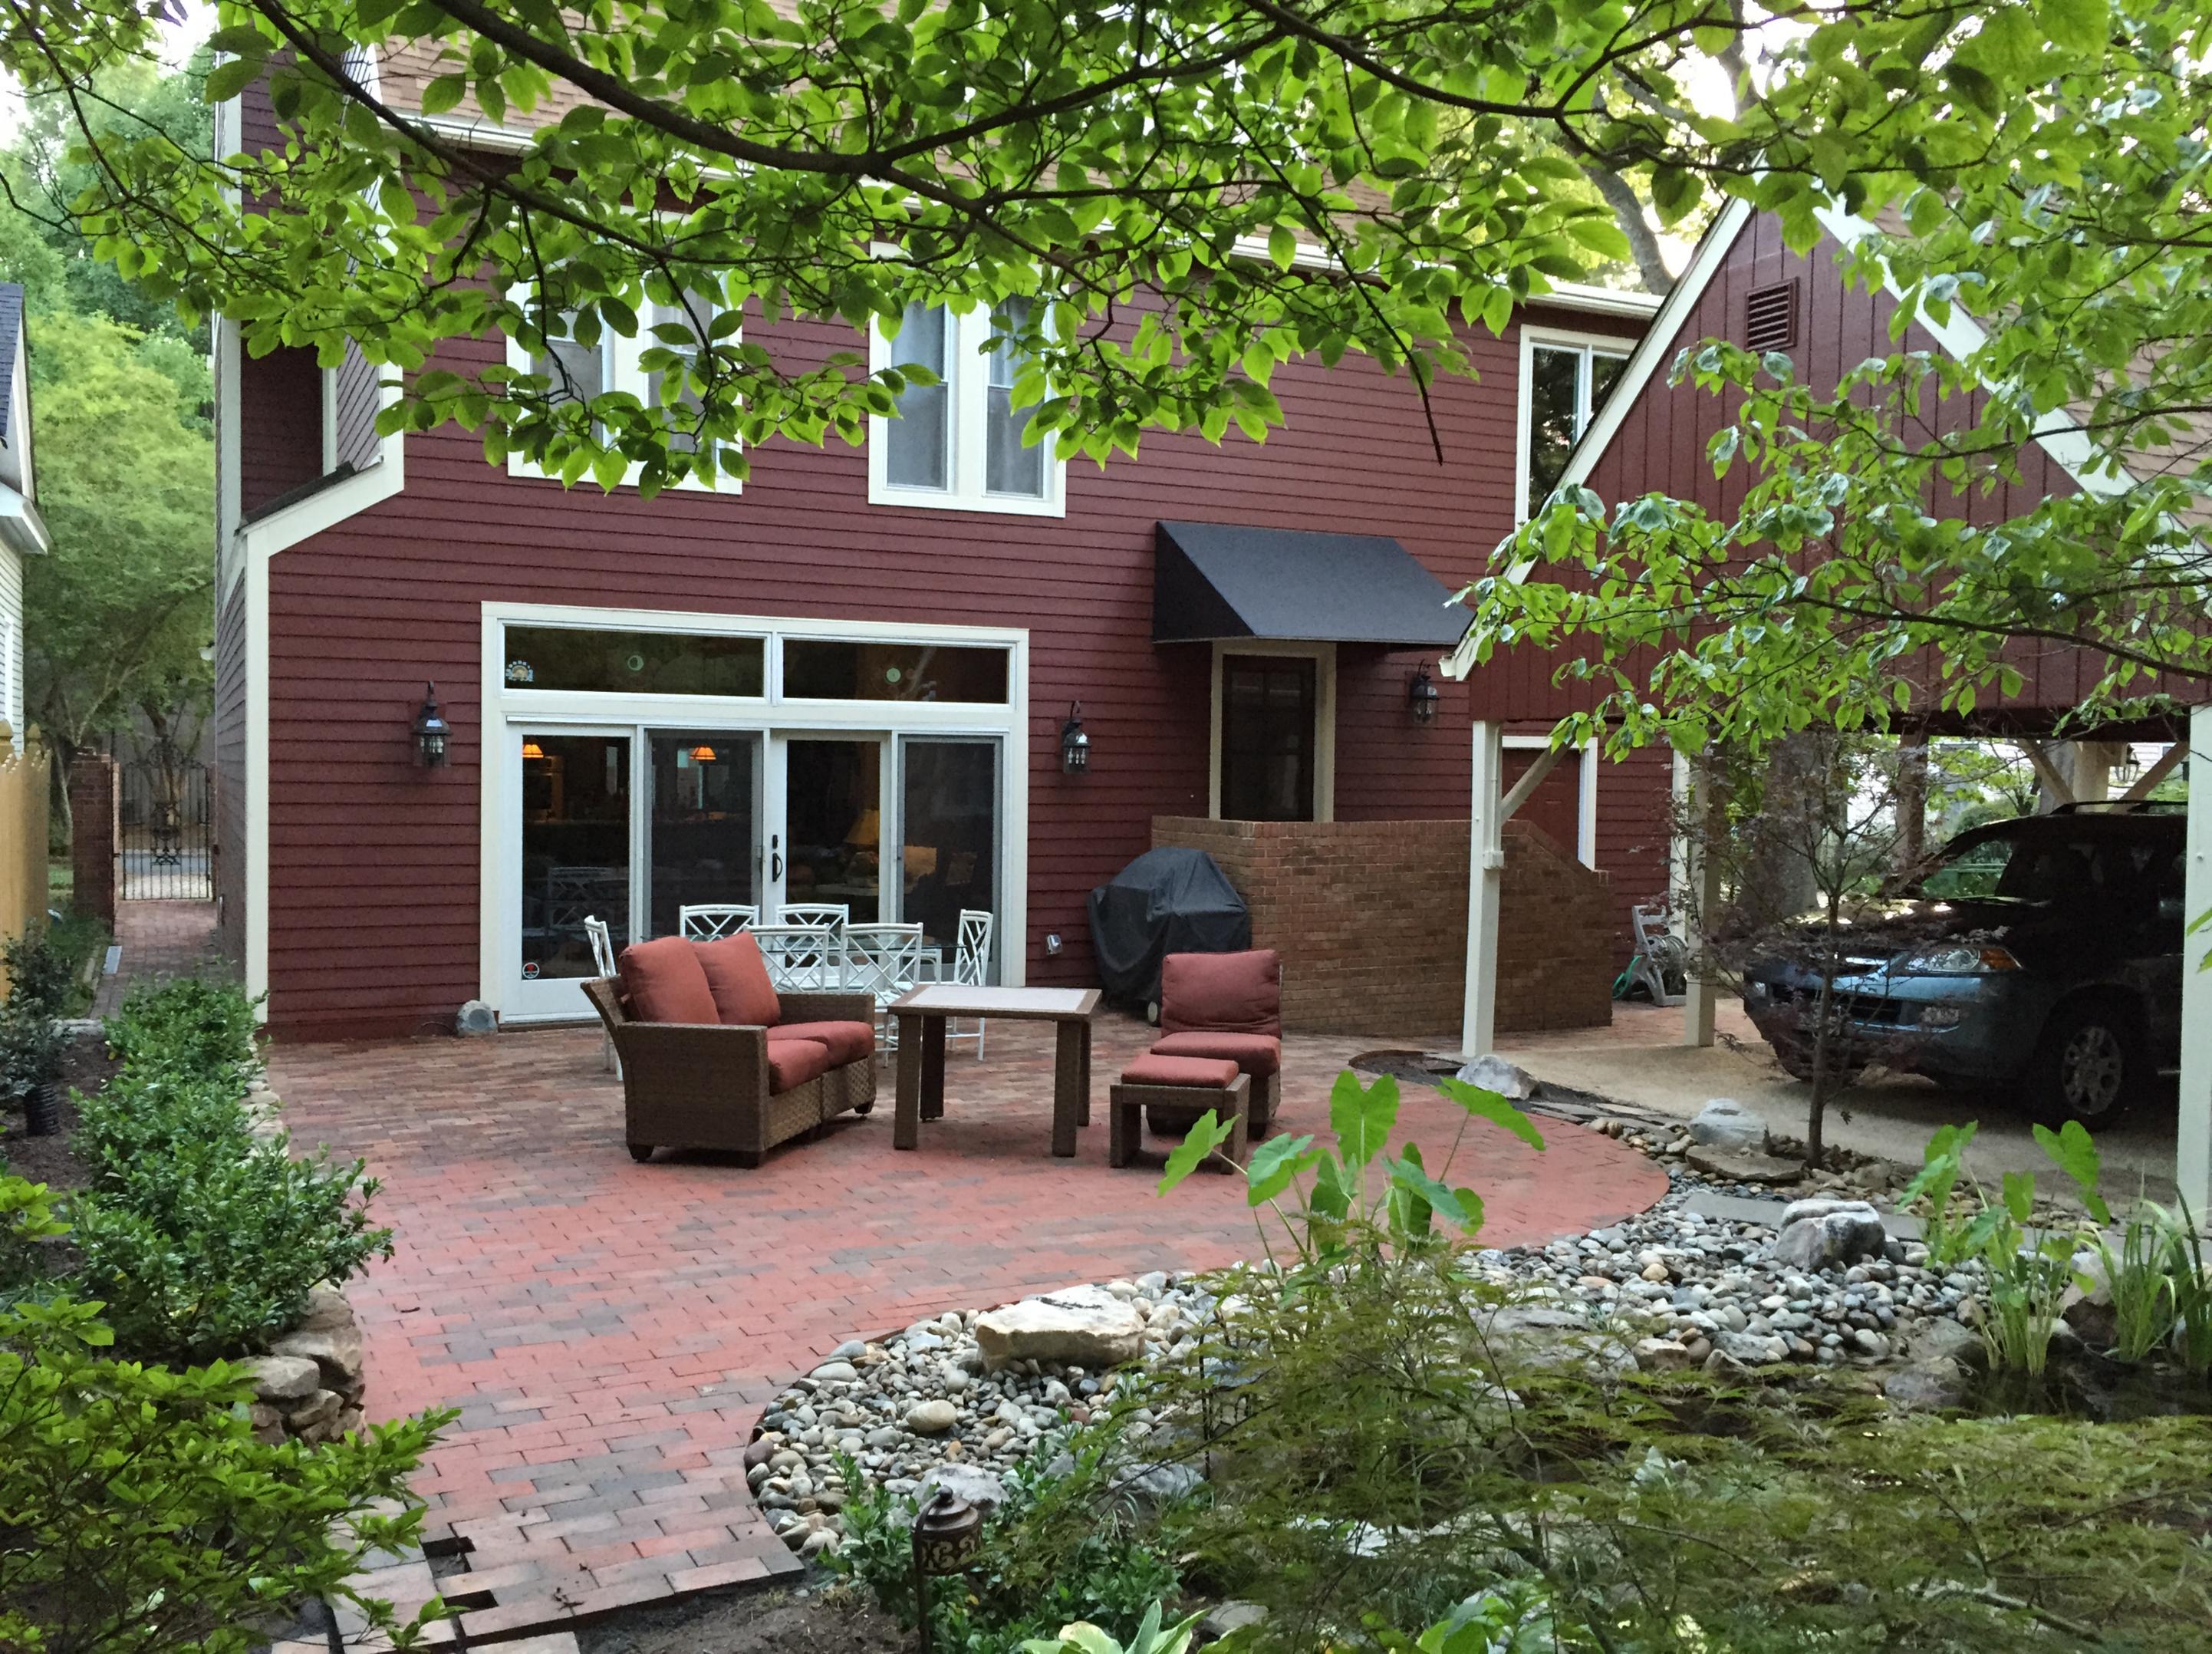
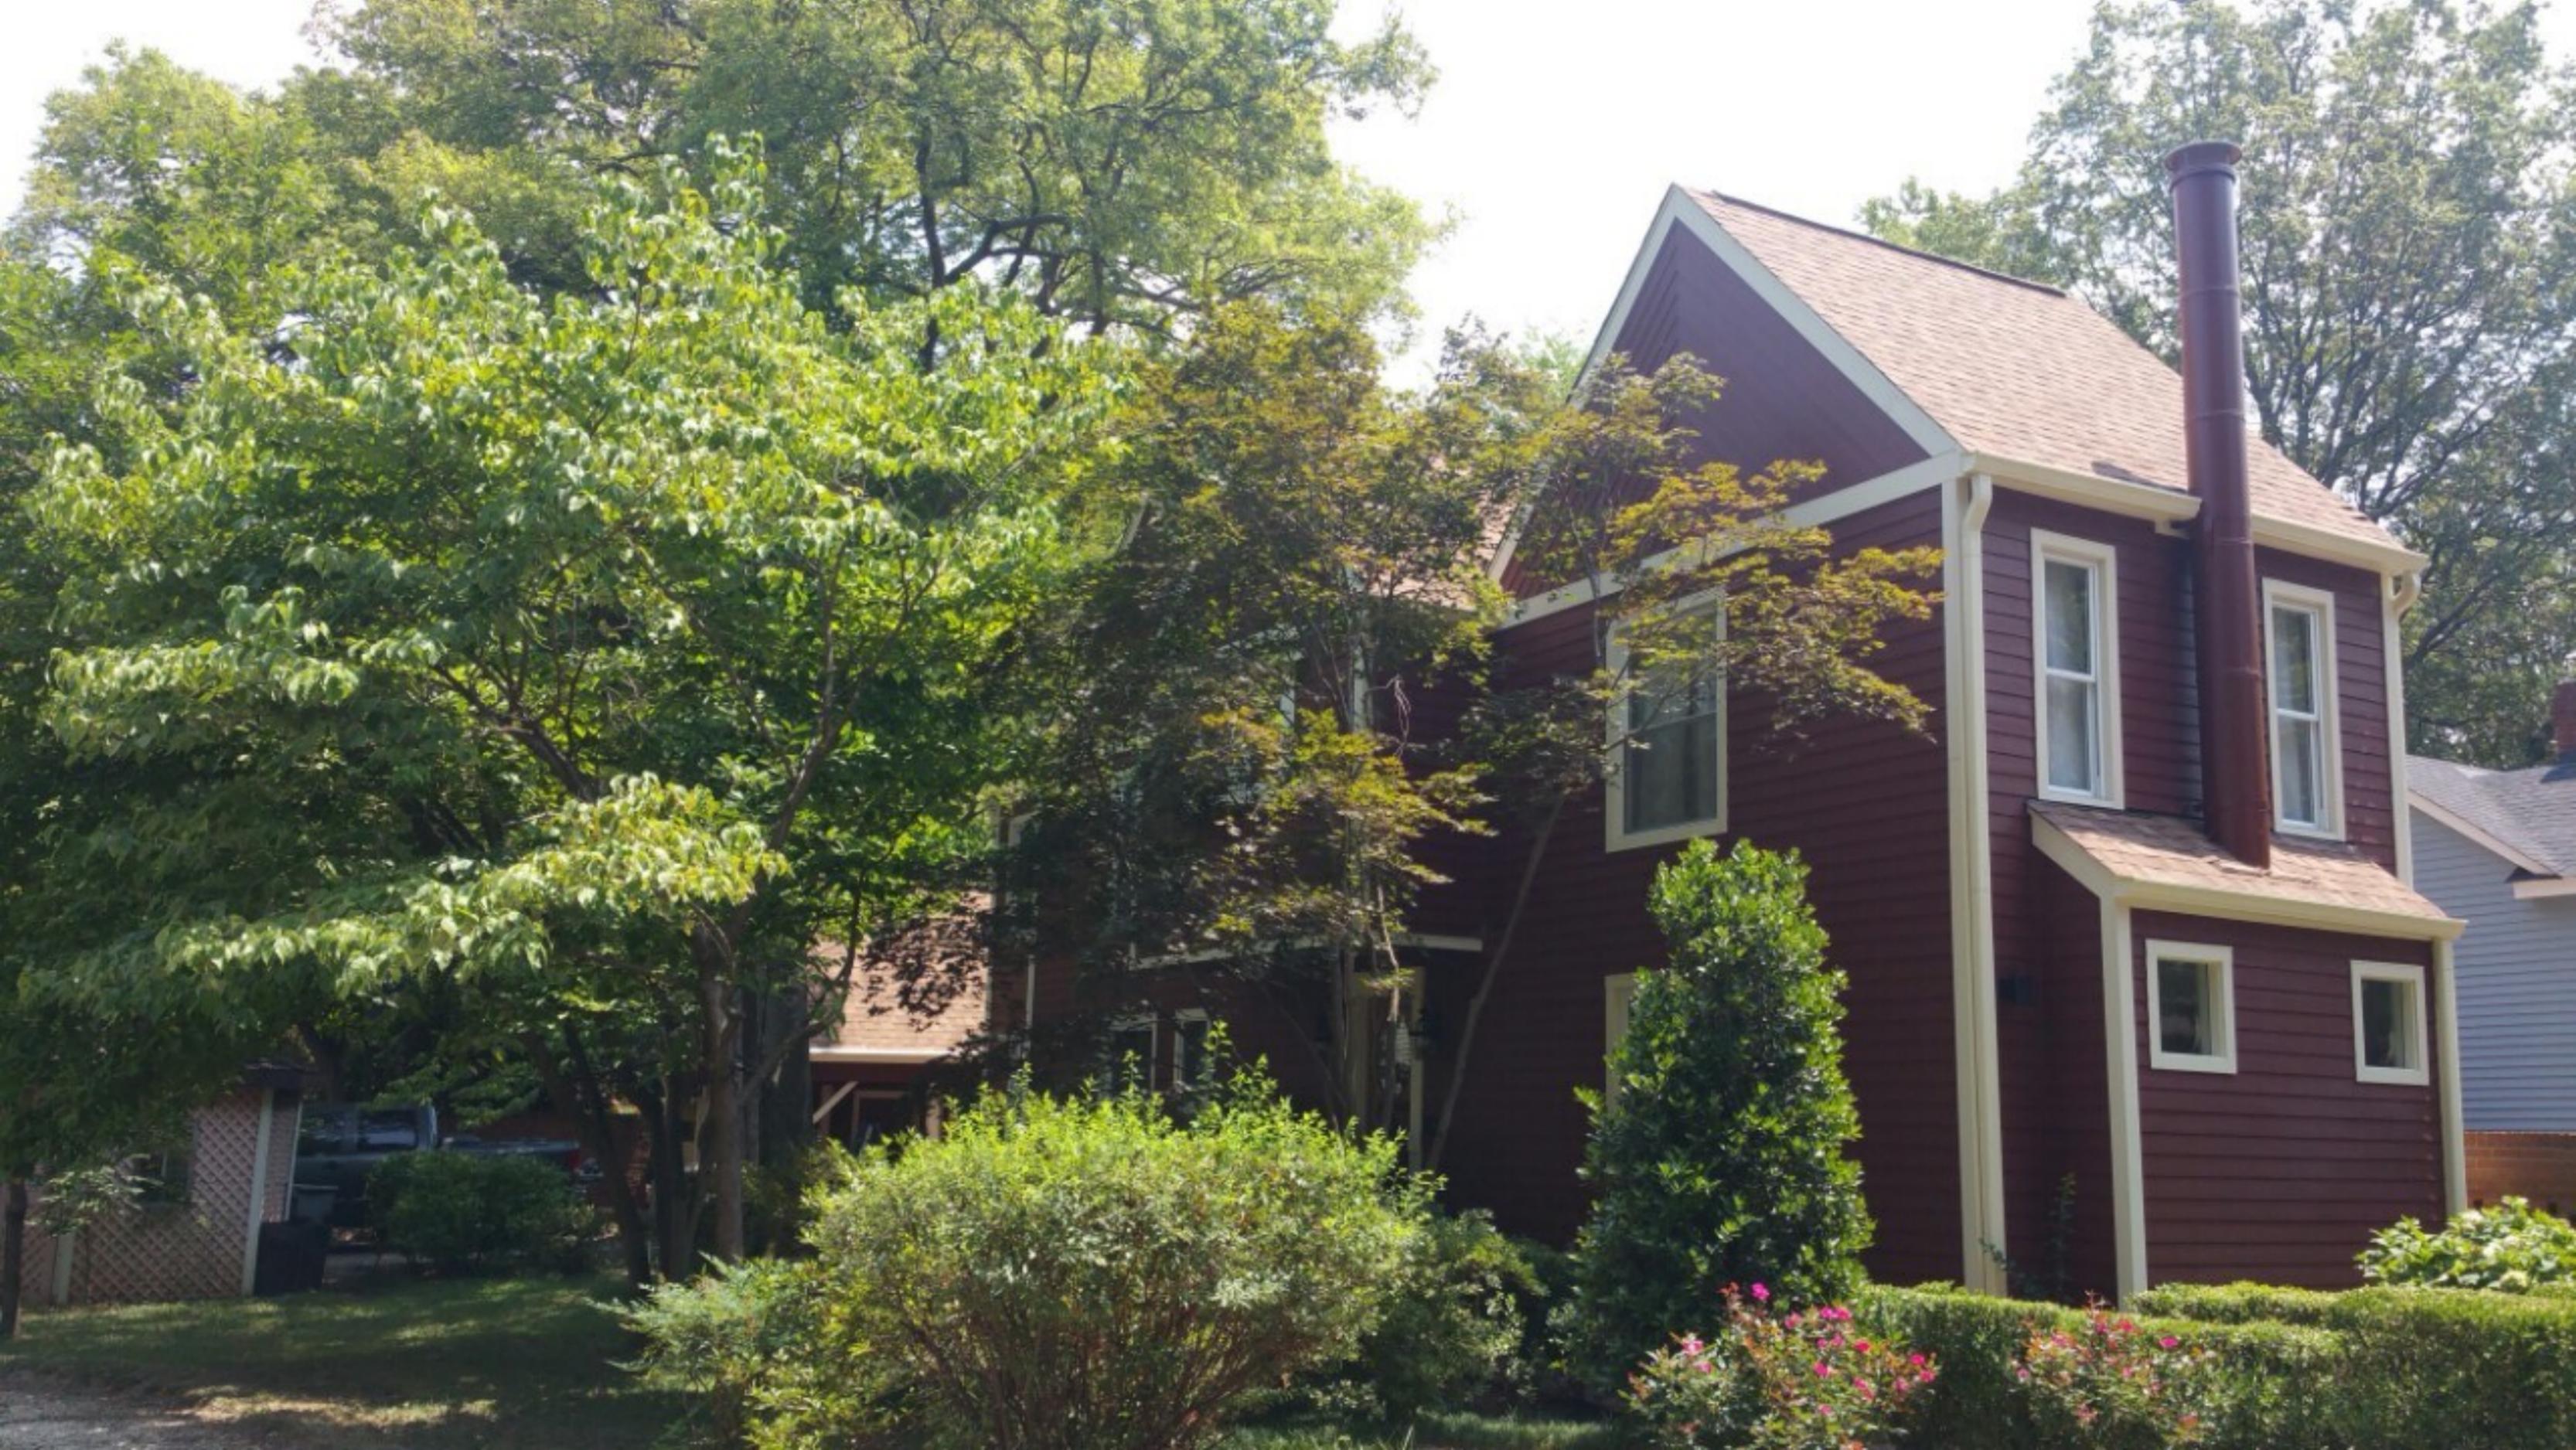
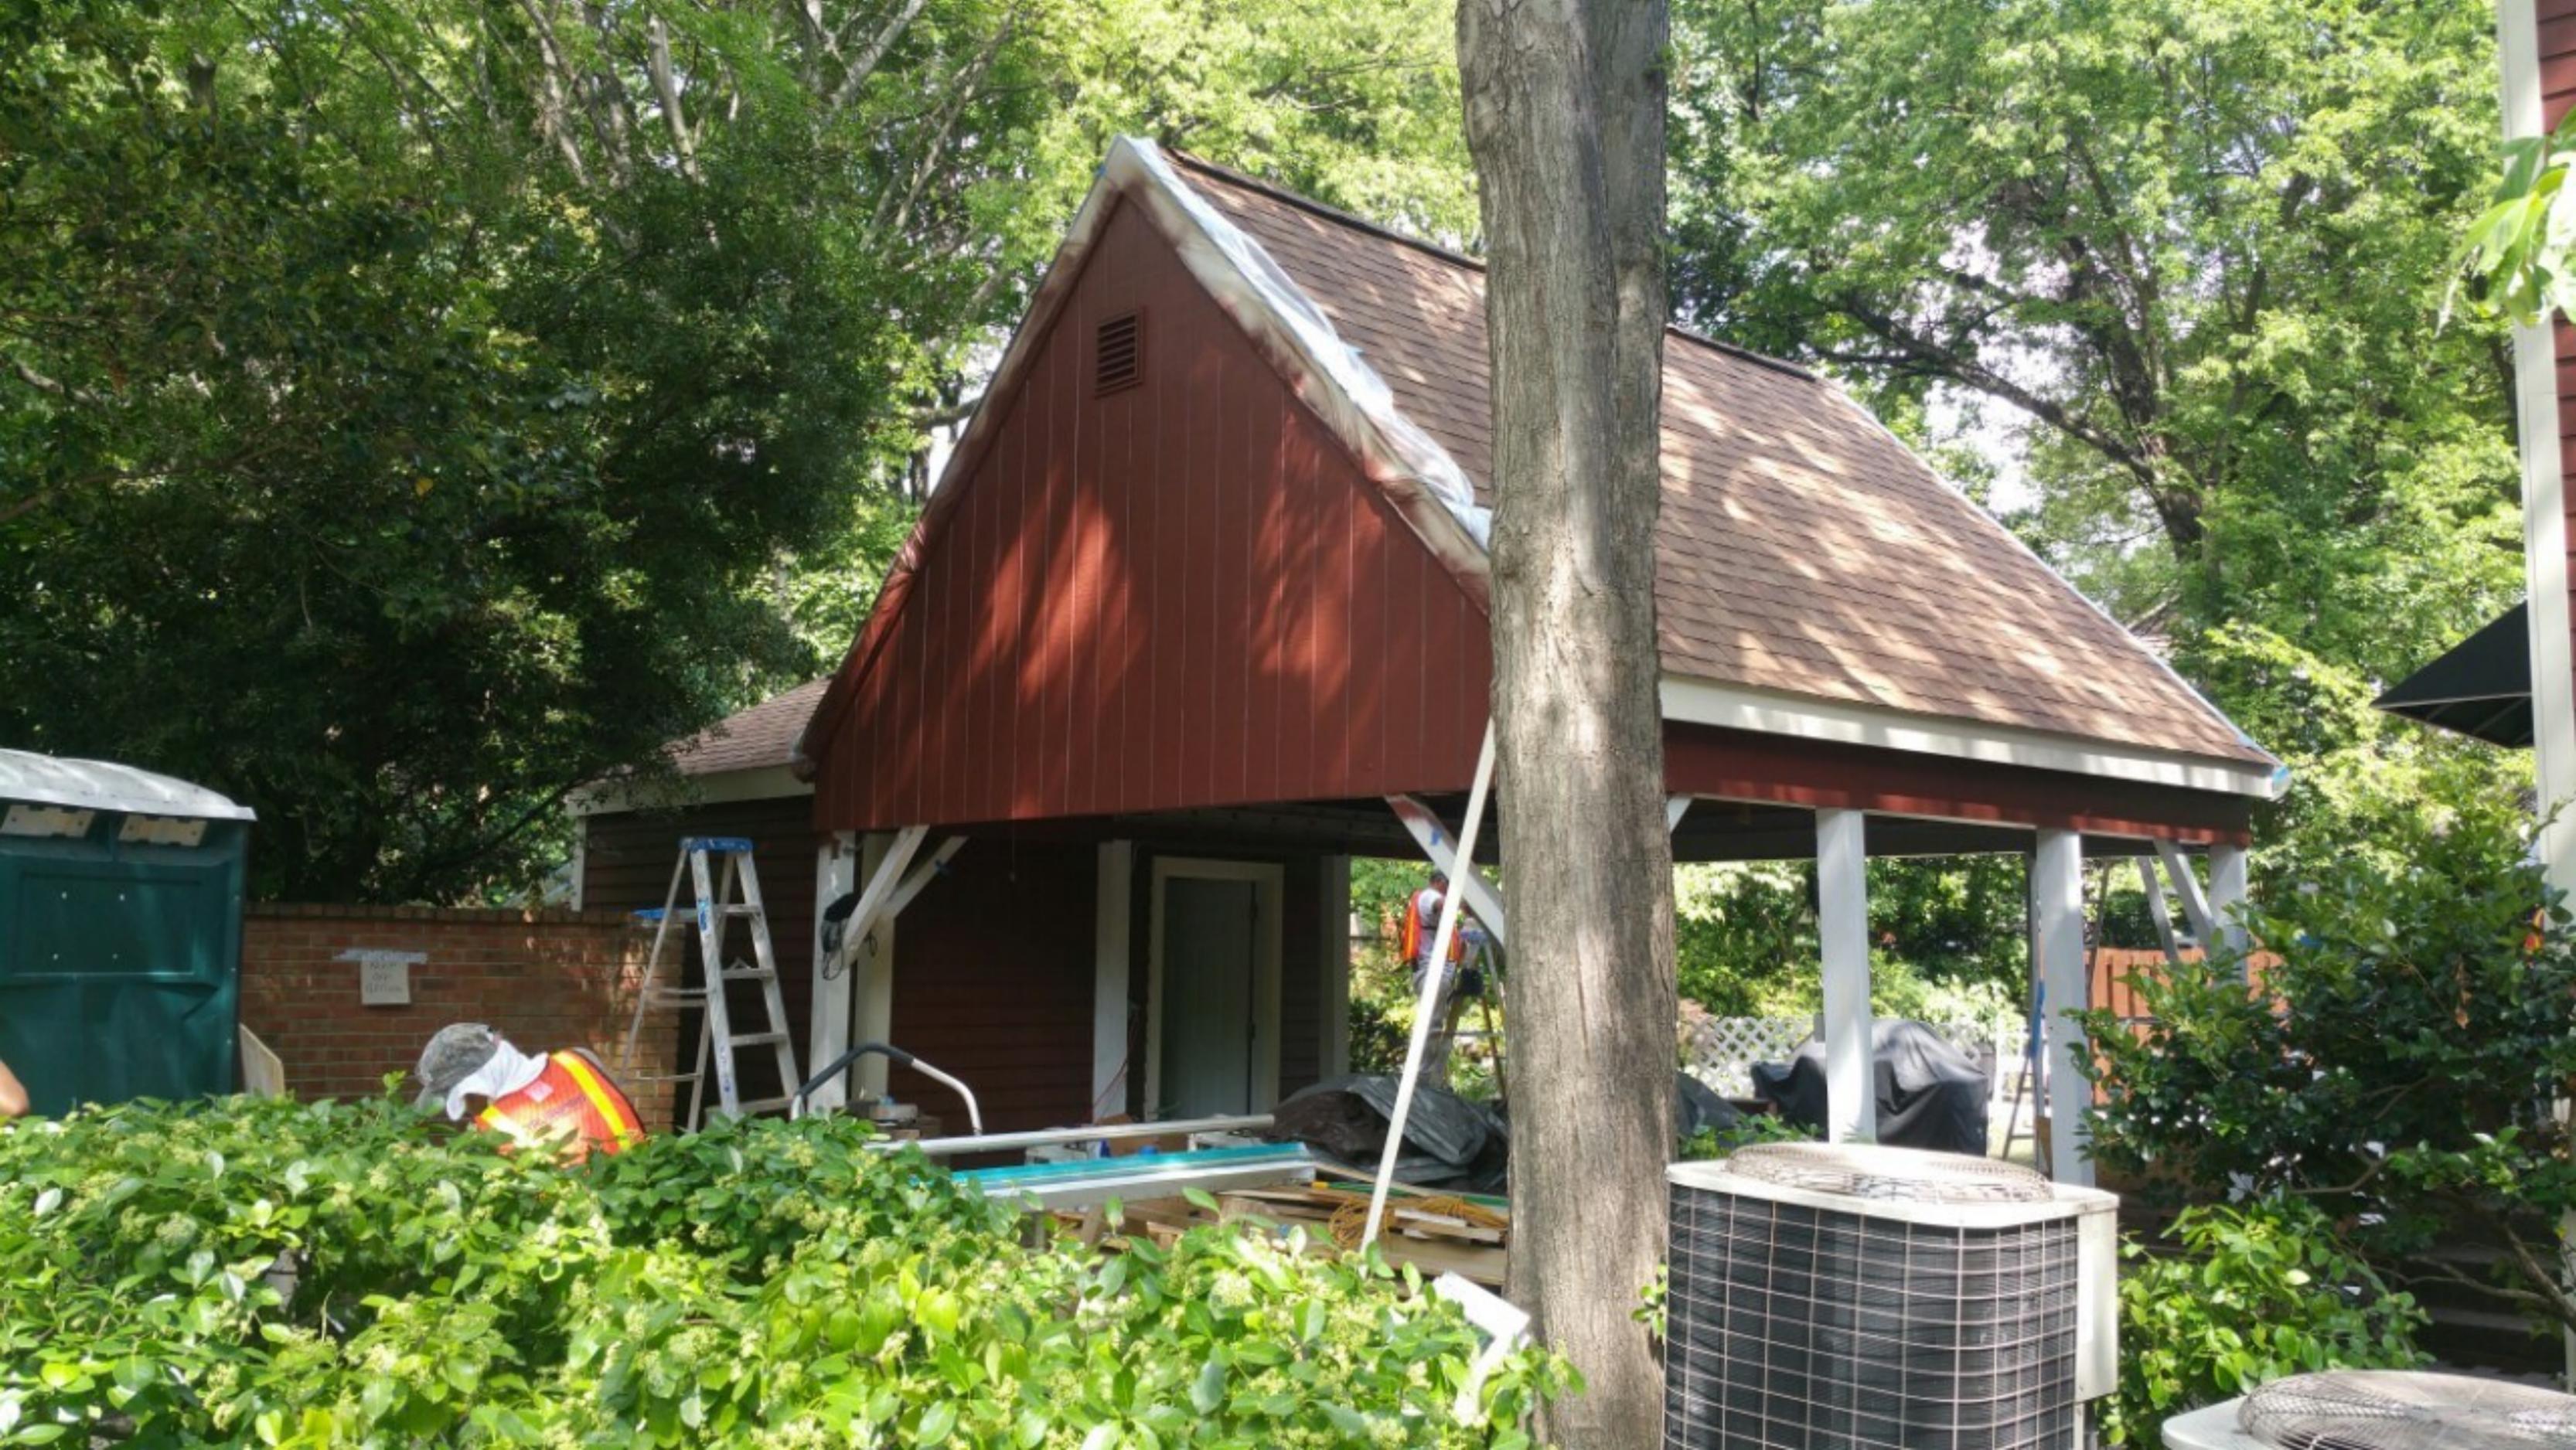
The mature maple tree in question has a very significant co-dominant leader in the main stem and included bark. The tree is also very mature and has a declining crown. We know that co-dominant leaders are a sign of weakness and cause for concern. Additionally, the tree roots have penetrated several areas of concern for the property owner. They have begun damaging the drainage system for the garage port and are heaving the concrete walk. To repair the drainage system and heaved walk, significant roots will have to be cut, and given the close proximity of the roots to the tree, this root excavation will likely cause irreversible damage to the tree. .

At this time, we are recommending that the identified and inspected tree be removed to allow for repairs and reduce risk of failure of co-dominant stem.
