**LOCAL HISTORIC DISTRICT:** Dilworth

**PROPERTY ADDRESS:** 329 Rensselaer Avenue

**SUMMARY OF REQUEST:** Demolition

# Inspection Report

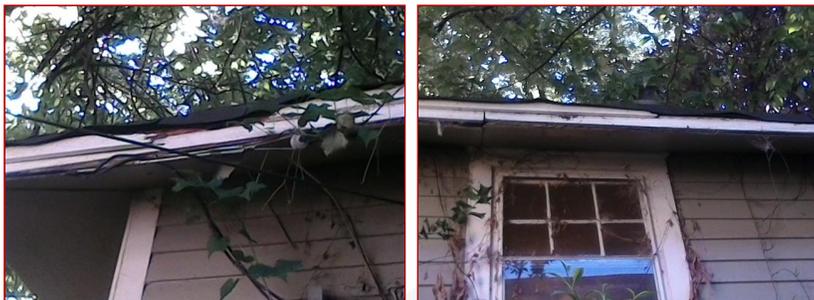
1. **Wood rot was noted in multiple areas at the wood trim on and around the entire home.**

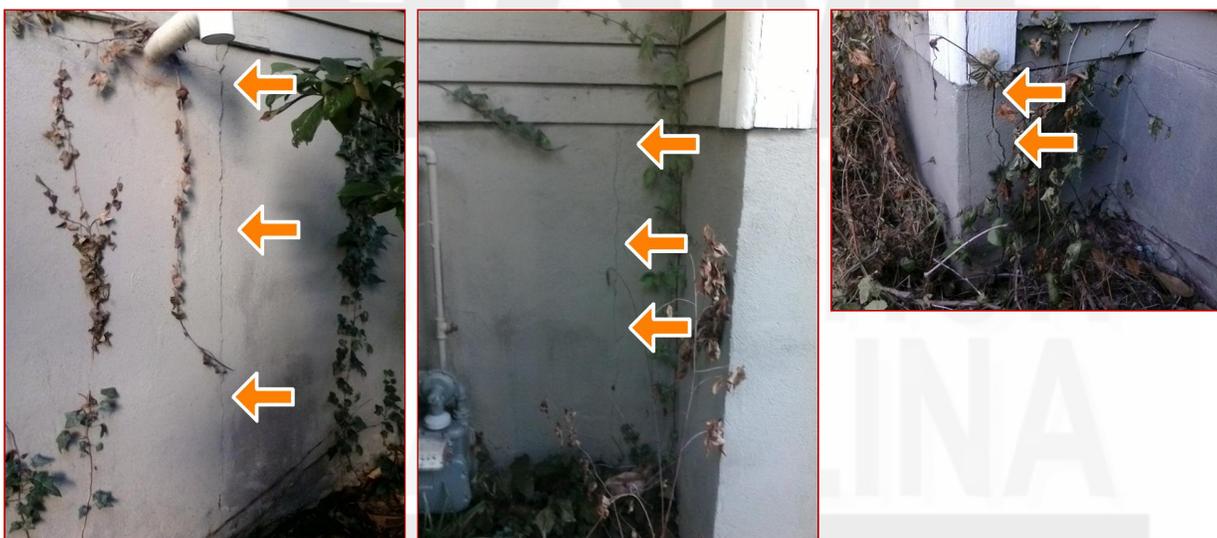
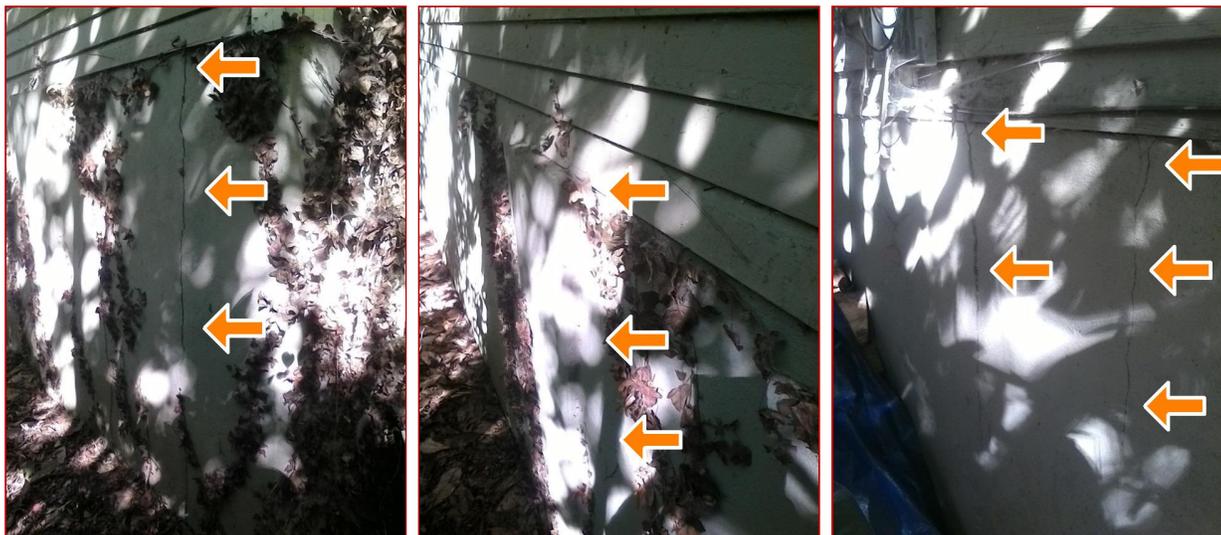
2. **The exposed portions of the perimeter foundation walls need repair and/or proper corrections due to evidence of stress or movement observed.** Unable to determine the extent of the movement and/or damage at the time of inspection.

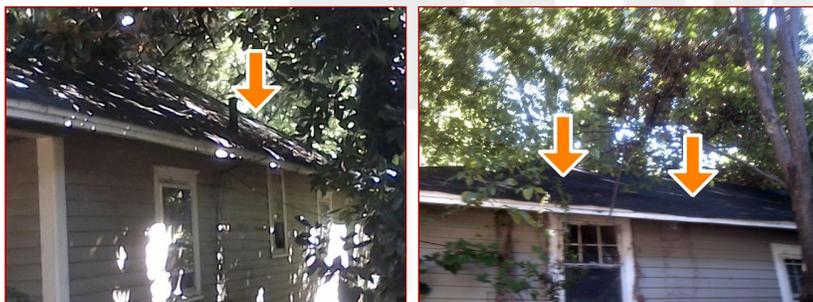
3. **From the exterior of the home, the roof has visible ridges or high spots that correspond to rafter locations. The raised areas have displaced the roof covering from its original installation and can increase the possibility of leaking.**

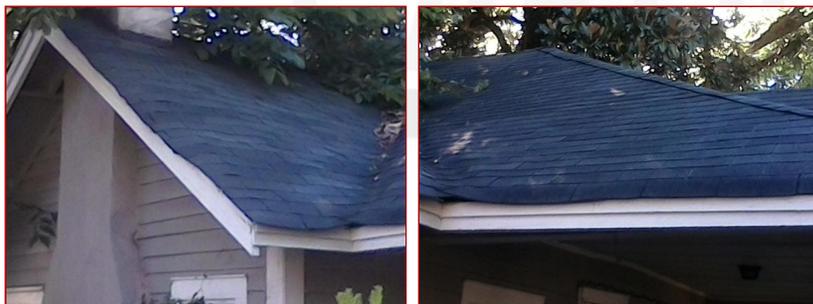
4. **Multiple nail pops were noted throughout the entire roof that need to be corrected properly to prevent the nail from damaging the shingle and/or allowing possible wind and/or water damage.**

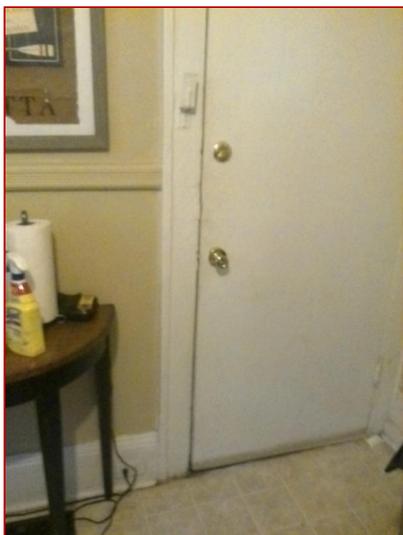
5. The following door(s) listed below were found to rubbed at the top and need adjustment and/or repair for the door(s) to open and close properly without rubbing: laundry room door, rear exterior door

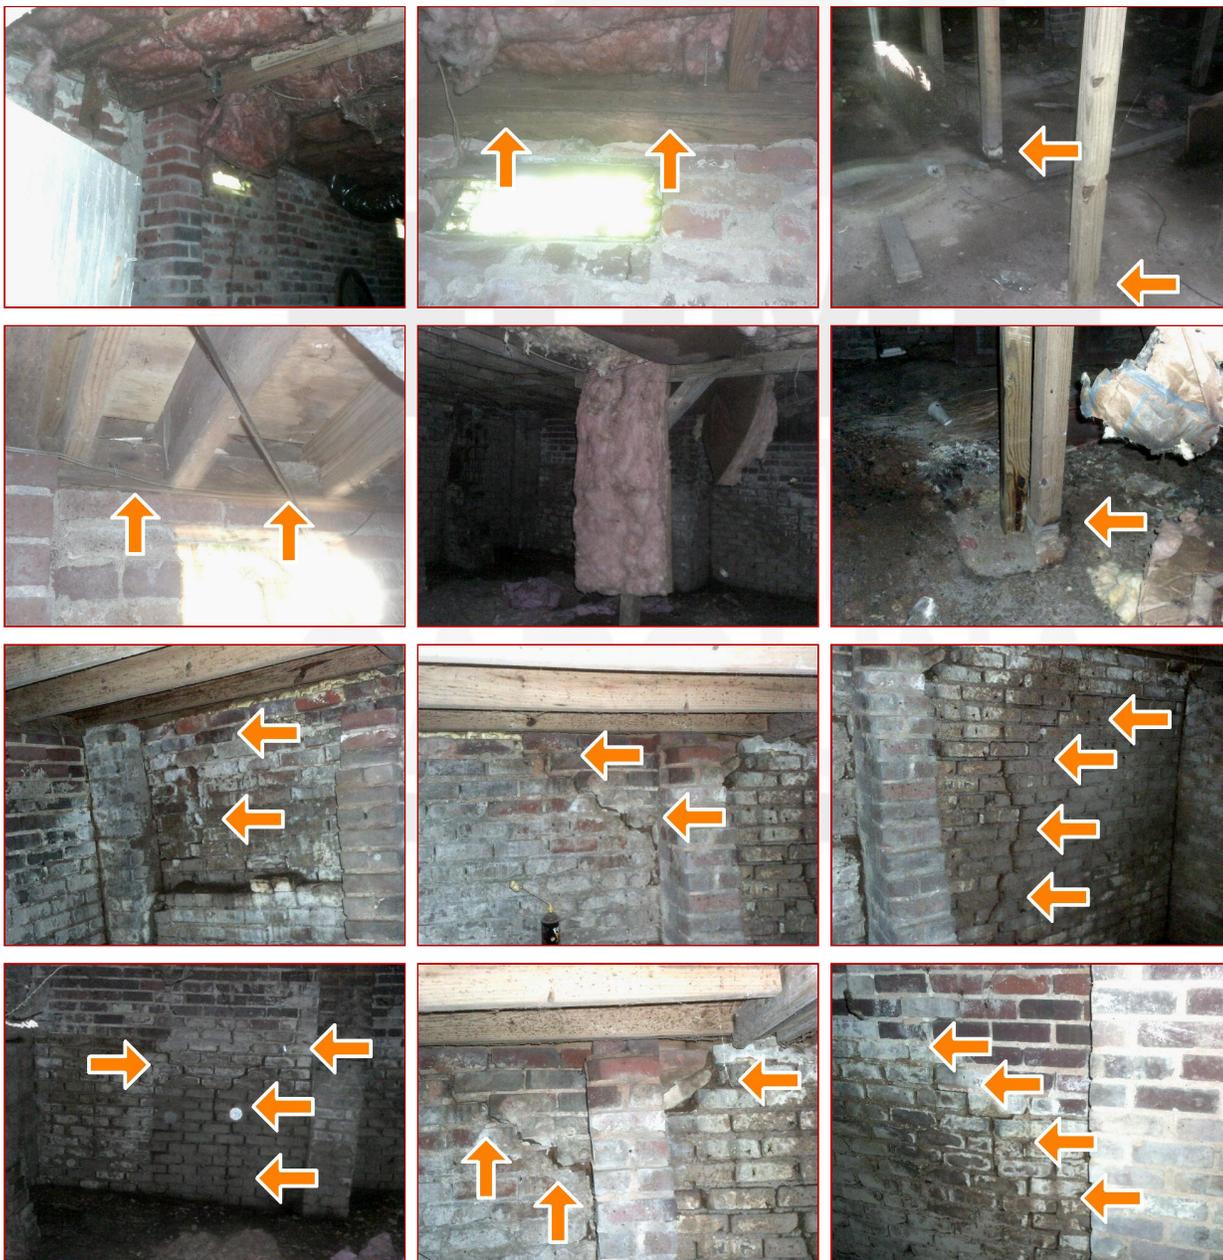
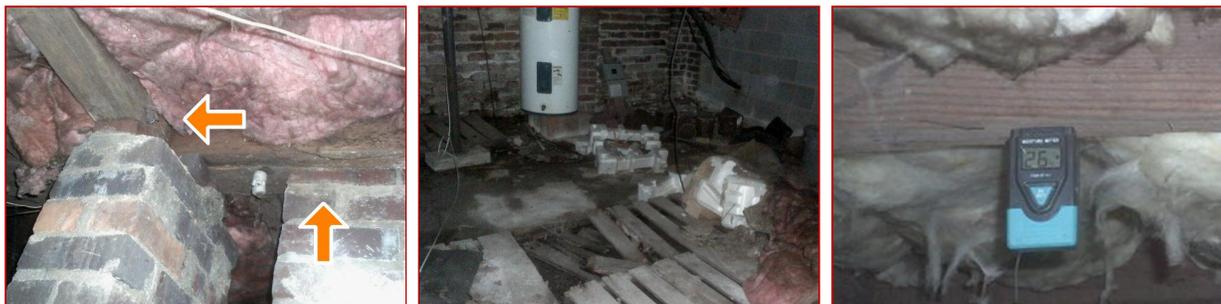
**Insulation was noted to be falling, fallen and/or is drooping within the crawl space area.** The insulation needs to be re-installed and/or supported properly. Note: Where it has touched the ground and become damaged needs to be replaced.

**Insulation has fallen, drooping or stringy throughout the entire crawl space.** This unusually indicates that there is or has had a moisture problem. Recommend leaving the crawl space vent open year round to allow adequate air flow in the crawl space.

**Wood debris was found within and or throughout the crawl space area.** The wood debris creates a conducive environment for termites and needs to be properly removed.

**Fungal growth found was noted within the crawl space.** Fungus growth can be viewed in just about every home. If there are concerns with the fungus growth found please contact us for testing. Additional services are not part of the home inspection. Additional services are independent of the home inspection and due not fall under the Standards of Practice within the state the inspection is being performed. If you require or were expecting an additional service(s) please feel free to contact us to schedule any additional services at 704-542-6575 or email us at [customersupport@hicarolina.com](mailto:customersupport@hicarolina.com).

**There is termite damage noted along the floor joints, band sill, and or girder along the multiple locations of the home.** Proper corrections and/or repairs are needed to prevent possible structural movement.

**Moisture levels in the crawl space were found to be above 20% throughout the crawl space at the time of inspection,** Note: When wood reaches the fiber saturation point - approximately 20% - it can support the growth of fungus and is also conducive for termites. A reading at or above 20% signals that there is a moisture problem and corrective action should be taken. Contact a company that specializes in crawl space moisture corrections to determine the measure needed to correct the problem.

**There is not a vapor barrier installed in the crawl space exposing the soil within and throughout the crawl space.** Exposed soils in a crawlspace should be covered with a retardant material to prevent moisture or standing water from possibly causing deterioration to the wood framing above. A vapor barrier is recommended to reduce or keep moisture levels down within the crawl space area.

**The observation of non centrally or not fully loaded piers are noted** at the girders throughout the home. If the load is not being properly transferred to the pier or piers below, other weaker components may suffer.

**Bending in at least one wall was noted.** Bending is when the center of the wall horizontally is bending inward.

**Repairs noted at the areas on portions of the multiple locations foundation wall(s).** Unable to determine the age of the repairs or the effectiveness of the repairs made or if the repairs made are properly installed.

Have a qualified licensed engineer further evaluate and make any additional recommendations as to any additional repairs that are required.

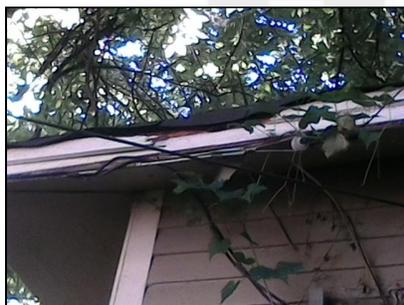
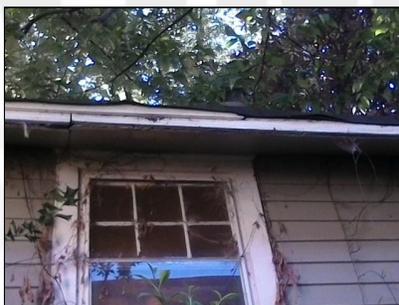
**Wood rot was noted in multiple areas at the wood trim on and around the entire home.**

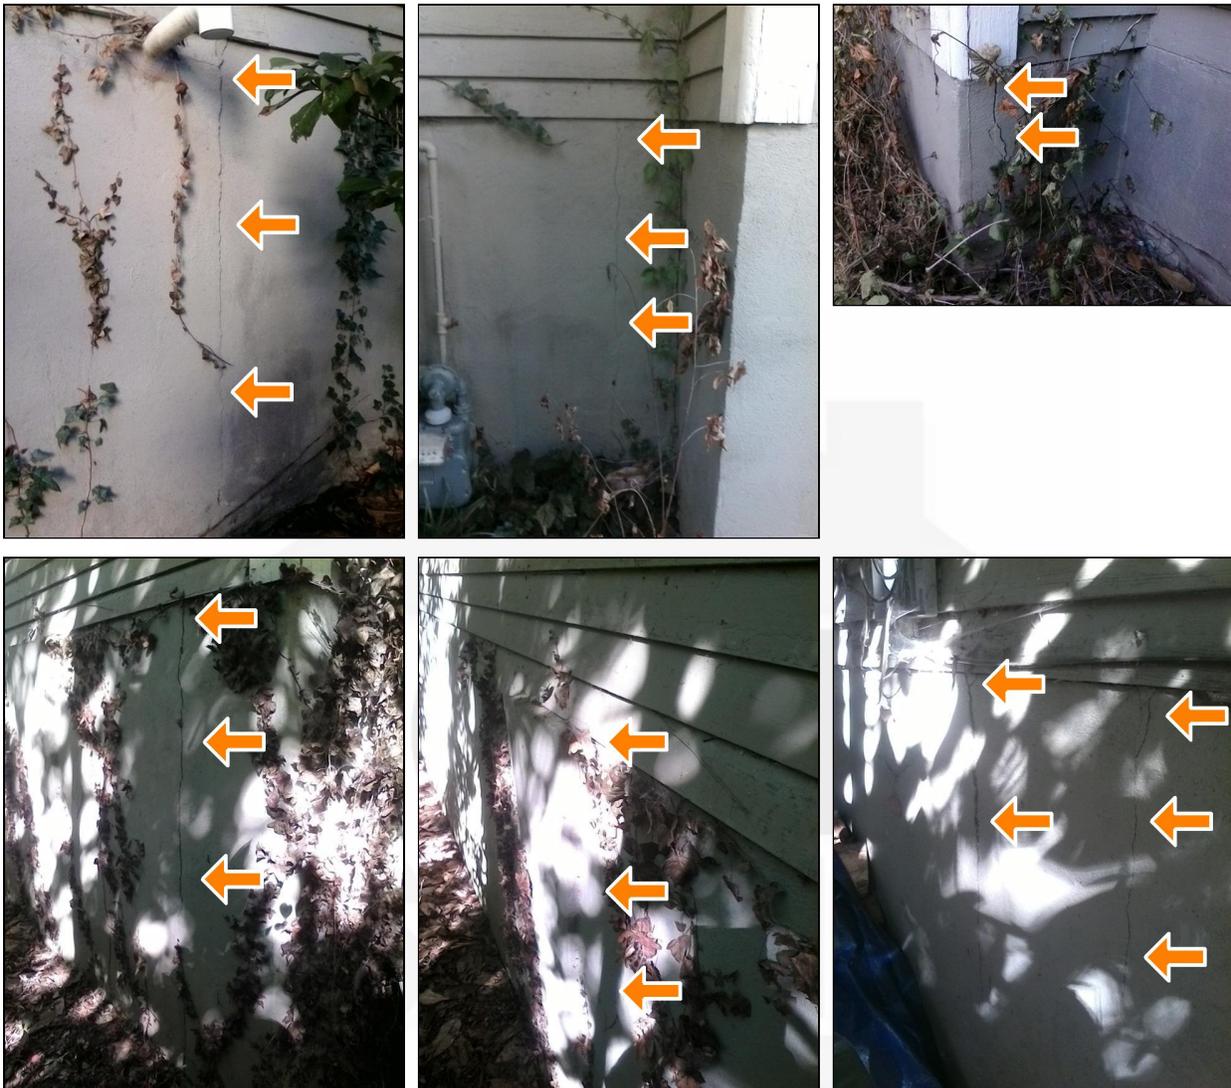
**SUMMARY** The exposed portions of the perimeter foundation walls need repair and/or proper corrections due to evidence of stress or movement observed. Unable to determine the extent of the movement and/or damage at the time of inspection.

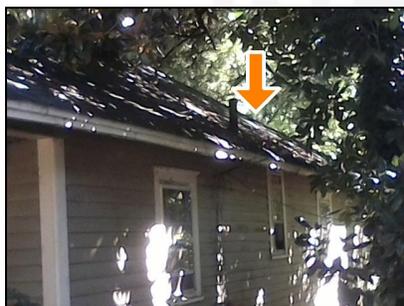
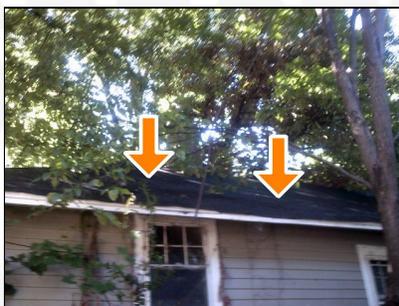
**SUMMARY** From the exterior of the home, the roof has visible ridges or high spots that correspond to rafter locations. The raised areas have displaced the roof covering from its original installation and can increase the possibility of leaking.

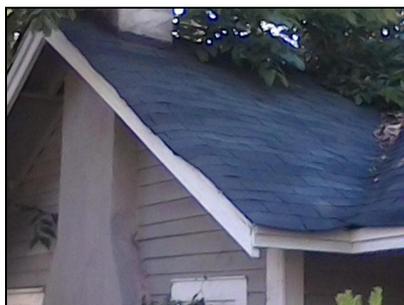
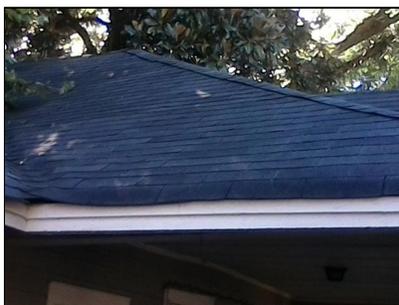
**SUMMARY** Multiple nail pops were noted throughout the entire roof that need to be corrected properly to prevent the nail from damaging the shingle and/or allowing possible wind and/or water damage.

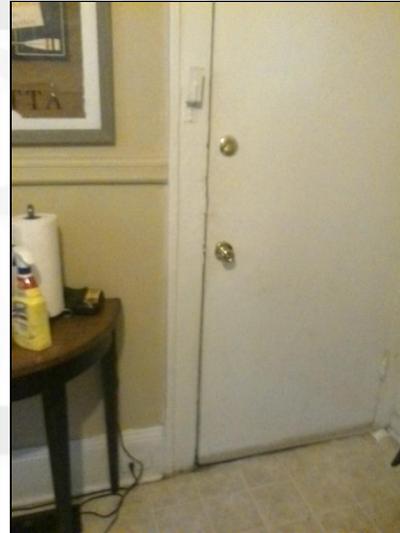
**SUMMARY** The following door(s) listed below were found to rubbed at the top and need adjustment and/or repair for the door(s) to open and close properly without rubbing: laundry room door, rear exterior door

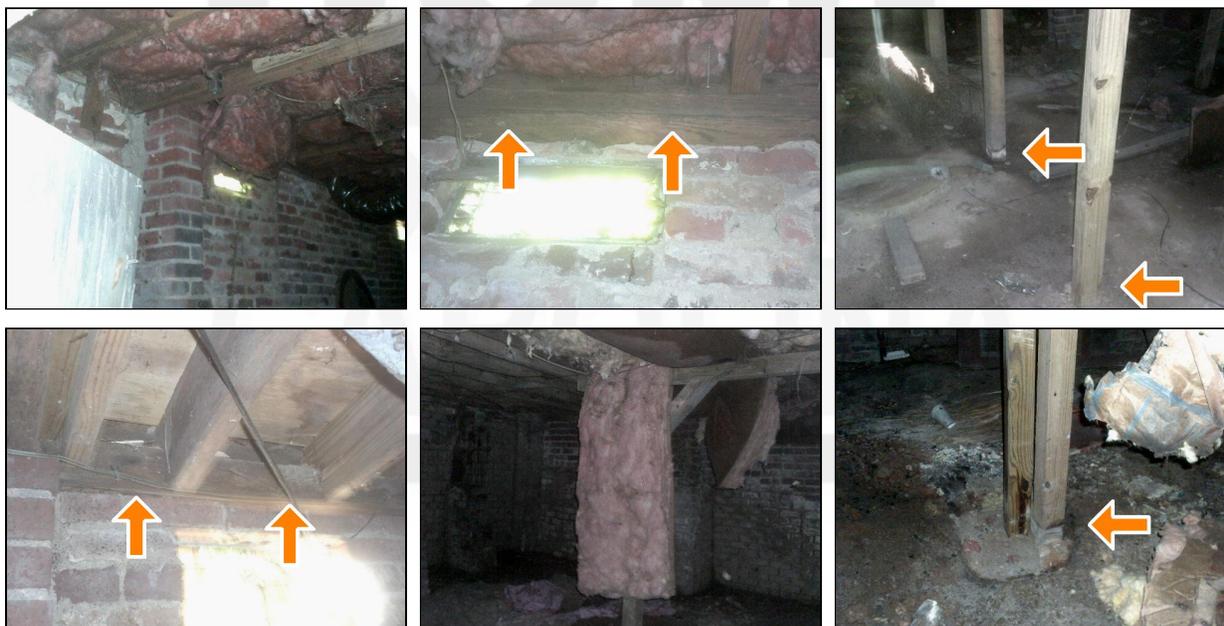
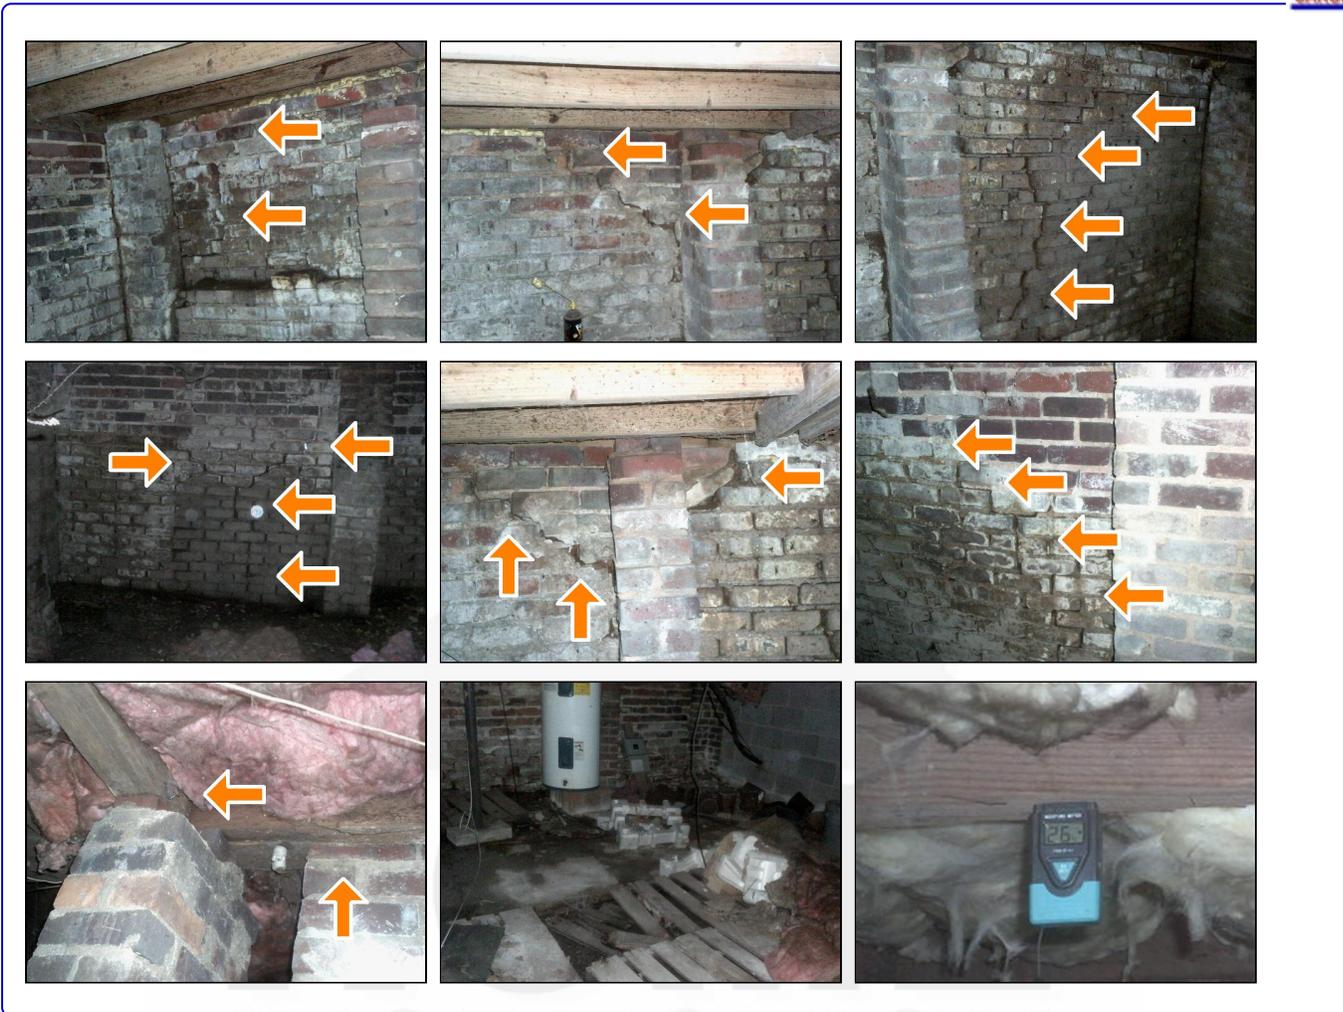
**Insulation was noted to be falling, fallen and/or is drooping within the crawl space area.** The insulation needs to be re-installed and/or supported properly. Note: Where it has touched the ground and become damaged needs to be replaced.

**Insulation has fallen, drooping or stringy throughout the entire crawl space.** This unusually indicates that there is or has had a moisture problem. Recommend leaving the crawl space vent open year round to allow adequate air flow in the crawl space.

**Wood debris was found within and or throughout the crawl space area.** The wood debris creates a conducive environment for termites and needs to be properly removed.

**Fungal growth found was noted within the crawl space.** Fungus growth can be viewed in just about every home. If there are concerns with the fungus growth found please contact us for testing. Additional services are not part of the home inspection. Additional services are independent of the home inspection and due not fall under the Standards of Practice within the state the inspection is being performed. If you require or were expecting an additional service(s) please feel free to contact us to schedule any additional services at 704-542-6575 or email us at [customersupport@hicarolina.com](mailto:customersupport@hicarolina.com).

**There is termite damage noted along the floor joints, band sill, and or girder along the multiple locations of the home.** Proper corrections and/or repairs are needed to prevent possible structural movement.

**Moisture levels in the crawl space were found to be above 20% throughout the crawl space at the time of inspection,** Note: When wood reaches the fiber saturation point - approximately 20% - it can support the growth of fungus and is also conducive for termites. A reading at or above 20% signals that there is a moisture problem and corrective action should be taken. Contact a company that specializes in crawl space moisture corrections to determine the measure needed to correct the problem.

**There is not a vapor barrier installed in the crawl space exposing the soil within and throughout the crawl space.** Exposed soils in a crawlspace should be covered with a retardant material to prevent moisture or standing water from possibly causing deterioration to the wood framing above. A vapor barrier is recommended to reduce or keep moisture levels down within the crawl space area.

**The observation of non centrally or not fully loaded piers are noted** at the girders throughout the home. If the load is not being properly transferred to the pier or piers below, other weaker components may suffer.

**Bending in at least one wall was noted.** Bending is when the center of the wall horizontally is bending inward.

**Repairs noted at the areas on portions of the multiple locations foundation wall(s).** Unable to determine the age of the repairs or the effectiveness of the repairs made or if the repairs made are properly installed.

Have a qualified licensed engineer further evaluate and make any additional recommendations as to any additional repairs that are required.
