**PROPERTY ADDRESS:** 408 Grandin Road

**SUMMARY OF REQUEST:** Demolition

HDCRDEMO 2019-00421

LOCAL HISTORIC DISTRICT: WESLEY HEIGHTS

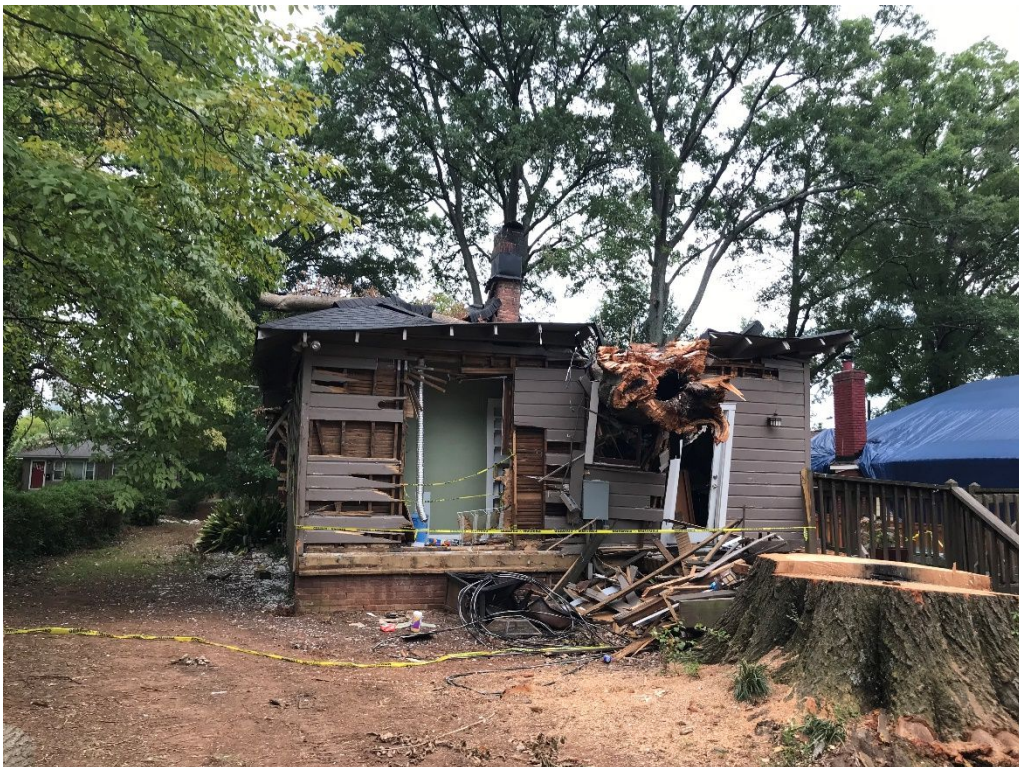
A large diameter (about 6 feet) hardwood tree fell onto the house. The base of the tree is about 15 feet on the west side of the house and the body of the tree impacted the entire house from front to back (Photograph 2). Portions of the tree remained on and in the house at the time of inspection (Photograph 3). The entire roof framing portions of the

**Photograph 2: The base of the tree near the back of the house.**

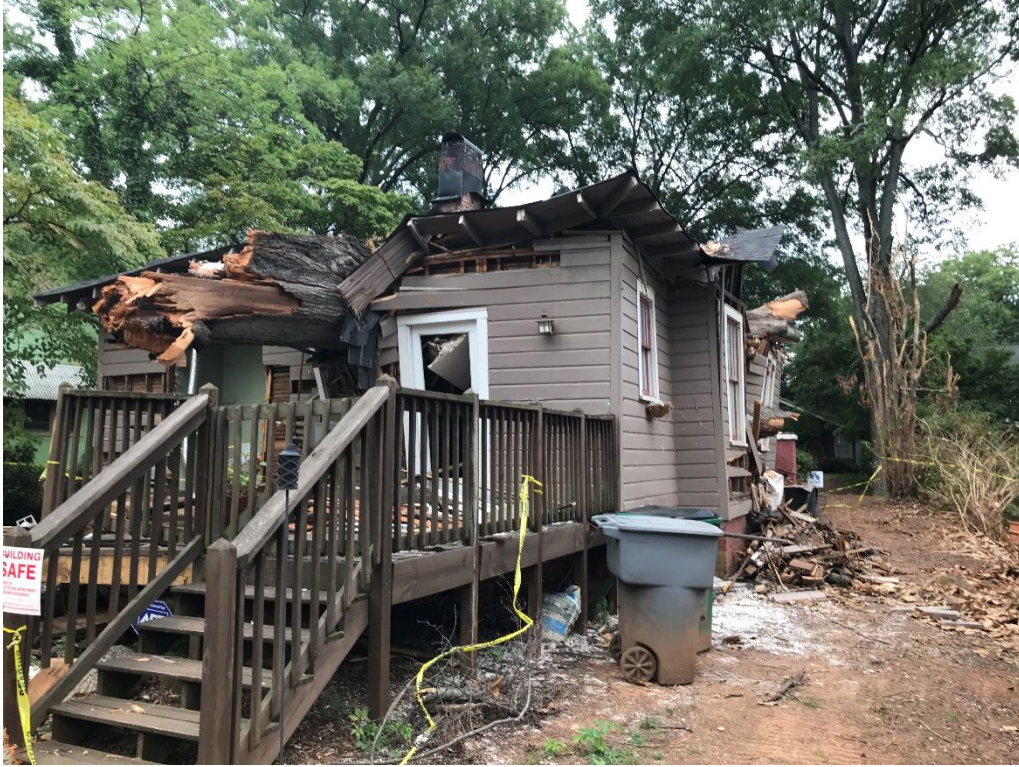
**Photograph 3: The tree's base is still in the house.**

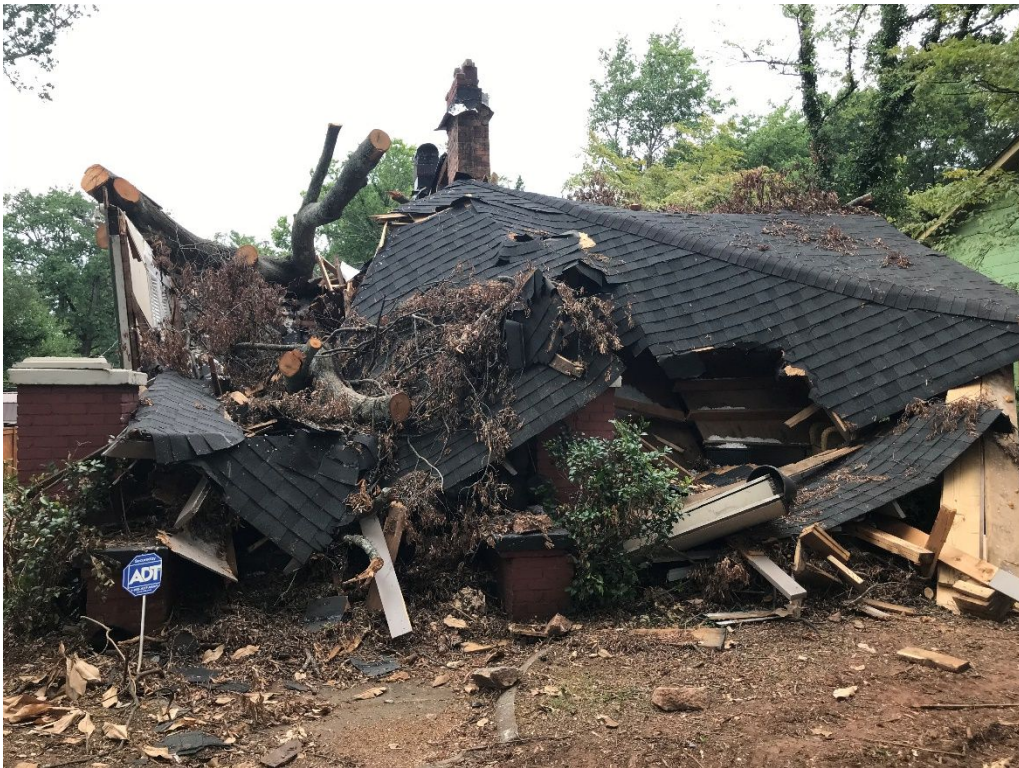
house is displaced into the house. The east and west (front and back) walls are completely crushed and fractured (Photographs 4 and 5). The south exterior wall is leaning outward from the foundation (Photograph 6). The north exterior wall is only slightly leaning (Photograph 7).

**Photograph 4: The current east (front) elevation with the collapsed roof and walls.**

The entire roof framing system and wall framing systems (both interior and exterior) are to be removed and replaced. Large sections of the floor framing are fractured and should be removed and replaced.

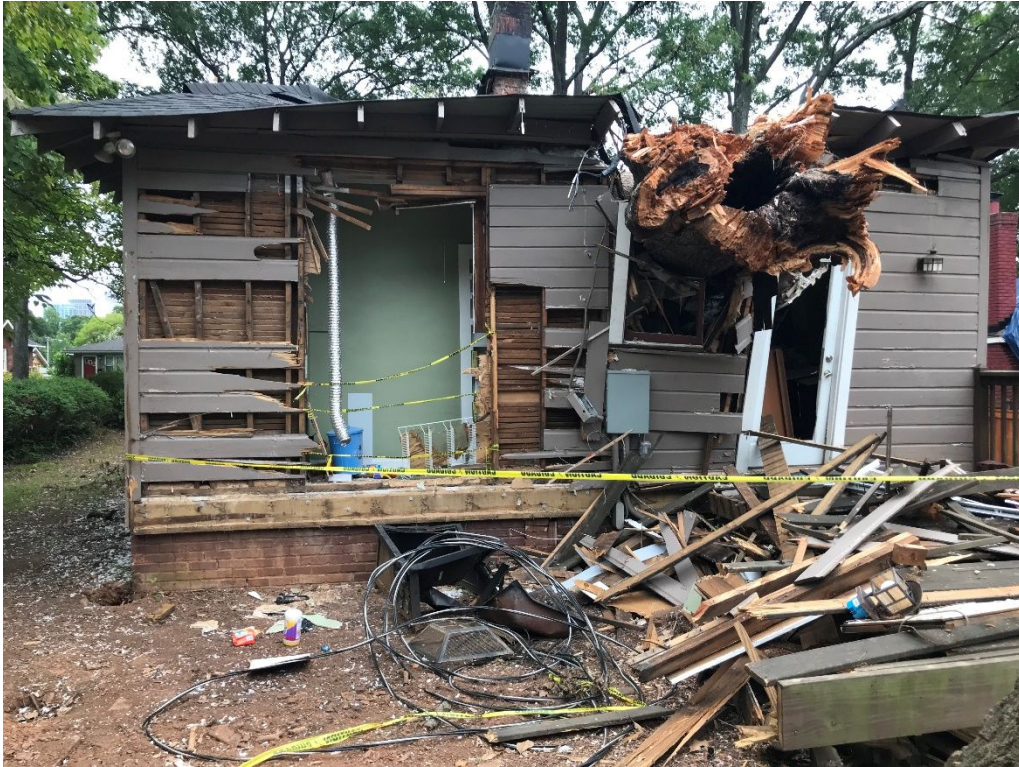
Photograph 5: The west (rear) elevation.

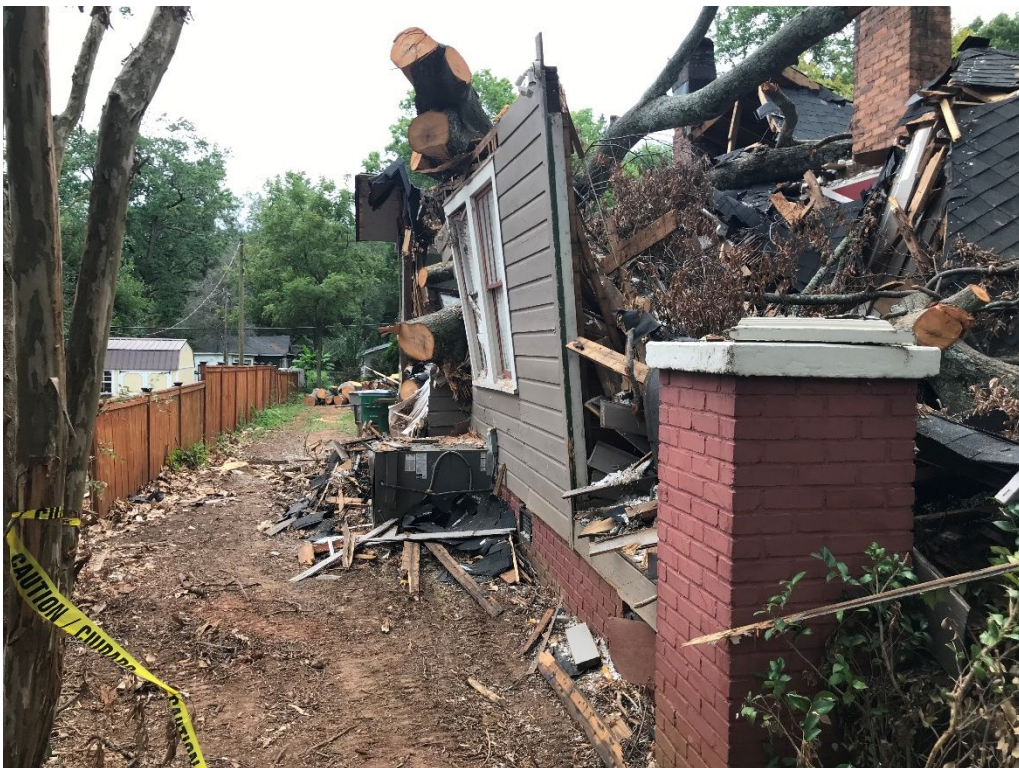
Photograph 6: The south elevation of the house.

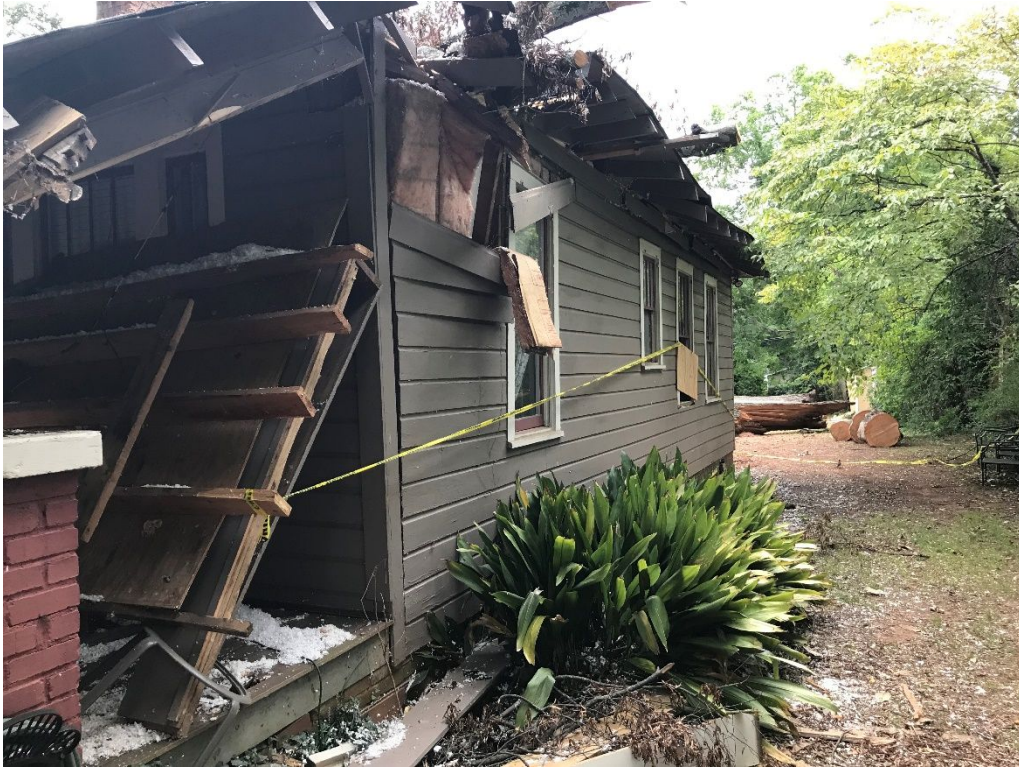
Photograph 7: The north elevation.

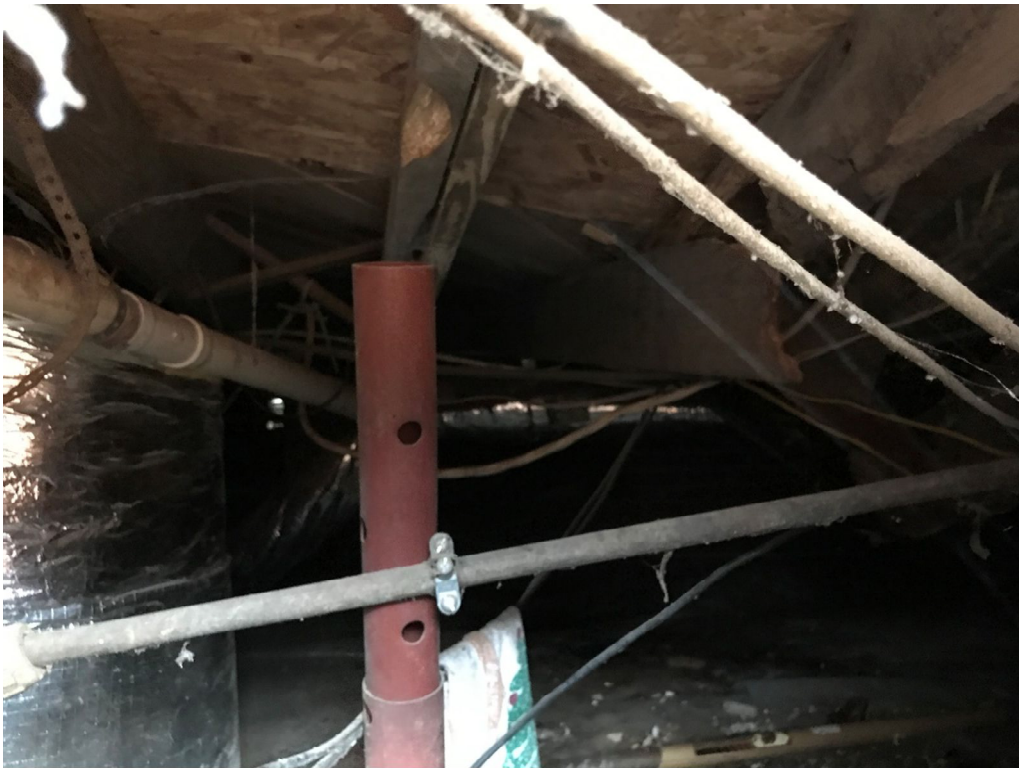
The crawlspace was visible only through foundation vents on the sides. Cracked floor framing and displaced supplemental piers are visible (Photographs 8 and 9). The foundation itself has a single wythe brick curtain wall with piers ranging from a single brick thickness up to 8 inches (Photograph 10). The house has no seal plate or anchoring system to connect the house to the foundation. Minor mortar cracks (up to 1/8") and missing mortar is present at various points on the foundation. Two of the primary columns on the front of the house are leaning (Photograph 11).

Photograph 8: Displaced and cracked flooring and supplemental piers.

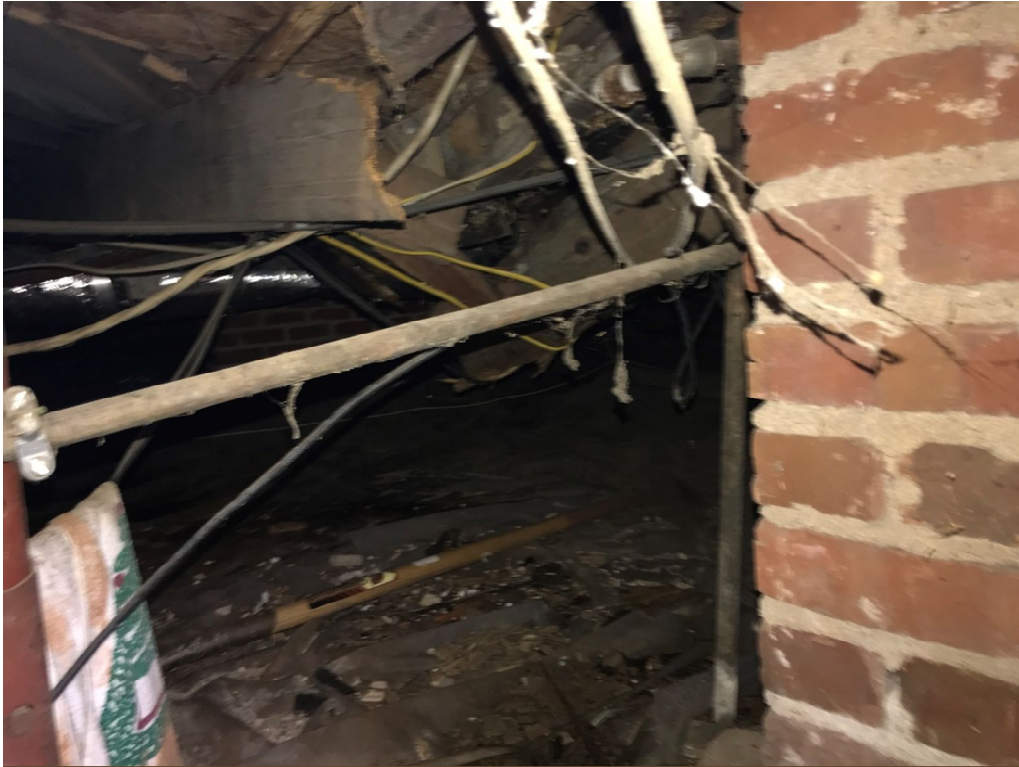
Photograph 9: Additional cracked floor joists.

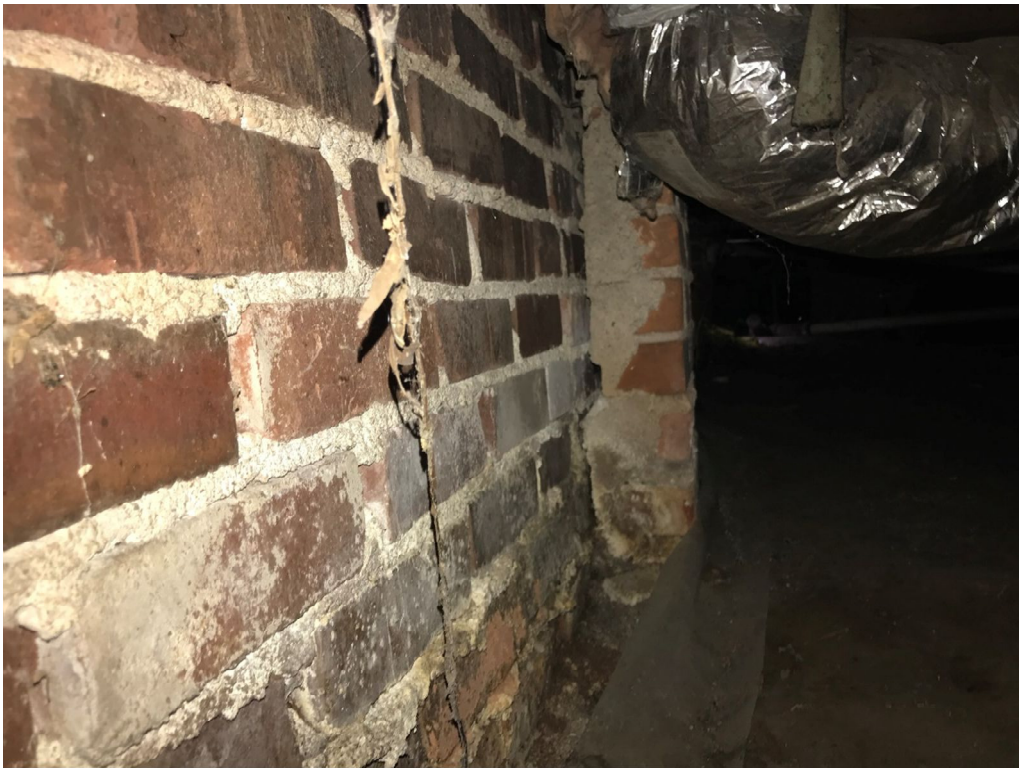
The foundation of the home is not adequate for rebuilding and is in poor condition. There is no practical way to tie the new framing to the foundation or ensure that the foundation can support the modern framing and loads to be applied. Two of the front brick porch columns should be removed and rebuilt. Overall, it is my professional opinion that the entire house be razed and rebuilt.

Photograph 10: Single wythe curtain wall with single brick thickness pier.

- The foundation is inadequate to receive the new framing and should not be reused given the poor condition.
- Based on the extent of damage, it is my professional opinion that the house be razed and rebuilt.

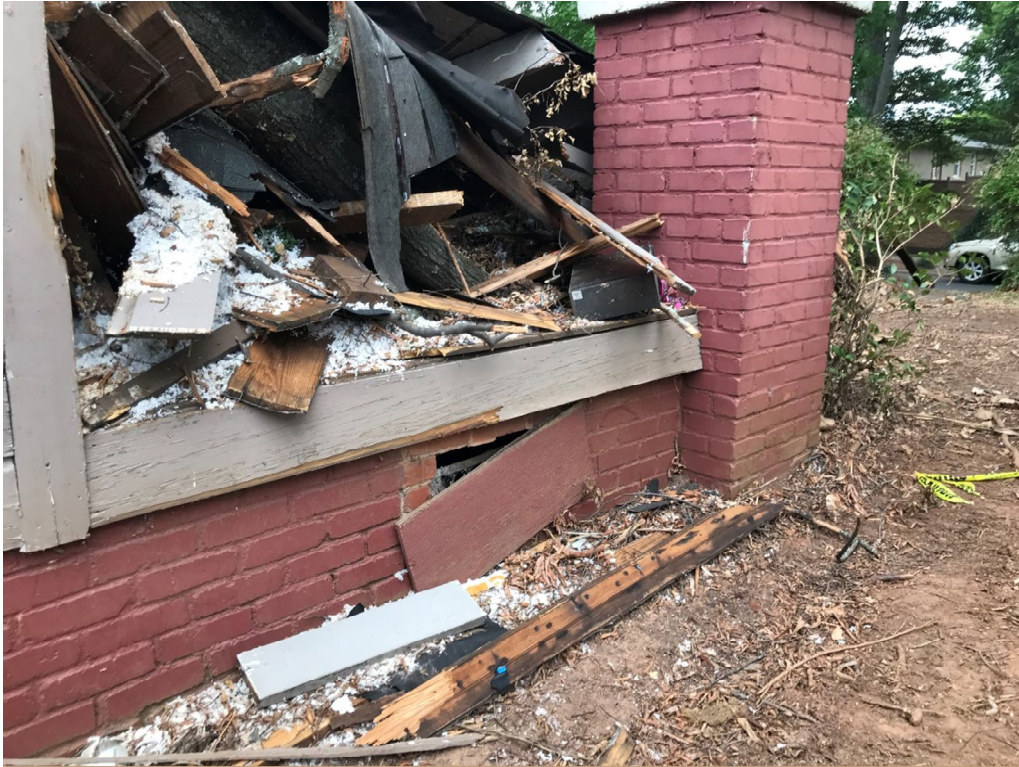
**Photograph 11: Two front brick columns are leaning.**
