LOCAL HISTORIC DISTRICT: Wilmore

PROPERTY ADDRESS: 1816 Wickford Place

SUMMARY OF REQUEST: Demolition

Re: 1816 Wickford Place

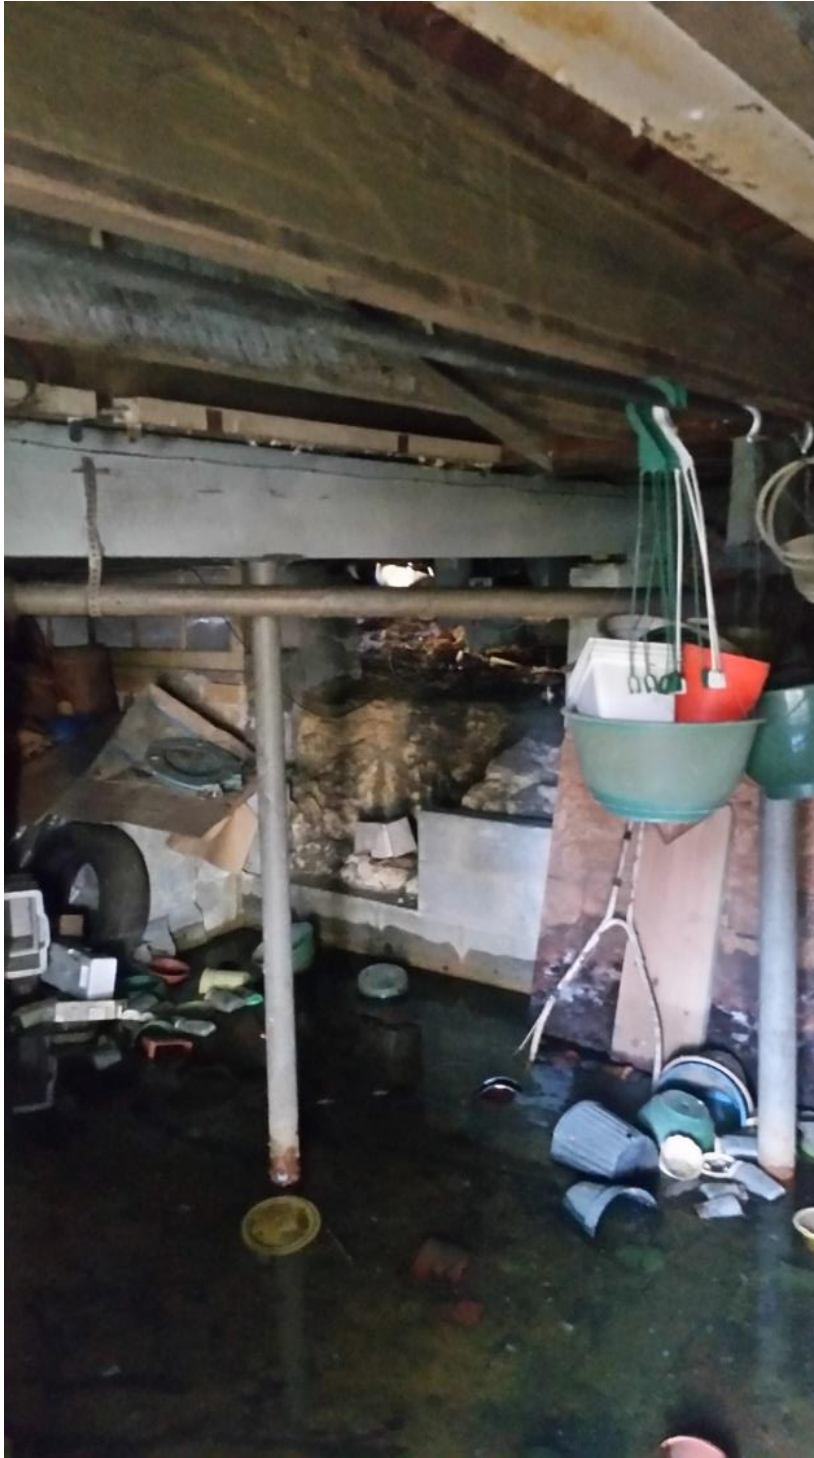
Standing Water in the Crawl Space

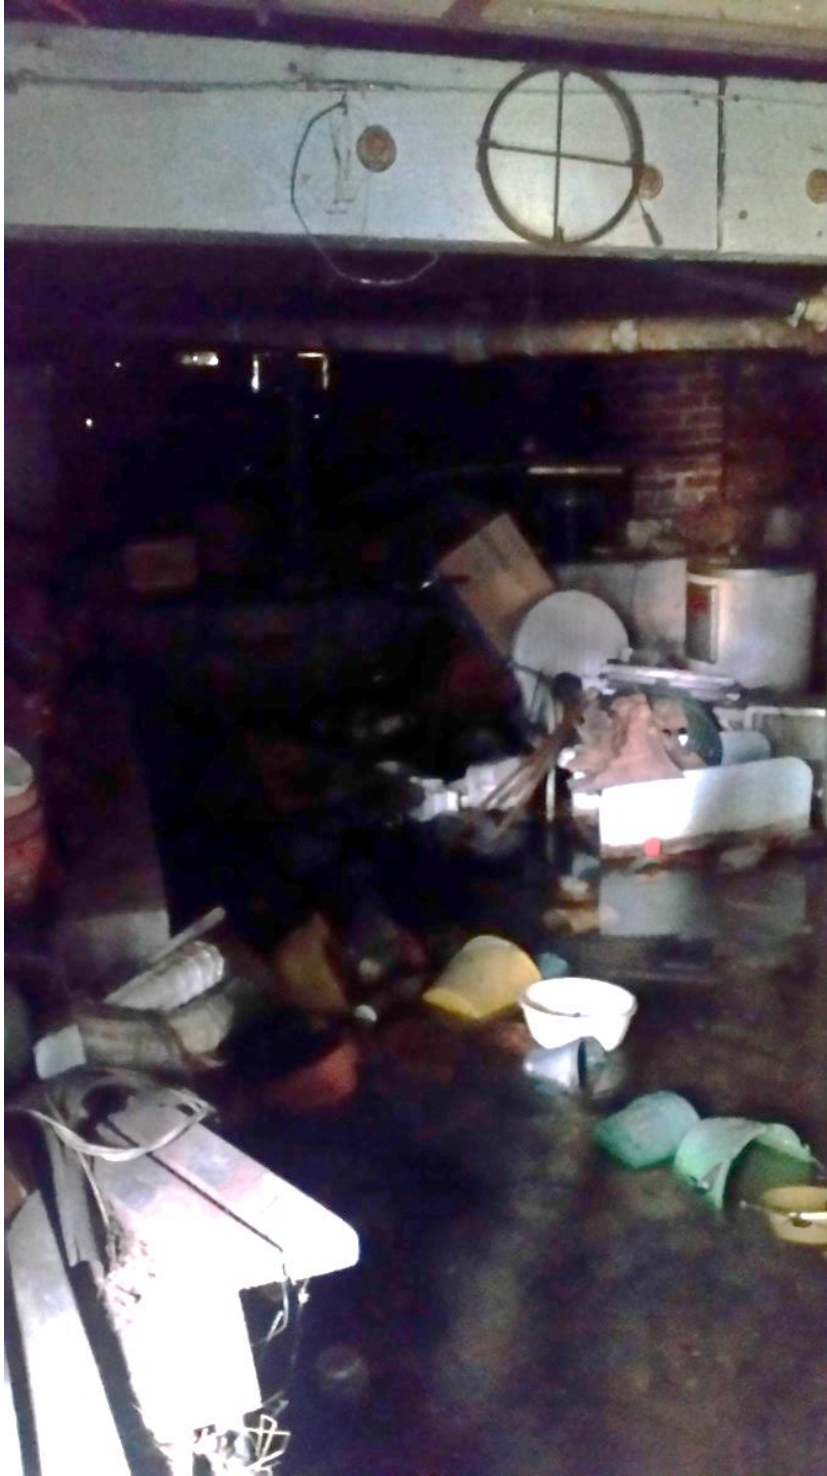
Standing Water in the Crawl

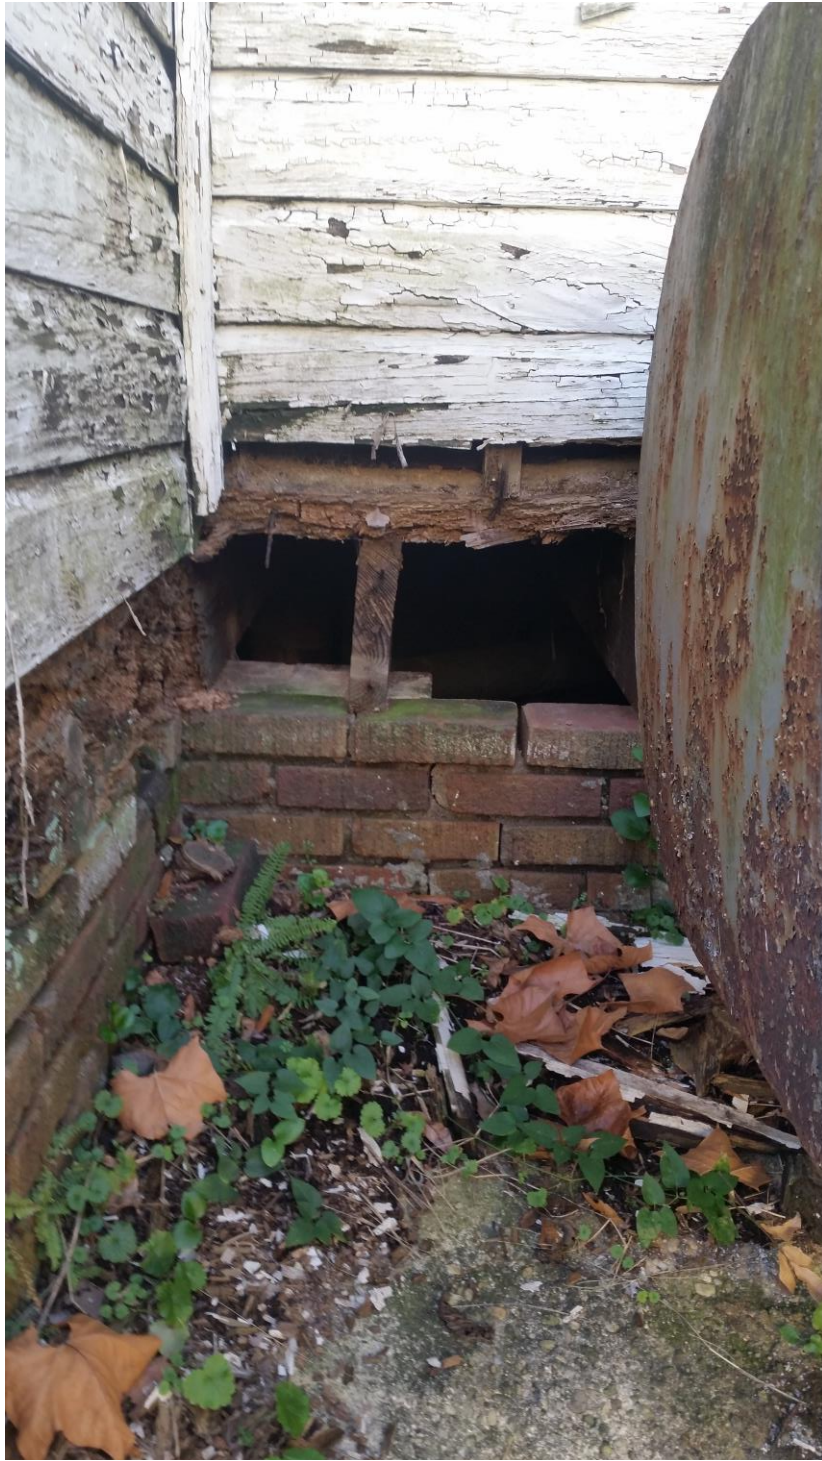
Compromised Foundation and Structure

At the time of the inspection, the house was found to have been built as a typical mill house found in this region. Unfortunately, there was no attic access to inspect the roof and ceiling framing, but there is evidence of significant water intrusion in the ceilings that would suggest that the three tab shingles are falling and a new roof would be required. The roof was found to have noticeable deflections which is typically the result of a lack of bracing. The house was found to have been built on a lot that slopes down from the front to the back and from the right to the left without an adequate fall in the grade away from the foundation. As a result, water has continually entered the foundation and has result in the rear cellar section of the foundation being under several inches of water. Therefore, a thorough inspection of the foundation could not be performed. However, there are significant settlement cracks in the foundation as a result of these drainage conditions. The front porch slab was also found to have settled and would need to be completely replaced. A section of the siding on the right side of the house was missing and the exterior band and framing in the area was found to be significantly damage from water and insects. The extent of the damage to the house framing cannot be determined but it is likely that the majority of the floor and wall framing is no longer structurally sound. Therefore, it is our recommendation that the house be demolished and a new house built in its place.
