PROPERTY ADDRESS: 700 Templeton Avenue

SUMMARY OF REQUEST: Demolition

Charlotte Historic District Commission - Case 2016-123
HISTORIC DISTRICT: DILWORTH

Structural Assessment Letter

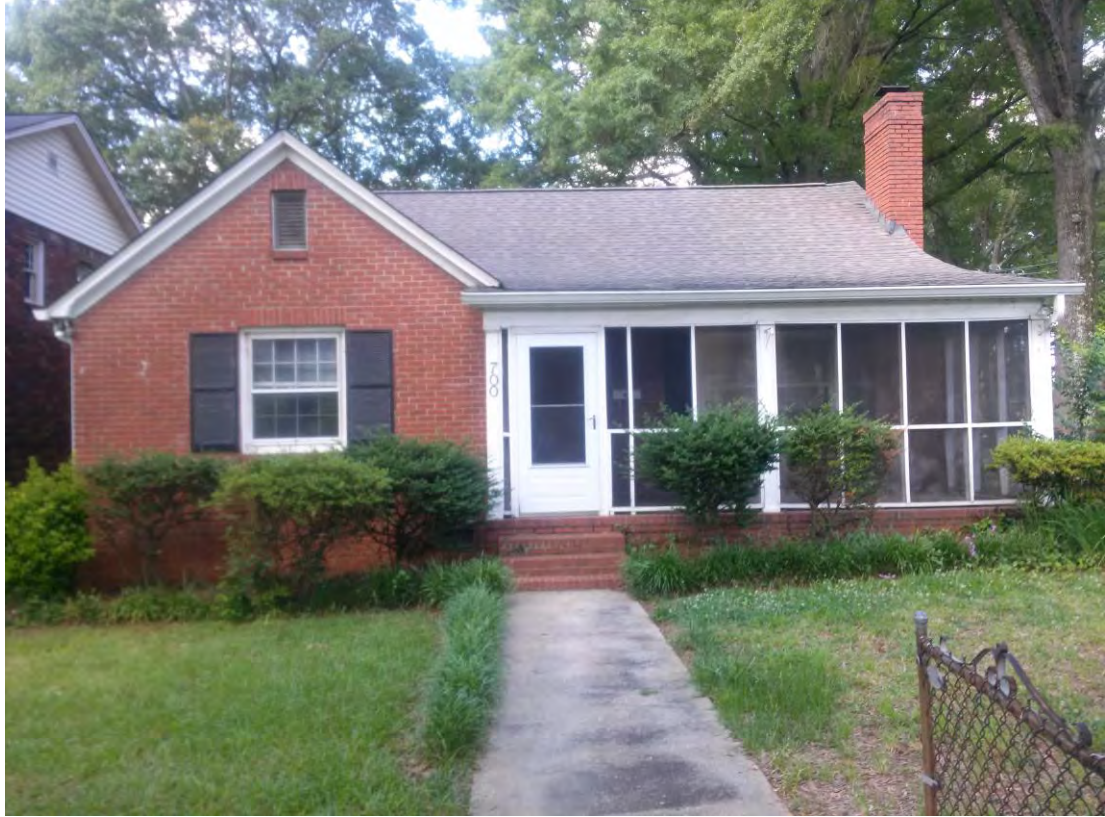
1.1

- 1.1. The house is constructed of conventional wood framing with brick veneer. See corresponding photograph.
- 1.2. The foundation is a crawlspace constructed of masonry pier and curtain wall.
- 1.3. House was built in 1936 according to tax records.

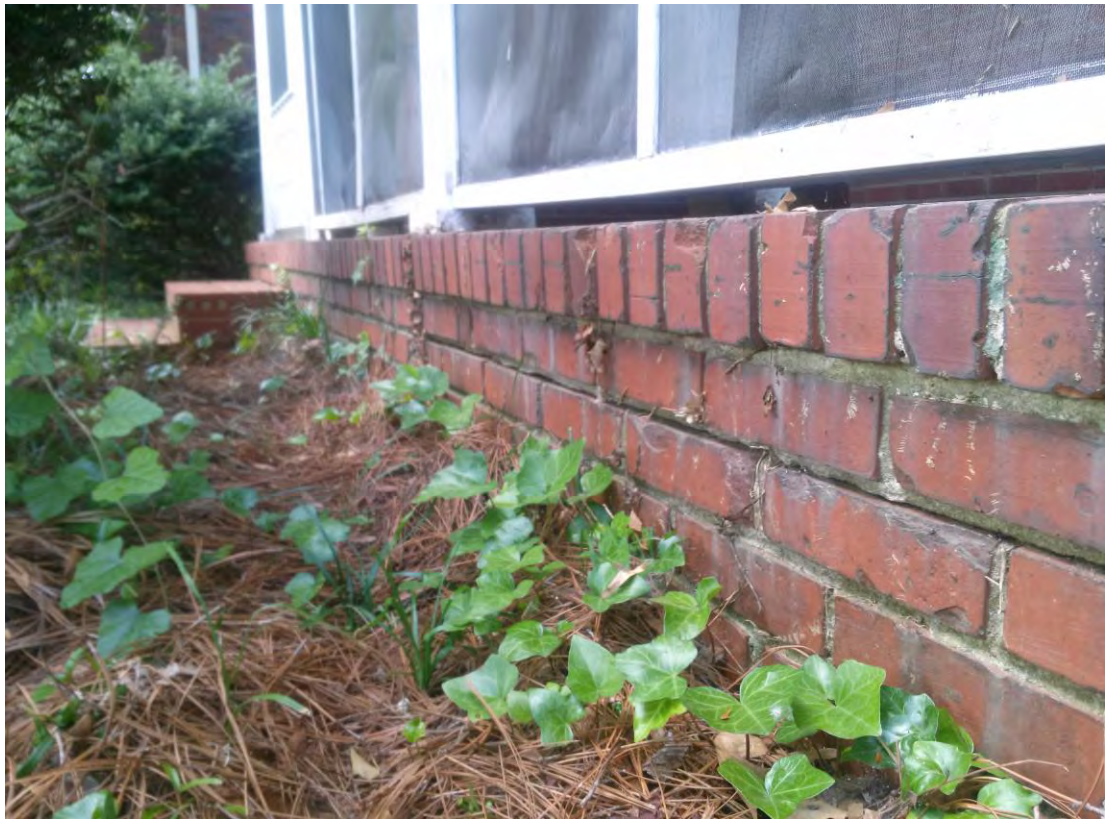
2.1.1

- 2.1.1. Observed horizontal crack in the foundation of the porch. See corresponding photograph.
- 2.1.2. Observed missing mortar in steps. See corresponding photograph.
- 2.1.3. Observed cracks in right corner and right window. See corresponding photograph.
- 2.1.4. Observed cracks left of right window. See corresponding photograph.
- 2.1.5. Observed repaired cracks left of door. See corresponding photograph.
- 2.1.6. Observed separation of front porch slab from masonry foundation wall. See corresponding photograph.
- 2.1.7. Observed cracks below left window. See corresponding photograph.

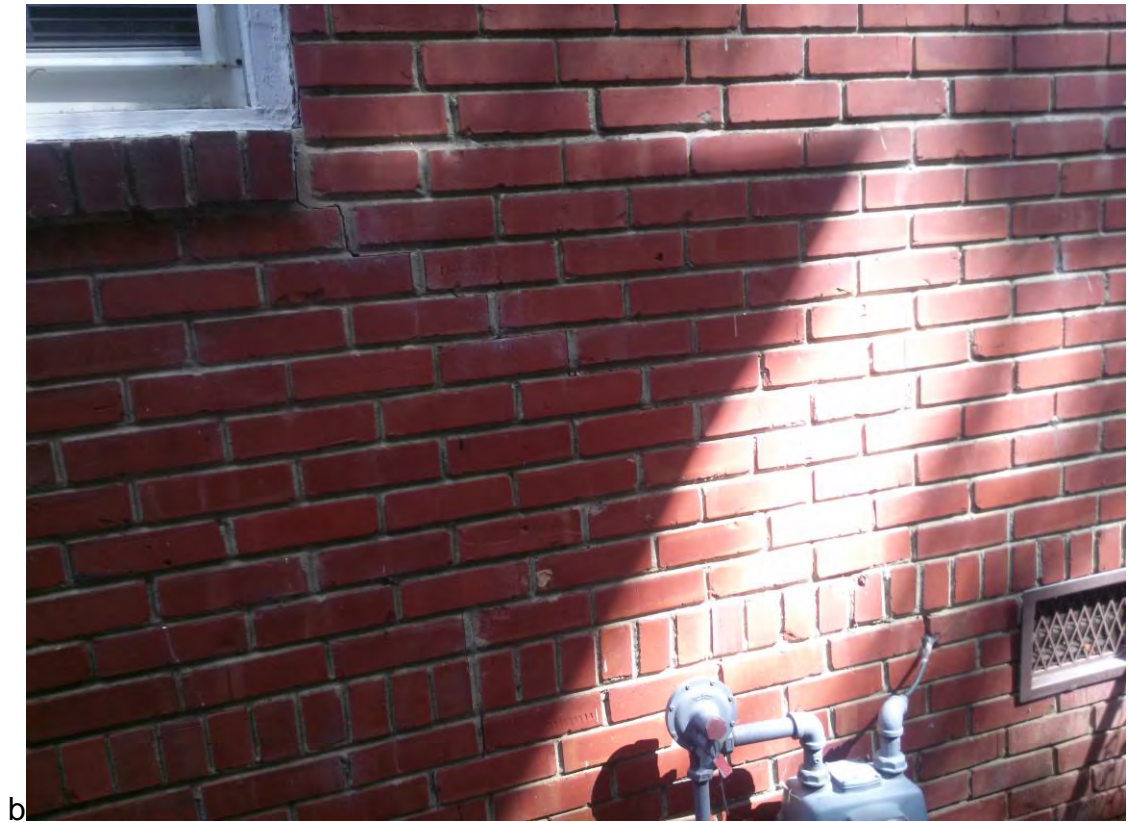
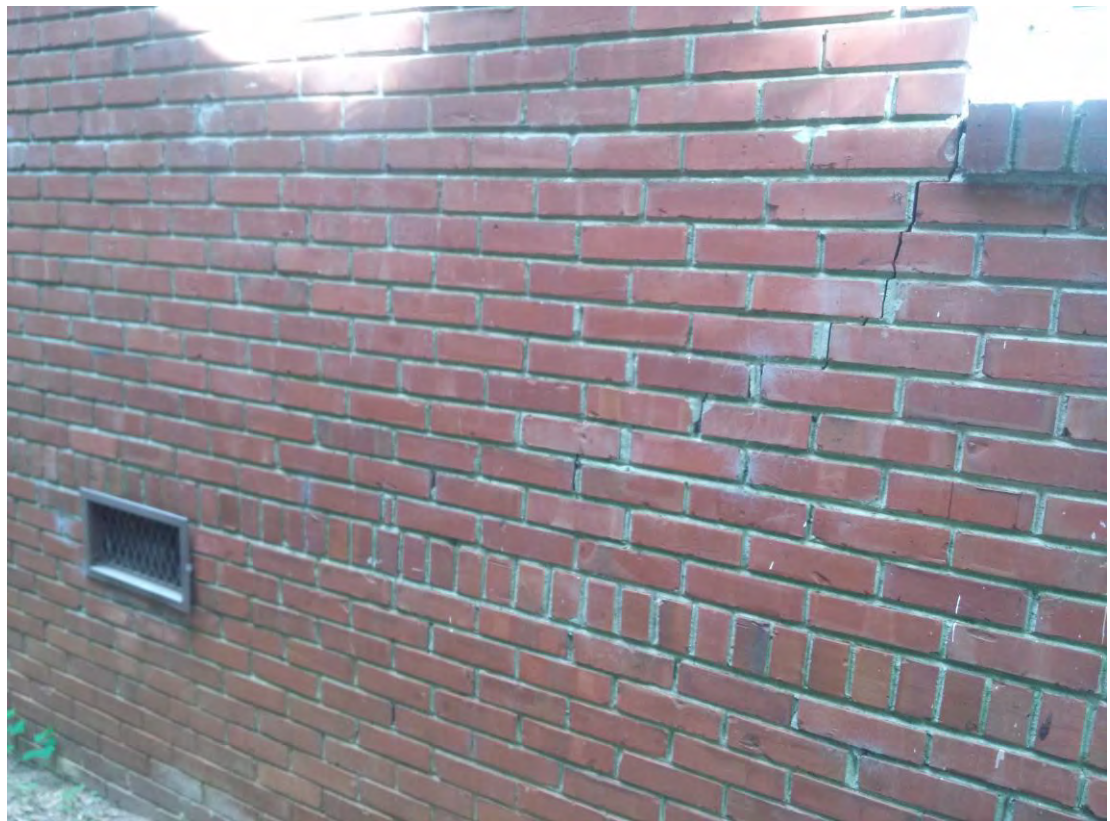
2.2.1

- 2.2.1. Observed cracks below front window. See corresponding photograph.
- 2.2.2. Observed missing mortar in brick above right window. See corresponding photograph.
- 2.2.3. Observed cracks above and below rear window with out of plane bricks below window. See corresponding photograph.
- 2.2.4. Observed that the rear corner brick veneer has been replaced. See corresponding photograph.

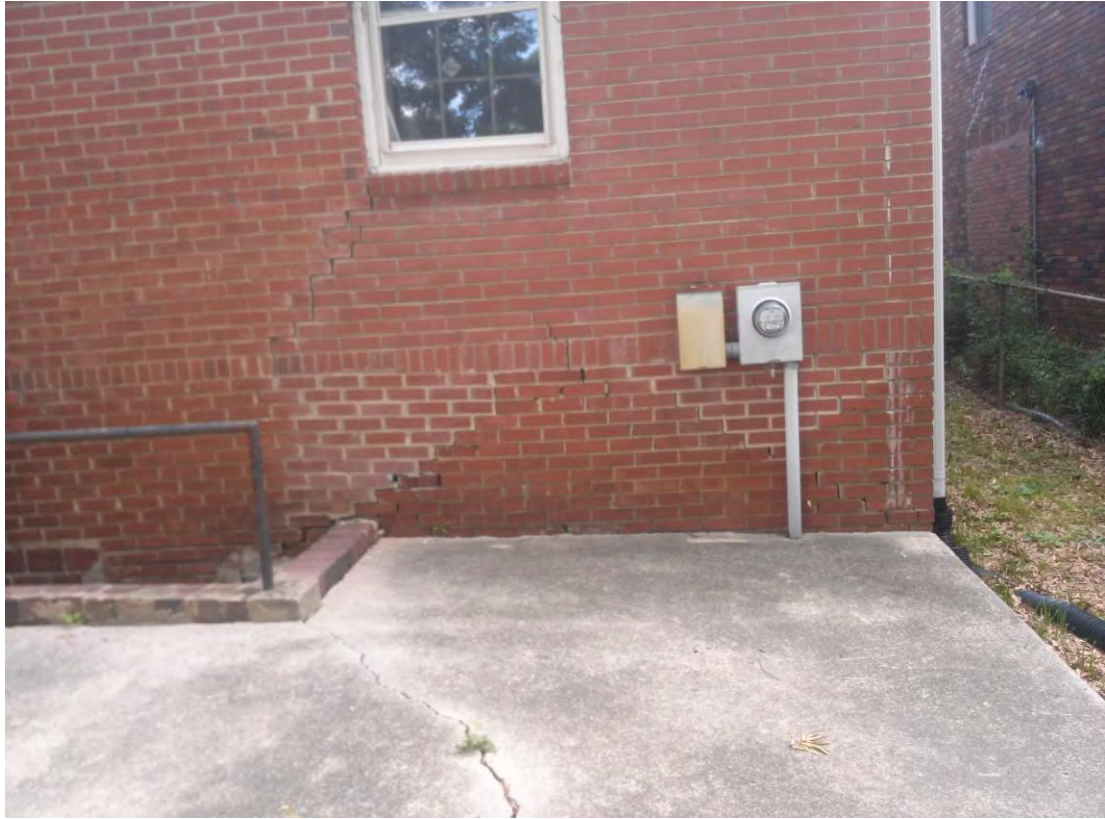
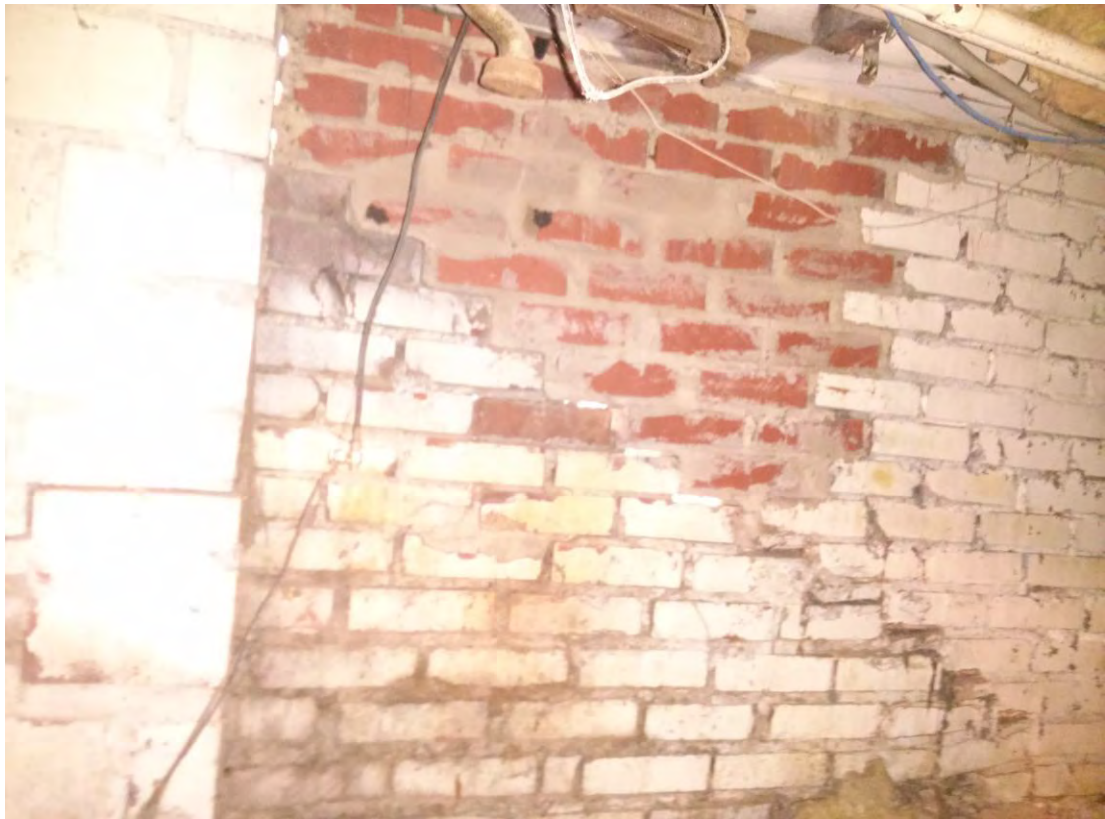
2.3.1-2.3.2

- 2.3.1. Observed that left corner brick veneer has been replace. See corresponding photograph.
- 2.3.2. Observed cracks under left window along with settlement of concrete slab. See corresponding photograph.
- 2.3.3. Observed cracks in brick veneer at rear entry. See corresponding photograph.
- 2.3.4. Observed loose bricks, out of plane bricks and cracks at rear entry steps. See corresponding photograph.
- 2.3.5. Observed cracks under right window. See corresponding photograph.

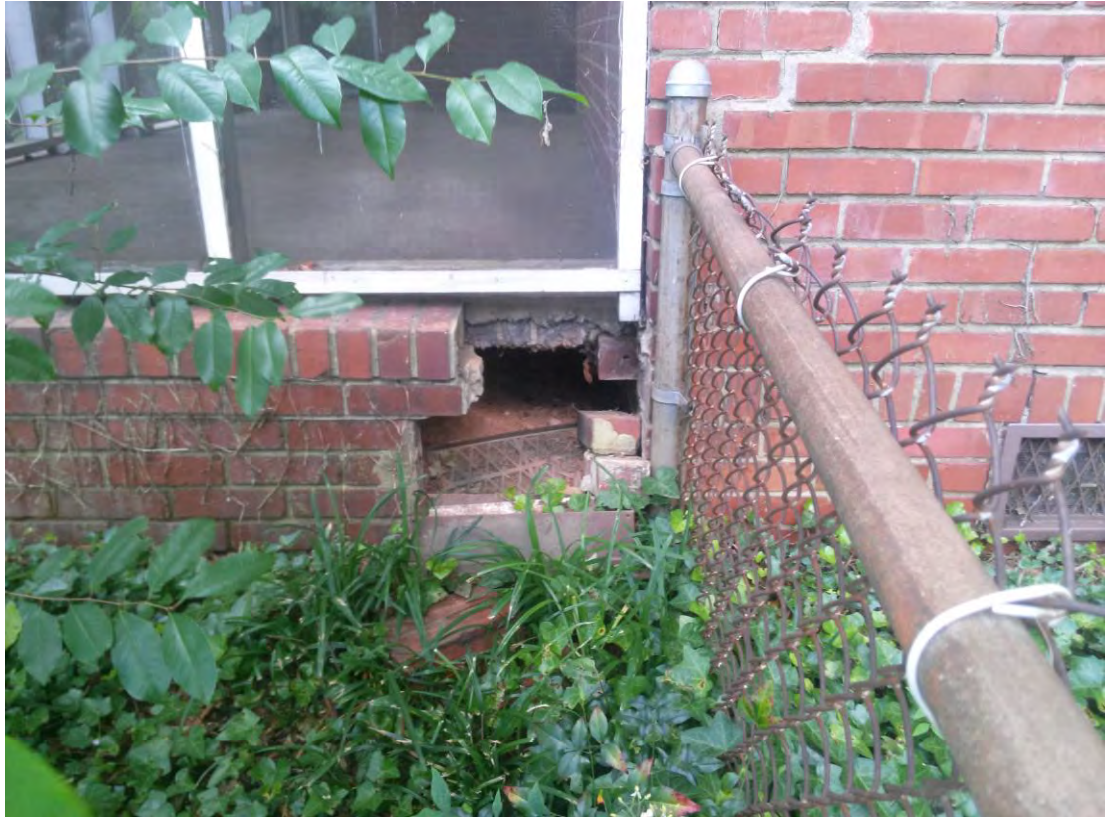
2.4.2

- 2.4.2. Observed collapse of perimeter wall of front porch. See corresponding photograph.
- 2.4.3. Repaired, re-cracked, and out of plane brick located at front right window. See corresponding photograph.
- 2.4.4. Observed that the chimney is cracked and pulling away from the house. See corresponding photograph.
- 2.4.4.1. This is a hazardous condition causing threat to human safety, and requires immediate attention.
- 2.4.5. Observed cracks in brick above and below the rear window.
- 2.5. Detached Garage
 - 2.5.1. Observed loose brick on the right side foundation. See corresponding photograph.
 - 2.5.2. Observed cracks and out of plane bricks on right and left side on the back foundation wall. See corresponding photograph.
 - 2.5.3. Observed cracks in the back of the left foundation wall.
 - 2.5.4. Observed cracks, loose brick, and termite damage on the left of the front wall.

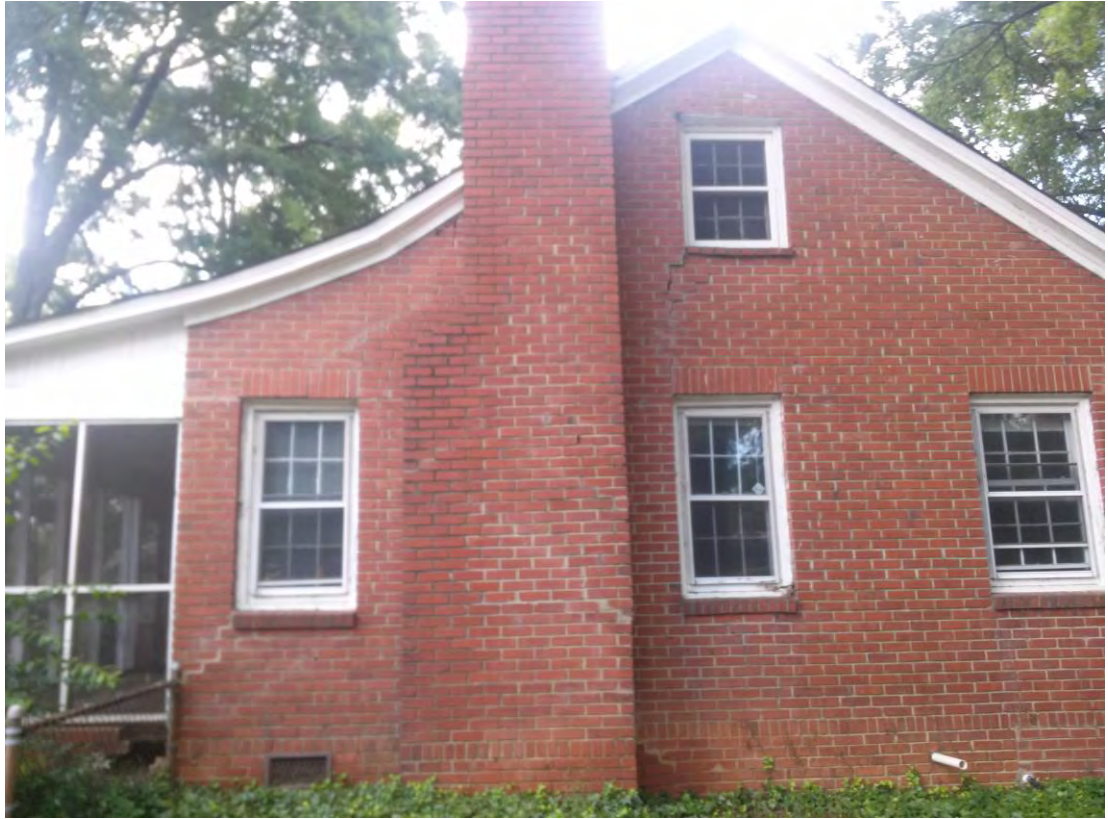
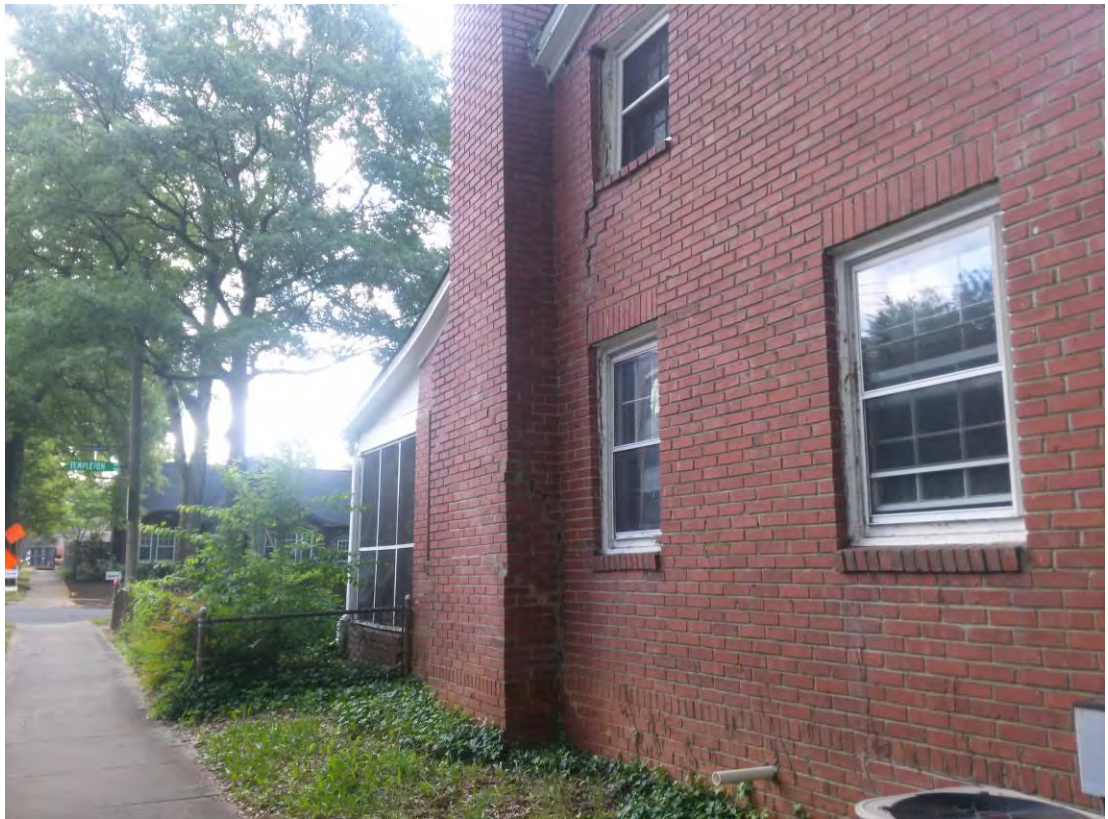
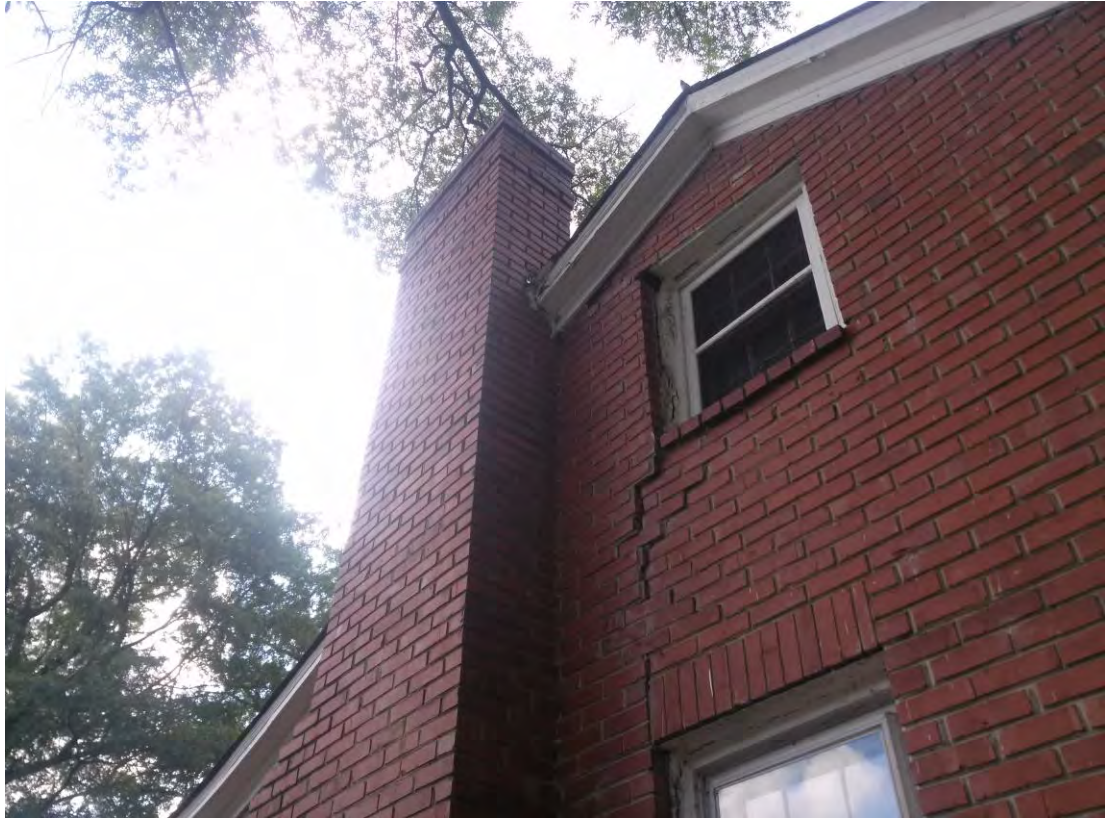
2.4.4

The chimney of the house poses a threat to public safety due to possible imminent collapse onto the public sidewalk to the right of the home. This issues requires immediate attention. The foundation wall has major settlement, out of plane movement, and cracking throughout, which could lead to possible collapse of portions of the foundation. Due to the extent of the structural distresses and the possible imminent collapse of the masonry chimney into public space, CDR+A recommends that the house be demolished. It is recommended that action be taken soon to prevent possible harm to human life.
