LOCAL HISTORIC DISTRICT: Dilworth

PROPERTY ADDRESS: 304 East Worthington Avenue

SUMMARY OF REQUEST: Demolition

Charlotte Historic District Commission - Case 2016-235
Demolition
HISTORIC DISTRICT: DILWORTH

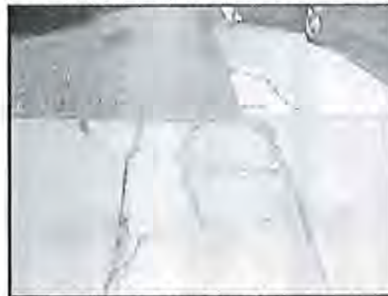
2.0 Picture 1

2.0 (1) Maintenance: There are various cracks present in the driveway surface. It is not apparent what caused the cracking, however, if the cracking gets worse they may require repair and or replacement.

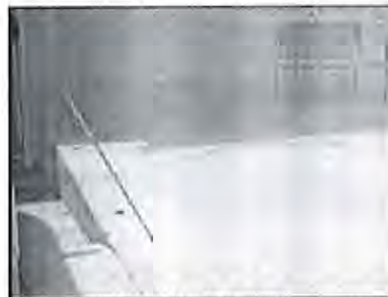
2.1 Picture 1

**2.1 (1) Front walk/entry:** Recommend a handrail be installed at walk and drive slope joint, this step off is uneven and a possible trip hazard.

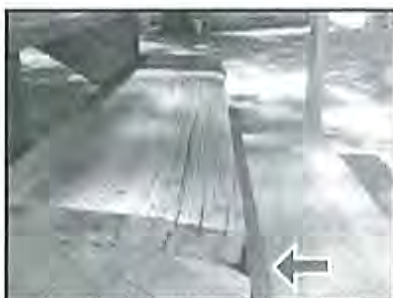
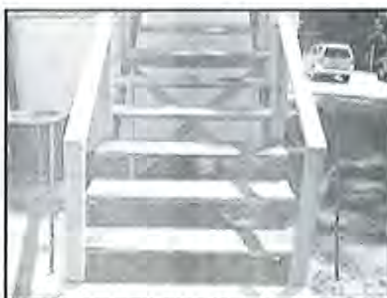
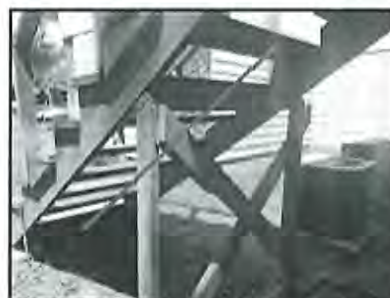
(2) **Rear steps:** There are multiple split step treads and some flex/sag when walked upon. Also noted are loose hand rails on both sides and a lack of a third stringer supporting the treads. These are a safety hazard. Recommend replacement by a licensed contractor for safety.

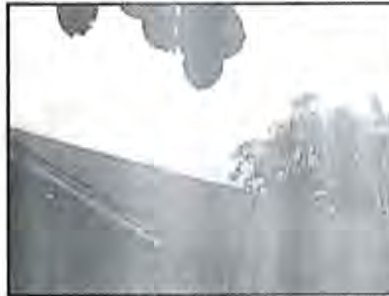
3.0 Picture 1

3.0 The roof shows typical wear for its age. The roofing shingles are 20 year type roof shingles, these roof shingles usually last between 15 to 18 years. We recommend typical maintenance and monitoring.

The asphalt/fiberglass roof shingles and penetration flashings appear to be near the end of their service life. It appears that they will need replacement in the not too distant future. They show signs of heavy wear typical for their age, consisting of heavy loss of mineral surface granules resulting in areas with none left and moderate to heavy wear along the edges of the tabs. The shingles are brittle, which is also a sign of advanced aging. Cracked, split and or missing shingles were observed in some areas. Some of the shingles are curling which is also a sign of advanced age.

The roof appears to have two or more layers of shingles. Newer shingles were installed over heavily worn shingles. This is done to avoid the cost of removing and disposing of the old shingles. This is considered acceptable if the existing framing is judged able to accommodate the extra weight imposed. Shingles installed in two layers usually achieve only 50-75 % of the life span they would otherwise achieve if the old roofing had been removed. Reasons for this are little understood. They are also a bit more likely to leak as the flashings around roof penetrations are usually not replaced.

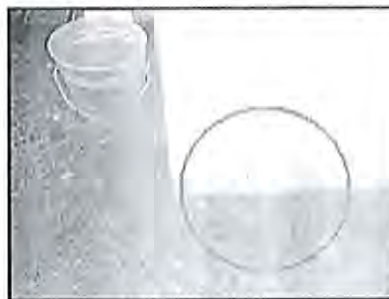
3.4 Picture 1

**3.4** The following roof drainage system concerns were noted during the inspection. Recommend review and repair as deemed appropriate by a qualified roofing/gutter contractor: At least one down spout discharges rain water at the foundation. Recommend installing down spout extension pipes or splash blocks to divert water away from the foundation.

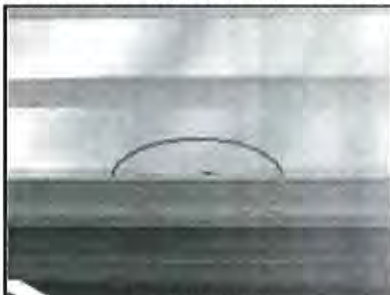
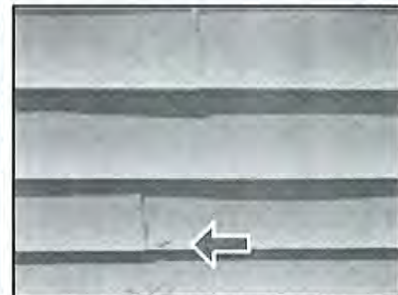
(2) The vinyl siding shows damage at rear, left and right sides of the house. Recommend repairs to prevent possible water intrusion into the sheathing.

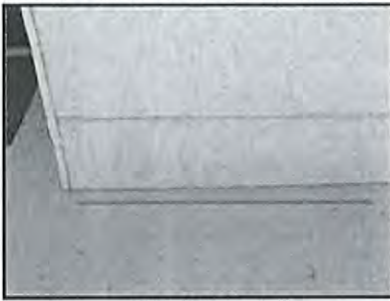
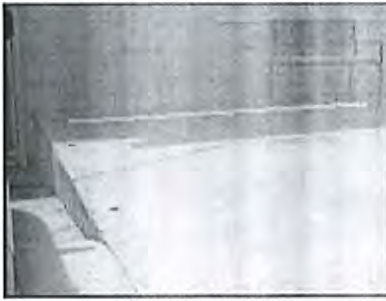
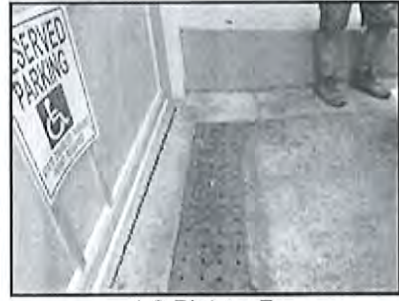
clearance of six inches between earth and bottom sill is recommended to prevent moisture from wicking into the siding leading to deterioration.

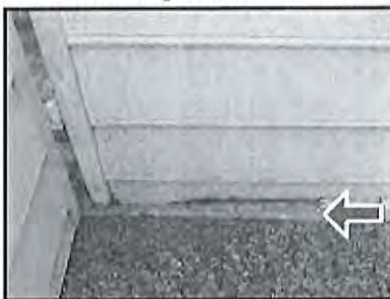
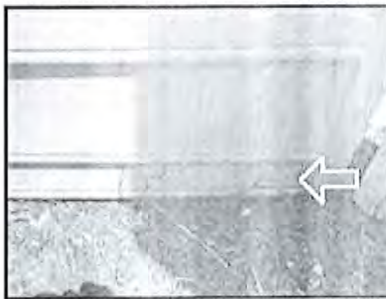
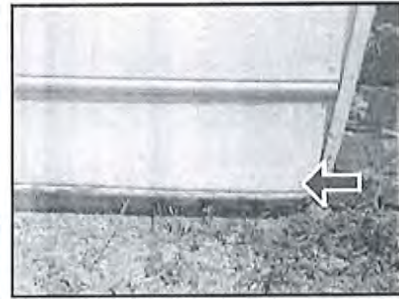
(4) The siding shows signs of moisture damage, softness and or deterioration at various areas along rear of the building. Recommend repairs by a qualified contractor to prevent possible moisture penetration behind/into the wood framing which can lead to deterioration of wood building components.

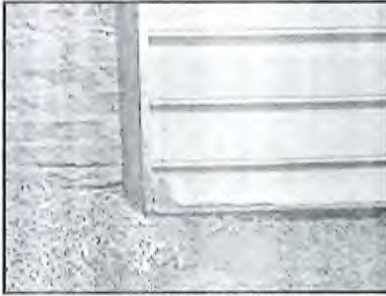
4.0 Picture 13

(5) Composite Siding and trim needs to be scraped, primed, painted/sealed and caulked at various areas around the entire building, this is typical maintenance. Minor moisture penetration and surface deterioration noted at some areas. Based on age of the building there are paint layers that may contain lead based paint. Recommend proper lead based paint testing prior to repairs by a qualified testing firm.

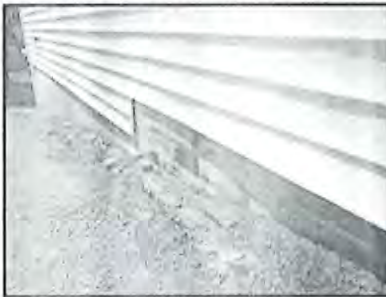
4.0 Picture 15

(7) Evidence of loose siding and or no starter strip at the front of the left side.

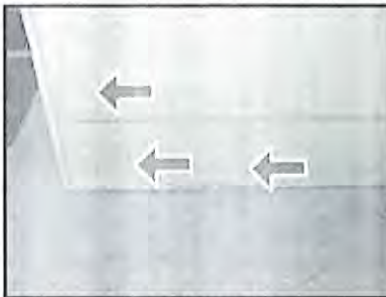
4.0 Picture 16

(8) Portions of the home are clad with and old siding that may contain asbestos. We noted portions of this siding that are cracked and or broken. Recommend siding be properly tested by a qualified laboratory prior to repairs and or replacement for safety.

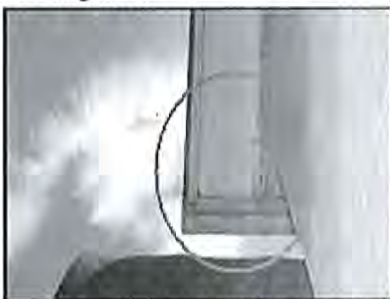
there are paint layers that may contain lead based paint. Recommend proper lead based paint testing prior to repairs by a qualified testing firm.

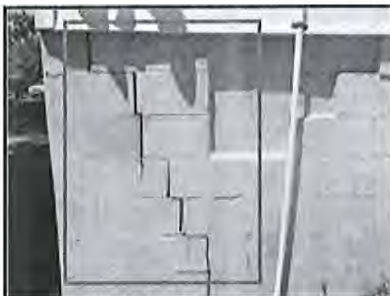
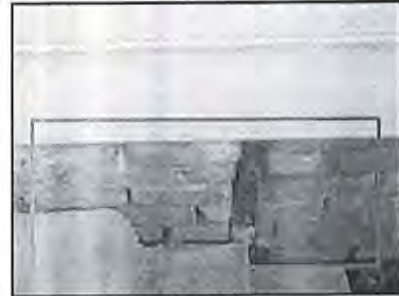
Loose bricks and or missing mortar visible at exterior noted at the rear of the right side foundation wall (facing front) (Picture 3).

Due to the foundation issues listed above recommend further investigation and repair/replacement recommendations as deemed necessary by a qualified engineer. The repair/replacement should be completed by a licensed contractor to the engineers satisfaction.

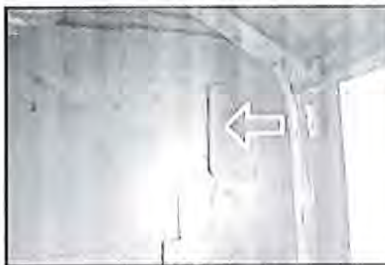
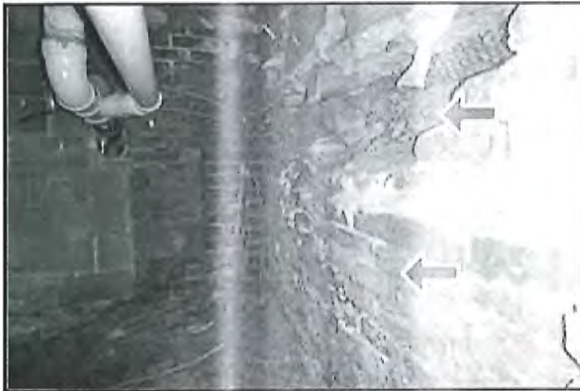
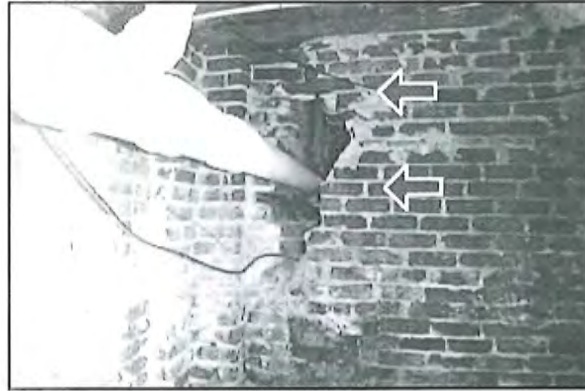
📷 (2) In the crawl space at left side there are areas of missing brick and a bow in the foundation (Picture 4). To the rear of the wall an original foundation wall has a large hole punched in it for a drain line (Picture 5). This hole has loose brick at top of the opening.

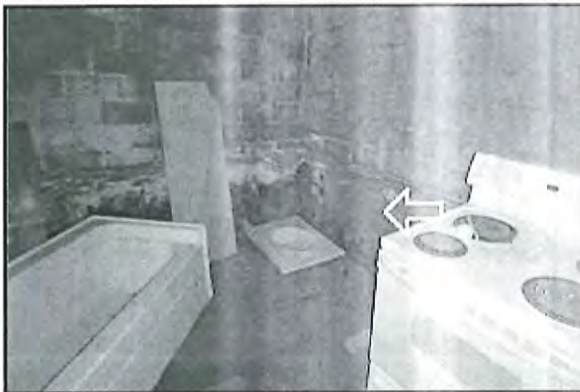
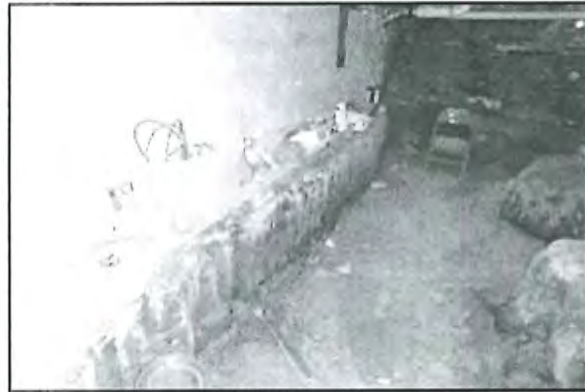
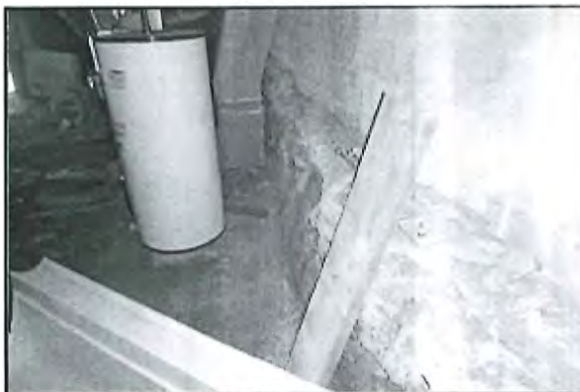
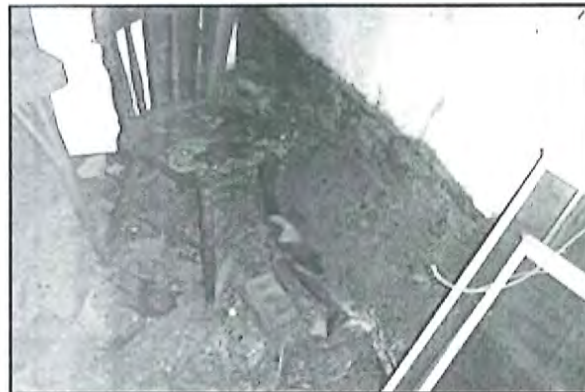
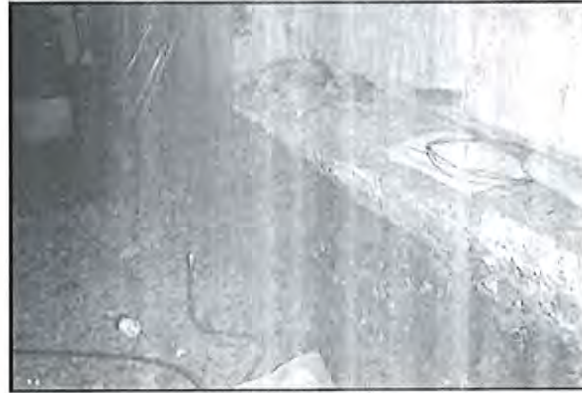
📷 (3) In the crawl space areas to the left, soil have been disturbed/dug out at/within a 45 degree angle below the footers. This has likely reduced the stability of the soil supporting the foundation footers. At rear right soil removed has exposed footer edge and some soil has eroded from under areas of the footers.

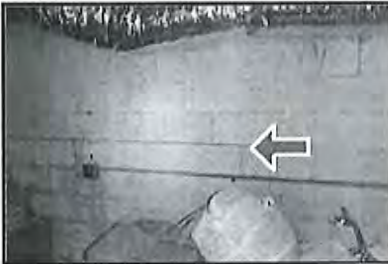
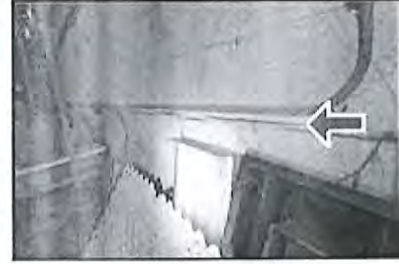
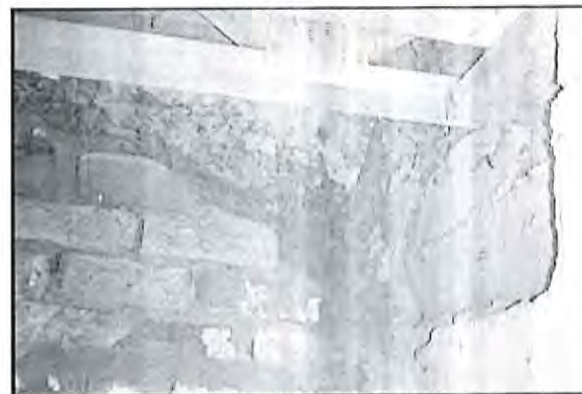
📷 (4) At left rear interior foundation there is a long horizontal crack in the foundation with some smaller step cracks off of this crack. Cracks of this type typically indicate some bowing and or exterior pressure on the foundation.

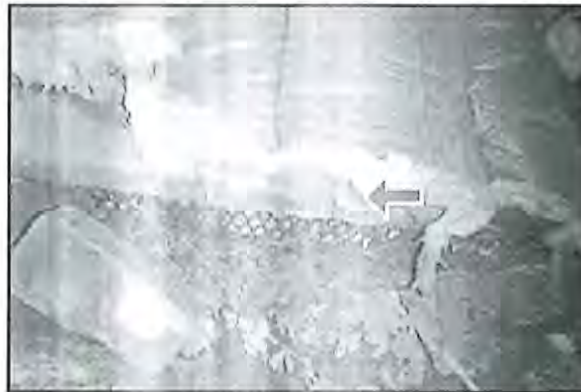
5.2 Picture 1

5.2 At left side of the crawl space at beam at/in the foundation has areas of damage. Due to the damaged floor framing recommend further investigation and repair/replacement recommendations as deemed necessary by a qualified engineer. The repair/replacement should be completed by a licensed contractor to the engineers satisfaction.

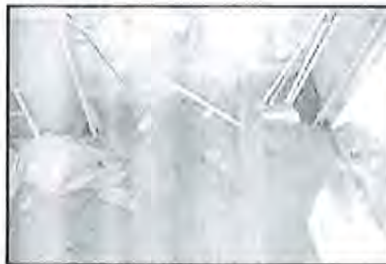
5.5 Picture 1

5.5 Water penetration, moisture staining and or efflorescence was observed in the crawl space at left side foundation. Recommend further evaluation by a foundation and or crawl space moisture control contractor to eliminate any and all possibilities for water intrusion.

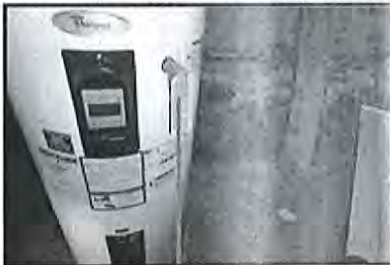
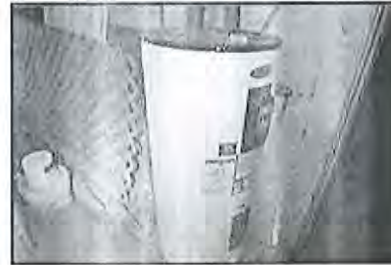
📷 (3) Both units: The overflow pipe that extends from the T&P (Test and Pressure) valve on the water heater is missing, this pipe should be properly installed so that it extends to within 6 inches of floor for safety. This is typically an easy repair, using common industry standards.

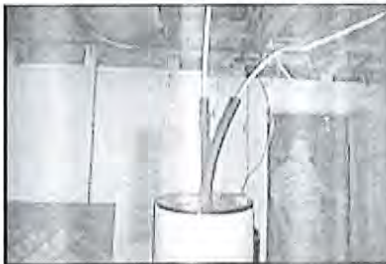
7.2 Picture 5

📷 (4) Left crawl space unit: Your water heater does not have a "Thermal Expansion tank" installed to prevent a possible leak at the TPR valve and or damage to the water heater or plumbing system. Recent changes in installation guide line require one when a new water heater is installed. There were no leaks or drips at the TPR valve during inspection. Recommend further investigation and repairs as deemed necessary by a licensed plumbing contractor.

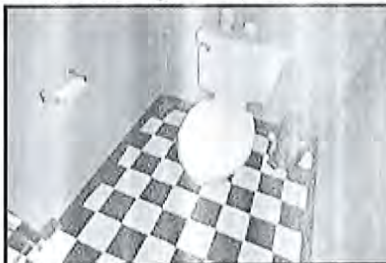
7.3 Picture 1

📷 **7.3** The following plumbing system concerns were noted during the inspection. Recommend review and repair as deemed appropriate: Toilet is loose from the floor at upper bathroom. The flange should be checked and wax ring changed. Non visible moisture damage that is not readily visible maybe present in, under and or around the toilet base, this should be checked during the repair.

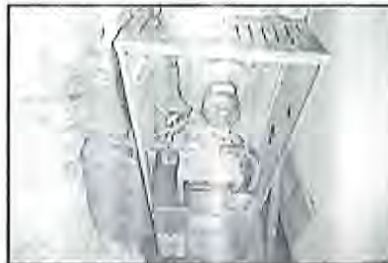
8.0 Picture 1

8.0 (1) View of heating/cooling system air handler(s) in closet (for your info). This is an Aire Ease, model #GN180BT050D12A-3A. **Monitor:** The furnace is past/near the end of it's normal life span, you should budget for repairs or replacement in the not to distant future. We cannot determine how long your unit will last before replacement is necessary.

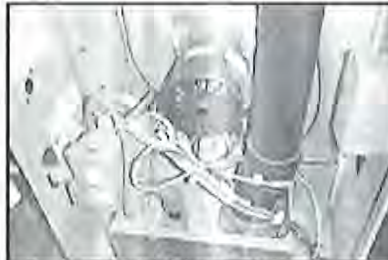
8.0 Picture 2

(2) View of heating/cooling system air handler(s) in crawl space (for your info). This is an Aire Ease, model #G1T80AT075D14B-1A. **Monitor:** The furnace is past/near the end of it's normal life span, you should budget for repairs or replacement in the not to distant future. We cannot determine how long your unit will last before replacement is necessary.

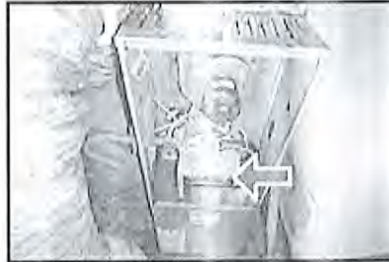
8.1 Picture 1

**8.1** The following heating system concerns were noted during the inspection. Recommend review and repair/replacement as deemed appropriate: Closet unit: AC condensate is leaking into the unit, rust formation noted at bottom of burner chamber.

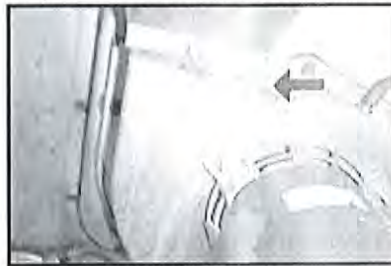
8.3 Picture 1

**8.3 (1)** The following heating system concerns were noted during the inspection. Recommend review and repair/replacement as deemed appropriate: Crawl space unit: Metal flue pipe shows extensive signs of rust and corrosion at its joints/connections, this evidence typically indicates that excessive moisture is present in the flue and that the system may not be burning/operating properly.

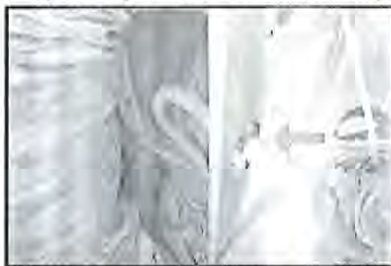
8.6 Picture 2

(2) Both units: CSST gas piping noted in the furnace cabinet. Typically CSST cannot be used in a furnace cabinet unless a protective bushing is installed at entry point to prevent possible abrasion of the gas line on the furnace cabinet wall. Typically when a bushing is not installed rigid gas piping is used inside the furnace cabinet. Recommend repairs by a licensed HVAC or gas appliance tech.

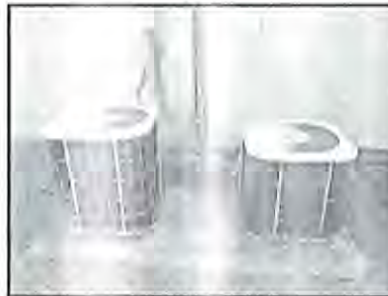
9.0 Picture 1

9.0 View of cooling system outside condenser(s) (for your info). The unit on the right is a Lennox, model #CCU10A24A-1, built in 2001. The unit on the left is a Lennox, model #CCU10A30A-1, built in 2001. **Monitor:** The cooling system outside condenser(s) are past/near the end of their normal life span, you should budget for repairs or replacement in the not to distant future. We cannot determine how long your units will last before replacement is necessary.

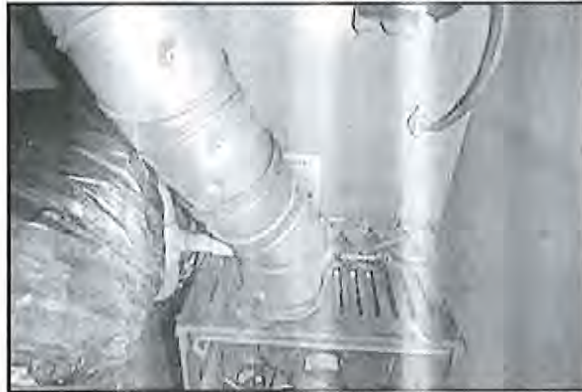
9.1 Picture 1

9.1 (1) Evidence of present moisture conditions (water, rust and water stains) present on top of air handler unit located in the closet on the second floor at the left rear side. This is a typical past and or present indication of the air handler, A-coil and or refrigerant lines leaking and not draining properly, also the condensation drain piping maybe clogged.

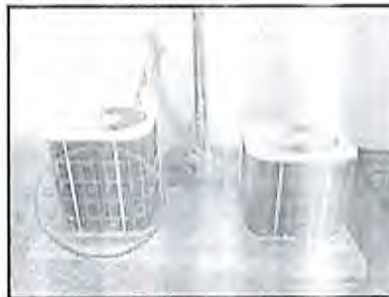
9.1 Picture 2

(2) Both outside HVAC condenser unit fins and coils have some compromised, bent and or corroded areas. Due to this condition, the system may be leaking refrigerant and should be leak tested by a qualified HVAC contractor. Also this condition is somewhat restricting air flow through the fins and coils causing the system to operate less efficiently than designed by the manufacturer.

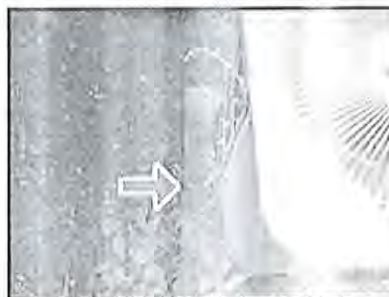
9.1 Picture 3

(3) **Maintenance:** Evidence of dirt and or debris at the outside HVAC condenser units. This condition is restricting air flow through the system. Evidence suggests that the system is being restricted from functioning as intended by the manufacturer.

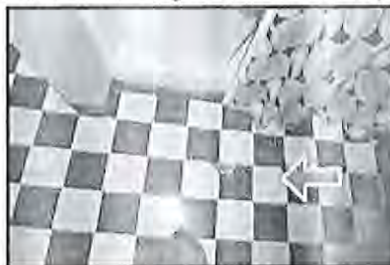
10.2 Picture 1

10.2 Upper bathroom: Noted damaged and or missing floor tiles and exposed wood sub floor.
