PROPERTY ADDRESS: 308 East Worthington Avenue

SUMMARY OF REQUEST: Demolition

Charlotte Historic District Commission - Case 2016-235
Demolition
HISTORIC DISTRICT: DILWORTH

Property Address:
308 E Worthington Aveune
Charlotte NC 28203

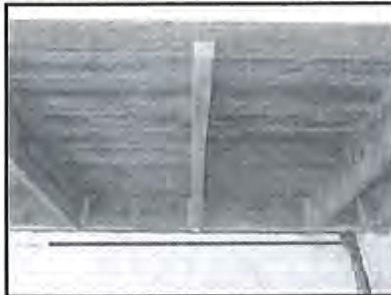
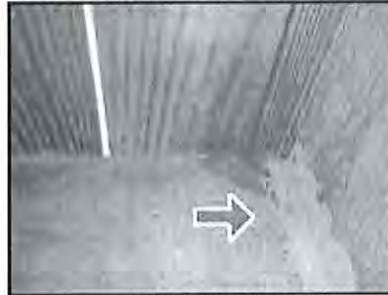
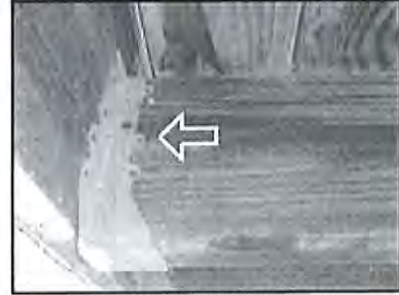
**2.2 (1)** Missing nails noted at multiple joist hangers. Typically all nail holes must be used in a hanger to ensure proper structural support. The rear deck is nailed to the house with no other visible means of attachment. Nails can corrode and fail behind the deck band causing the deck to collapse. Concealed damage to framing and/or siding behind the deck can also result in deck collapse. Unless it can otherwise be demonstrated that the deck attachment to the house is secure, the deck should be directly supported from below or bolted to the house. Have the deck attachment investigated and modified or repaired as deemed necessary by a licensed general contractor or professional engineer.

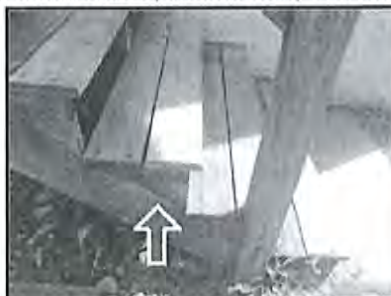
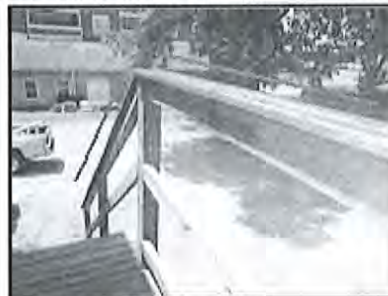
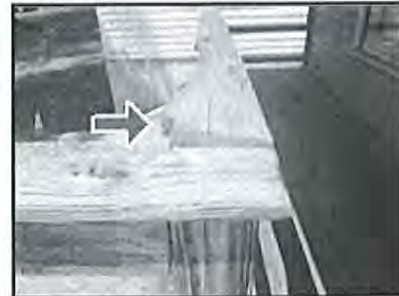
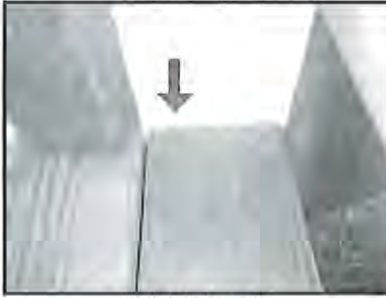
**(2)** Rear deck steps: There are multiple split step treads and some flex/sag when walked upon. Also noted is a loose hand rail and split/damaged stringers as well as popped up nails. These are a safety hazard. Recommend replacement by a licensed contractor for safety.

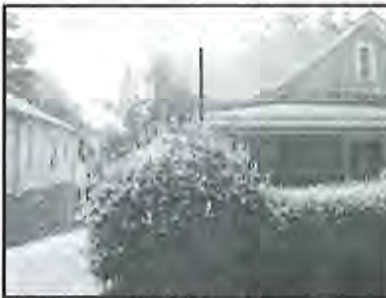
2.3 Picture 1

2.3 Maintenance: Shrubs, plantings and or vegetation near or in contact with the structure. This can create moisture problems and provide a harborage for insects. Recommend keeping all vegetation trimmed to at least 18 inches away from the structure.

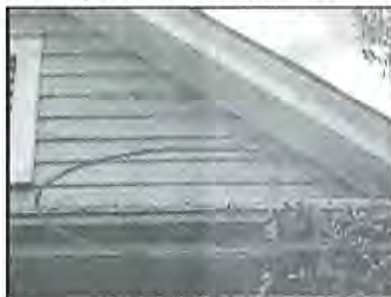
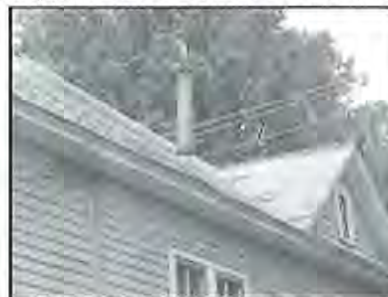
3.0 The roof shows typical wear for its age. The roofing shingles are 20 year type roof shingles, these roof shingles usually last between 15 to 18 years. We recommend typical maintenance and monitoring. The asphalt/fiberglass roof shingles and penetration flashings appear to be near the end of their service life.

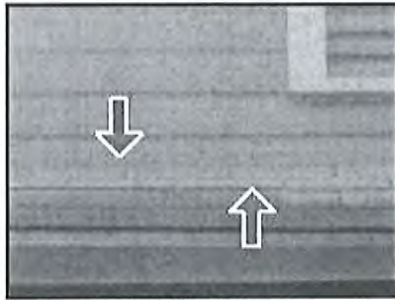
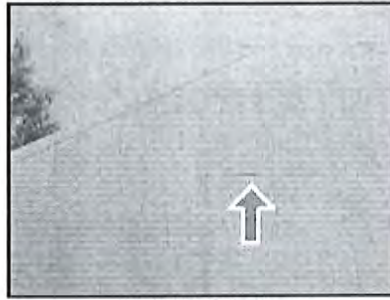
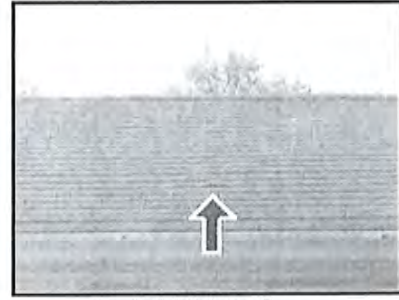
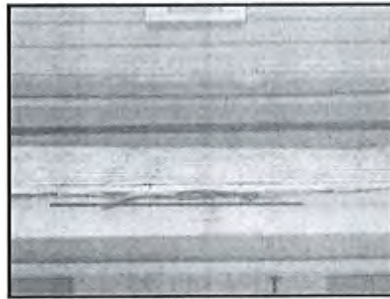
3.1 The following roofing concerns were noted during the inspection. Recommend review and repair/replacement as deemed appropriate by a qualified roofing contractor: Nail pops and or loose uplifted shingle tabs are present at numerous areas across the roof surface, this condition may allow wind and or rain to cause physical damage to the roofing materials.

Numerous areas of exposed nails heads noted throughout the roofing. Damaged shingles noted at drip edge/s, example at front.

Portions of the roof covering/flashings are past their normal life span, Evidence suggests that the roof covering/flashings should be replaced. The old roof covering and flashing should be removed prior to the installation of the new materials.

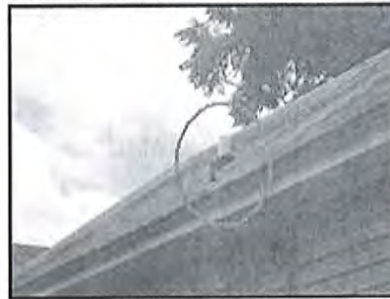
3.3 Picture 1

**3.3** The following roof flashing/penetration concerns were noted during the inspection. Further review and repair as deemed appropriate: Roof plumbing vent pipe flashings/boots are split/damaged at left side.

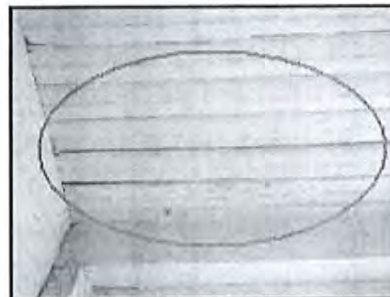
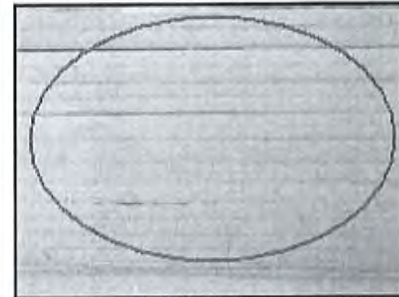
**3.4 Investigate Further:** Evidence of past water/moisture/staining penetration observed in the attic/ceiling structure/framing at/around front and rear porch, these areas were dry at the time of inspection. The seller should be asked about the status of these moisture stains and any recent repairs, further investigation recommended.

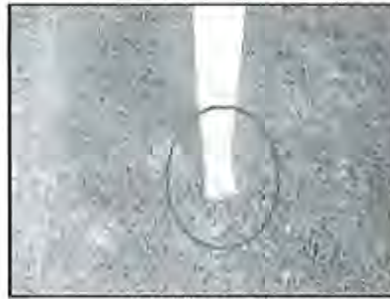
3.5 Picture 1

**3.5** The following roof drainage system concerns were noted during the inspection. Recommend review and

repair as deemed appropriate by a qualified roofing/gutter contractor: At least one down spout discharges rain water at the foundation. Recommend installing down spout extension pipes or splash blocks to divert water away from the foundation.

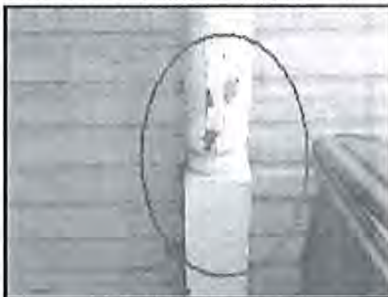
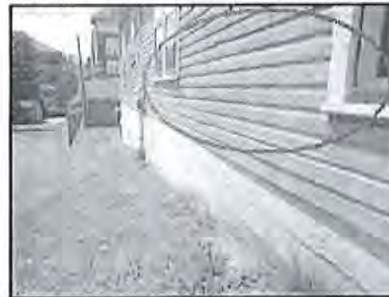
4.0 (1) Siding and trim needs to be scraped, primed, painted/sealed and caulked at various areas around the entire building, this is typical maintenance. Minor moisture penetration and surface deterioration noted at some areas. Based on age of the building there are paint layers that may contain lead based paint. Recommend proper lead based paint testing prior to repairs by a qualified testing firm.

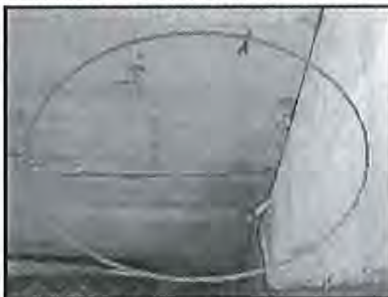
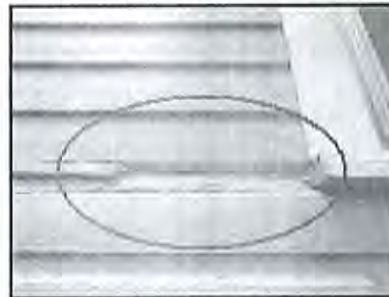
(2) Siding is damaged/compromised at/around nail head penetrations, bottoms and end cuts. Water absorption present, blisters and soft/deteriorated areas observed at left side of the front porch and center of the left side. Recommend repairs by a qualified contractor to prevent possible moisture penetration behind/into the wood framing which can lead to deterioration of wood building components.

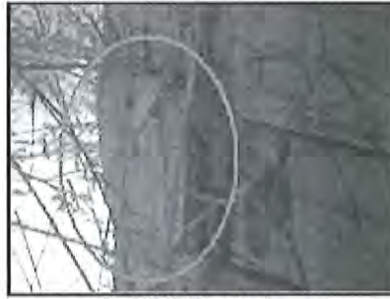
4.1 Picture 1

4.1 (1) The trim and or corner boards show moisture damage and or deterioration at/near the bottom left

side of the porch at the front. Recommend further investigation of all trim and repair/replacement of damaged trim by a qualified contractor to prevent possible moisture penetration which can lead to deterioration of wood building components.

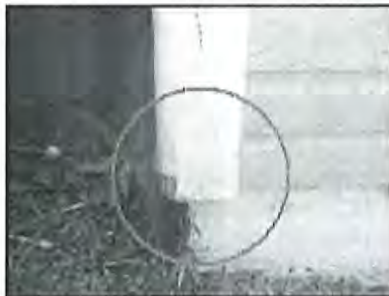
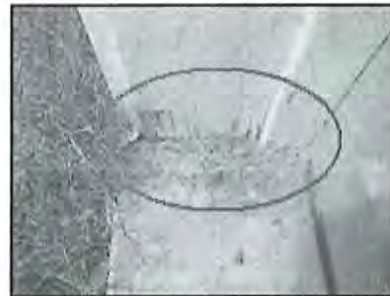
(2) The wooden exterior trim needs to be scraped, primed and painted and re-caulked in the near future, some areas of bare wood showing, this is typical maintenance. Based on age of the building there are paint layers that may contain lead based paint. Recommend proper lead based paint testing prior to repairs by a qualified testing firm.

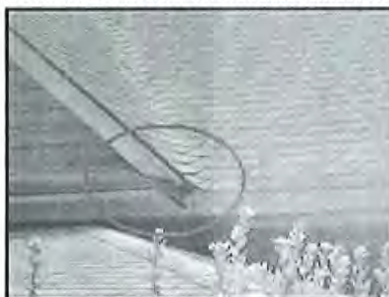
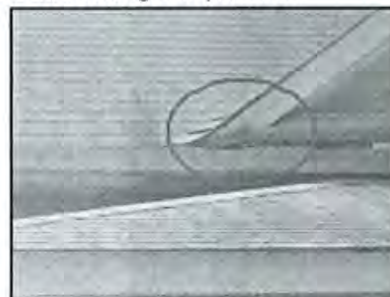
**4.2** Moisture damage visible at fascia at front gable. Recommend further investigation of all fascia and repair/replacement of damaged wood as deemed necessary by a qualified contractor to prevent possible moisture penetration which can lead to deterioration of wood building components.

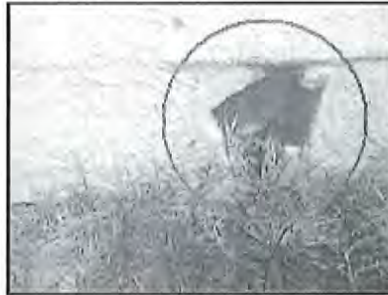
5.0 Picture 1

5.0 Damaged CMU at the rear left side corner.

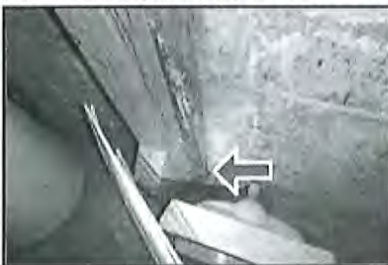
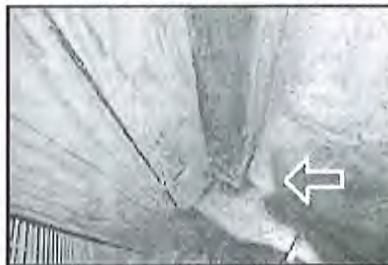
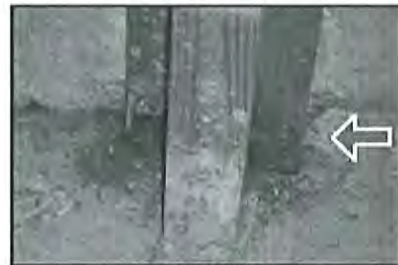
**5.1 (1)** Wood columns were added for support at the outside foundation walls of the basement. The majority of these supports have areas of deterioration at base floor/wall contact. Recommend further investigation and repair/replacement recommendations as deemed necessary by a qualified engineer. The repair/replacement should be completed by a licensed contractor to the engineers satisfaction.

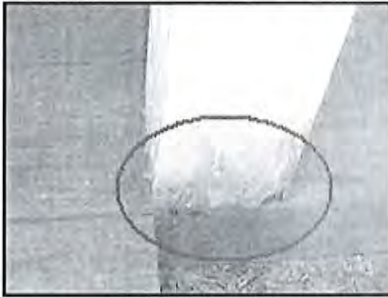
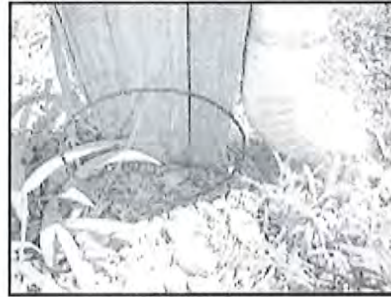
(2) Evidence of deterioration at/near the bottom of the columns at the front porch overhang and rear porch/deck. Recommend replacement of damaged columns by a licensed contractor to ensure proper structural support of the framing above.

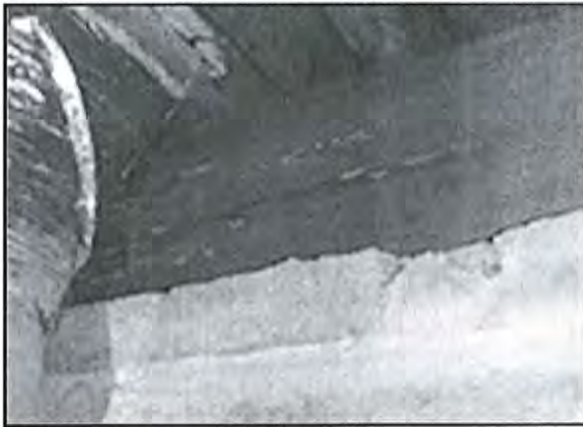
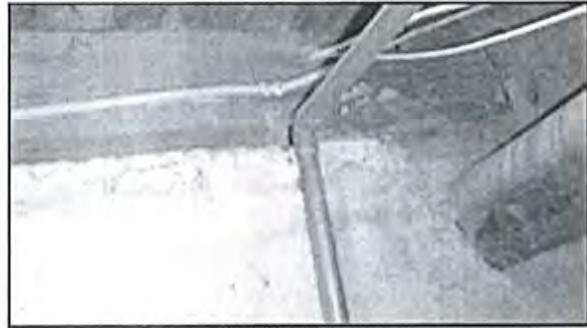
**5.2** Damaged and or deteriorated sill noted at a few areas including front left, Recommend further investigation and repair/replacement recommendations as deemed necessary by a qualified engineer. The repair/replacement should be completed by a licensed contractor to the engineers satisfaction.

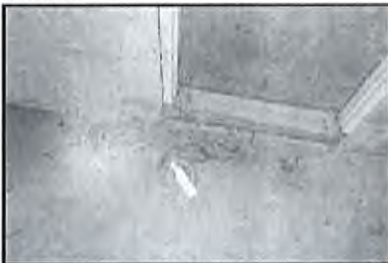
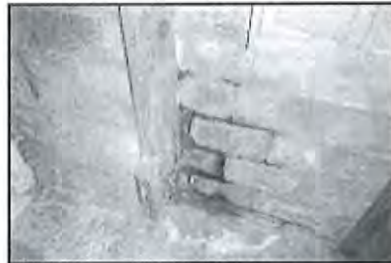
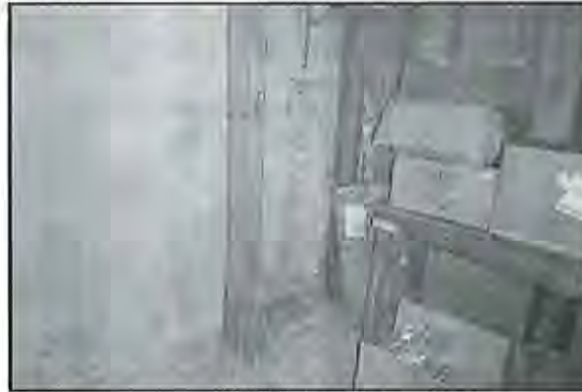
**5.3** Evidence of water/moisture present inside the basement foundation area at various areas. This water/moisture entry needs to be eliminated to reduce dampness in the structure/foundation that may lead to deterioration of the building components. Recommend further investigation and corrective action by a licensed foundation moisture control contractor.

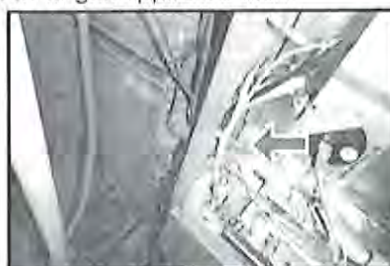
8.5 Picture 2

(2) CSST gas piping noted in the furnace cabinet. Typically CSST cannot be used in a furnace cabinet unless a protective bushing is installed at entry point to prevent possible abrasion of the gas line on the furnace cabinet wall. Typically when a bushing is not installed rigid gas piping is used inside the furnace cabinet. Recommend repairs by a licensed HVAC or gas appliance tech.
