# Charlotte Historic District Commission Staff Review

HDC 2017-439

**PROPERTY ADDRESS:** 301 West Kingston Avenue

**SUMMARY OF REQUEST:** Front porch addition

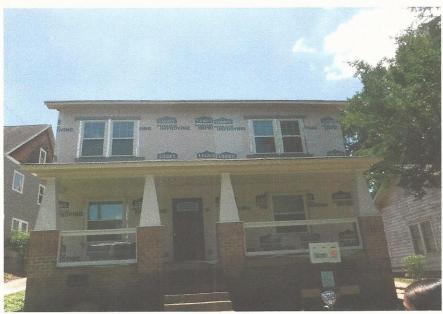
Photo #1

At your request, HowardVerna Engineering made a visit to the referenced address on July 19<sup>th</sup>, 2017, to provide an inspection and consultation on the roof and ceiling front porch cover framing. This is a two-level home, originally built in 1948, that is clad with siding, is covered with a truss framed gable roof (front to rear), and is supported over a crawlspace foundation (see photo #1).
