<b>LOCAL HISTORIC DISTRICT:</b>	Dilworth
<b>ADDRESS OF PROPERTY:</b>	325 East Boulevard
<b>SUMMARY OF REQUEST:</b>	Demolition
<b>OWNER:</b>	Gary West, Max Maintenance Company
<b>APPLICANT:</b>	Gary West, Max Maintenance Company

# Charlotte Historic District Commission - Case 2014-021

**325 East Blvd.  
Charlotte, NC 28203  
Limited Structural Observations  
Photo Narrative  
for  
Gary West  
Dwelle Property Management  
and Real Estate Inc.  
756 Tyvola Road, Ste 119  
Charlotte, NC 28217  
by  
A. Wynn Yates, PE  
Yates Structural Engineering, PA  
3300 Elstree Drive  
Charlotte, NC 28226  
704-650-5541  
wyates@yseng.com**

**August 29 and September 5, 2013  
(Revised) January 8, 2014**

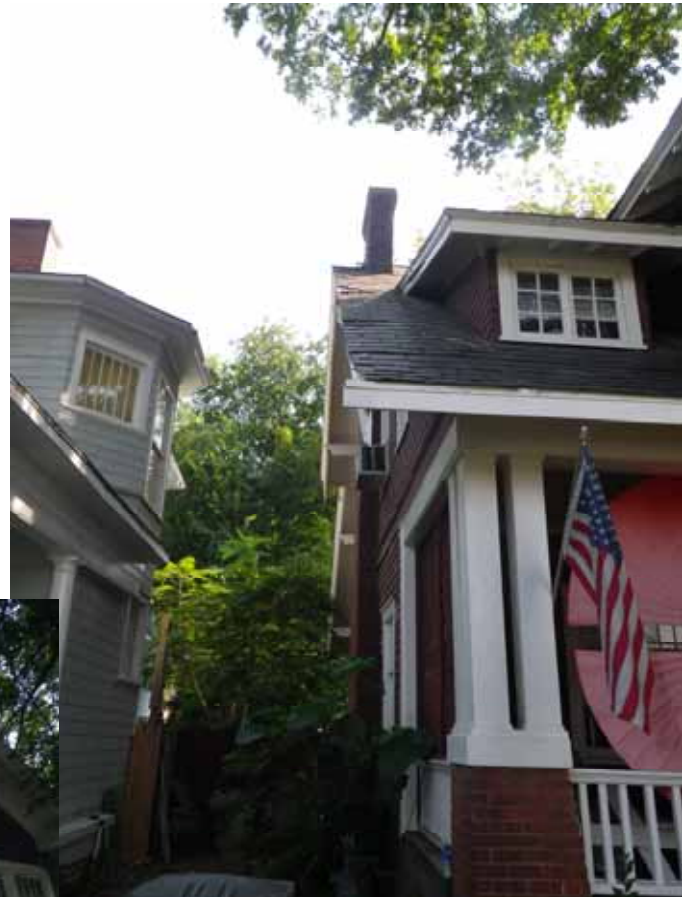
Photo #1

This is the front of the main house. Today's investigation began with the intent of addressing structural deficiencies in need of immediate repair and/or structural entities that are not functioning as intended. The first observation trip made August 29, 2013 was confined to the perimeter of the house. On September 5, 2013, a second job-site observation trip was made where much of the interior was visible with the exceptions being the attic floor, which was covered three feet deep with costumes. There were also areas of the house, where deterioration of the structure was determined to be so advanced that there appeared to be a threat to one's safety if entered.

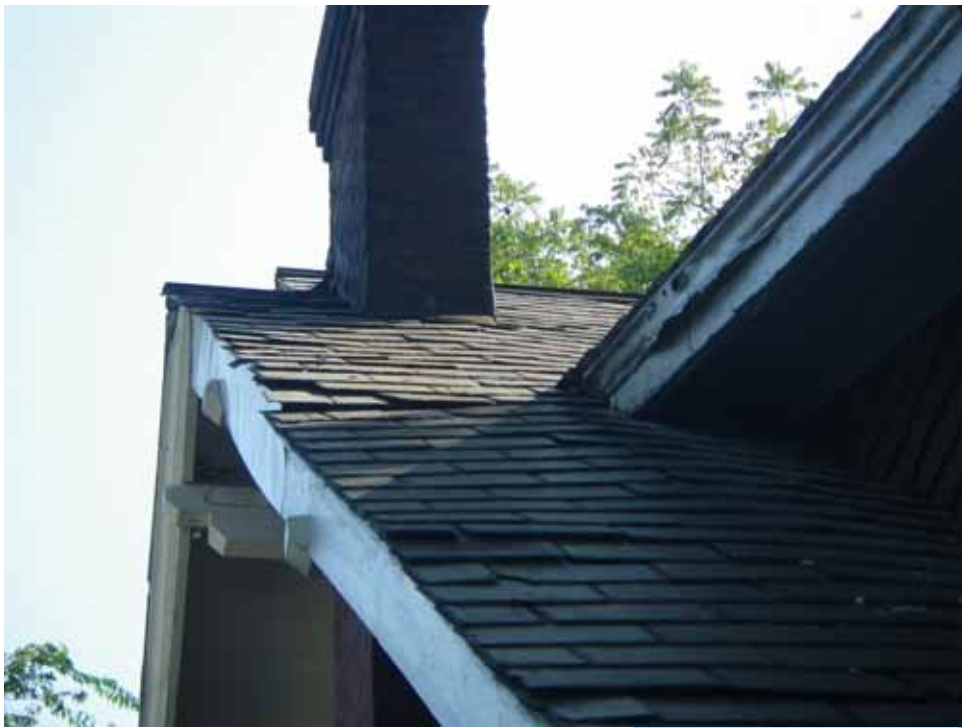
Photo #3

These pictures show the overhanging roof extensions to the left of the house, with a flying barge board supported with intermediate braces. There is a significant bend in the roof due to the inadequacy of the supporting buttress and the roof sheathing. The slate roof covering has responded to the bend by falling off the house as best seen in Photo #5.

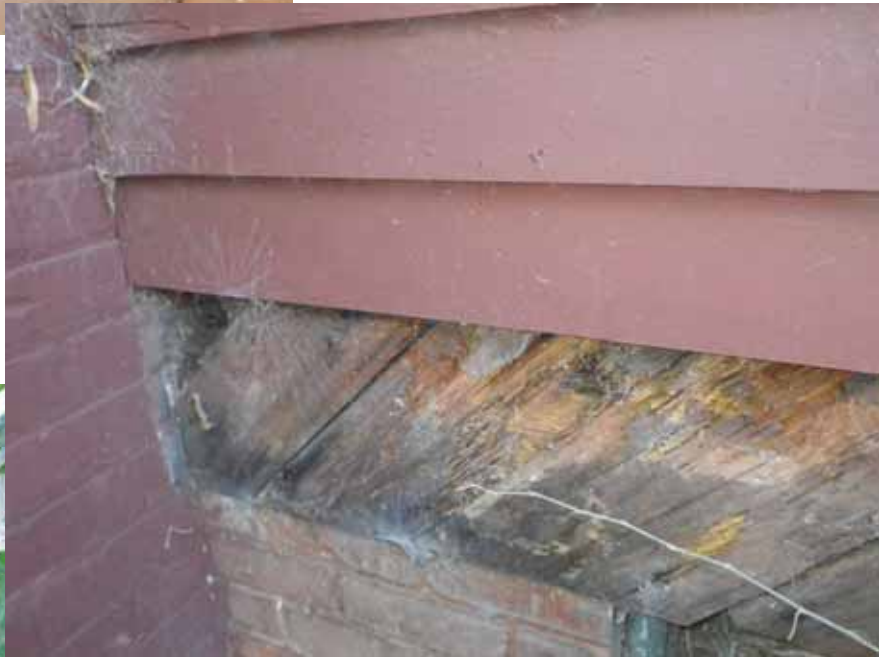
Photo #6A

These pictures show the original diagonal wood sheathing as well as the lapped wood siding. The extent of the damage to the diagonal wood sheathing is visible in these pictures. There are indications that the damage extends well up to the height of the two-story wall and even into the third level left gable wall. This report is based on visual observations only. No intrusive measures were authorized or undertaken. The severity of the damage to various wood components is based on exposed wood decomposition. Concealed and latent deterioration is ubiquitous, but not verifiable in absolute terms.

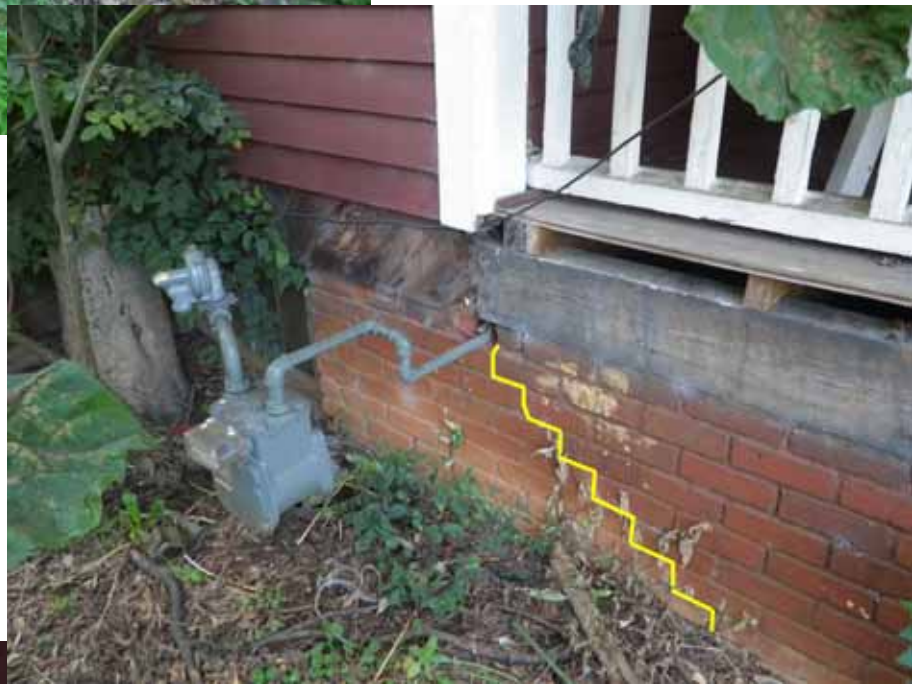
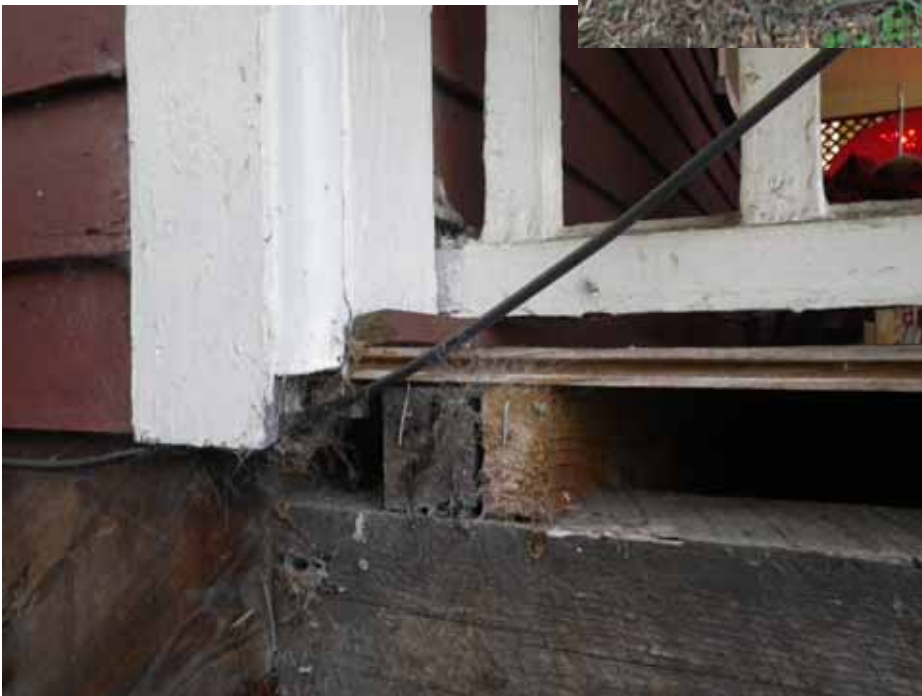
Stair-step cracking of the front porch brick (highlighted in yellow) seen in Photos #8 and #9 are not related to the proximity of living trees. On the other hand, the stair-step cracking seen in Photo #9 at the left foundation wall just below the left/front corner of the house is the result of tree root heave and or deterioration and decay of dead roots of the tree stump seen in Photo #6.

This picture and Photo #8 show exposed wood porch framing at the left/rear corner of the covered front porch. Vermin are free to enter the crawl through the gaps seen in these pictures.

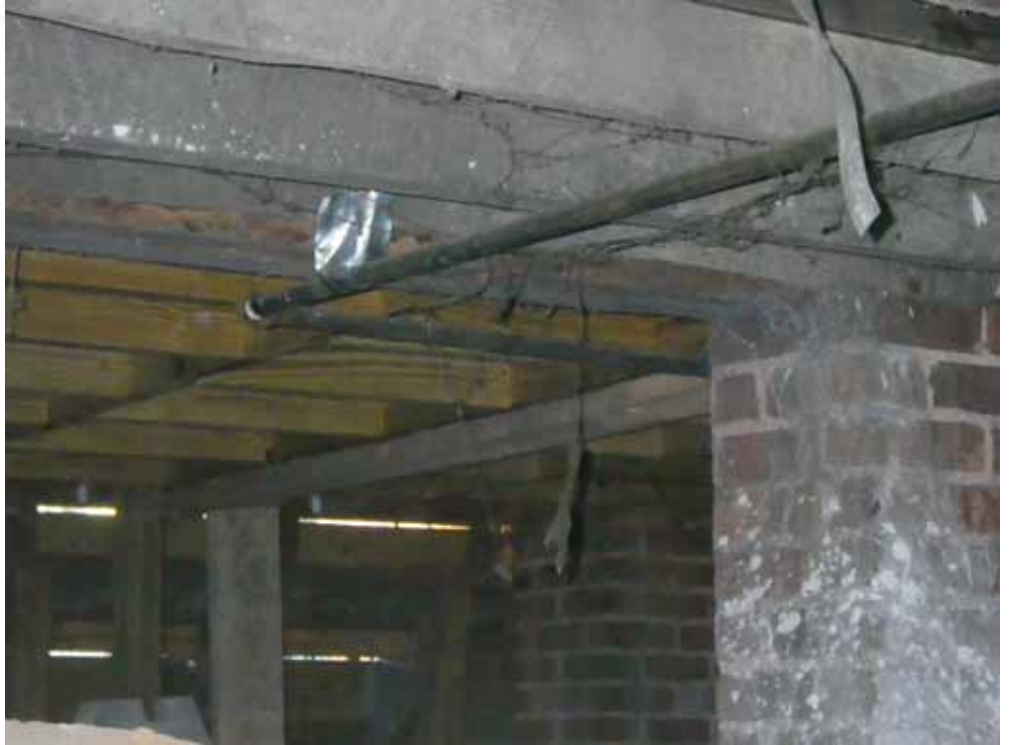
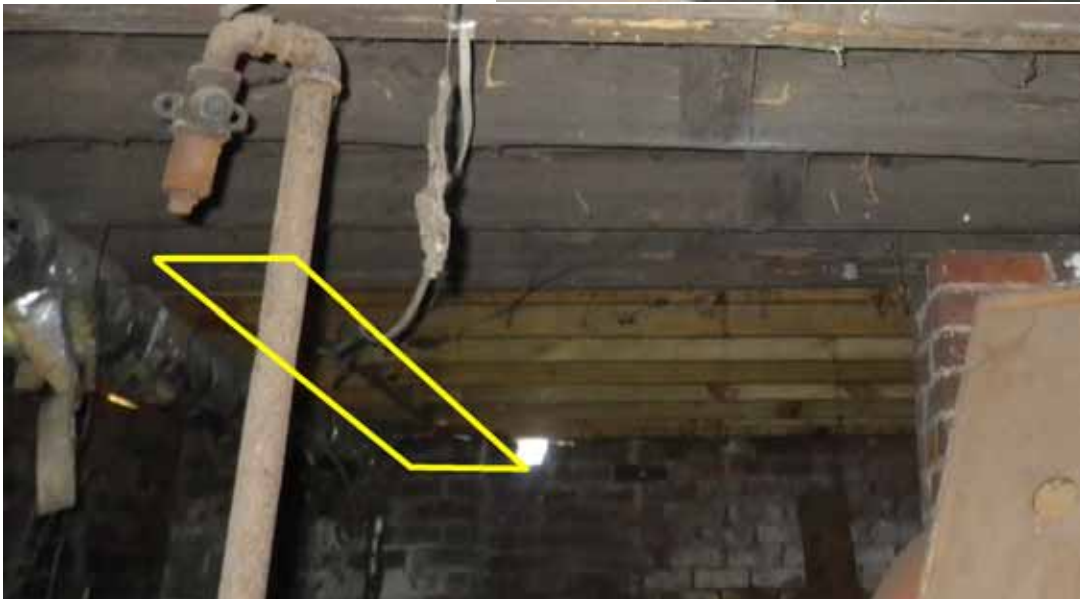
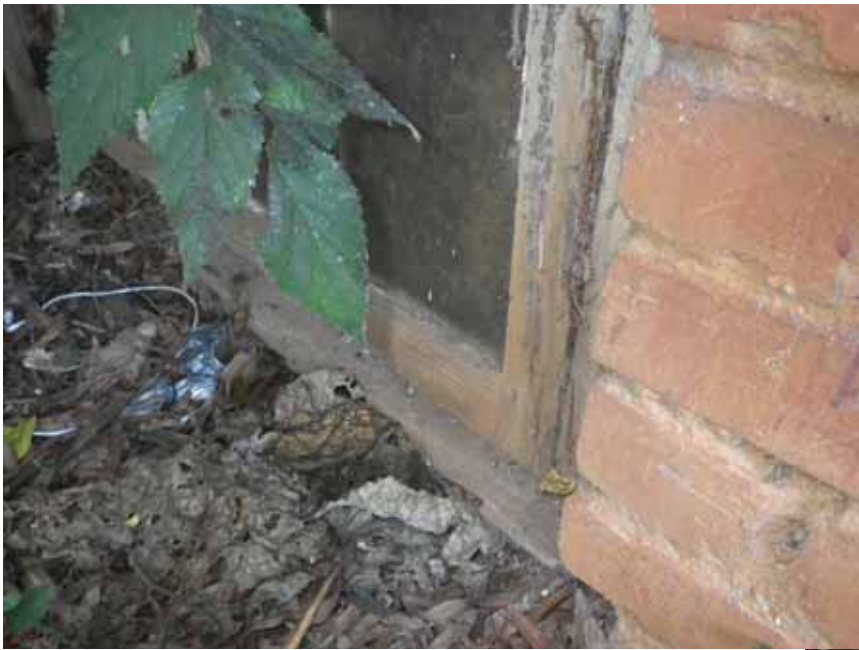
These pictures show the front porch framing, which for the most part is replacement construction. The new floor joists span left-to-right and are supported by single-ply, front-to-back joist/girders spaced approximately four-feet on center. Photo #10C shows a front-to-back, single-ply supporting member located approximately three feet to the left of the right foundation wall supporting left-to-right joists to the left that span at least 8'. The combined joist loads from both sides of the front-to-back, single-ply joist calls into question the entire framing of the front porch floor. This replacement construction is not code-worthy and must be replaced.

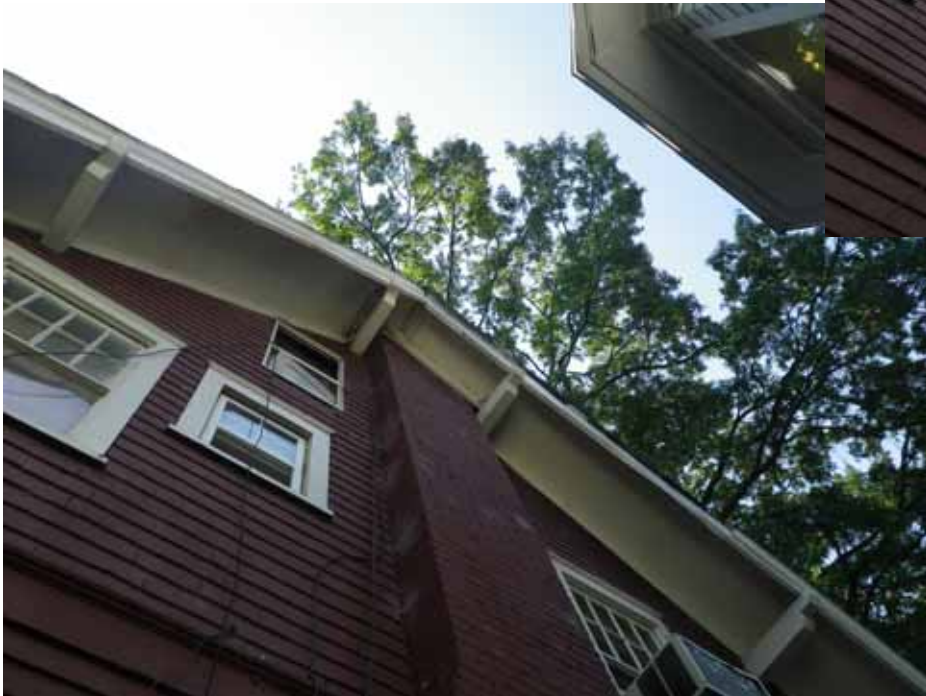
Photo #12

One comforting observation is the masonry chimney on the left side of the house shows no visible evidence of having pulled away from the face of the house.

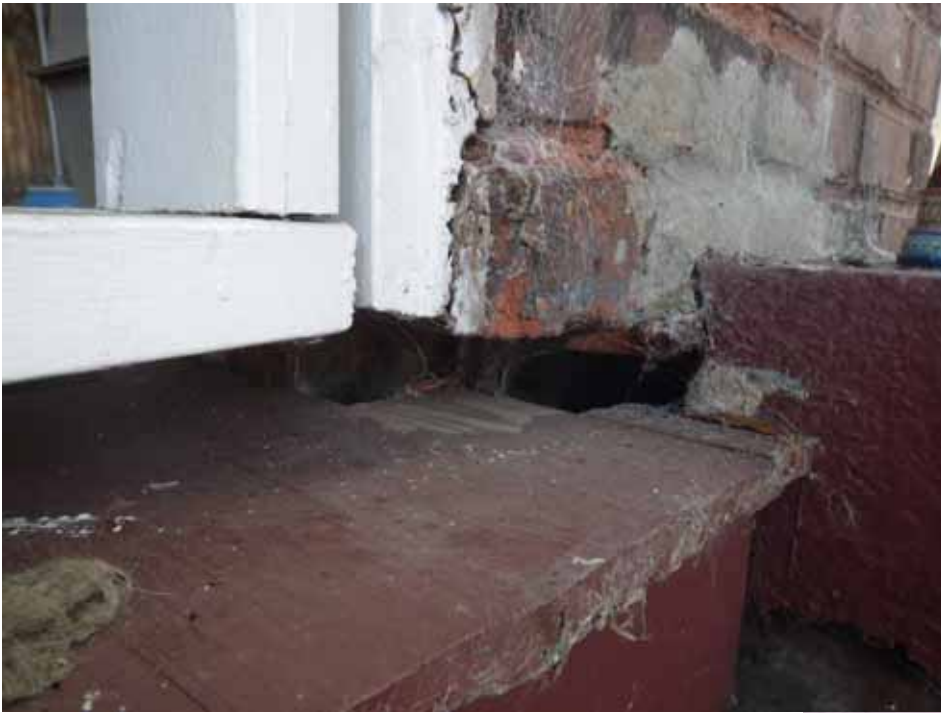
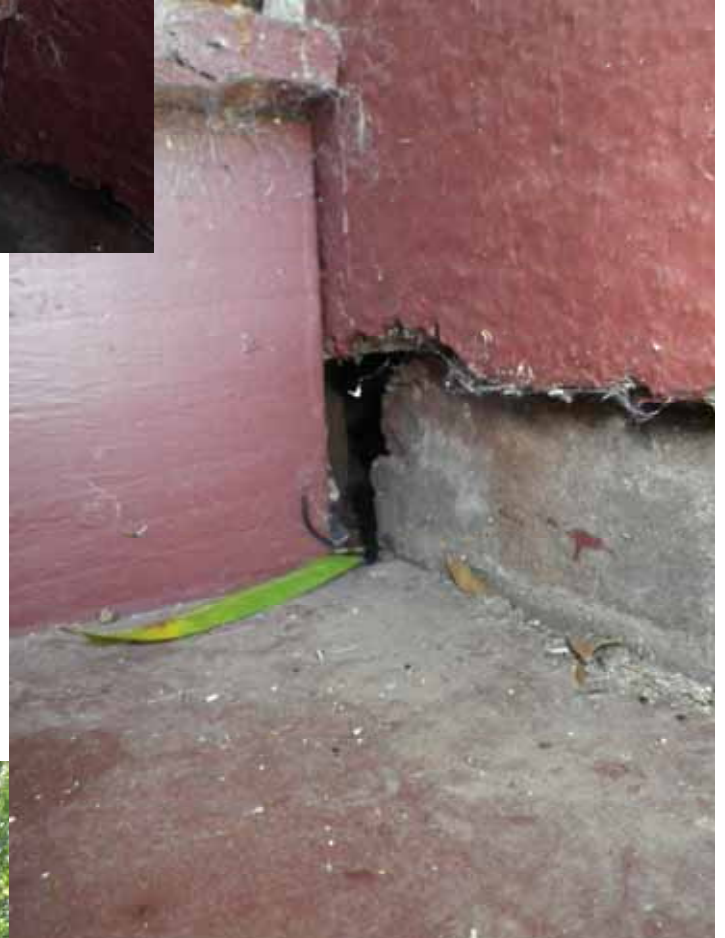
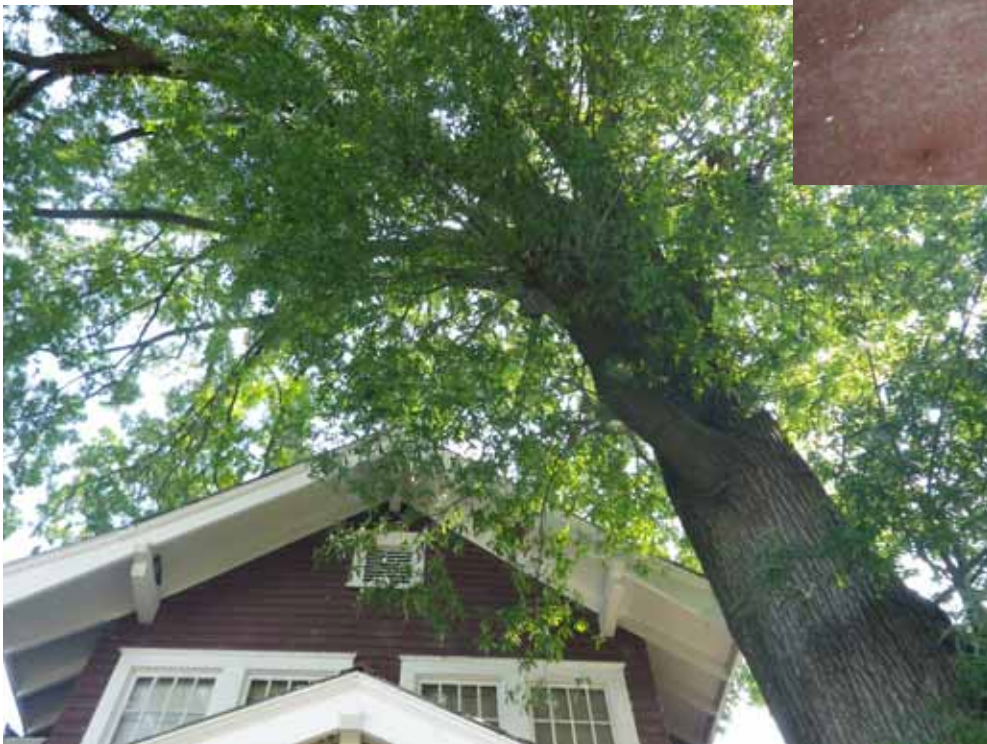
These pictures were taken at the front stoop stairs leading up to the covered front porch. There are several gaps that are of concern, seen in the close-ups. The load-path of the load-bearing pier seen in the Photo #15 is questionable. Again, the large gaps have allowed untold nesting of wild life over the years.

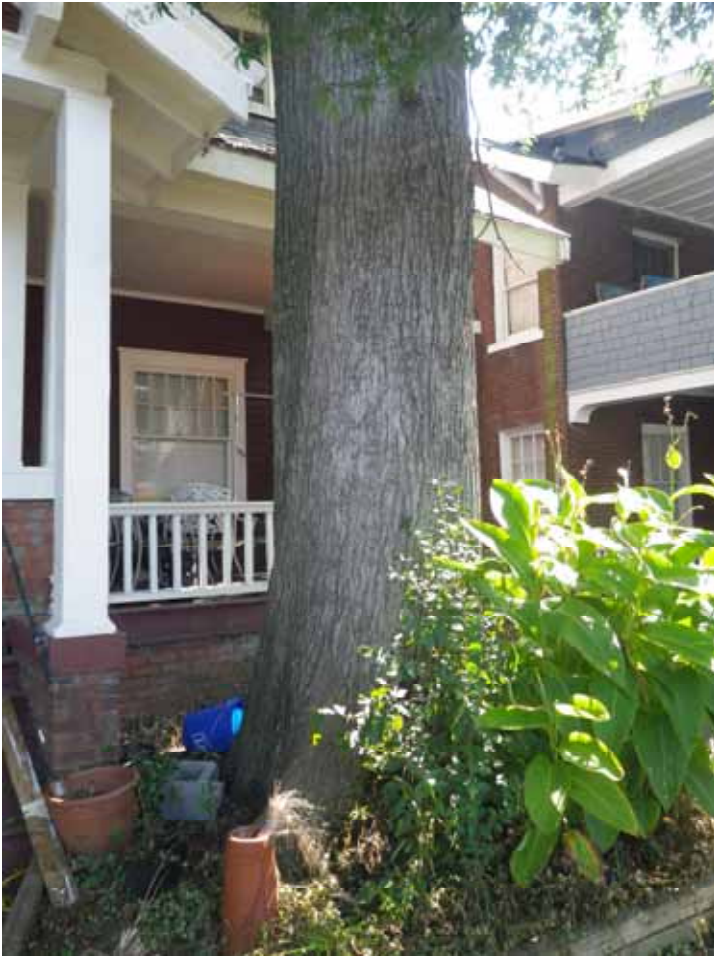
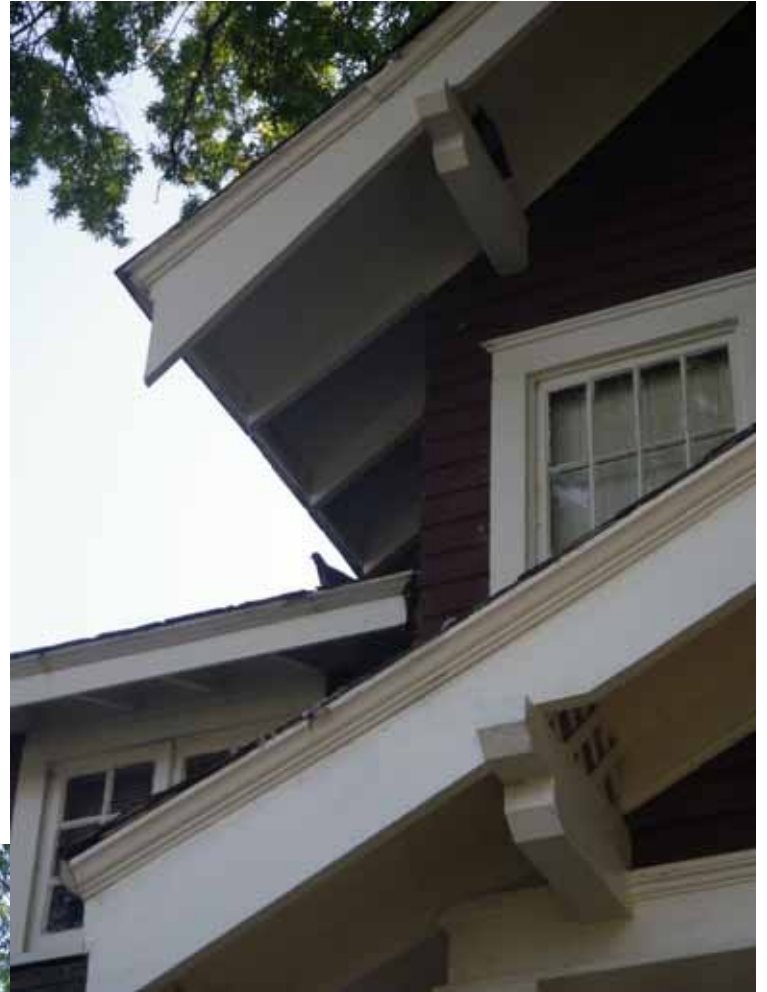
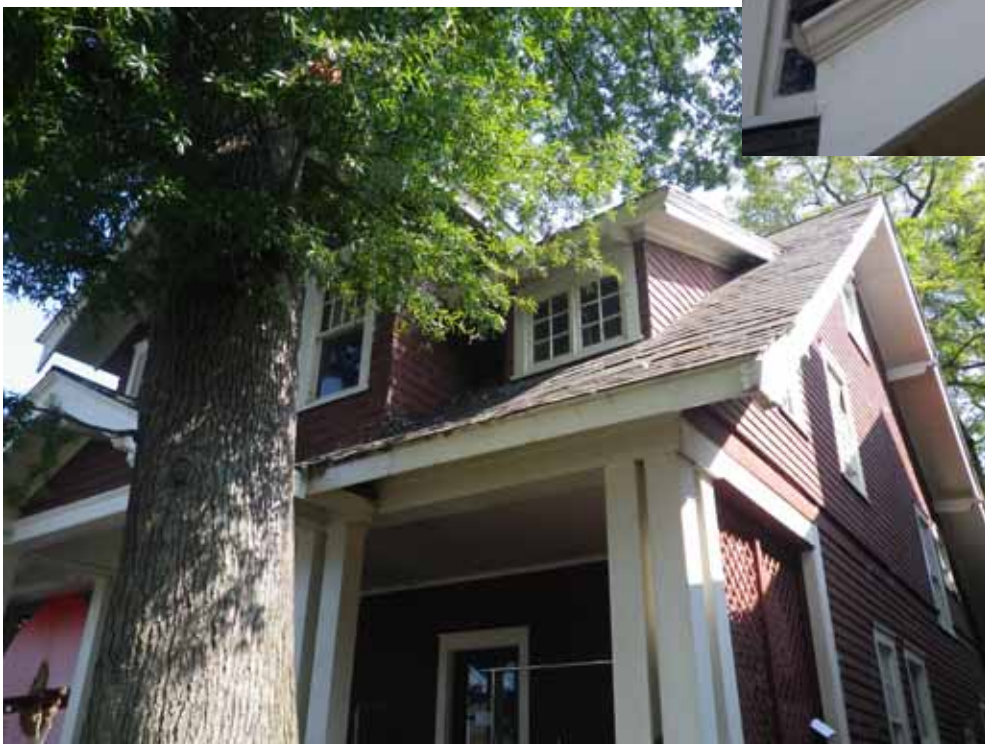
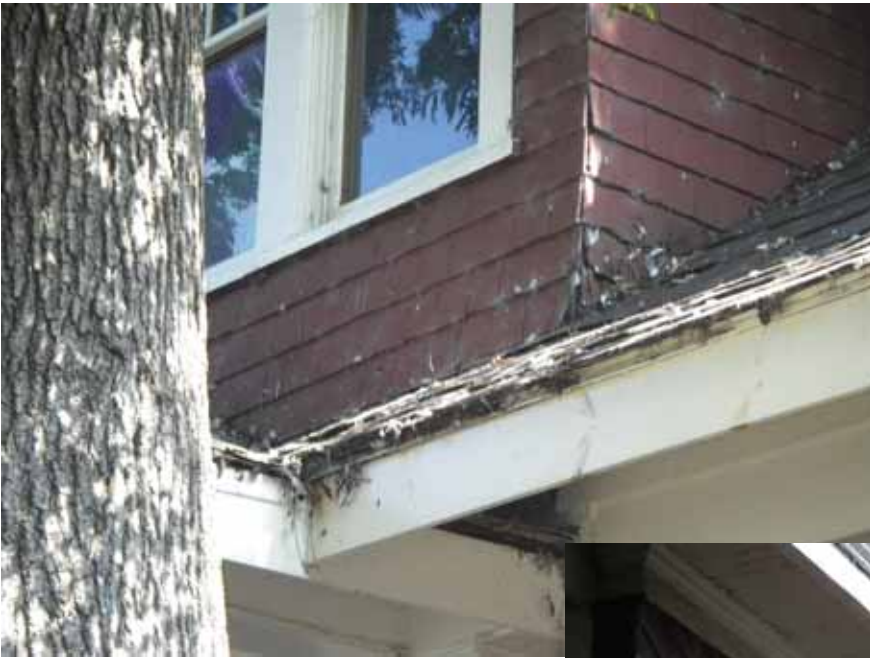
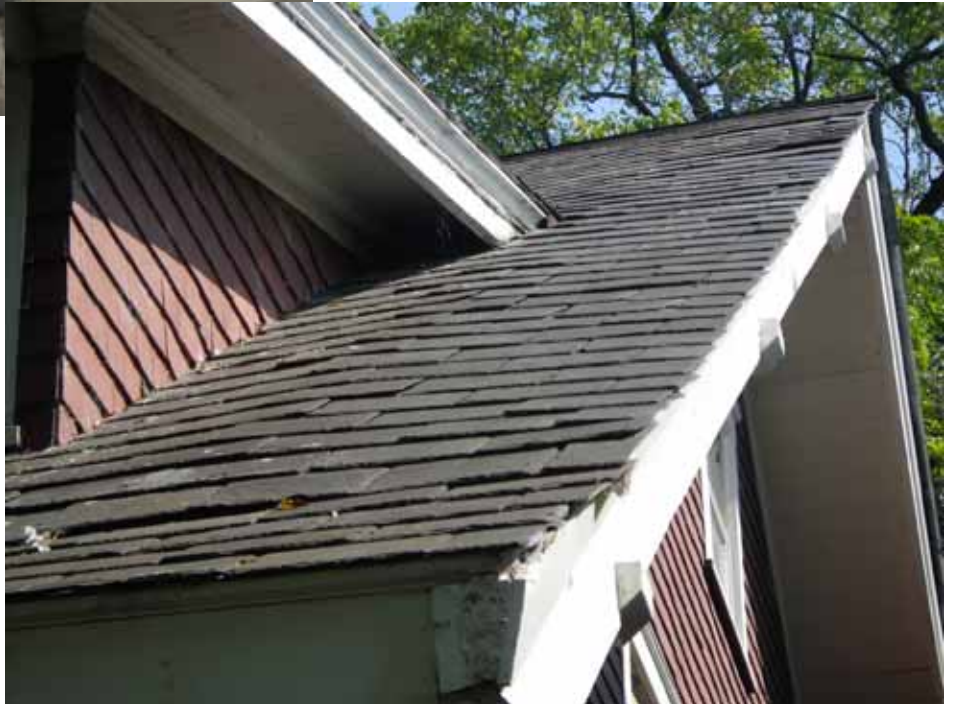
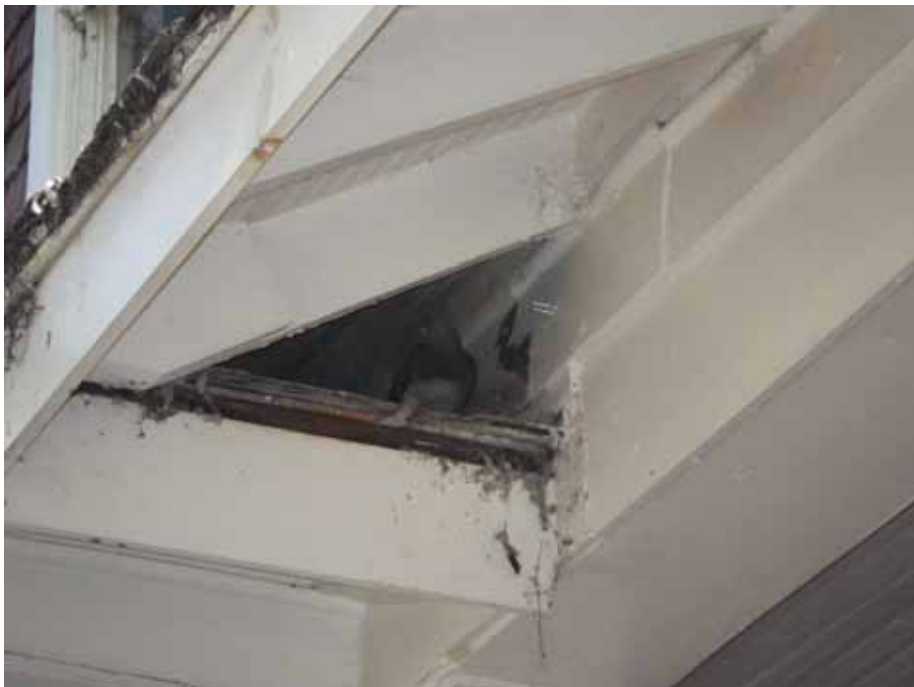
The most visibly prevalent presence of wildlife is pigeons, which are nesting in every nook and cranny and making damaging deposits all across the front of the house. The large tree (trunk diameter approximately 3'-6") in the front yard is a concern due to its proximity to the right side of the front porch and roof above and because so many of its branches hang above the front half of the house.

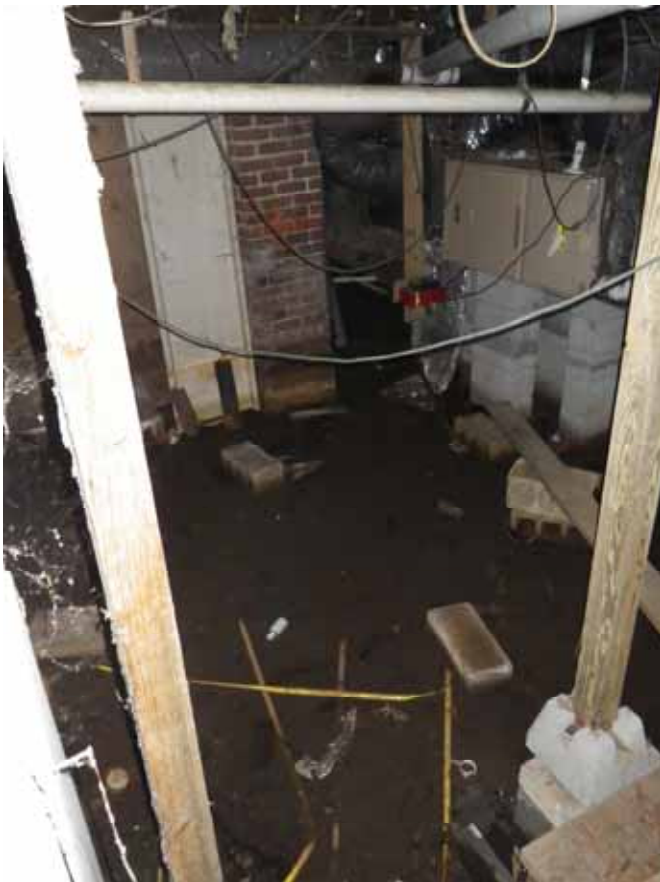
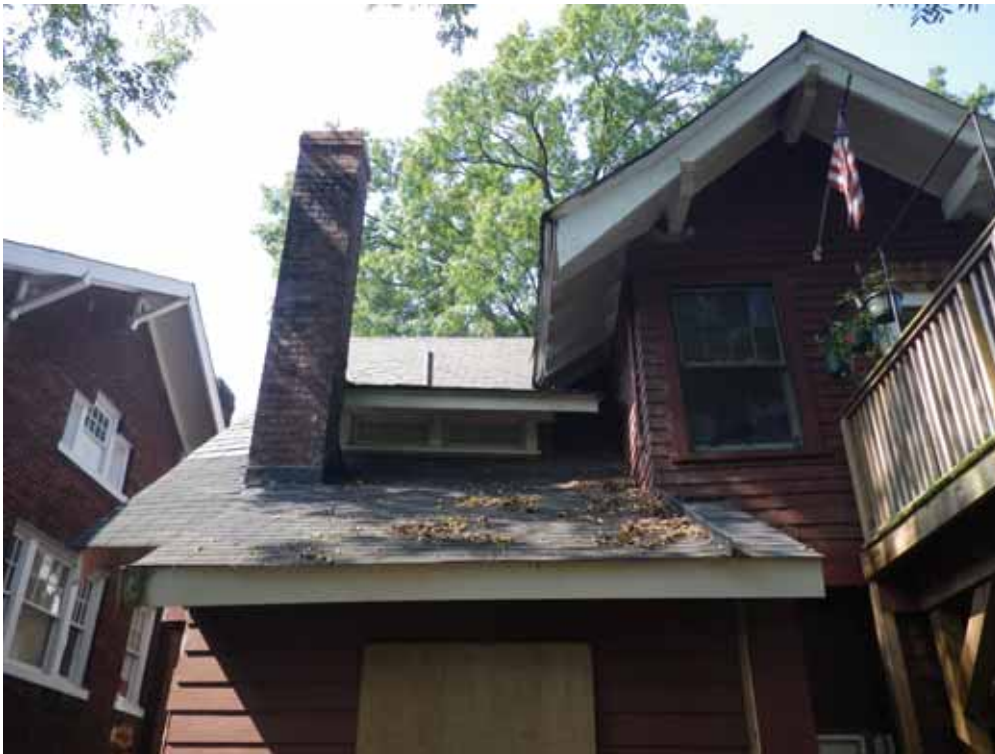
These pictures show the partial basement located under the right/rear corner of the building. A number of vertical 4x4 posts have been added in an effort to support deteriorated first and second floor framing above. They are too tall and are improperly supported at both ends; top and bottom. There is considerable water in the basement where no provisions for removal exist. Photos #54, #55 and #56 show more views of the right/rear partial basement.

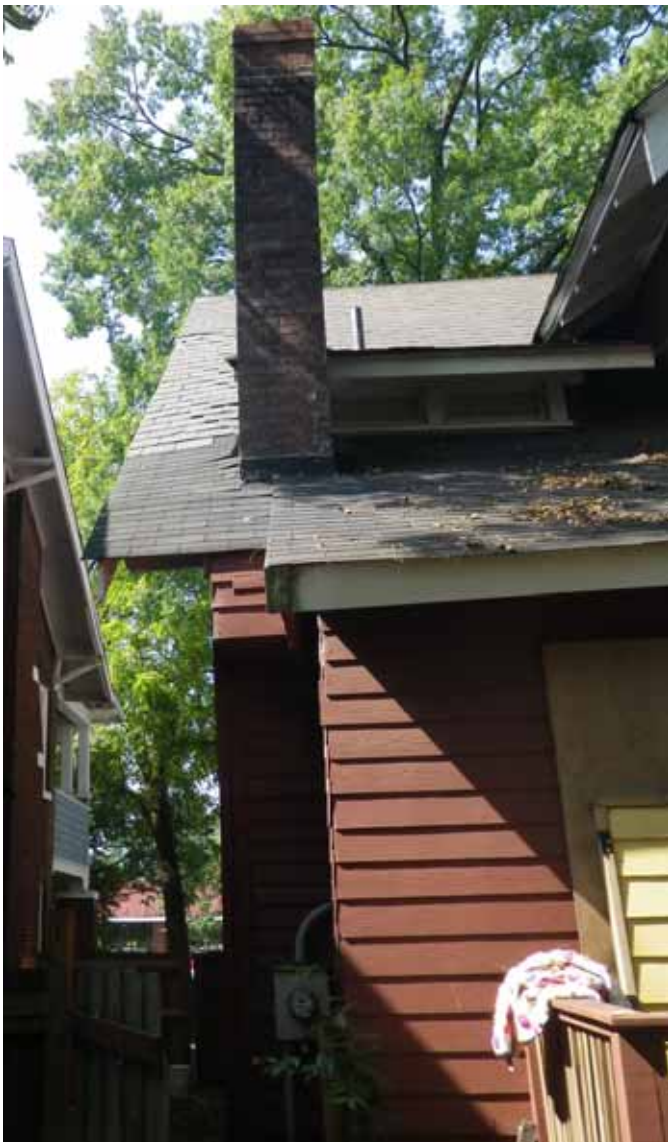
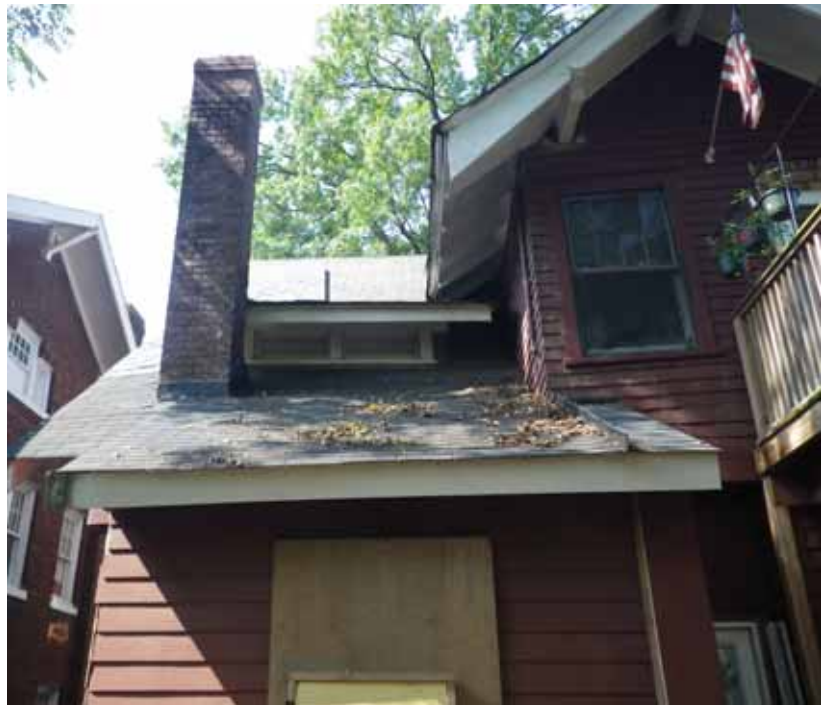
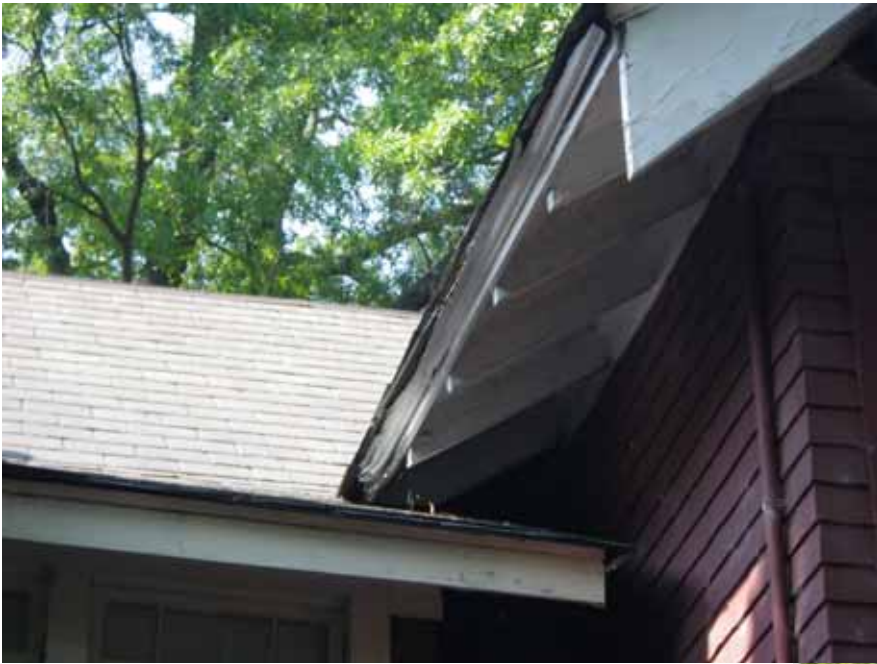
These pictures were taken at the right/rear corner of the property looking back-to-front. The rear roof of the second floor right/rear bathroom above the clerestory window slopes down from right-to-left more than 3" across a distance less than eight feet in length. As was discovered during the second job-site observation trip, the bathroom floor is perilously close to catastrophic failure as a result of extensive damage caused by wood destroying insects.

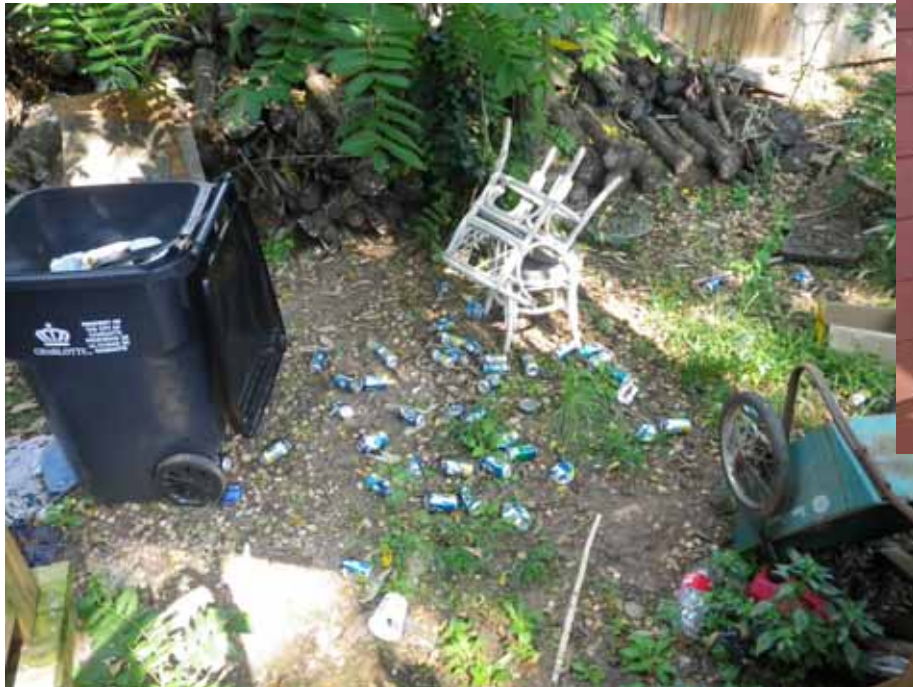
Photo #41

The rear wall of the house has suffered extreme damage as a result of wood destroying insects. While not visible in this picture, the damage will be seen in the photos that follow later in this report.

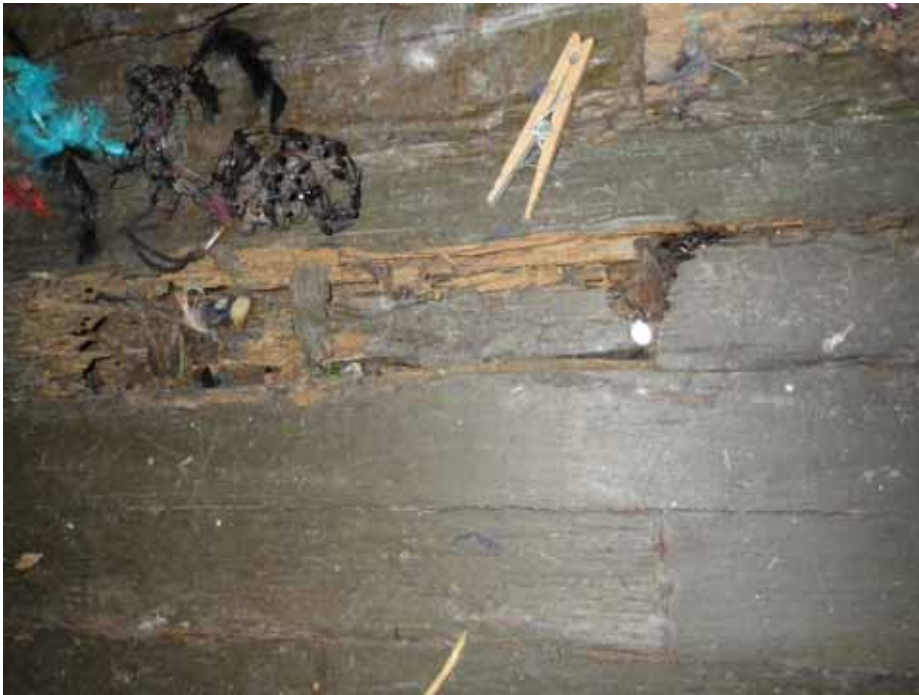
Photo #47

These pictures and those that follow were taken on September 5, 2013. As seen in Photos #44 and #45 there is extensive damage at the rear portion of the left/rear, first floor room and to the rear wall adjacent to the deck as seen in Photo #41. Not seen in these pictures is the damage to the rim band below, which not surprisingly is extensive as well.

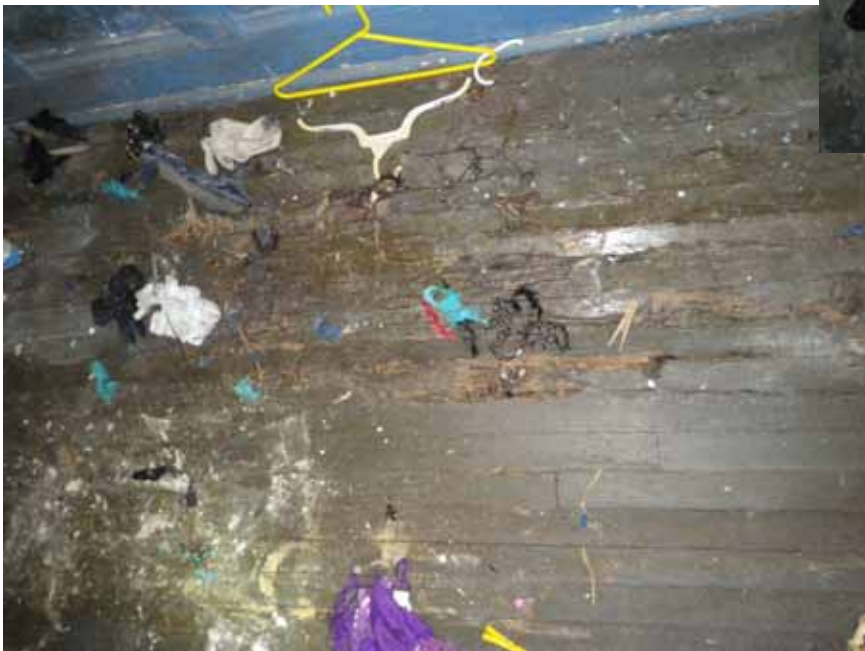
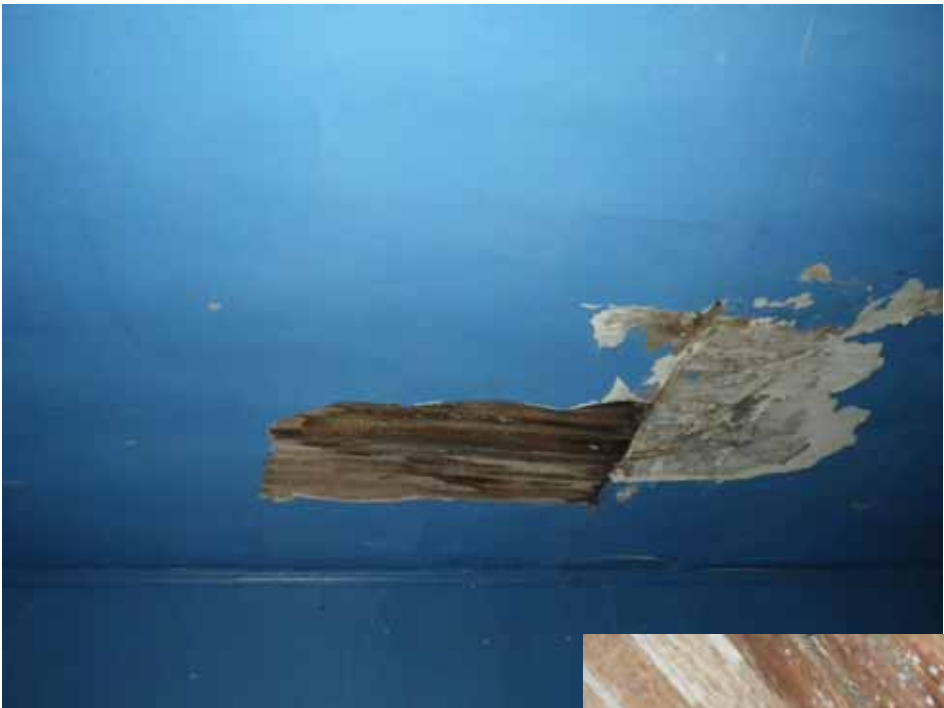
These pictures show just a few examples of hardwood floor covering devoured by wood destroying insects. The first and second floors are not at all flat. Deviations in levelness measure as much as 4". A small portion of the extreme dips and ridges can be explained by the natural aging of wood in which long term creep can cause floor sagging twice that allowed by codes in response to prescriptive superimposed live loads. Sag due to creep is non-recoverable deflection as opposed to elastic deformations/sagging, which recovers its un-deflected position once the superimposed load is removed.

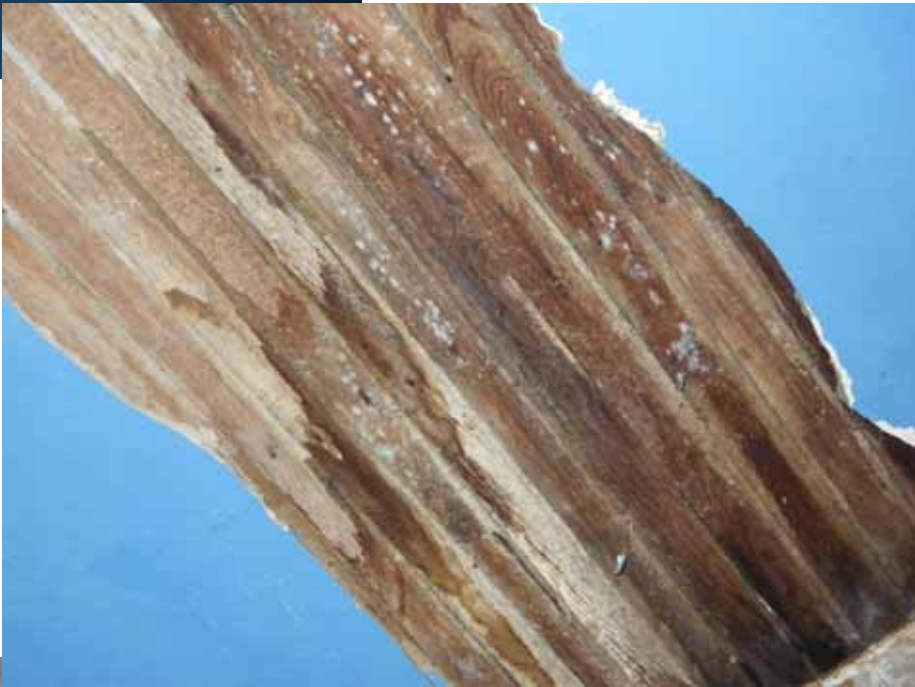
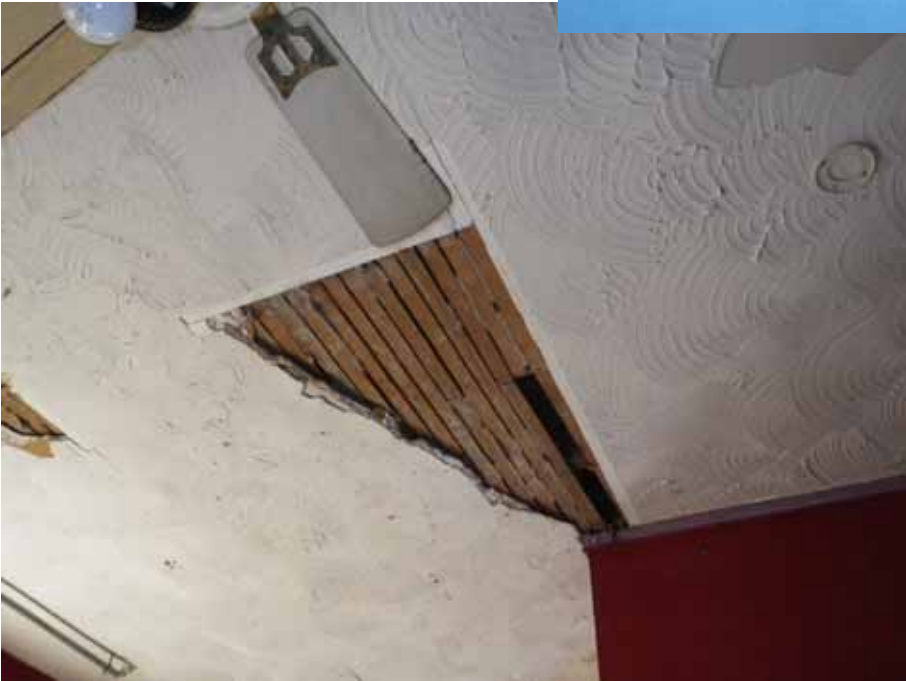
These pictures show a few of areas of ceiling where persistent roof leaking has broken the bond between the plaster ceilings and the wood lath. The water entering the interior of the building has increased its vulnerability to attack from wood destroying insects as well as led to decay associated with saturated wood.

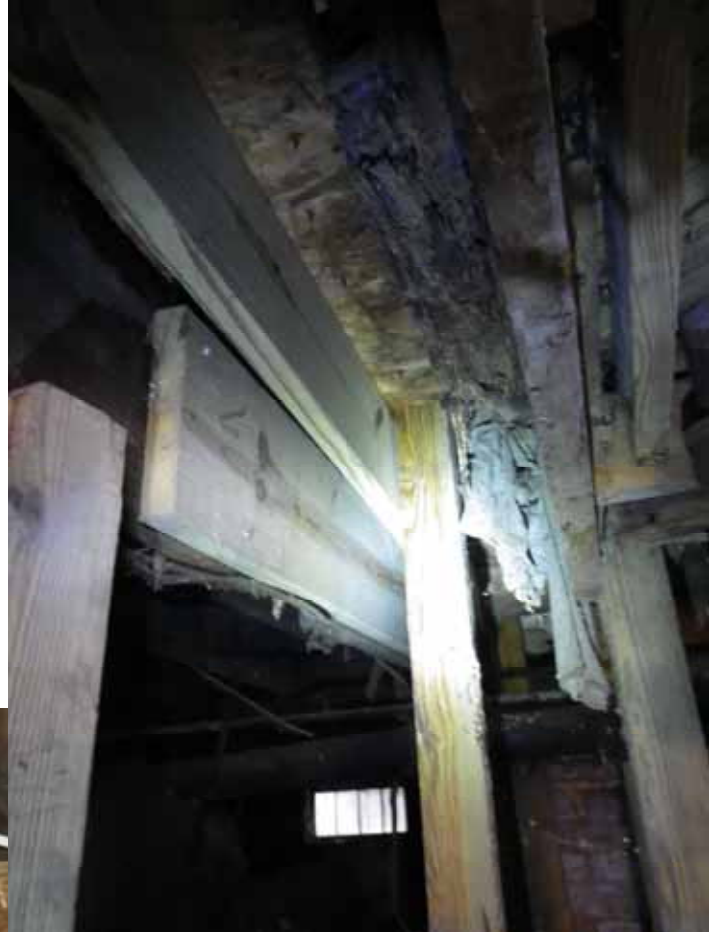
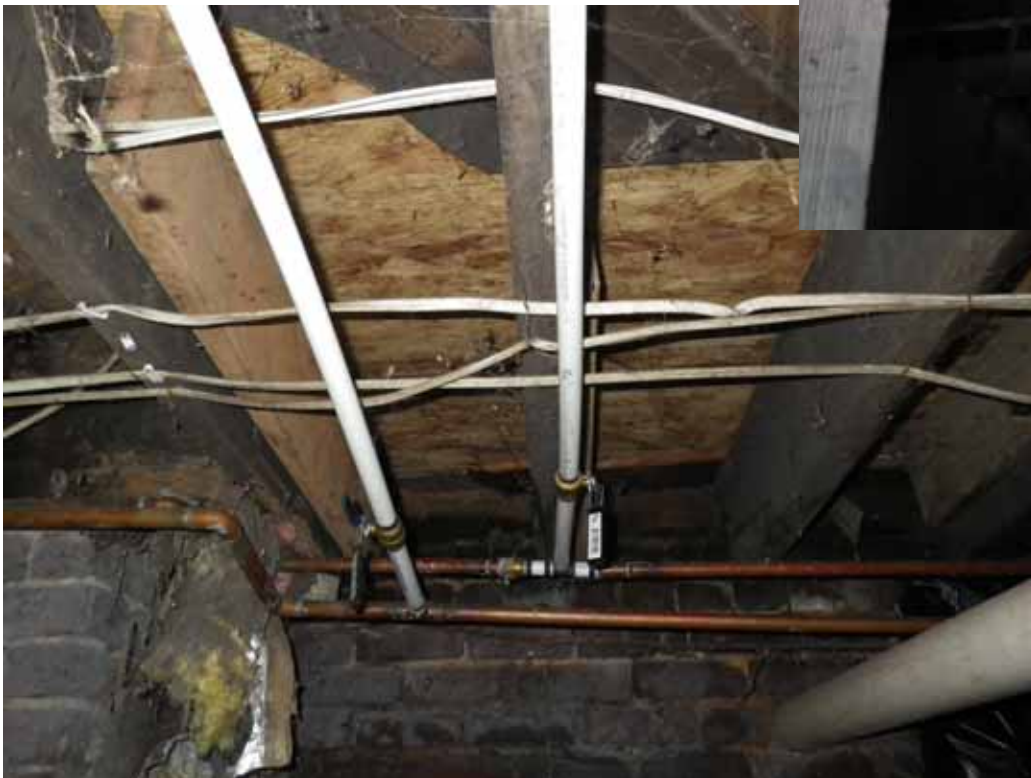
As noted in Photo Narrative #27 - #29, there are 4x4 wood posts that were added in the right/rear partial basement to shore up the failed first floor above. This picture shows one such post that is supported at its base with precast concrete deck pedestal (patio block). Beneath the pedestal is a masonry or concrete plinth used to spread the load over a larger foot-print. Except for the fact that the 4x4 has pin-connections at both ends, there is some merit to the concept of spreading the load in the manner chosen at this location. However, the pinned-ends of the post effectively double its height (from a structural engineer point-of-view), which is already higher than allowed for free-standing 4x4's. Its effective design height is in the range of twenty-feet, which means it is entirely too high and would buckle under the prescribed superimposed live load. This explanation is included to illustrate the current delicacy of this structure and its vulnerability to structural failure in the near term.

These pictures were taken from within the right/rear basement looking up at the destroyed/shored portions of the first floor. The structural repairs are inadequate and would never have been permitted or inspected by a building inspector.
