<b>LOCAL HISTORIC DISTRICT:</b>	Dilworth
<b>ADDRESS OF PROPERTY:</b>	325 East Boulevard
<b>SUMMARY OF REQUEST:</b>	Demolition
<b>OWNER:</b>	Gary West, Max Maintenance Company
<b>APPLICANT:</b>	Gary West, Max Maintenance Company

# Charlotte Historic District Commission - Case 2014-021

**325 East Blvd.  
Charlotte, NC 28203  
Limited Structural Observations  
Photo Narrative  
for  
Gary West  
Dwelle Property Management  
and Real Estate Inc.  
756 Tyvola Road, Ste 119  
Charlotte, NC 28217  
by  
A. Wynn Yates, PE  
Yates Structural Engineering, PA  
3300 Elstree Drive  
Charlotte, NC 28226  
704-650-5541  
wyates@yseng.com**

**August 29 and September 5, 2013  
(Revised) January 8, 2014**

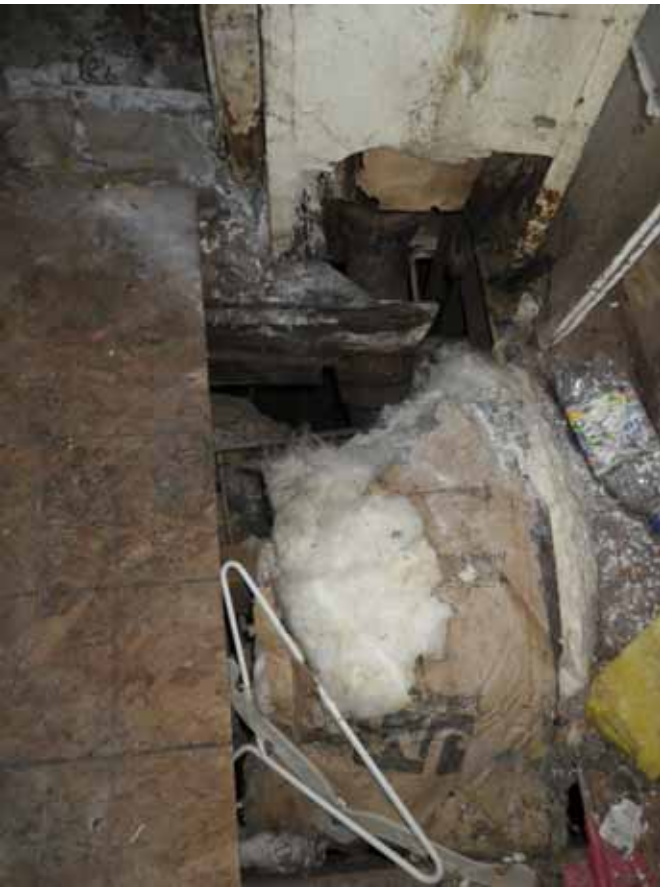
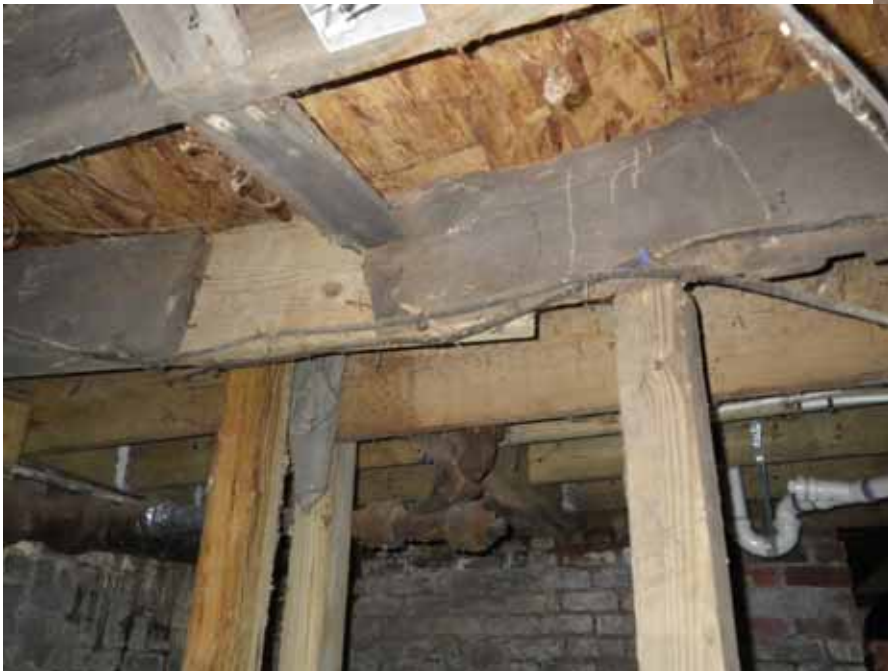
These pictures were taken at the first floor level during the January 8, 2014 data gathering job site observation trip in the room to the rear of the stairs located on the right side of the house. A piece of loose OSB is currently used to keep someone from falling through the floor. The edge of it can be seen in Photo #56B where someone is foolishly standing on it.

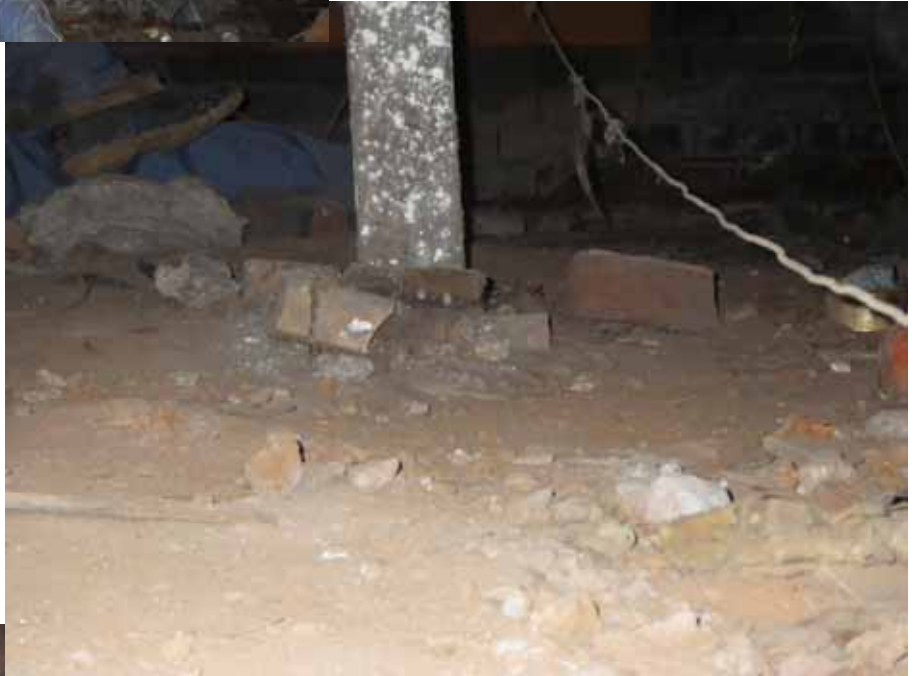
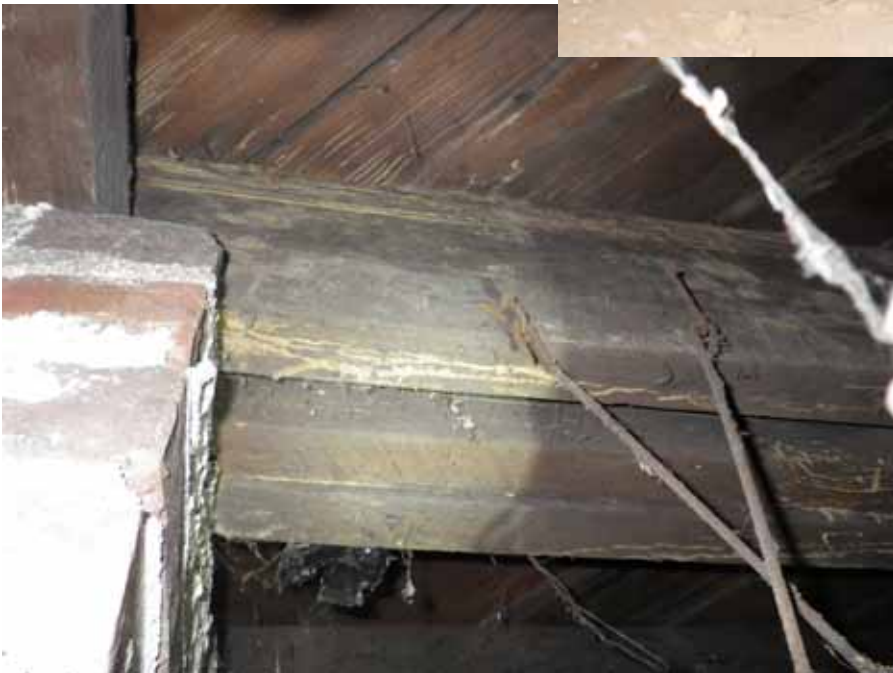
These pictures show another example of 4x4 wood post that was added and is free to translate laterally in conflict with the governing code and "accepted engineering practice." Photo #56F shows only loose brick remaining at the base of the 4x4 seen in this picture, which is taken in the crawl just to the rear of the rear wall of the front/left first floor room. There are several other conditions present in the crawl that are similar in nature to the one seen in these photos.

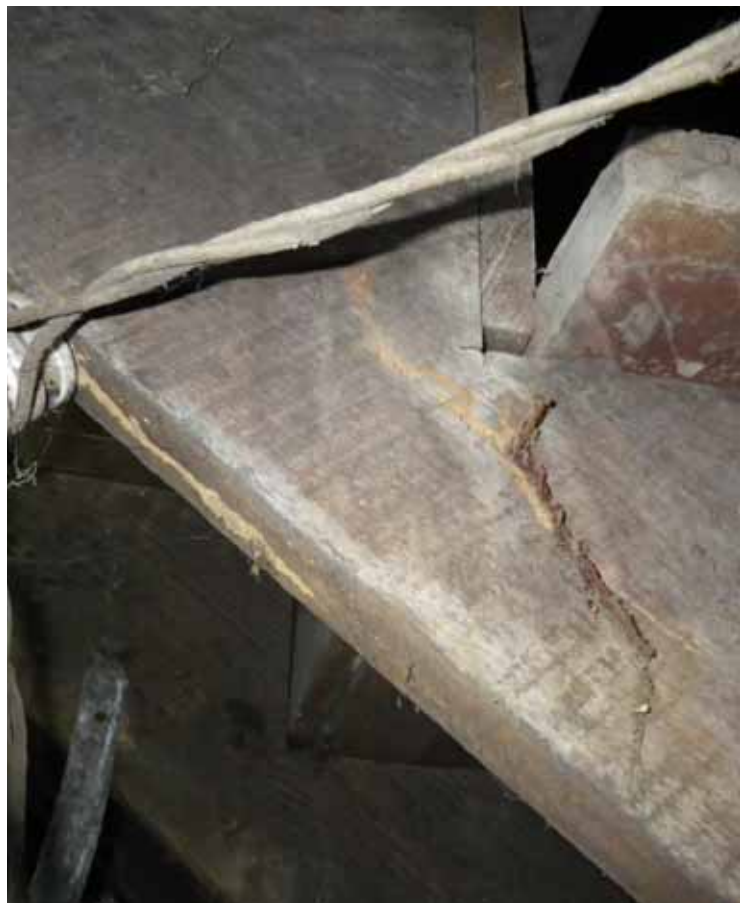
Photo #56K

These pictures show inadequate support of the basement access stair stringers where they intersect the first floor framing. Previous photos showed considerable damage at the base of the basement access stairs, such that total replacement of the basement access stairs would be required.

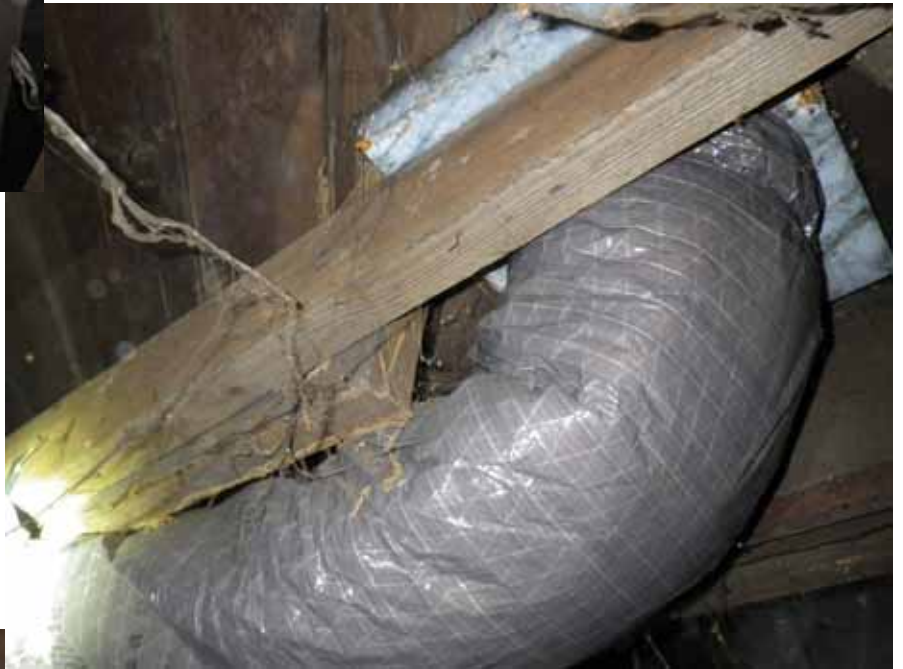
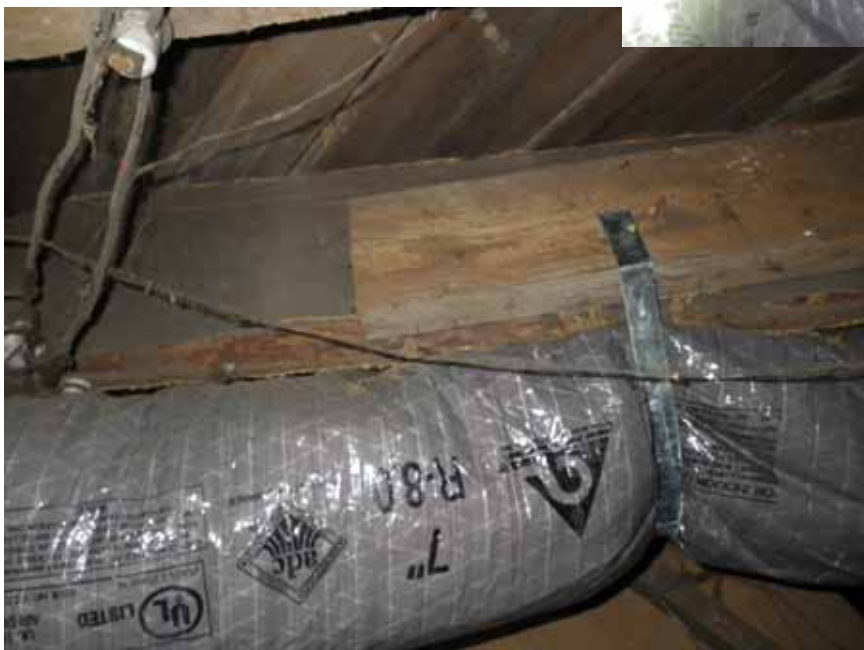
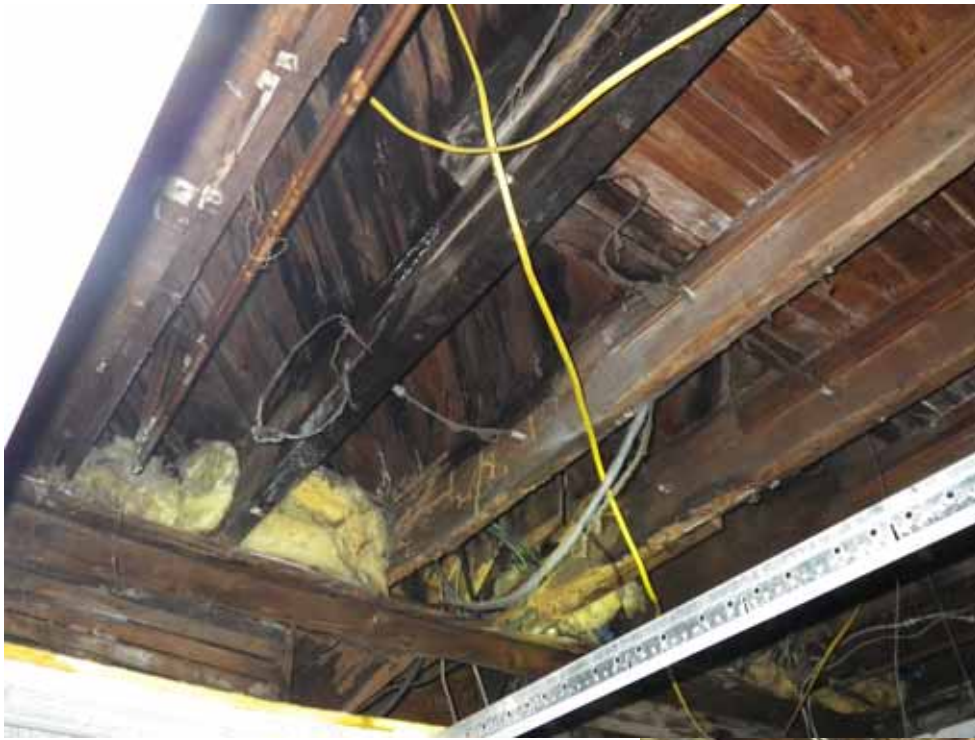
These pictures show a left-to-right, 2x10 floor joist located about 20" to the front of the basement access opening. The supplemental sister added to one side of the defective 2x10 joist is not effective. There is rotation of the joist and 2-by scab, best seen in Photo #56N. A full-length, point-to-point floor joist should be added to supplement poorly behaving floor joists such as the one seen in these three photos.

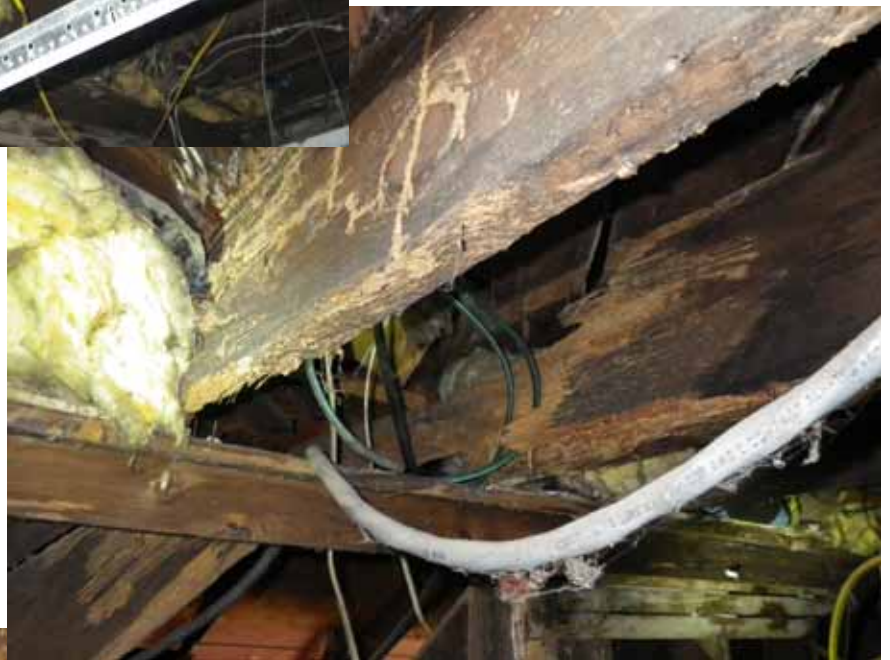
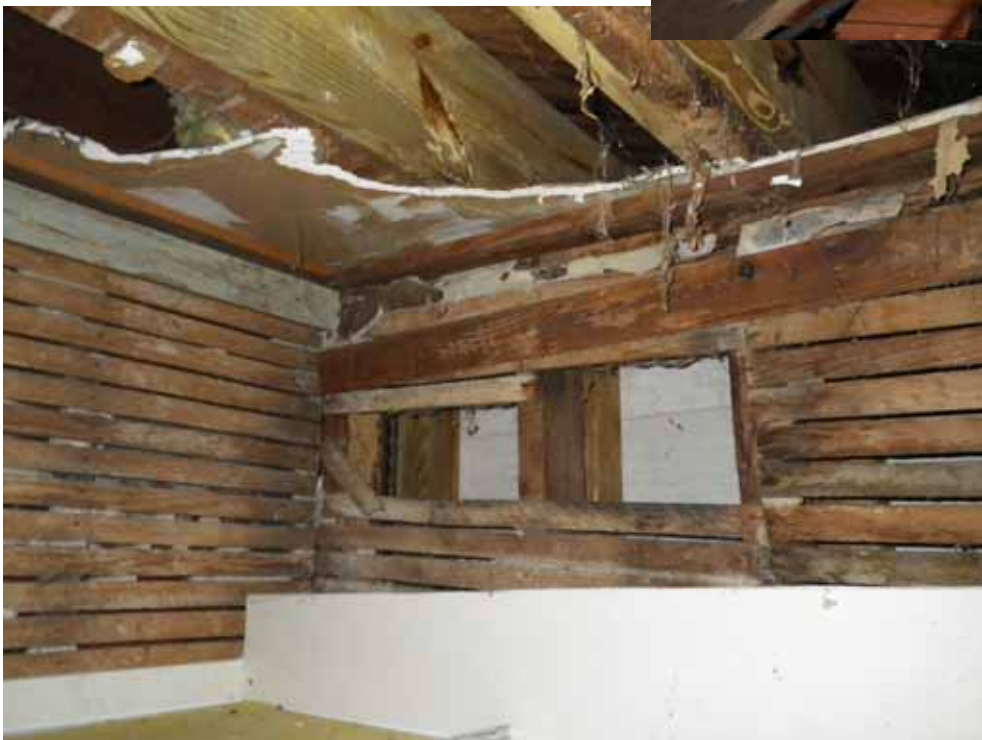
These pictures were taken looking up from the right/rear corner of the first floor to the ravished second floor structural framing. Photo #58 is a close-up of the Photo #57 and shows an abundance of shelter tubes and the destruction of the wood resulting from wood destroying insects.

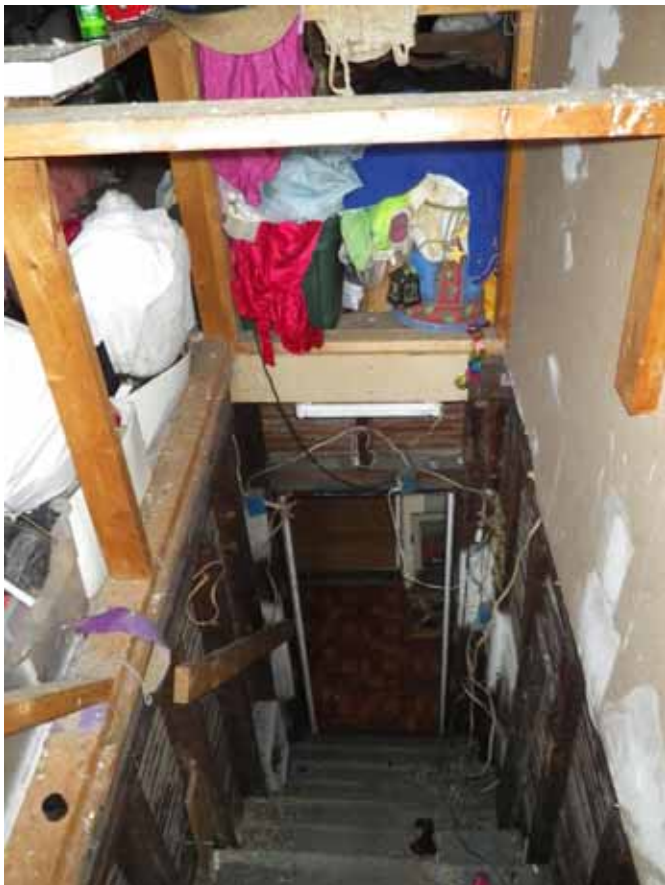
Photo #64

These pictures show the interior stairs that lead from the first to second floors with an intermediate landing and a single flight of stairs from the second floor to the third level. The stair treads tilt and lean and have so much give that they feel as if they will fail at any moment.

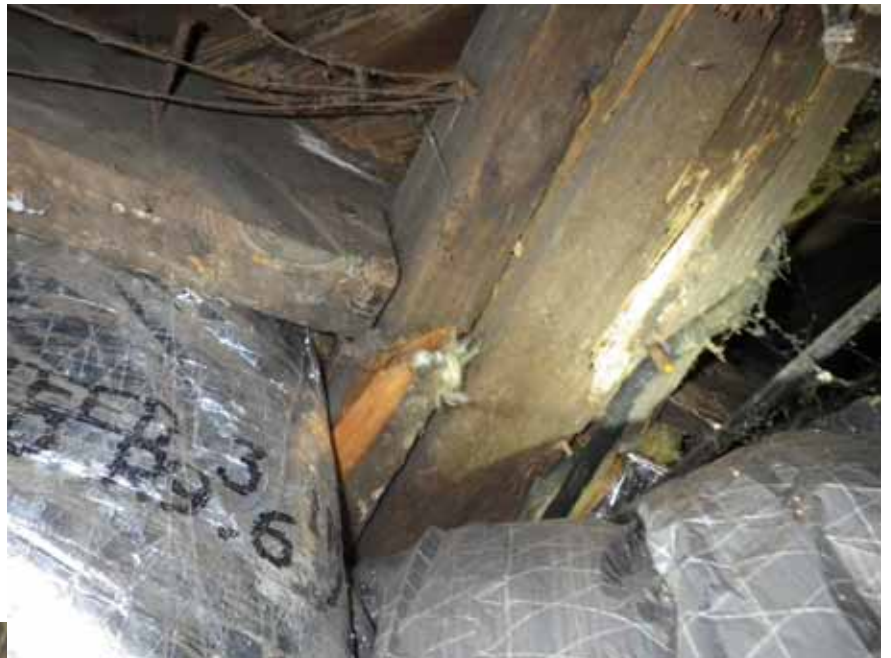
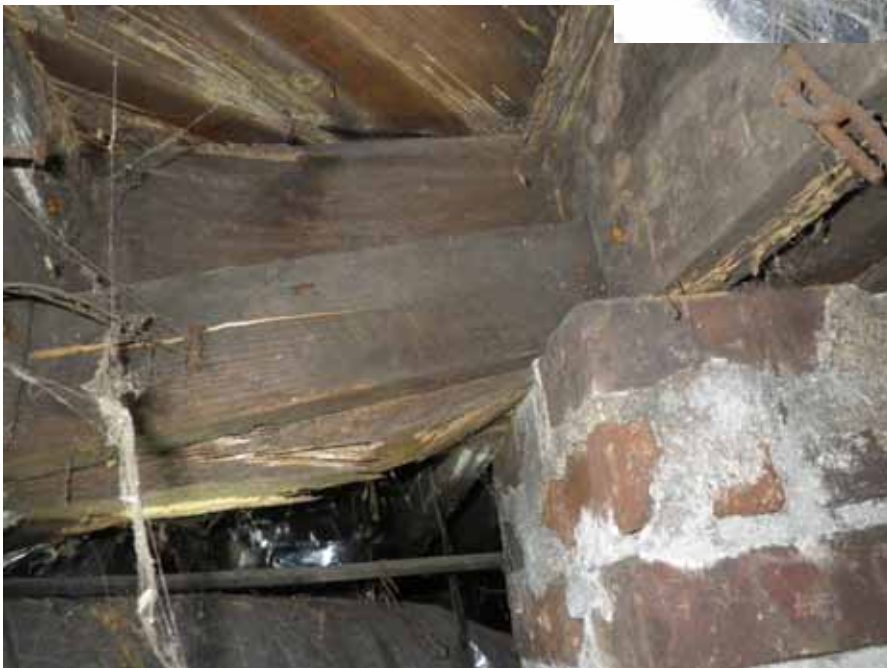
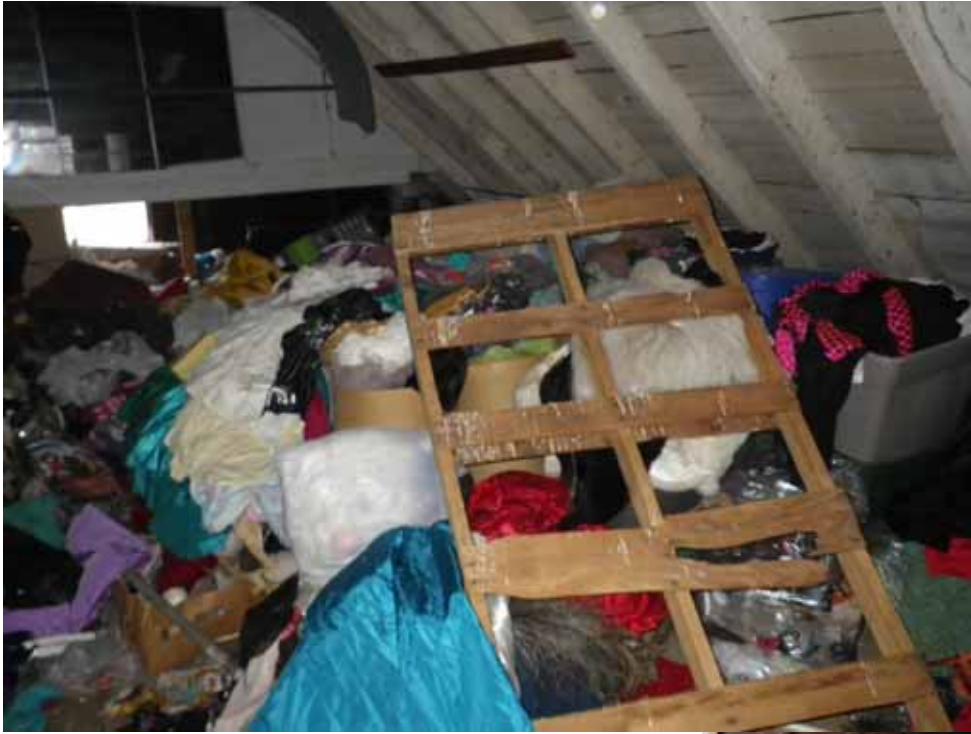
The most significant floor deflections occur around the stair openings at the first, second and third floors. The right rear quadrant of the house has deflections so extreme, safety is a concern. Photos #65A through #65G show a broken front-to-back girder that is so compromised, it has contributed to the much of the 2" (+/-) sagging seen at all three of the supported levels near the center of the house.

These pictures show the 4x10 girder that runs from front-to-back under the left wall of the corridor that aligns with the front entry vestibule. The girder has failed completely and is one of the areas that first made us fear for our safety. The most dramatic picture is Photo #65G, which was taken looking right-to-left and shows the girder broken and sagging under the wall above. In fact, the floor above has a 3"-4" dip in it and is at risk of catastrophic failure.

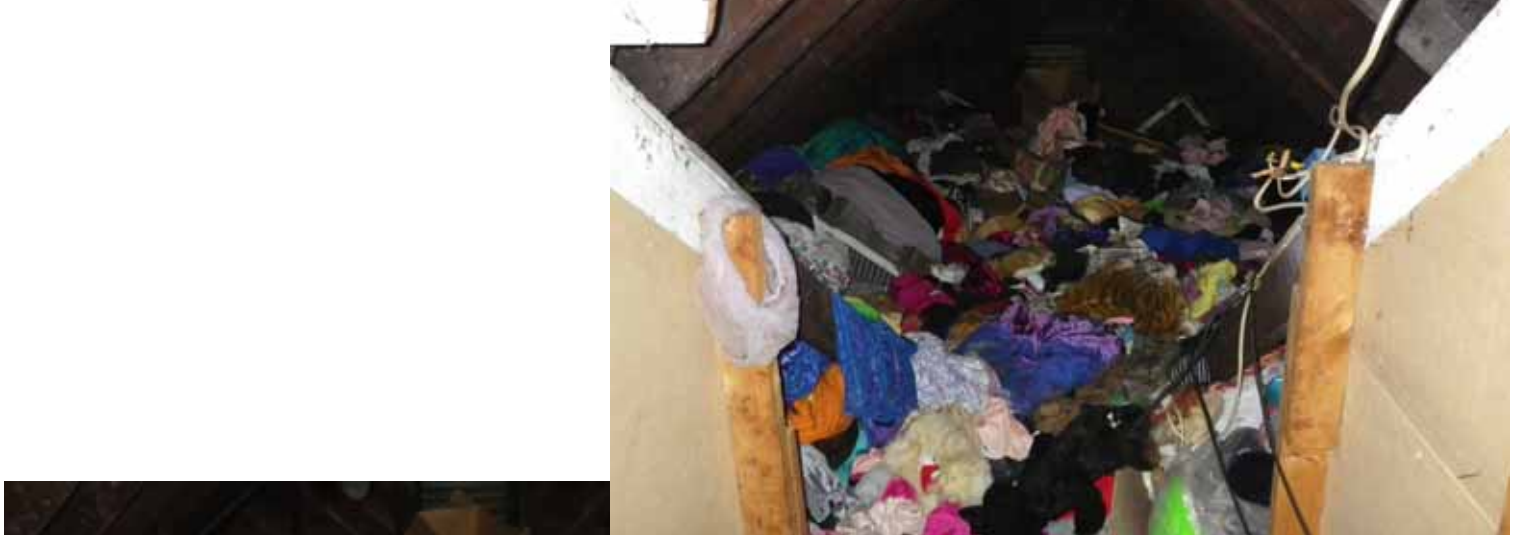
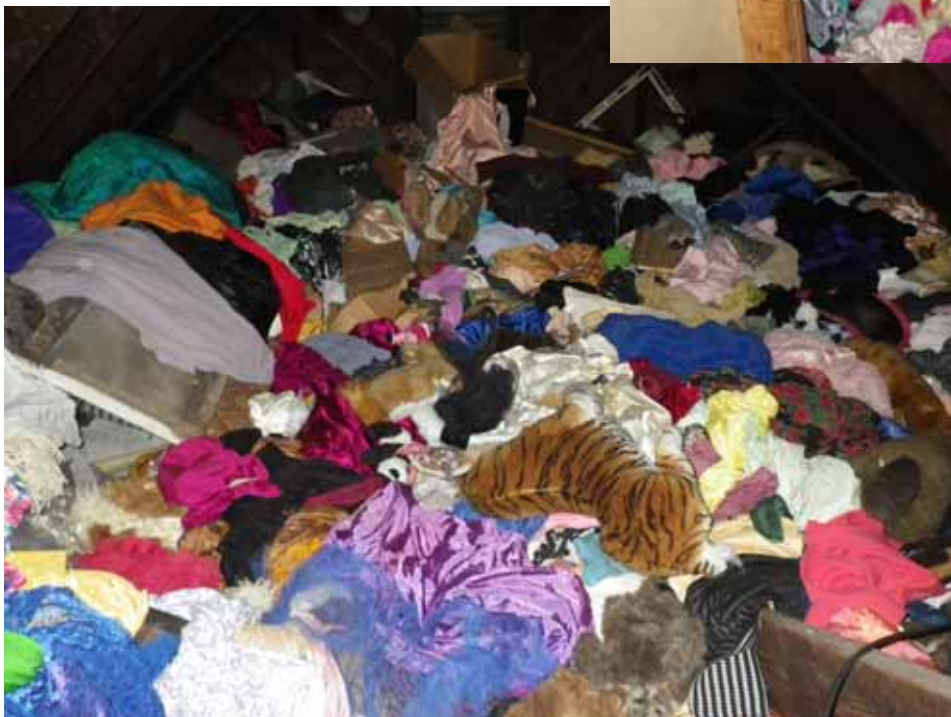
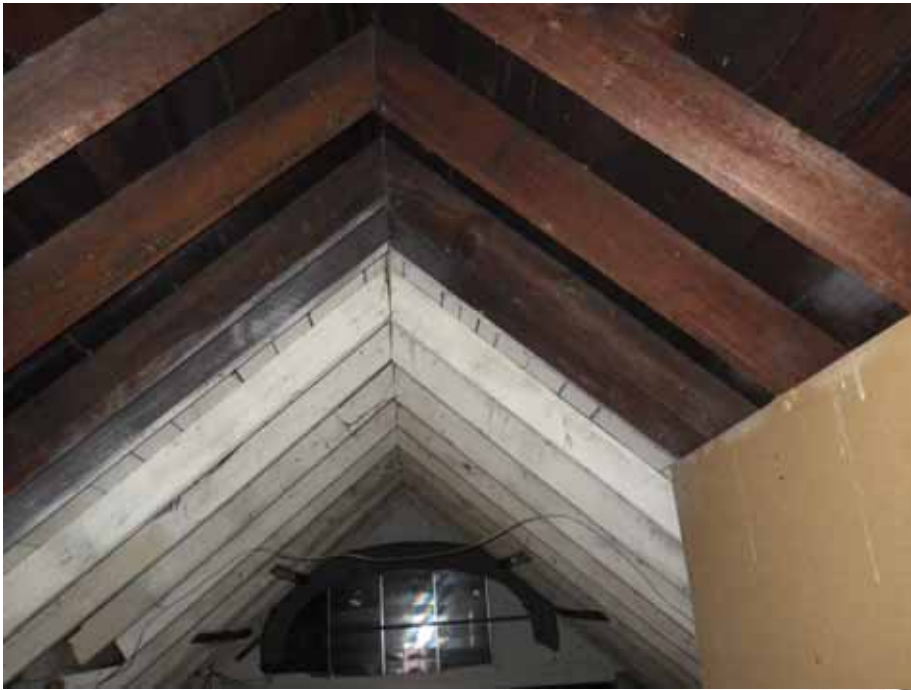
These pictures show the third level of the house knee-deep with costumes. One comforting aside is that the floor at this level has theoretically been load tested and proven capable of supporting "light storage" (20 pounds per square foot) without failure having ensued.

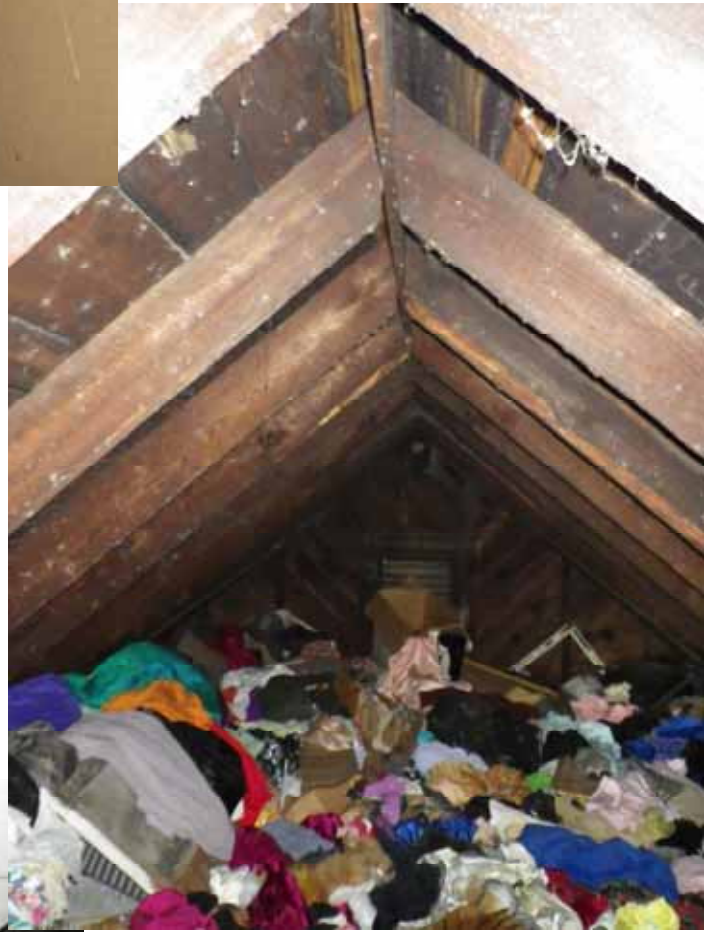
These pictures show the main gable roof rafters and the front reverse gable roof rafters. There is no ridge board or gusset at the intersection of sloping rafters as seen in Photo #69. As seen in Photo #70, there is only a piece of roof planking used as a ridge board. There are collar ties or ridge straps. The roof framing is inadequate.

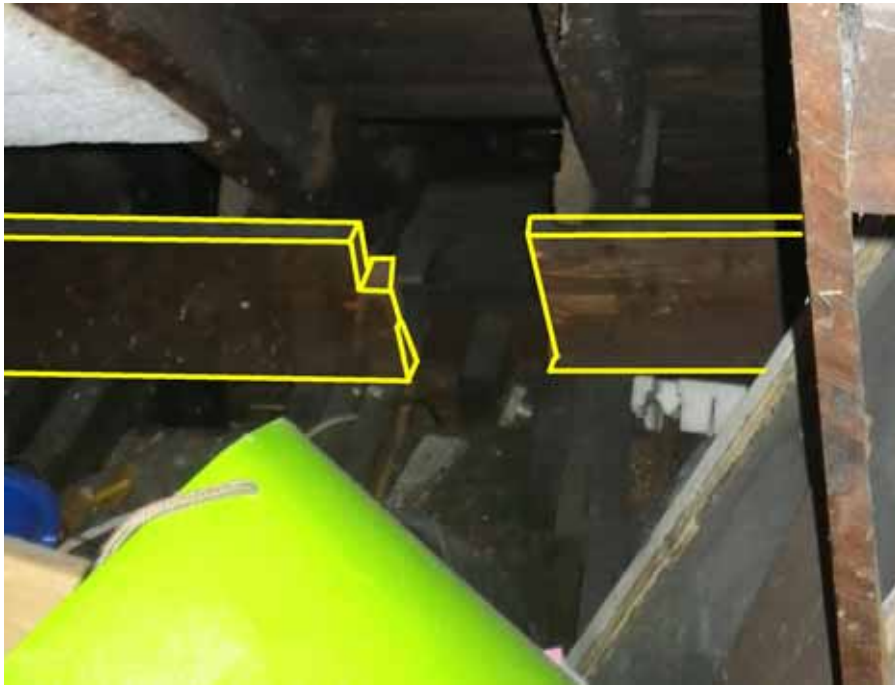
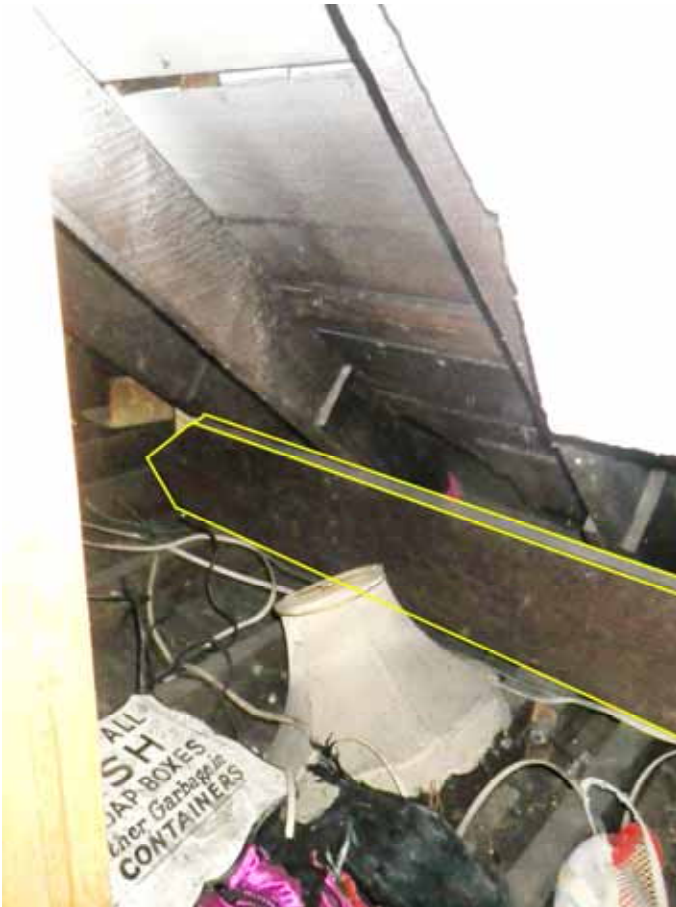
These pictures show a left-to-right girder located at the right/rear quadrant of the main, left-to-right gable roof. The intent of the member is to function as a beam aiding in the support of the low-pitched roof rafters above the right/rear roof. The yellow highlighting shows notches and severed sections of the beam, which render it ineffective as a beam. The roof loads are not properly accounted for and are imposing unforeseen loads on walls below not intended to support the ends of the low and high pitched rafters.

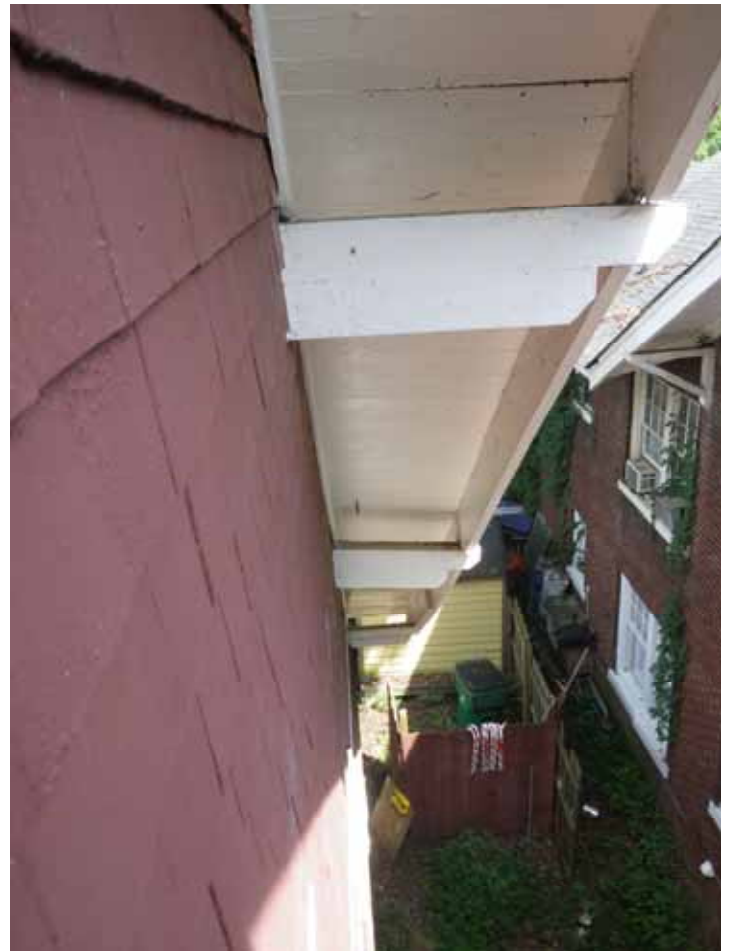
Photo #76

These pictures address the condition and support of the cantilever roof support brackets seen in Photos #77 and #78. There is insufficient back-span length to the 2-ply, vertically stacked 4-by cantilevered horizontal brackets. In addition, the only tie-down at the end of the brackets is a single 1-by as seen in Photos #76 and #79.

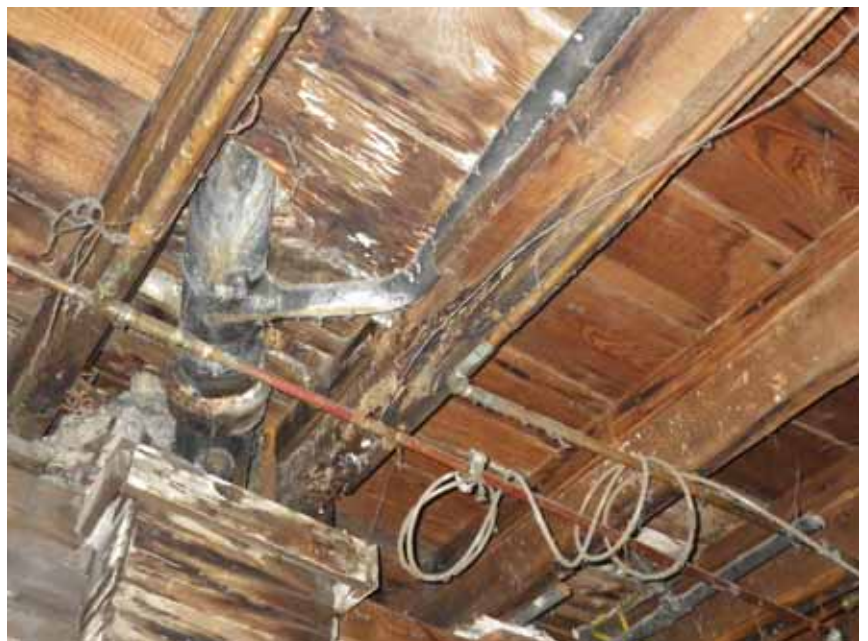
Photo #83

This picture shows another example of modifications to existing floor joists to accommodate plumbing; in this case, lead piping.
