### CERTIFICATE OF APPROPRIATENESS

**ADDRESS OF PROPERTY:** 1830 Ewing Avenue

Painting Brick

HDC 2015-232

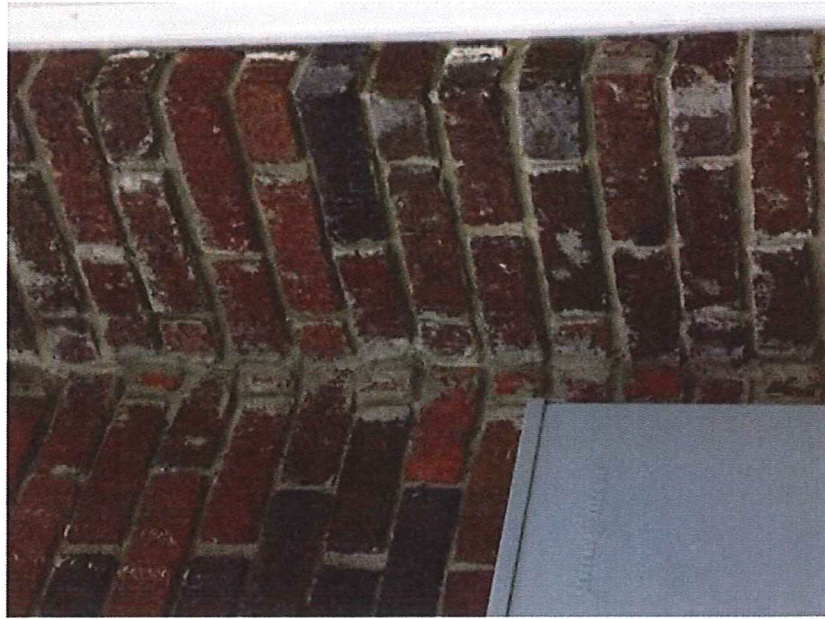
Inferior joint between original structure (left) and 2006 remodel (right). In addition to the obvious shoddy mortar work, note the mismatched brick and uneven brick courses and mortar joints, especially at the top. These photos of the *north side* of the 2006 addition are indicative of the error-filled workmanship throughout all three sides.

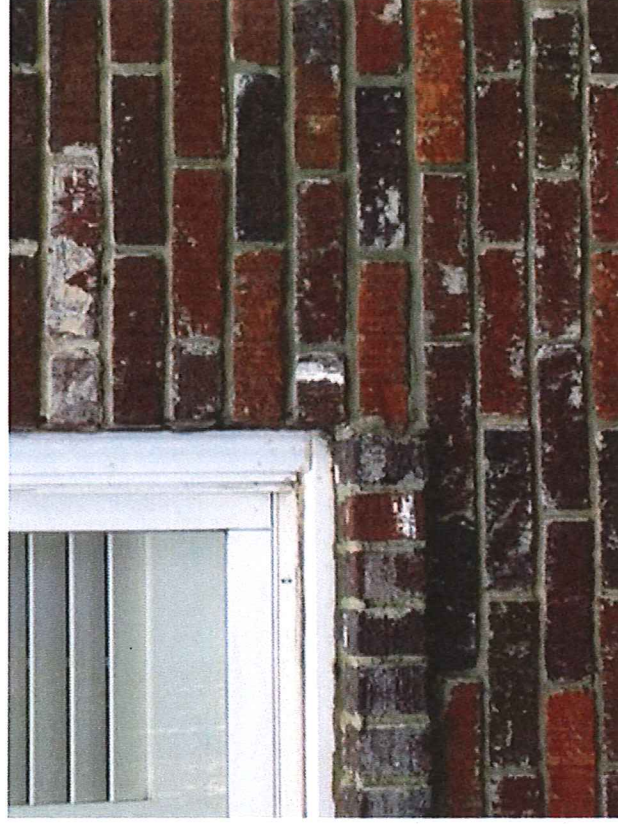
More sloppy, unsightly masonry work—*north side* wall of 2006 addition.

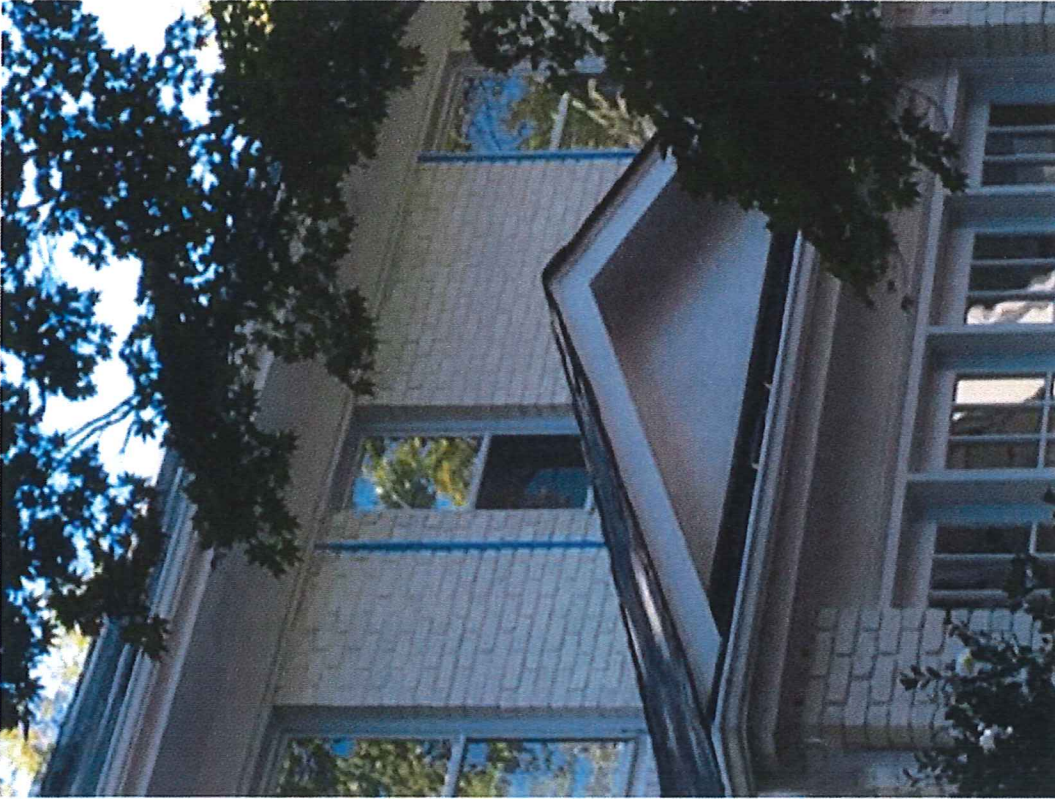
Distant view from 1823 Ewing Ave., across the street, of mismatched brick wall (inside the blue lines).

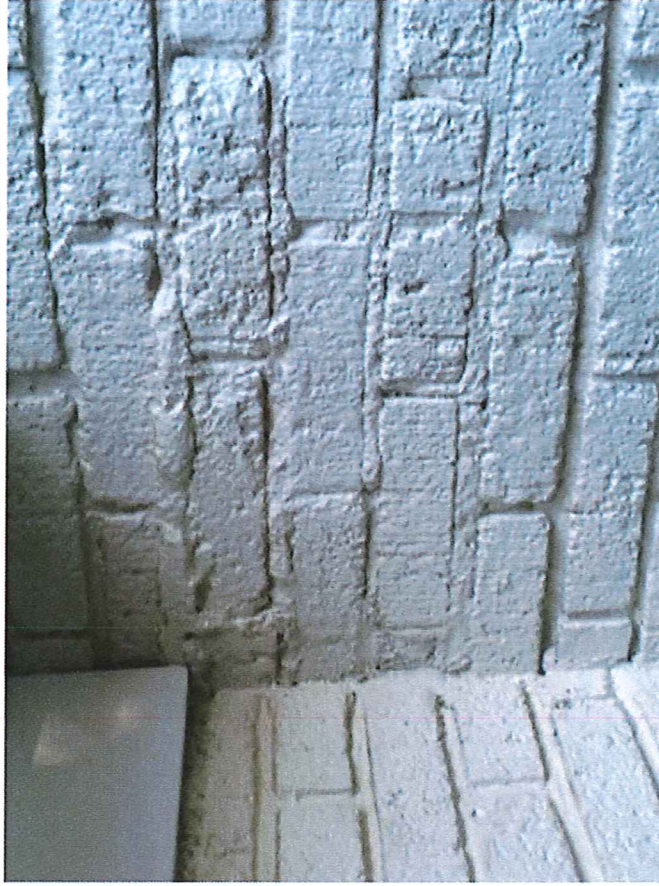
Despite being painted, this mismatched butt joint on the SW side, between the original house (right) and the 2006 addition (left), is clearly evident. Note once again the uneven rows of brick at the joint. The abundance of unsightly-and potentially damaging-mortar overfill on the upper right wall speaks for itself.

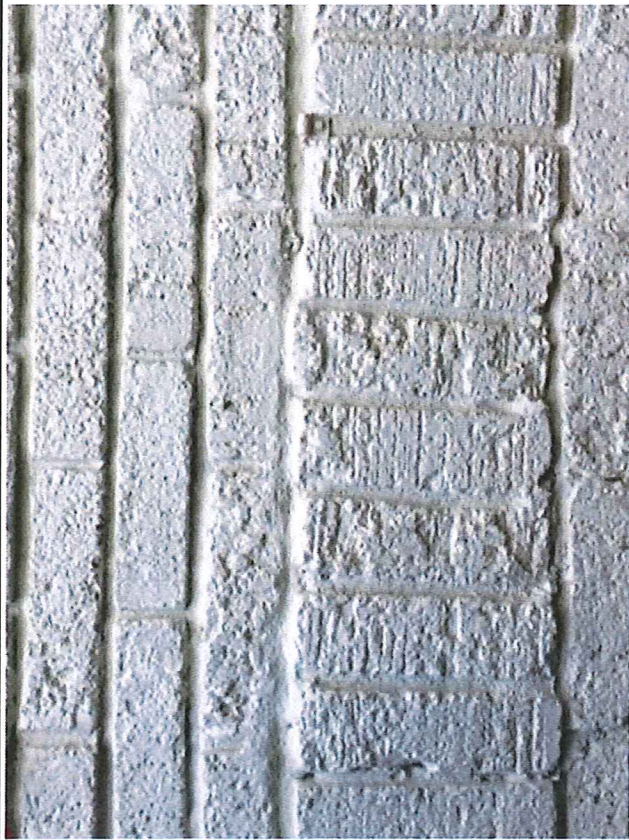
Crooked soldier course. NW wall of 2006 addition. Also note mortar overflow and drips.

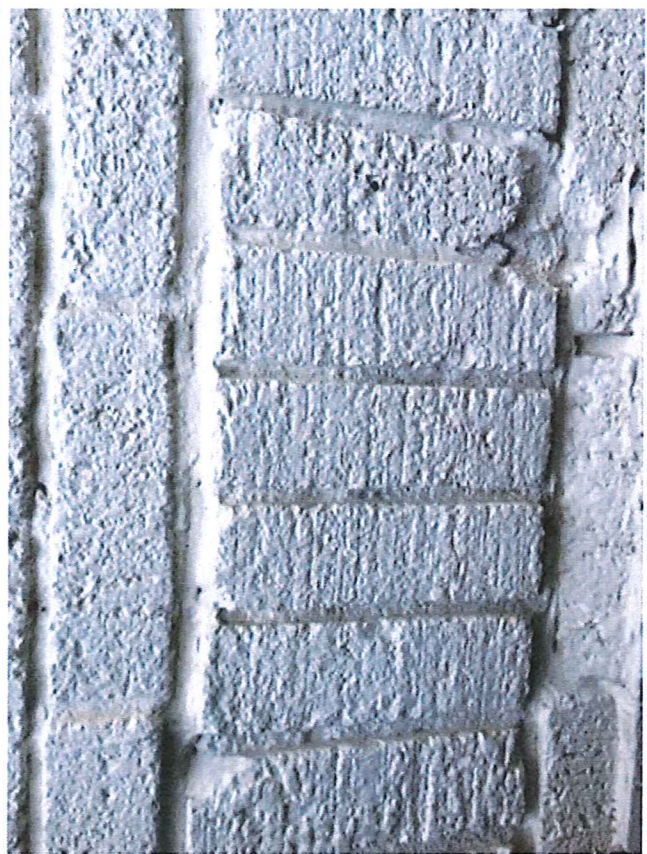
More NW wall with crooked, protruding soldier course and caved-in brick below.

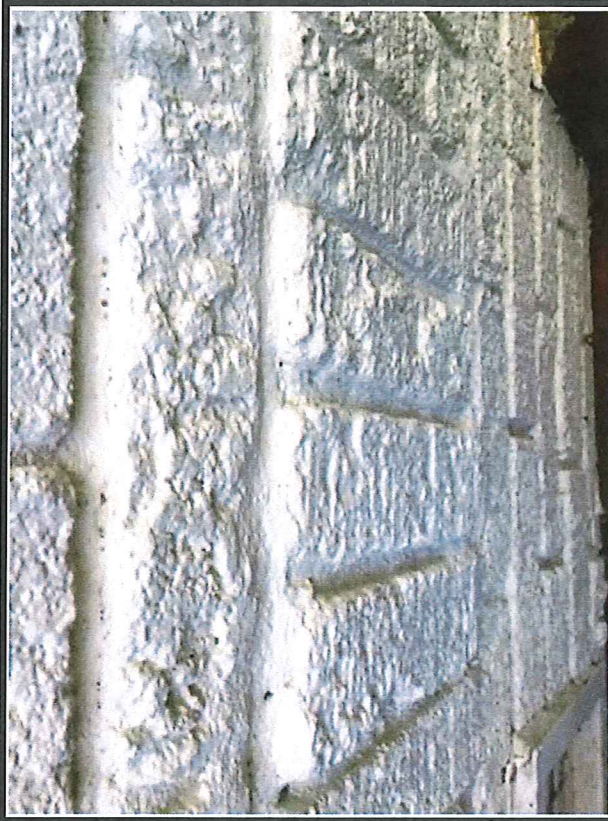
Top of crooked NW wall soldier course, protruding 1/4" - 1/2" from rest of wall-exposing it to standing water.

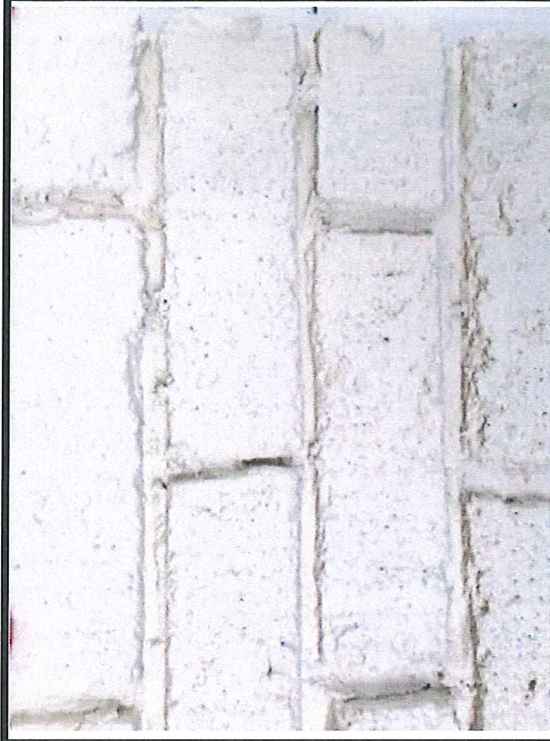
More inferior mortar work on left wall of addition: crooked, untooled joints and excess mortar drips indicative of substandard craftsmanship throughout.

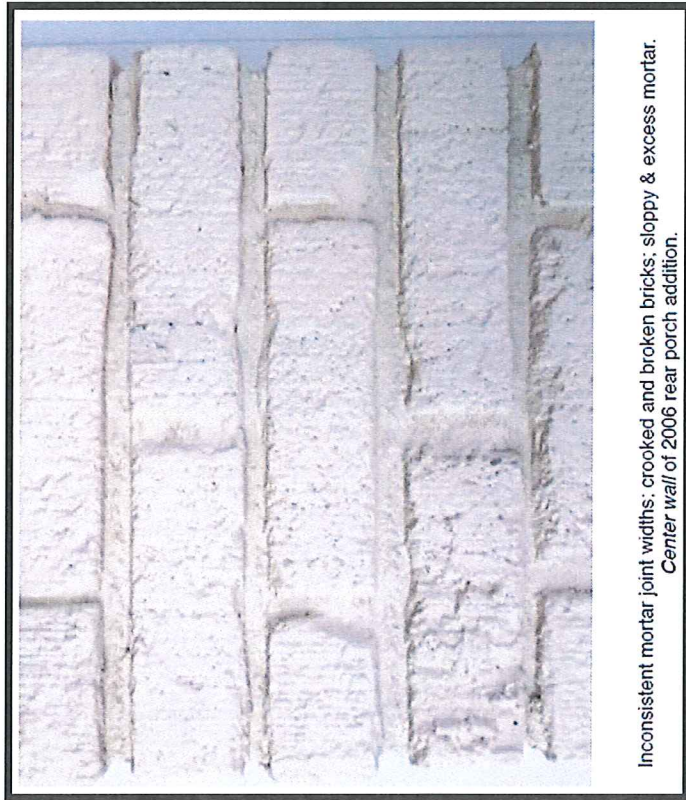
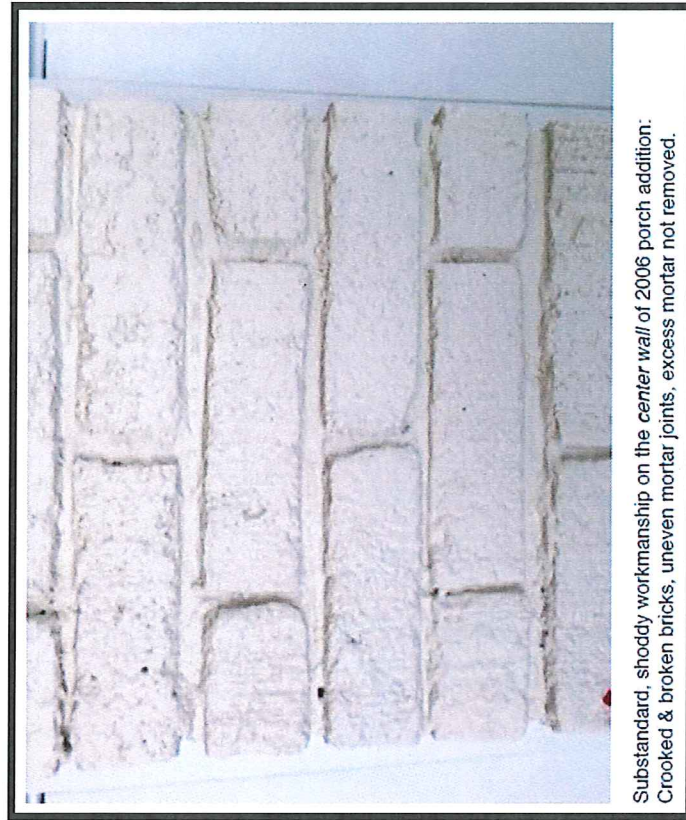
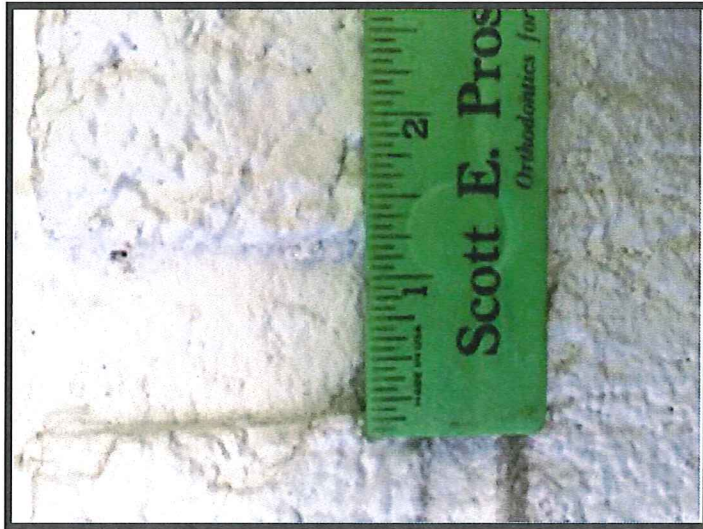
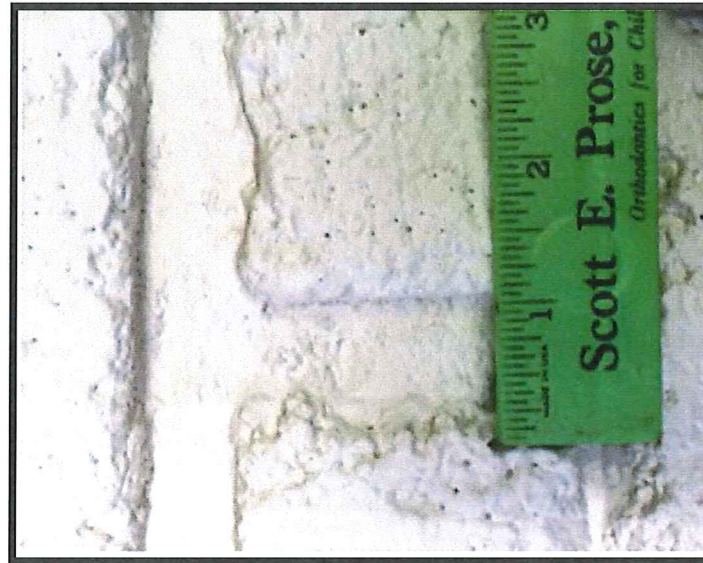
Center wall of 2006 addition

Mortar head joints in excess of one inch wide,  
common throughout all three sides of porch.  
(Industry standard is 3/8")

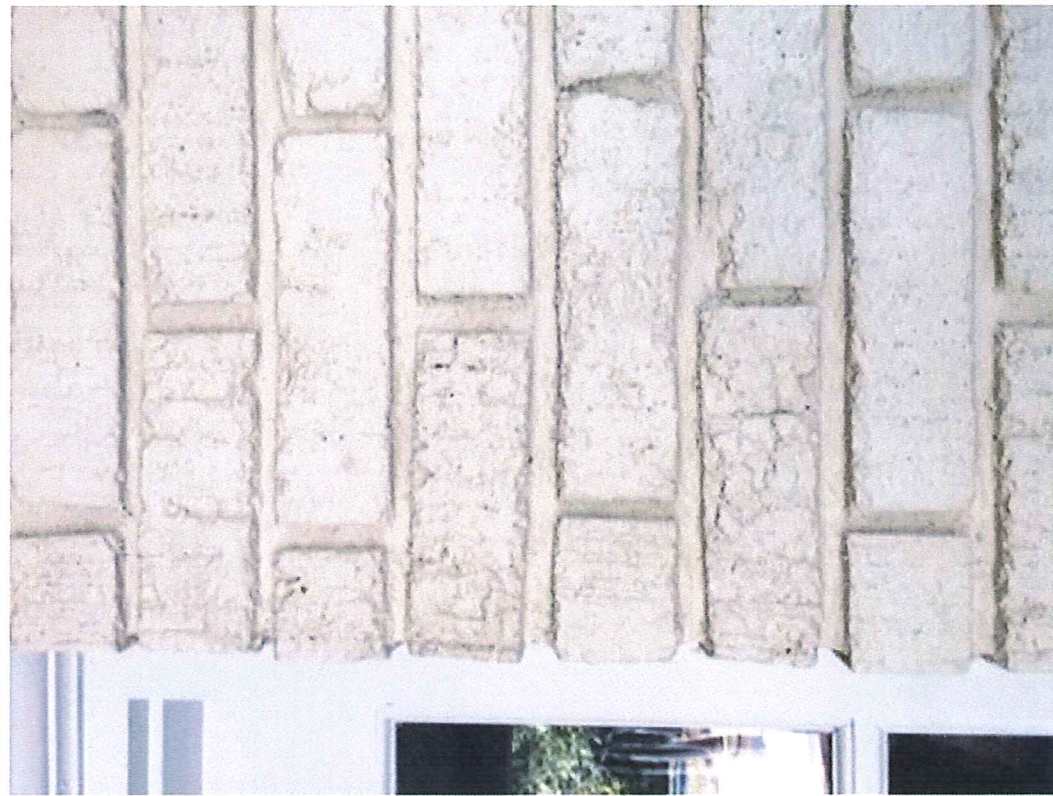
Uneven head & bed mortar joints, crooked & broken bricks-  
*right wall of 2006 rear addition*

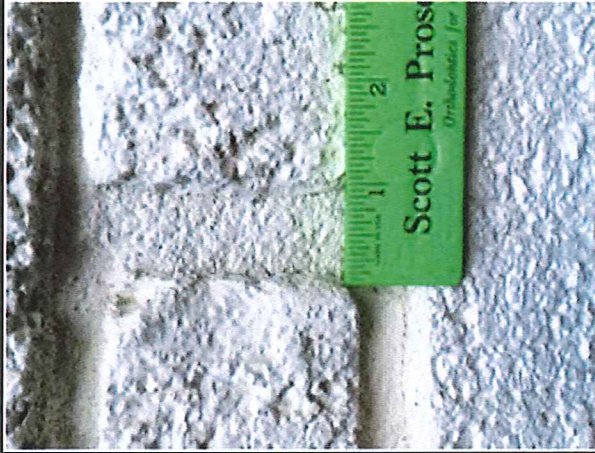
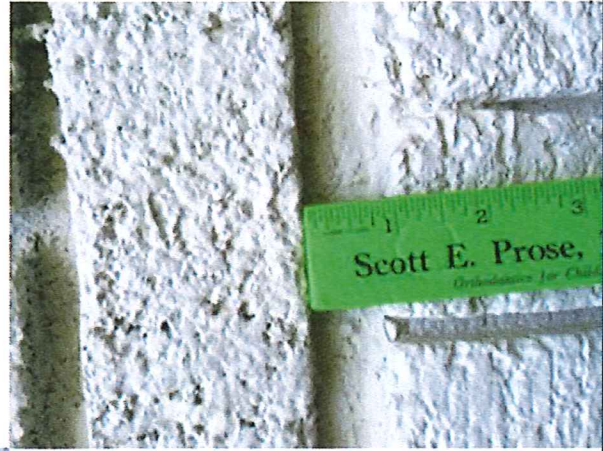
*SW wall of 2006 rear addition. One of many  
 head & bed mortar joints one inch wide.  
 (industry standard is 3/8")*
