LOCAL HISTORIC DISTRICT: Wesley Heights

PROPERTY ADDRESS: 408 Walnut Avenue

SUMMARY OF REQUEST: Parging

**408 Walnut Avenue
Charlotte, NC 28208
Limited Structural Observations
Photo Narrative
for
Lockhart Simpson
408 Walnut Avenue
Charlotte, NC 28208
by
A. Wynn Yates, PE
Yates Structural Engineering, PA
3300 Elstree Drive
Charlotte, NC 28226
704-650-5541
wyates@yseng.com**

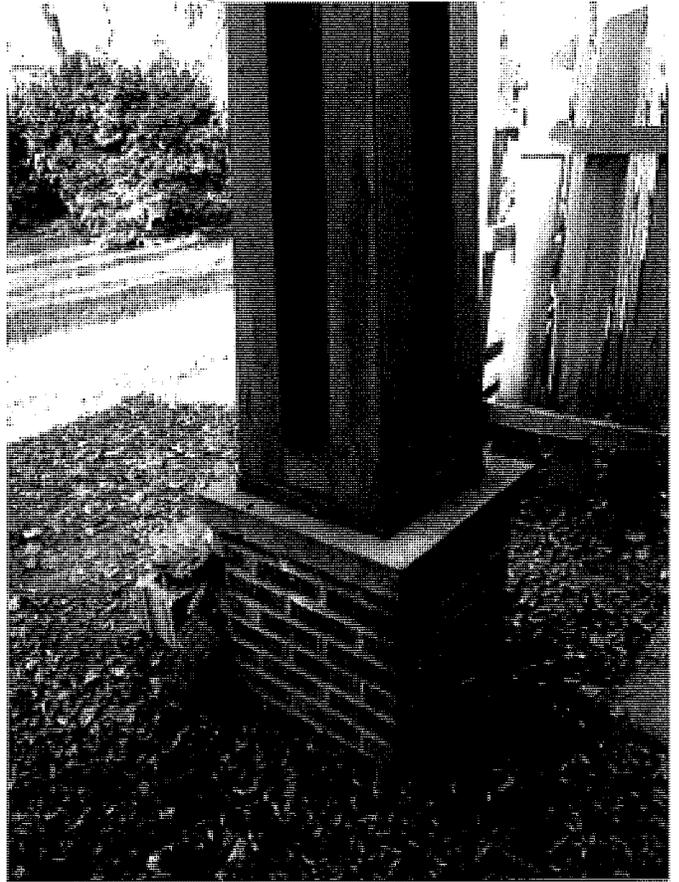
Photo #44

These pictures show the exterior left-rear deck. The interior 4x4 wood posts were not pressure-treated for ground contact.

Replace all 4x4 deck support posts and their footings with construction matching the existing exterior corner supports as seen in Photos #44 and #45.
