PROPERTY ADDRESS: 1230 East Worthington Avenue

SUMMARY OF REQUEST: Tree removal

Charlotte Historic District Commission Case 2017-075
HISTORIC DISTRICT: Dilworth
TREE REMOVAL

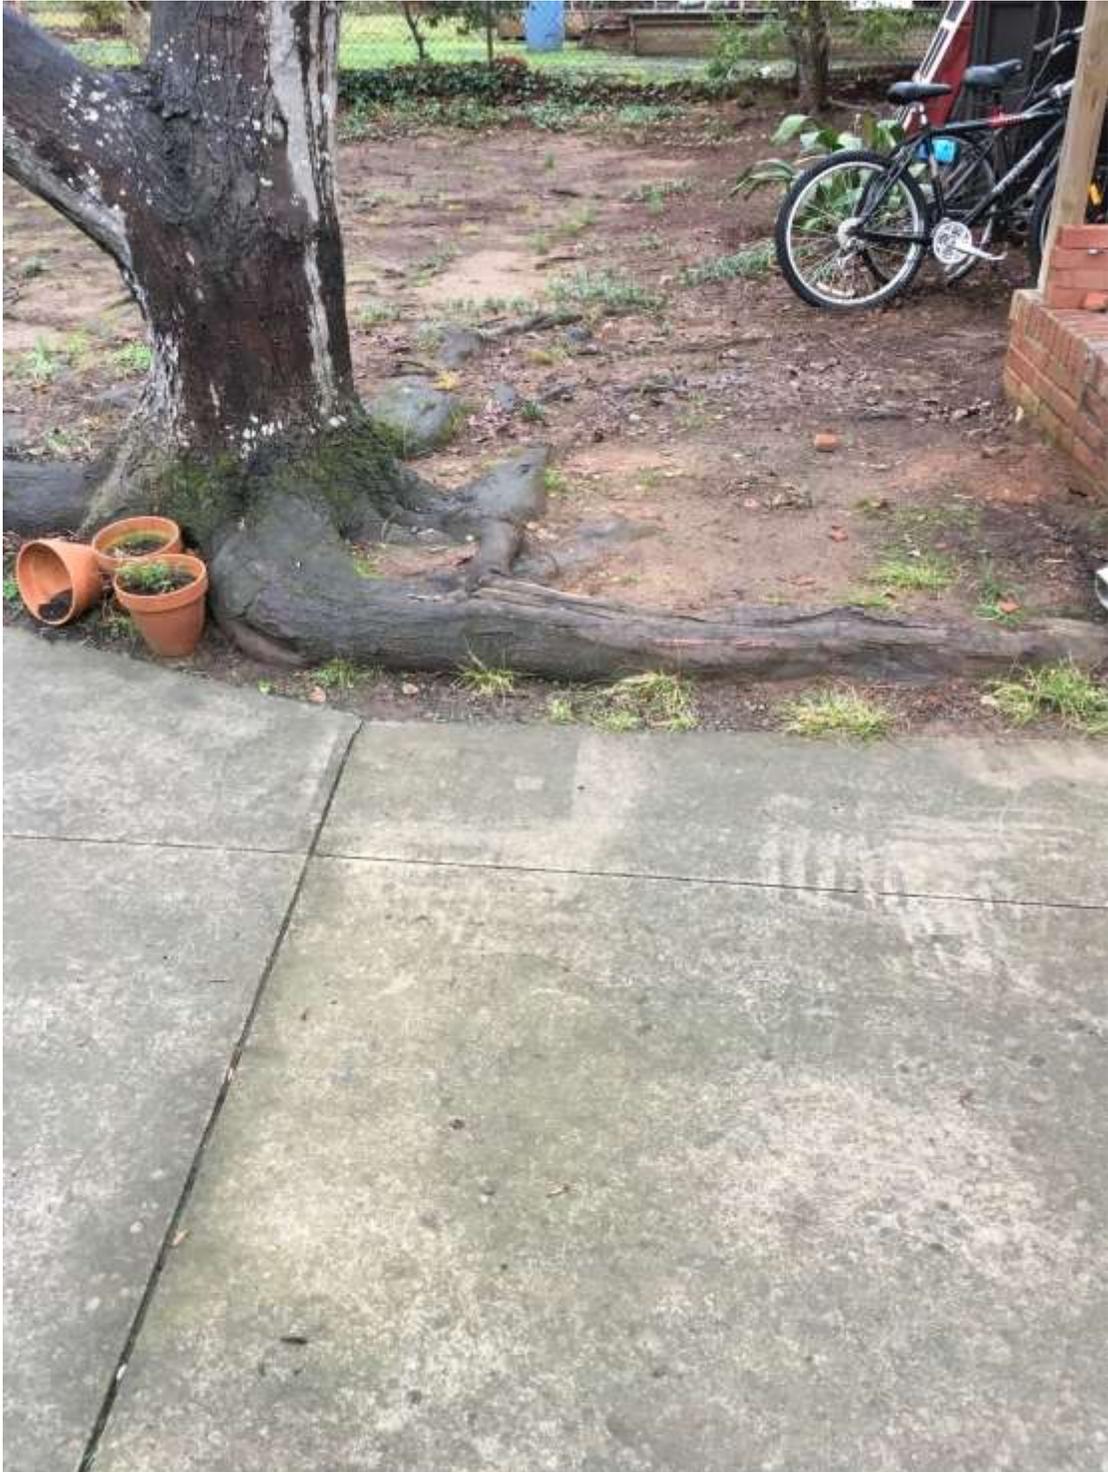
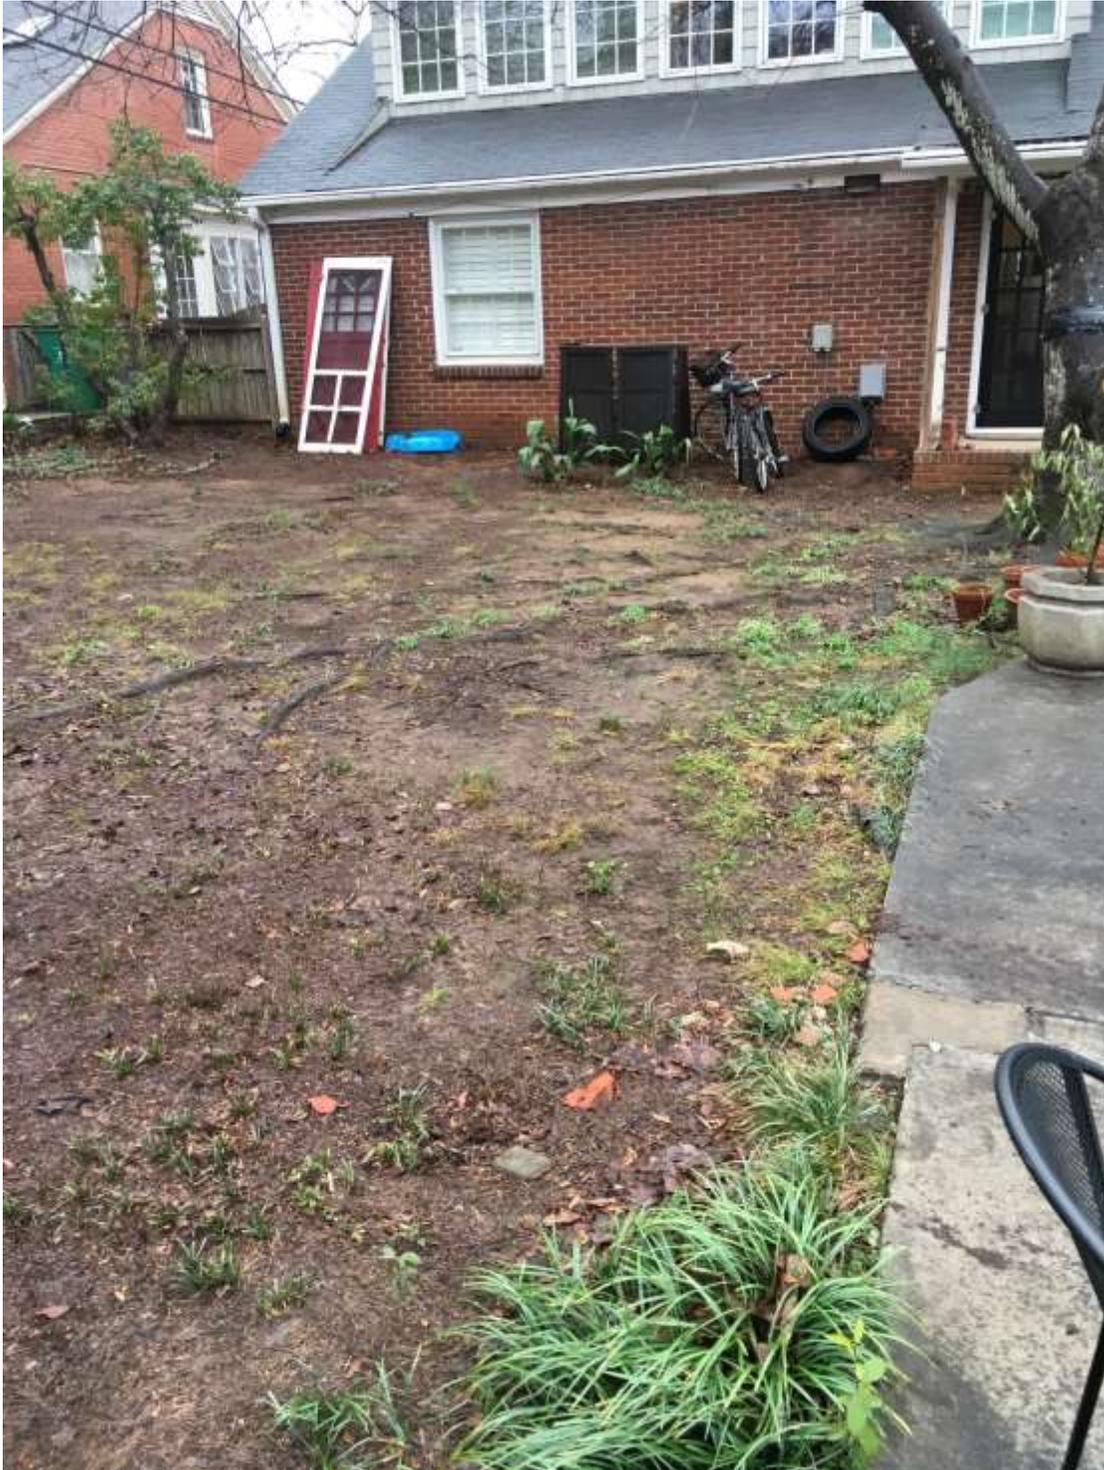
I am contacting you to request permission to remove a (21") Red Maple located at the left rear foundation of 1230 E. Worthington Ave. This tree was installed in very close proximity to the house and has a codominant branch structure. Codominant stem unions are structurally compromised as they are attached by included bark and have a high risk of splitting/separating at the seam. The exposed surface roots throughout the rear yard present significant tripping hazards. There is also a reasonable concern of the aggressive roots causing damage to the foundation.

The aggressive root pruning necessary to mitigate the hazards would result in severe stress and the likely decline/death of the tree. Another mitigation action would include building the soil level up over the roots with retaining walls; however, this too will be counter-productive for the tree's long-term health. The established root system will suffocate as the soil pore (air) space will collapse. Maple roots require oxygen in the soil for feeder root production, and root suffocation will result in tree decline/death.

The property owner, Elizabeth Zimmerman, has requested that the tree be removed. I've attached a couple photos (below) to document the concerns. She has been advised to replant a shade tree species in the far right rear of her property to replace the lost canopy. Please advise me with any questions, concerns, or how to move forward.

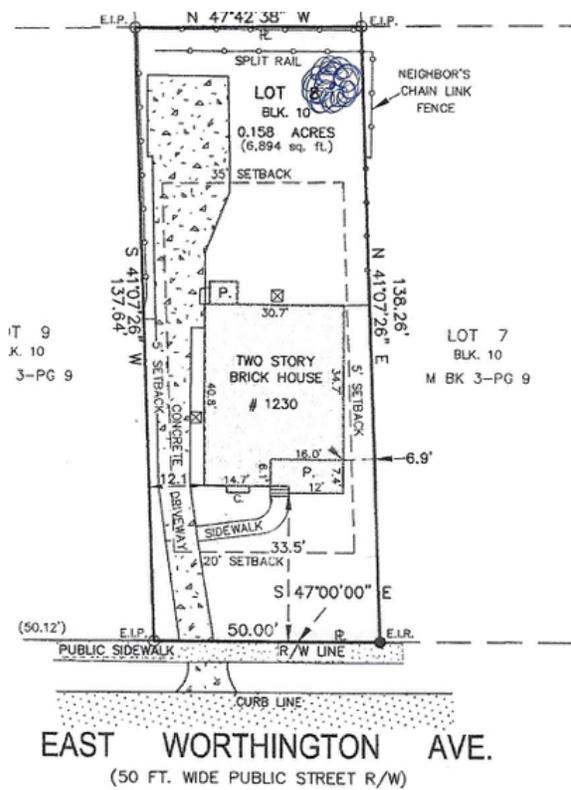
Proposed

The proposal is the removal of the tree because of tree roots exposed above ground. The applicant would plant a large maturing tree in the corner of the rear yard.

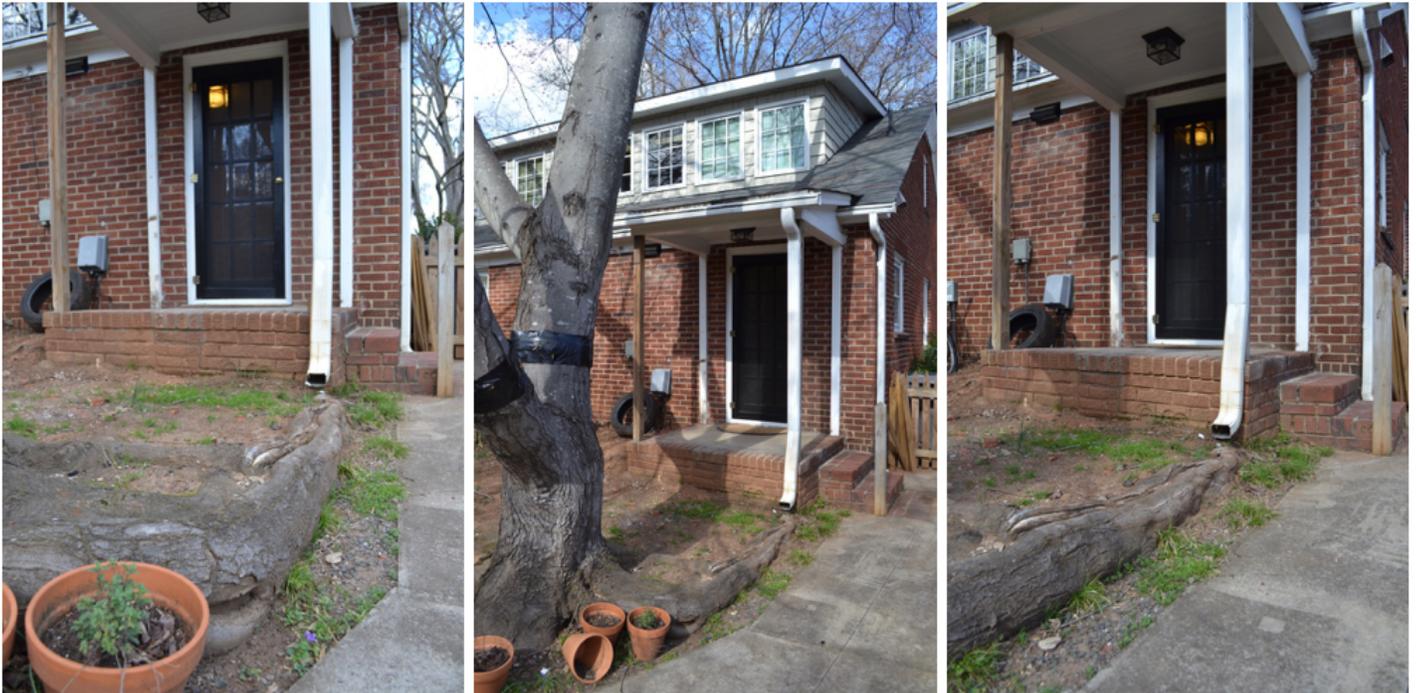
Additional Photos - Roots Encountering Foundation

*Photos taken from rear left of yard looking towards to the house

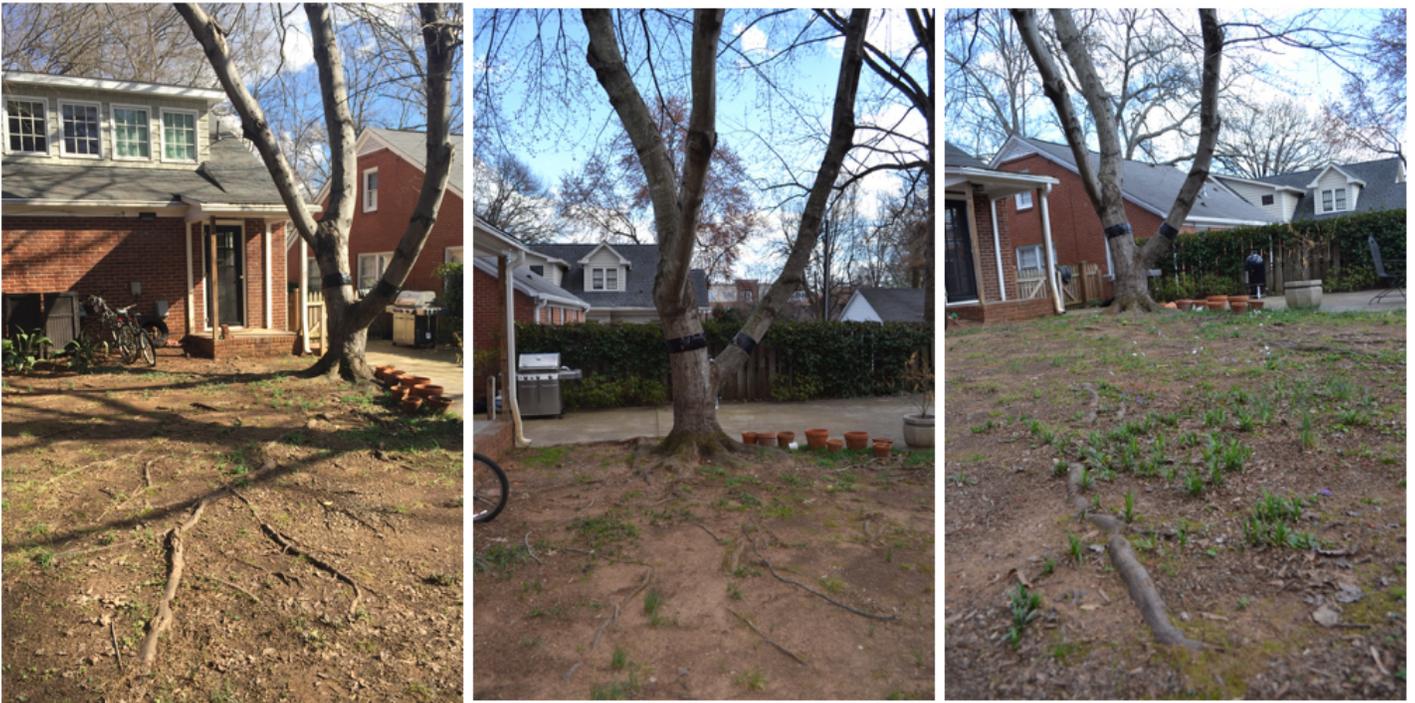
Additional Photos - Surface roots in the yard

*Photos taken from rear right of yard looking towards to the tree/house
