**LOCAL HISTORIC DISTRICT:** Dilworth  
**PROPERTY ADDRESS:** 901 East Worthington Avenue  
**SUMMARY OF REQUEST:** Tree removal  
**APPLICANT:** Steen Moss

*Charlotte Historic District Commission Case 2017-189*  
**HISTORIC DISTRICT: DILWORTH**  
**NEW CONSTRUCTION**

Subject: Report on Trees Located at 901 East Worthington Ave, Charlotte, NC

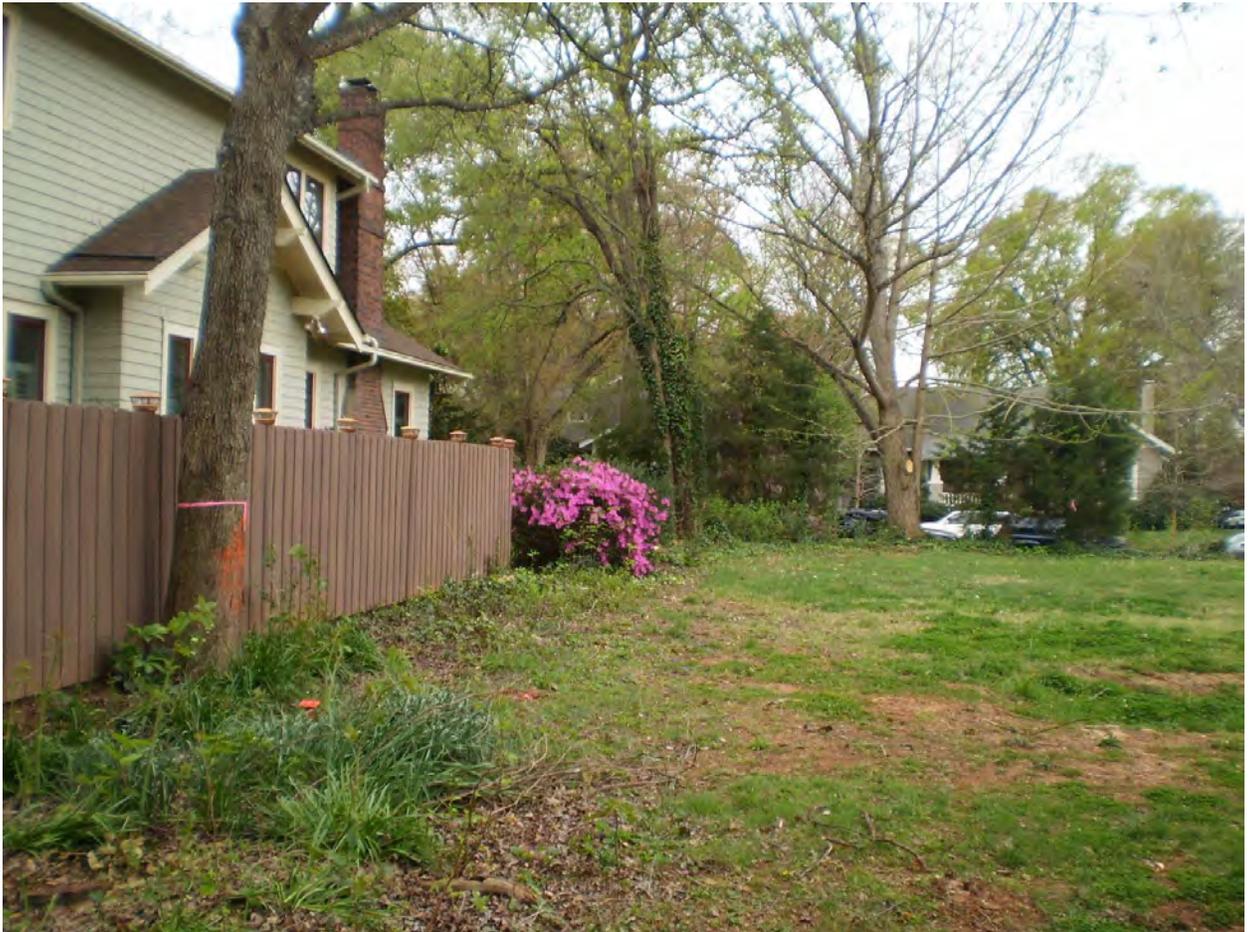
1. At the right middle of the lot immediately adjacent to the neighbor's fence is a single stem pecan tree of approximately 18" DBH (diameter-at-breast-height). The tree is currently healthy run and has good symmetrical form. Based on currently survey staking and the allowable side setback of five feet, excavation for the basement could occur within two feet of the base of the trunk, with the wall of the house sitting within five feet of the trunk. Excavation for the house foundation would remove approximately 40% of the root system. Additional damage from soil compaction by equipment and foot traffic would damage additional portions of the Critical Root

Zone. Of additional concern is that it is likely the trunk and root flare will be damaged. This will make the tree a potential future should the tree survive the construction.

In addition, much of the canopy on the north side of this 50-foot tall tree would need to be removed by pruning to make way for the structure. This would leave a poorly formed tree with little growing room.

*Figure 1- Pecan in left foreground and cherry/willow oak just beyond azalea; looking from rear of property toward Worthington Ave. Note orange marking on ground where proposed foundation corner is located.*

2. Black cherry tree 18" DBH located at the right property line about 30 feet from the front sidewalk. This tree occupies approximately the same juxtaposition to the right front of the

potential excavation as the pecan tree does. The potential for damage and survival is about the same as the pecan. In Addition, native black cherry is a relatively short-lived species with a host of insect and disease problems making it a poor choice for a residential tree. **For these reasons, it is my recommendation that this tree be removed.** Aside, there is a small (8" DBH) willow oak growing to the trunk of the black cherry and up into the canopy of the cherry and has not developed a main leader. **It should be removed** at the same time as the cherry.

**My recommendation is to remove the tree** because of all the potential damage it will incur and the minimal contribution it would make to future landscape and the neighborhood. Additionally, by removing the tree, it will allow a nice specimen elm immediately behind it more future growing space.
