PROPERTY ADDRESS: 1917 Lennox Avenue

SUMMARY OF REQUEST: Tree removal

Charlotte Historic District Commission Case 2017-514
HISTORIC DISTRICT: DILWORTH
TREE REMOVAL

TREE ASSESSMENT/ MEDIATION, June 29, 2017

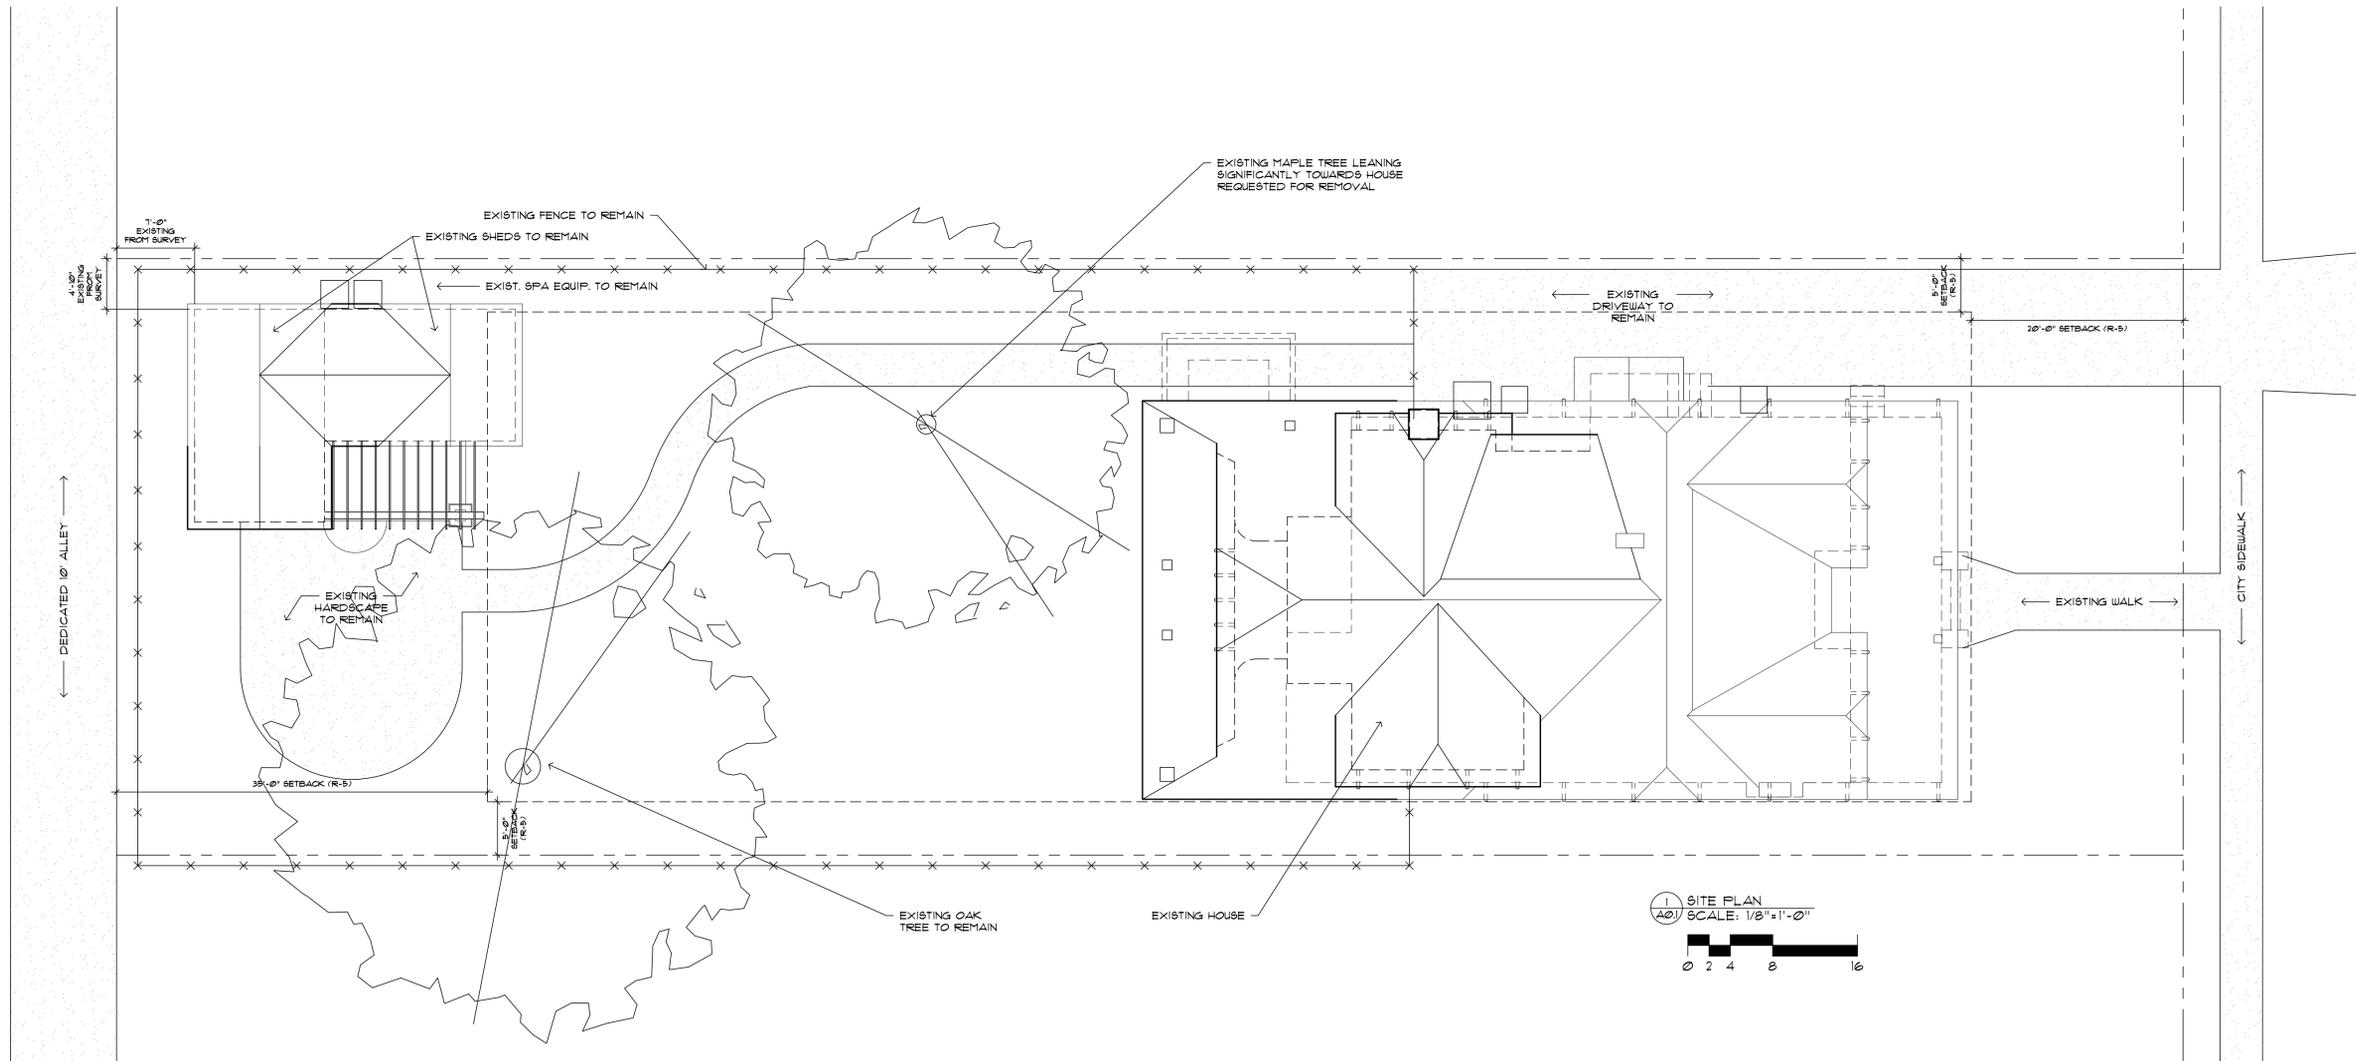
1 SITE PLAN
A01 SCALE: 1/8" = 1'-0"
0 2 4 8 16

Request for removal of an existing maple tree that is significantly leaning towards the house in the Historic Dilworth neighborhood of Charlotte, North Carolina.

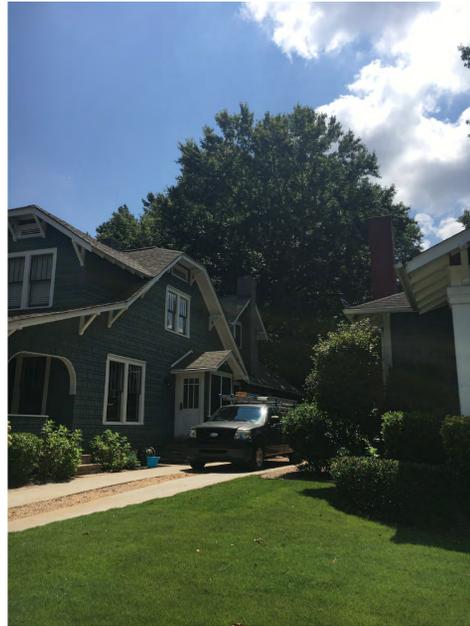
01 - STREET: VIEW FROM STREET TO TREE (IN BACKYARD)

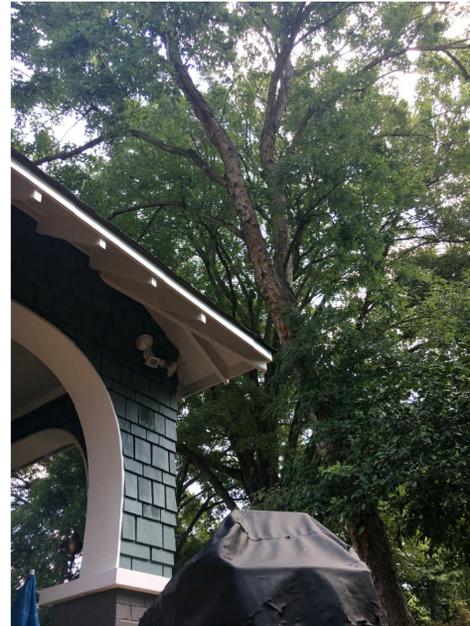
03 - REAR PORCH: SHOWS TREE LEANING SIGNIFICANTLY TOWARDS PORCH

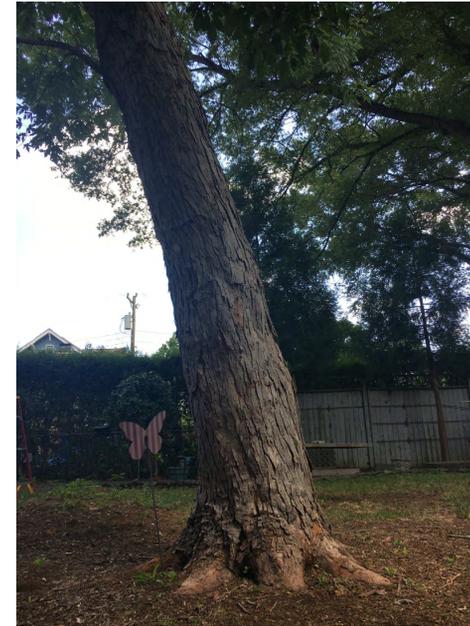
To whom this may concern: In May 2017 Mr. and Mrs. Rimany requested that I assess a large, over mature, leaning Silver Maple (Acer saccharinum) in their backyard. 38" DBH; 50' in height. This tree has a significant lean towards the house. With a history of limb drop, characteristic of the species and with children frequently playing beneath, it is my recommendation that this tree being removed.

04 - TRUNK FROM SOUTH: STRAIGHT-ON PHOTO OF SINGLE TRUNK WITH SIGNIFICANT LEAN TOWARDS WEST / PORCH

The project is the request to remove the large, mature tree in the rear yard that is leaning toward the house.

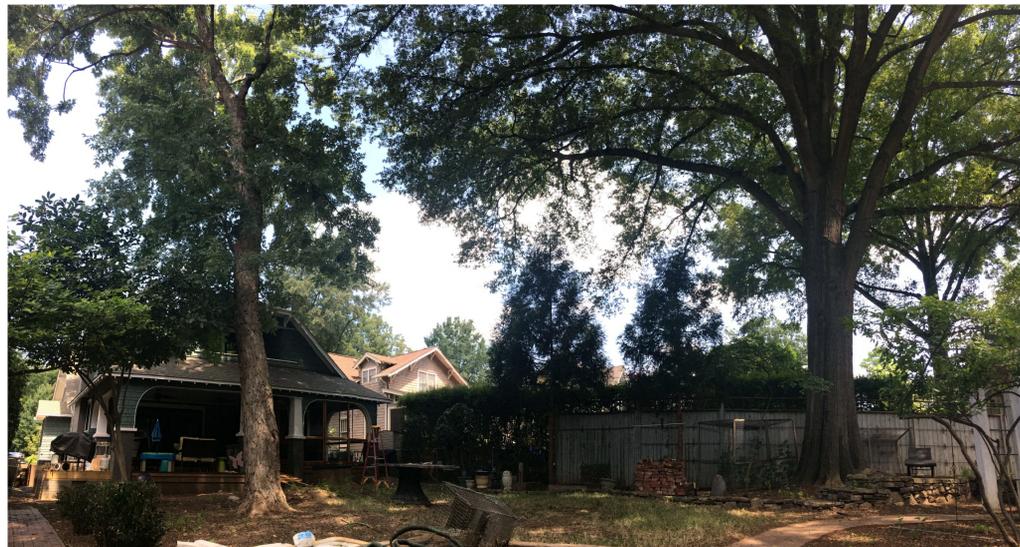
06 - PANORAMIC FROM SOUTH - THIS PHOTO SHOWS THE CANOPY. THE OAK (HEALTHY TO RIGHT) DOMINATES THE CANOPY ON THE BLOCK. THE MAPLE IN QUESTION HAS BEEN GROWING AWAY FROM THE OAK CANOPY TOWARDS THE HOUSE

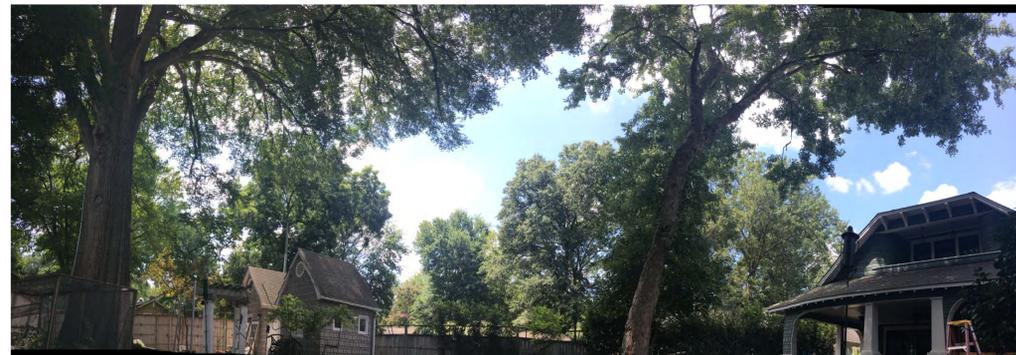
07 - PANORAMIC CANOPY FROM NORTH. THIS PHOTO SHOWS THE DOMINANCE OF THE OAK CANOPY AND THE LEAN OF THE MAPLE

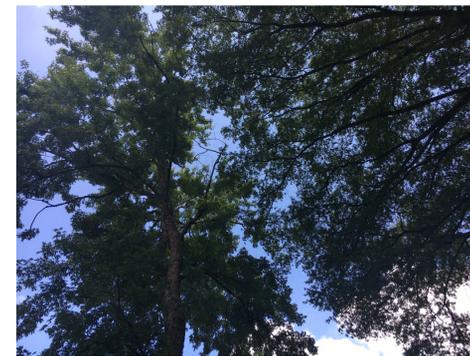
08 - CANOPY: THIS PHOTO SHOWS DEAD WOOD / LACK OF GROWTH ON THE EAST SIDE WHICH FACES THE OAK

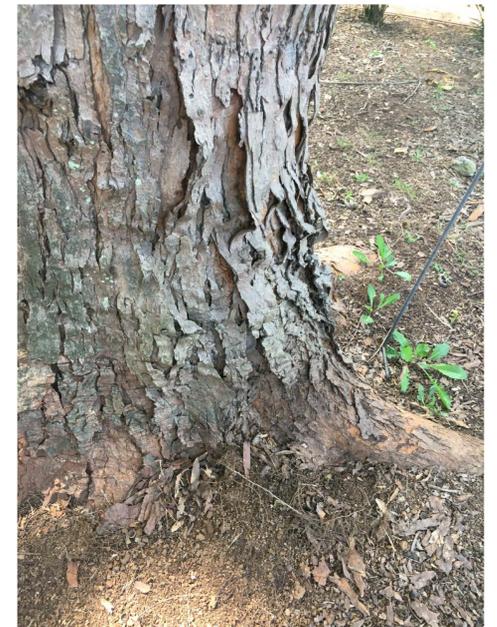
09 - BARK BUCKLING WEST SIDE AT BASE. THIS PHOTO SHOWS THE STRESS AT THE BASE OF THE TREE, WHERE THE BARK IS PULLING AWAY AND APPEARS TO SHOW SOME COMPRESSION BUCKLING ON THE WEST SIDE TOWARDS THE HOUSE
