CHARLOTTE HISTORIC DISTRICT COMMISSION CERTIFICATE OF APPROPRIATENESS - AMENDMENT

CERTIFICATE NUMBER: 2017-00364

ADDRESS OF PROPERTY: 1508 Dilworth Road

Re [EXT] Stockton 1508 Dilworth Road

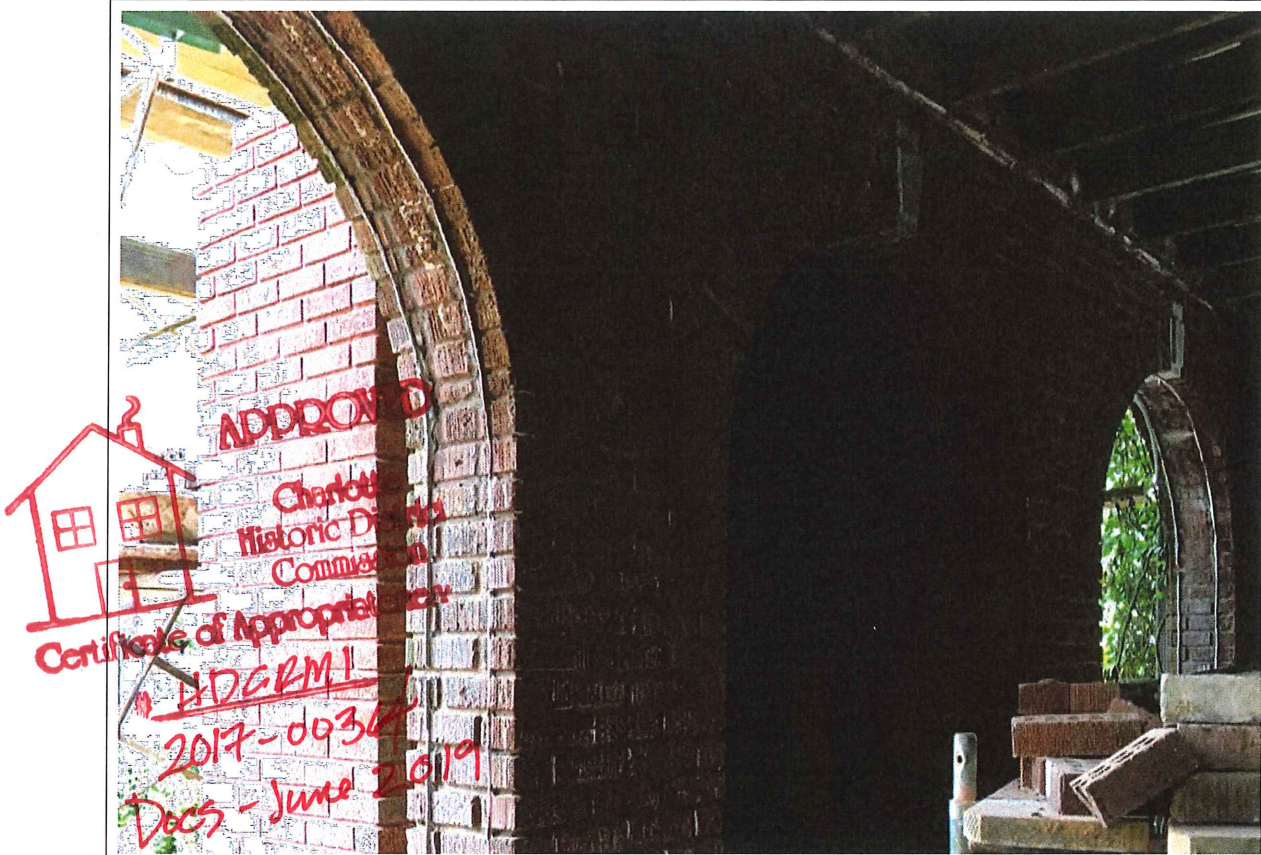
Photo Showing Solid 3-Wythe Brick Wall After Existing Window Was Removed

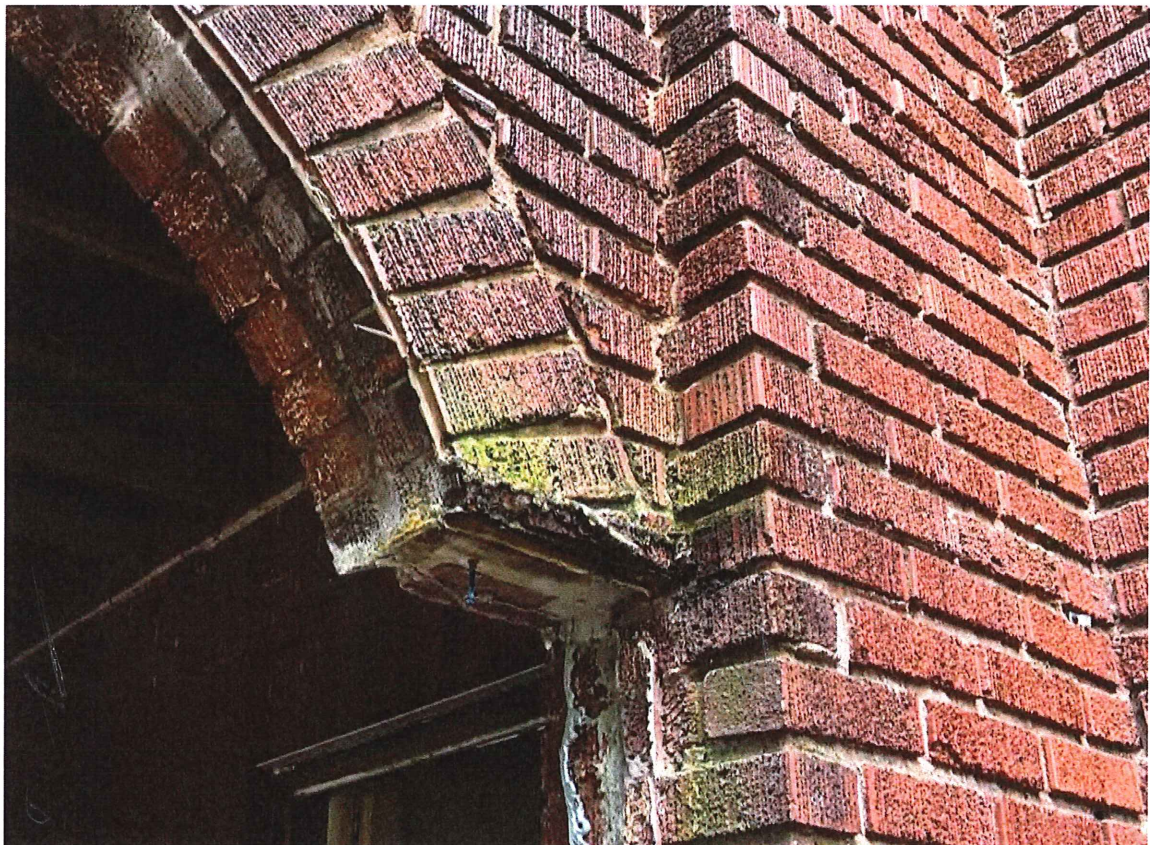
Photo Showing Solid 2-Wythe Brick Wall After Existing Door Was Removed

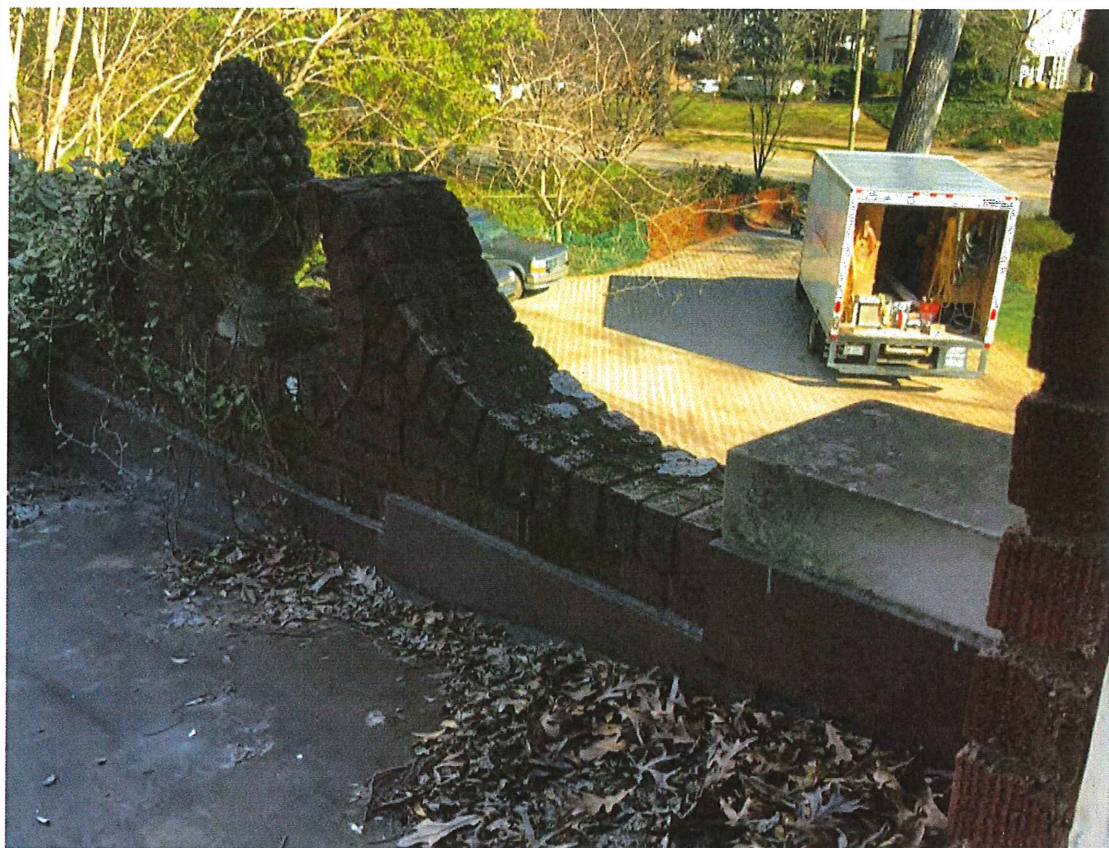
Photo Showing Existing Flashing at Back of Brick Feature

This flashing does not extend through the wall, and exposed mortar joints at top of wall allow water intrusion

Per your email approval dated 03/20/2019 addressed to Audry Barber of Ruard Veltman Architecture, Inc; the existing limestone cap and masonry feature will be removed and saved for re-use. A copper flashing will be installed over the brick wall with a 0.25" turn down at exterior. The limestone cap will be replaced, and the masonry feature re-constructed exactly as it was.

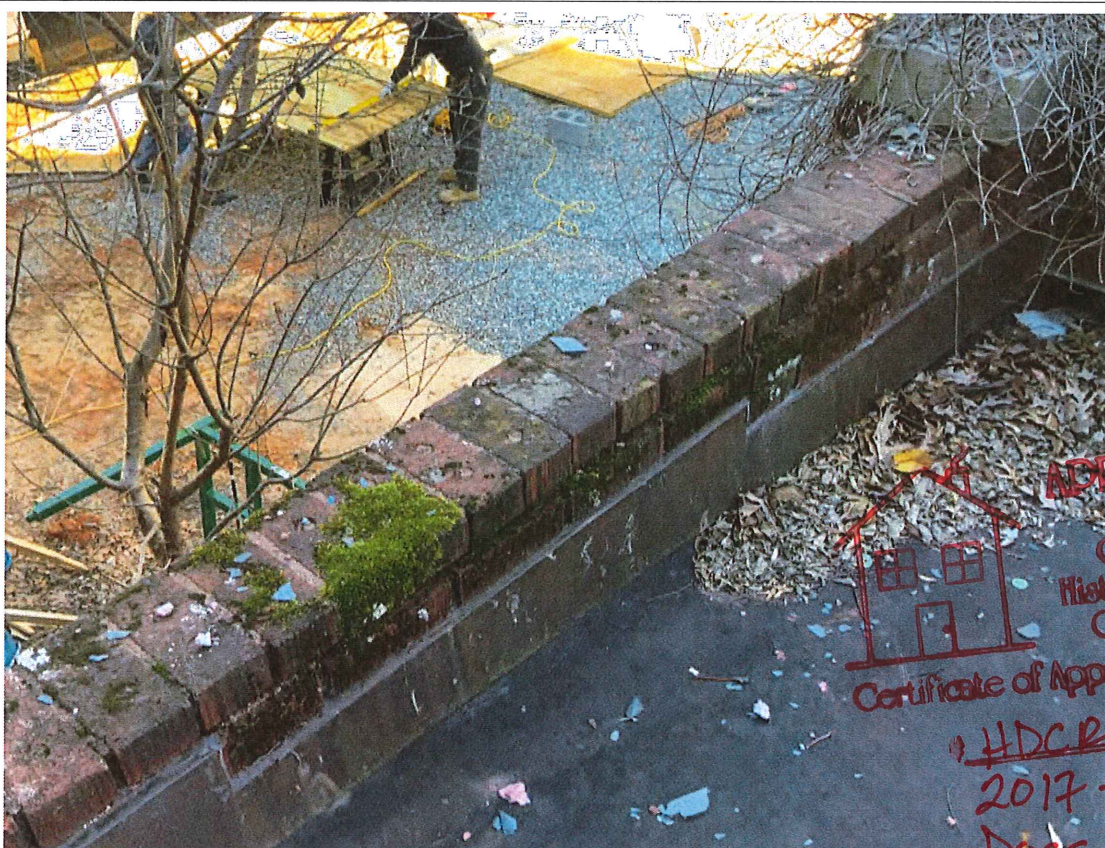
Photo Showing Top of Wall Where Limestone Coping is Missing at Rear of Brick Parapet

The degraded mortar and holes in the brick allow water to seep through the wall to the interior of the house

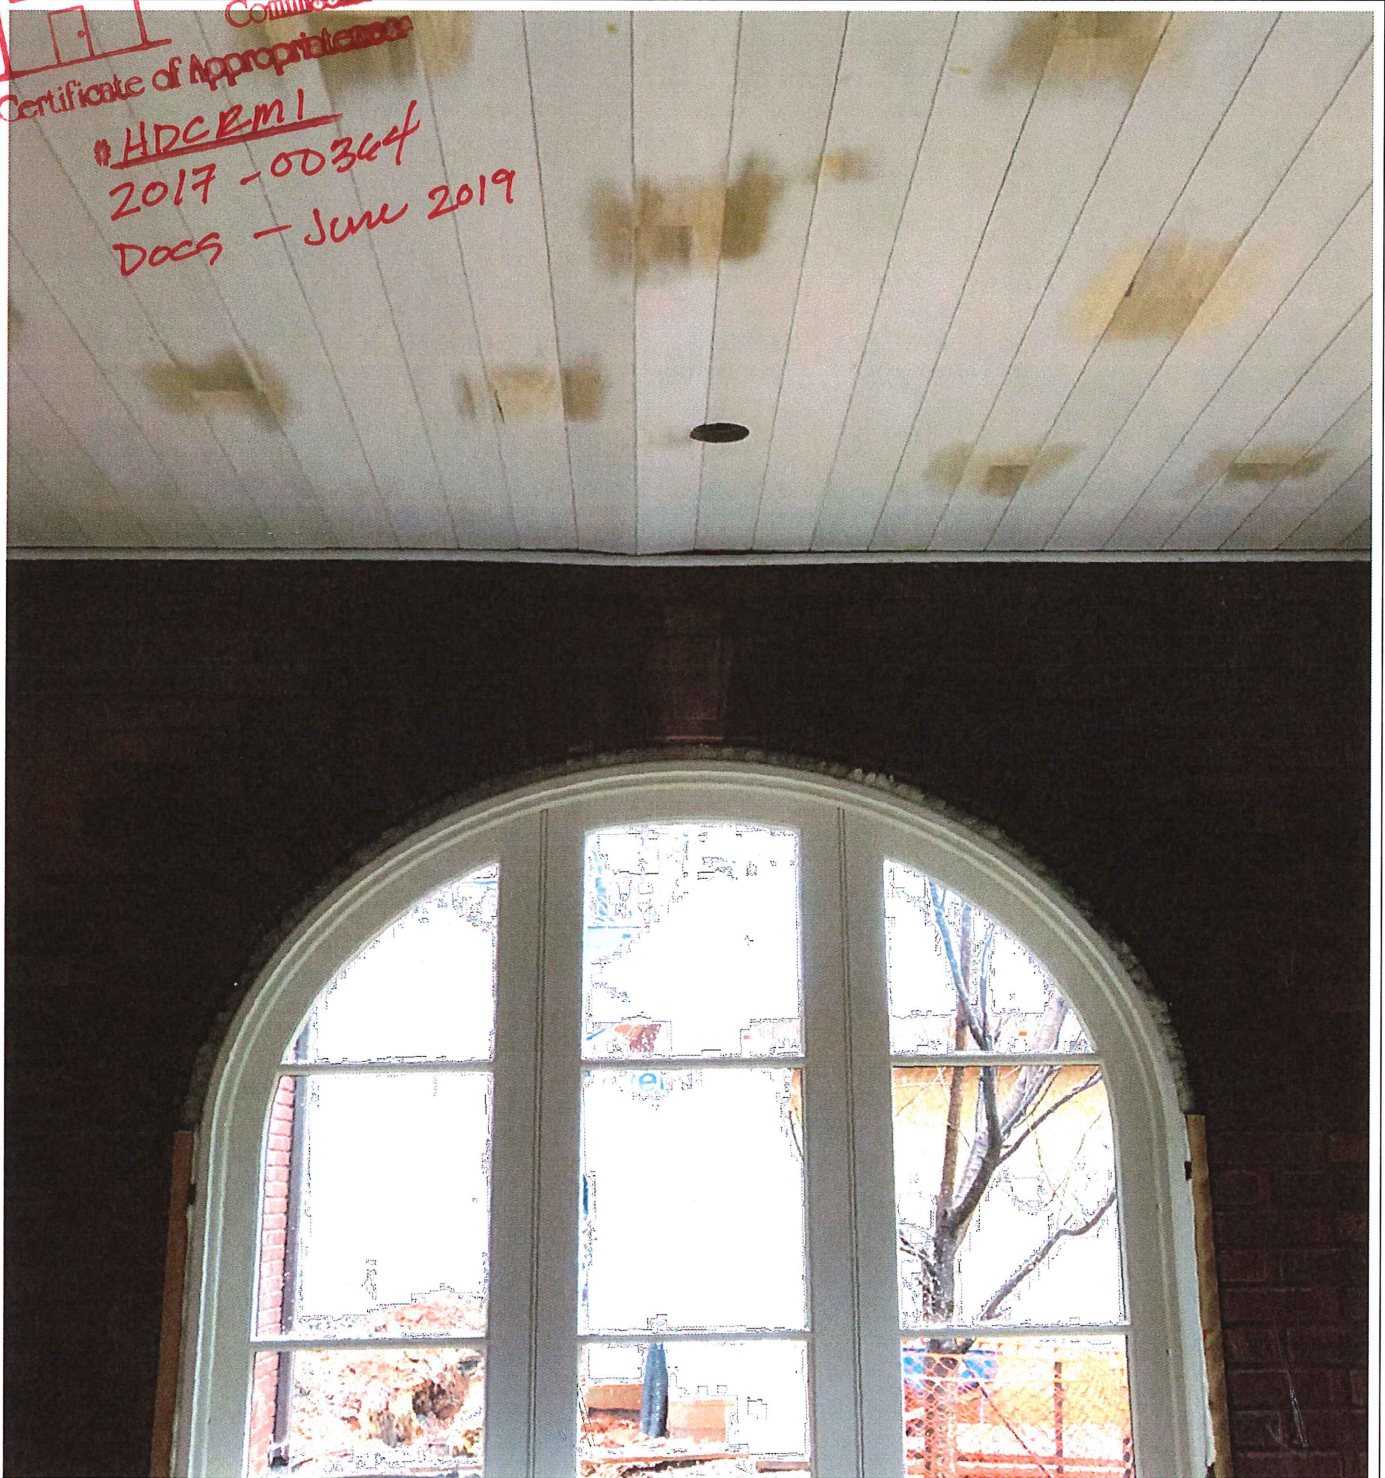
Whitlock Builders has determined that a through wall flashing is needed under the parapet wall cap at right side of house to stop water seepage down through the brick wall and into the living space below. The single-story room, while it had been enclosed prior to the current owners purchasing the home, was originally an open porch, and as such the walls were built from solid masonry with no flashing or other preventative measures taken to prevent water infiltration through the brick. A continuous barrier is required from one side of the wall to the other to prevent water intrusion.

Photo Showing Water Damage to New Wood Ceiling

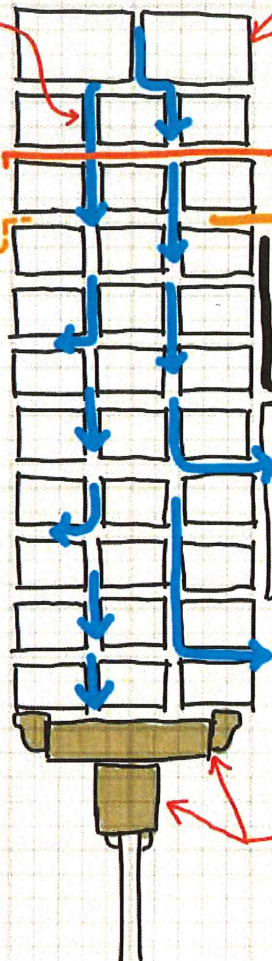
Diagram Showing Existing Water path and Proposed Flashing

Water is coming
THROUGH the
masonry joints

Existing Solid Masonry Wall

Existing Copper Flashing

Existing Rubber Roof

New Wood Door & Frame
(original was Badly Rotted)

* 1/4" turndown @
face of brick

Thru-wall Flashing Req'd to stop water
