LOCAL HISTORIC DISTRICT: Wilmore

PROPERTY ADDRESS:	1916 Merriman Avenue
SUMMARY OF REQUEST:	Demolition
APPLICANT:	Matthew Alexander

CD Swanson Inc. Home Inspections

Address 1916 & 1918 Merriman Ave. Charlotte NC 28203

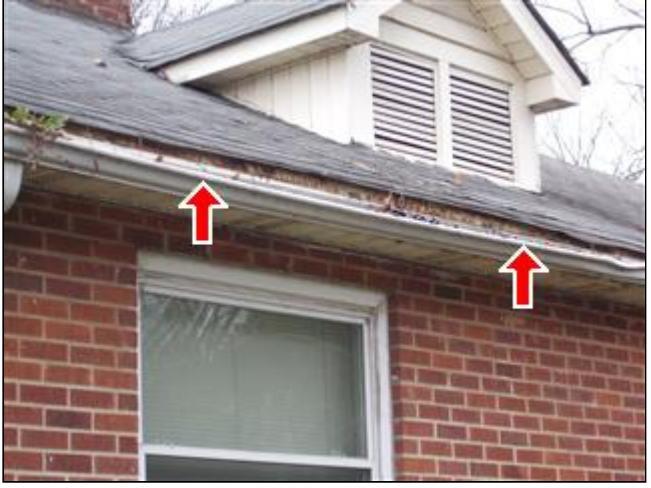
(1) There are multiple areas were the gutters around the home are pulled loose and or missing down spouts. Gutters are very important on a basement foundation to insure the water from the roof line is diverted away from the foundation wall.

1.3 Picture 1 Gutter along the front wall pulled loose.

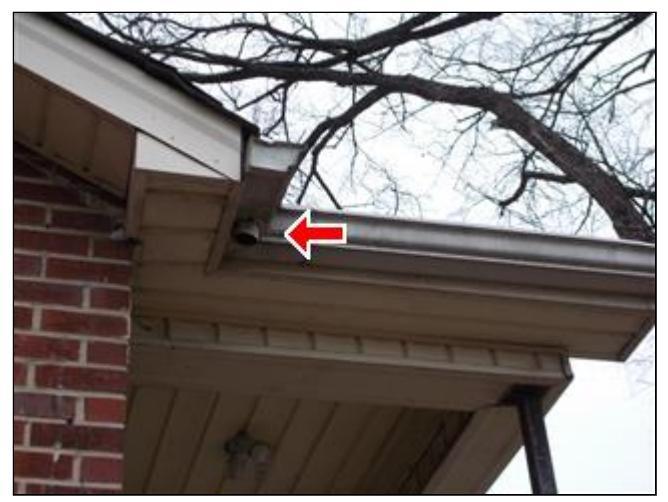
1.3 Picture 2 Gutter missing down spout.

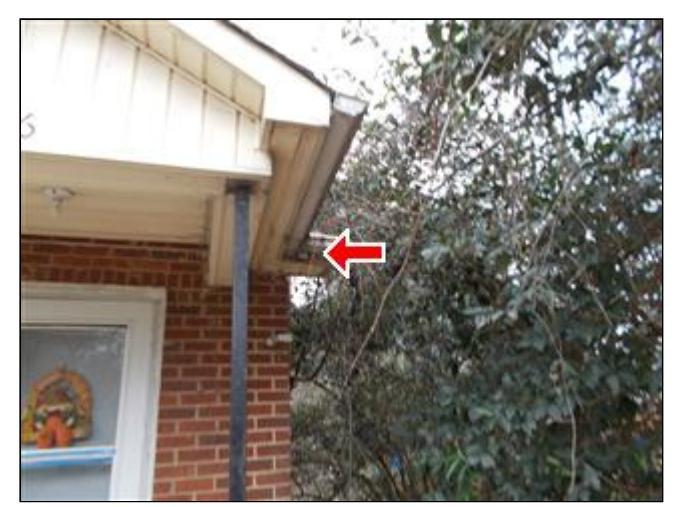
1.3 Picture 5 Missing down spout.

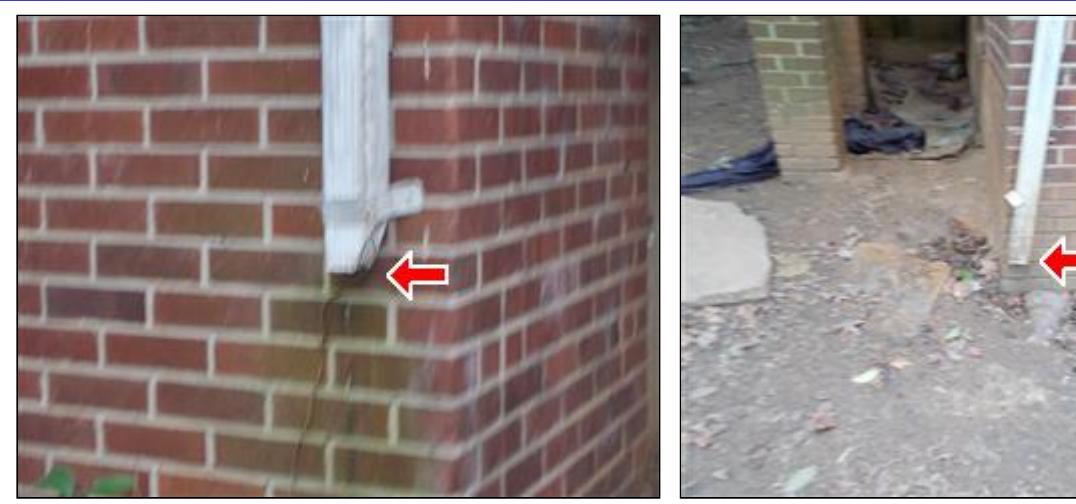
1.3 Picture 6

(2) There are multiple down spouts that are missing 90 degree elbows at the bottom. These elbows are in place to divert water away from the foundation wall.

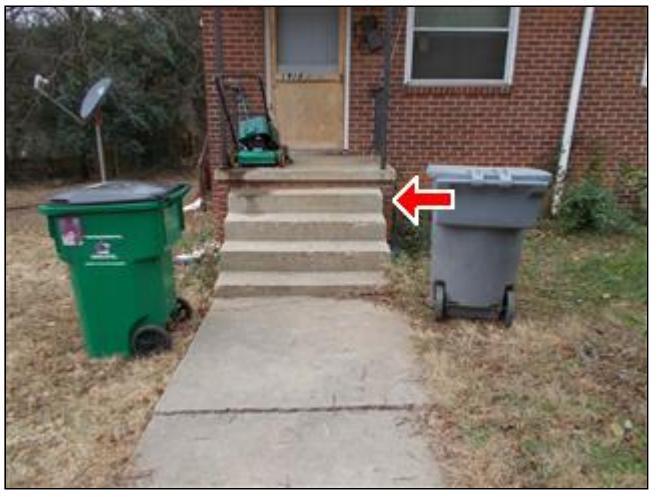
2.3 Picture 1

The stairs to the front entry are 5 risers high. When there are 4 or more risers on a set of stairs it is required to have a hand rail for safety. This may not have been required at time of construction but recommend adding for safety.

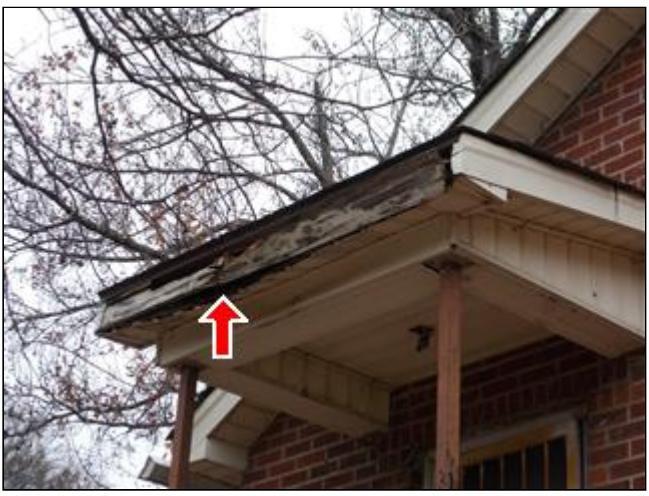
2.5 Picture 1

The fascia and soffit trim at the left side entry to unit #1918 is water damaged.

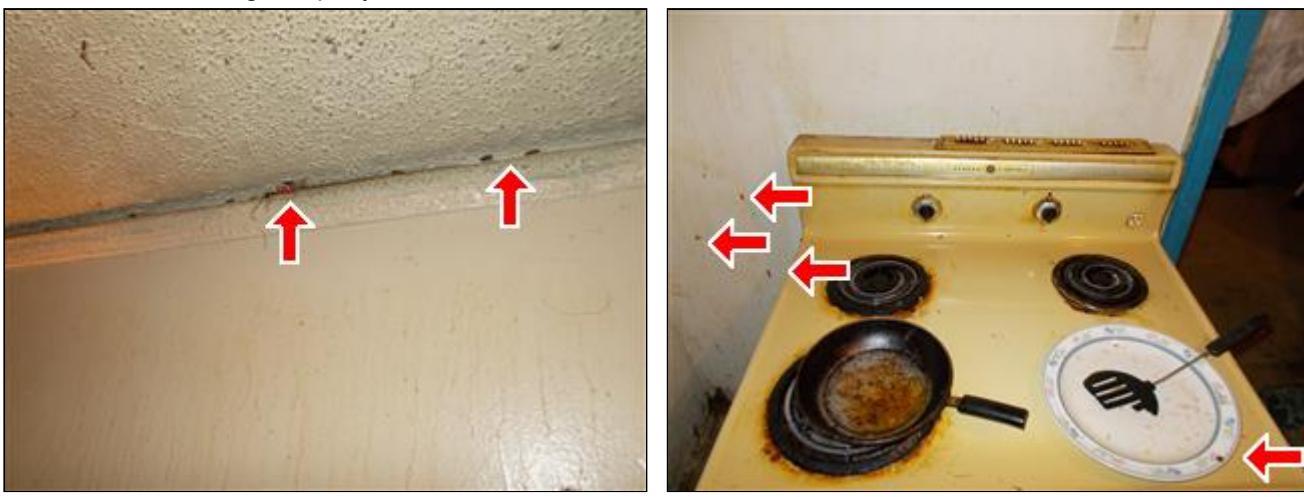
3.0 Picture 1

(1) There are multiple insects (roaches) inside this unit #1916. They were crawling on the ceiling and all over in the kitchen. Exterminating company needs to be scheduled for treatment.

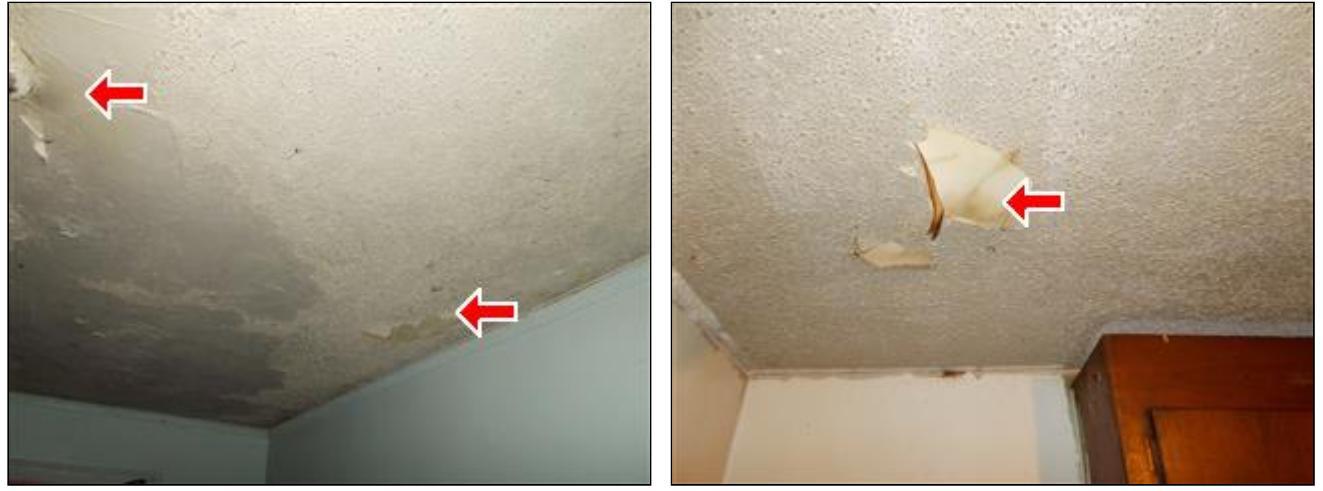
3.0 Picture 3

(2) There are a couple water stains and paint pealing off of the ceiling in #1916. This could be an indication of a water leak in this area.

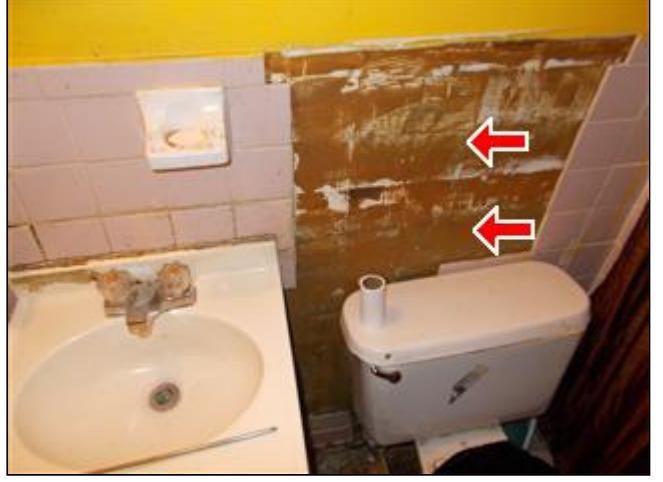
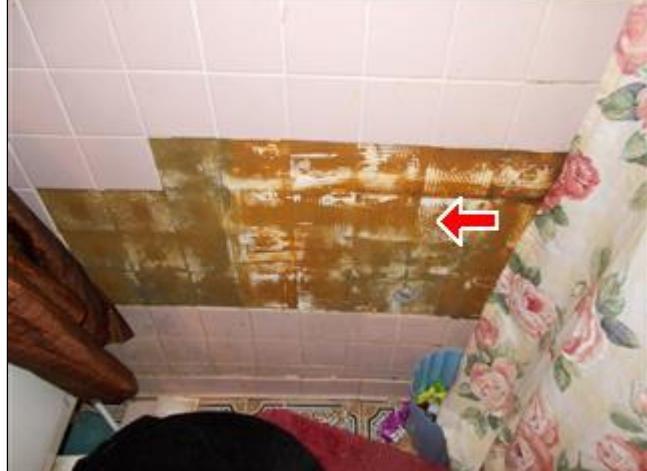
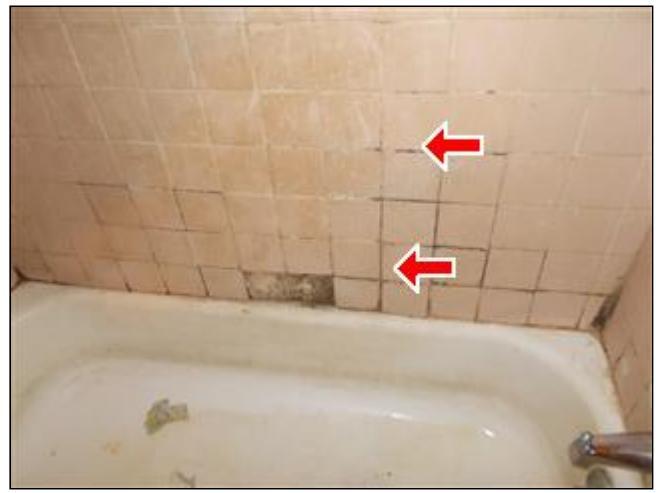
3.1 Picture 1

(1) There are multiple ceramic tiles that are pulled loose from the walls in the bathroom. These tiles are also loose and or missing in the tub/shower area. This has allowed water to leak to the structure of the home under this area.

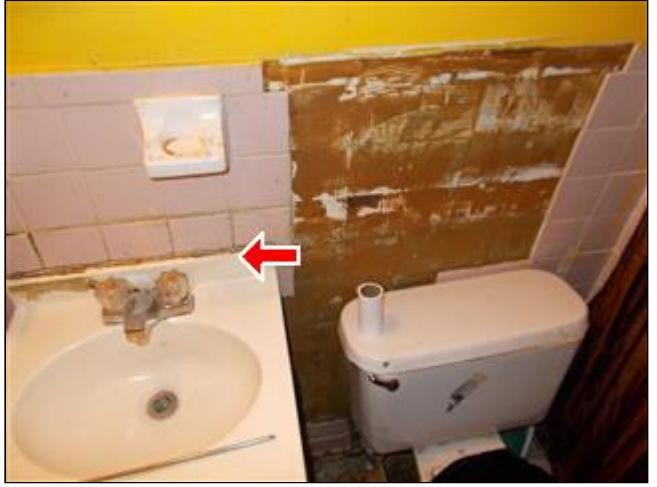
3.1 Picture 4

(2) The sink in the bathroom of unit #1916 has completely pulled loose from its mounting to the cabinet. Not sure how this unit is supported as the cabinet is broken apart under this area.

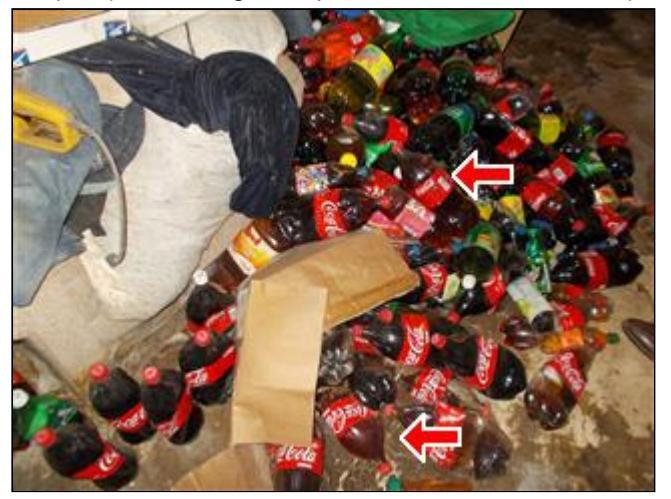
3.2 Picture 1

There were an excessive amount (hundreds) of 2-liter bottles on the floor of the basement that were filled with some type of liquid (not the original liquid that came in the bottle). This could be a health safety issue if this fluid is urine?

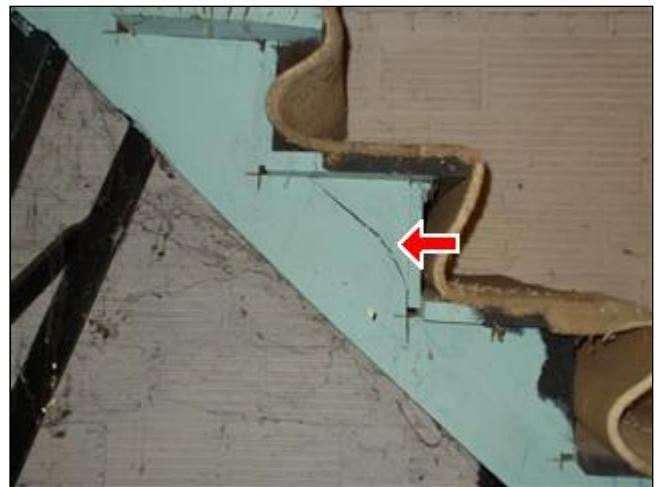
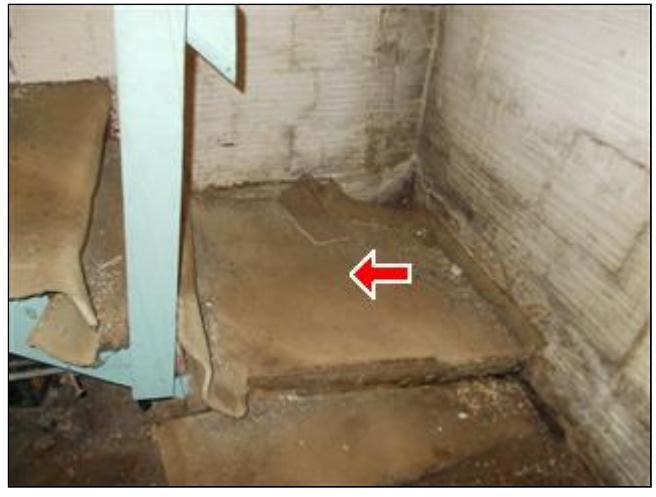
3.3 Picture 1

The stairs to the basement in #1918 are cracked in the middle portion. The landing at the bottom of the stairs is broken and needs repaired.

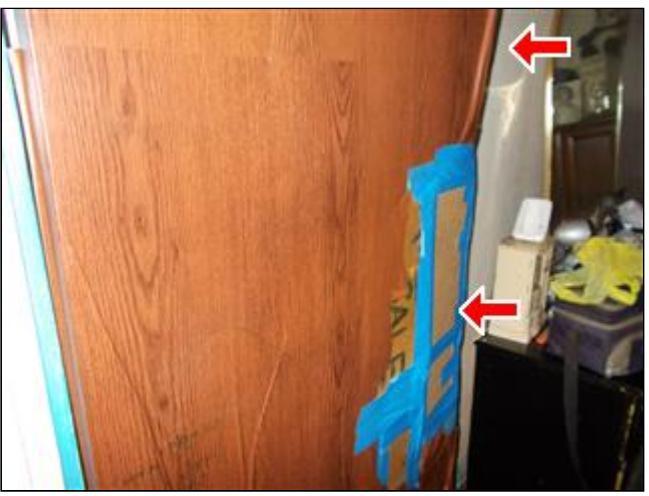
3.5 Picture 1

The entry door to the front bedroom of unit 1916 is broken.

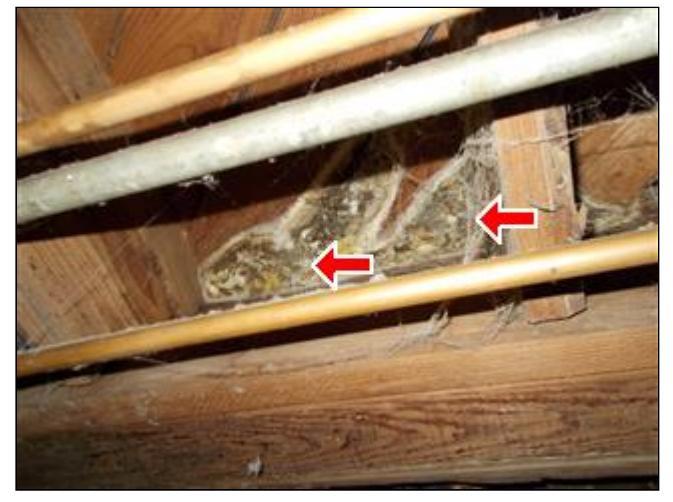
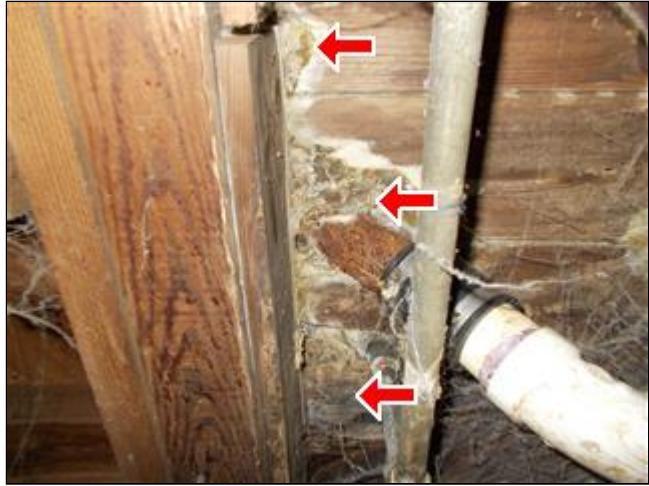
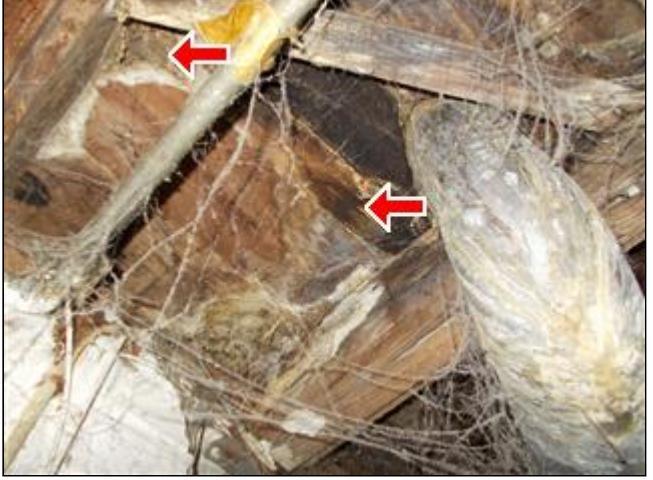
4.0 Picture 1

(1) There is some fungal growth on the sub-floor under the bathroom in unit #1916. This is an indication of a water leak in this area. The tiles around the tub/shower area, as noted earlier in the report, have fallen off in multiple areas from the shower walls. This will allow water to the structure of the home. The wood sub-floor is water damaged in this area.

4.0 Picture 4 Fungal growth under the bathroom sub-floor.

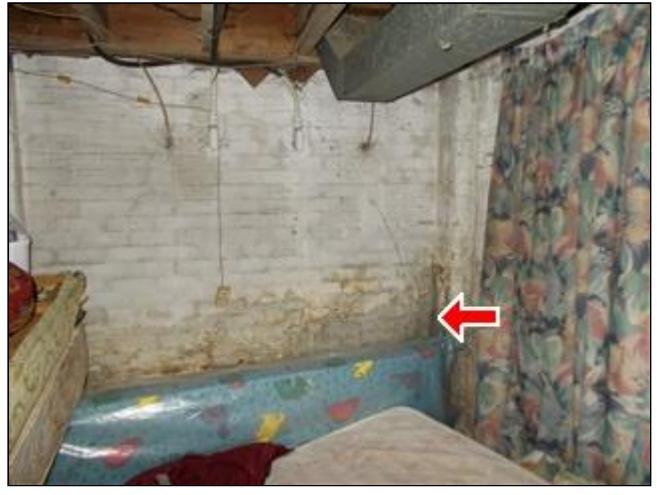
4.0 Picture 5

(2) There are multiple areas along the basement foundation walls where there appears to be water seepage through the wall. This is typically caused by improper grading and gutters that are not functioning. Current renter stated that water pours into the basement area when it rains.

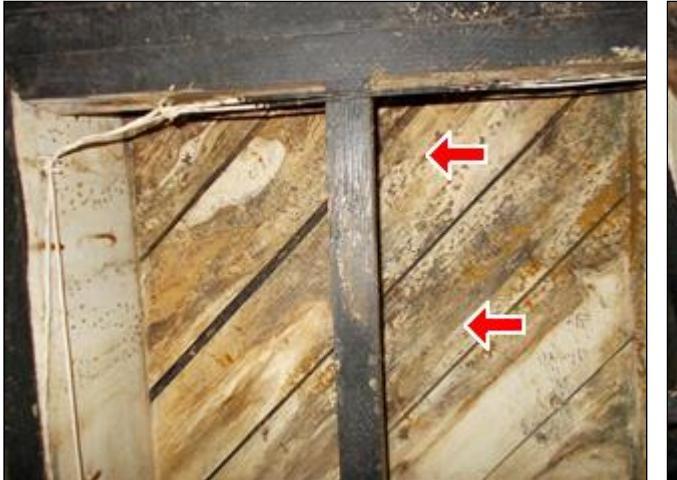
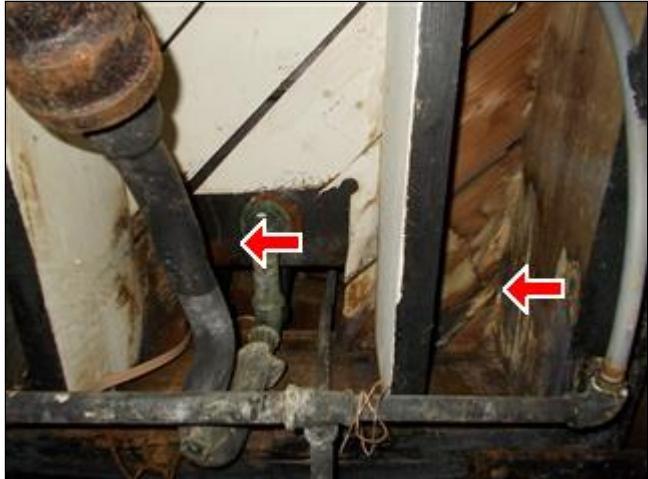
4.0 Picture 6

(3) There is fungal growth on the sub-floor under unit #1918. This can be seen from the basement area. Fungal growth is caused by excessive moisture in the area.

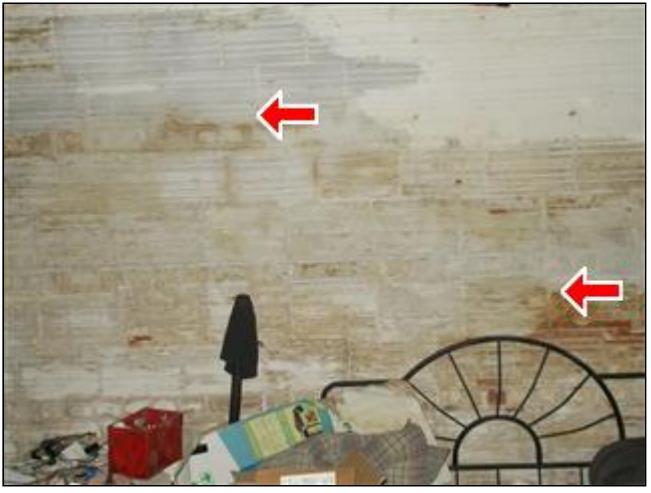
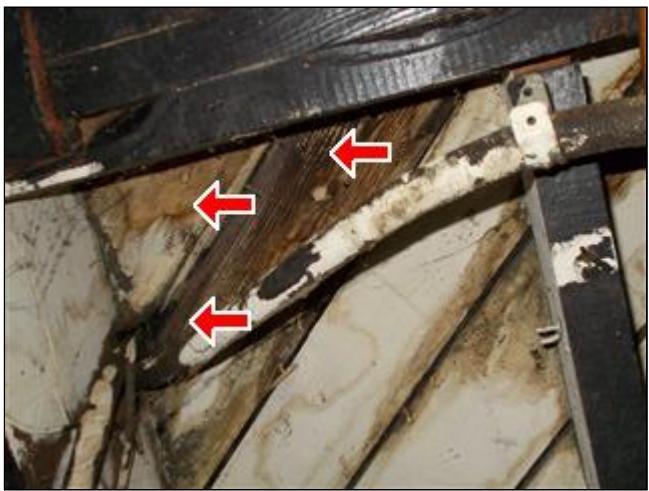
4.0 Picture 8

(4) Evidence of moisture intrusion on the basement foundation wall in unit #1918. There is also some fungal growth and water stains on the wood sub-floor in the basement area of this unit under the bathroom area.

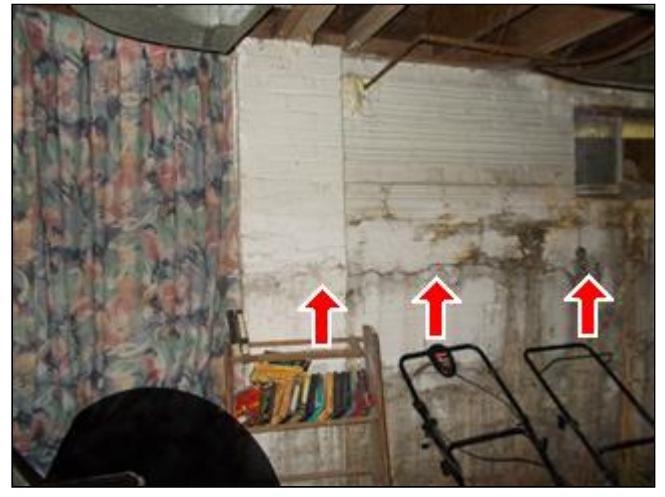
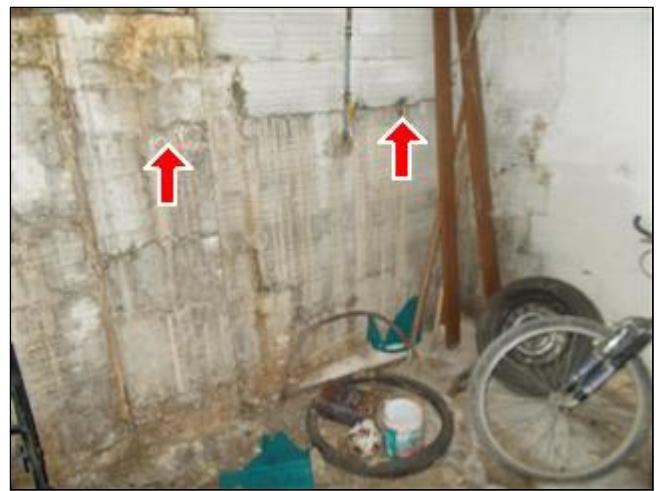
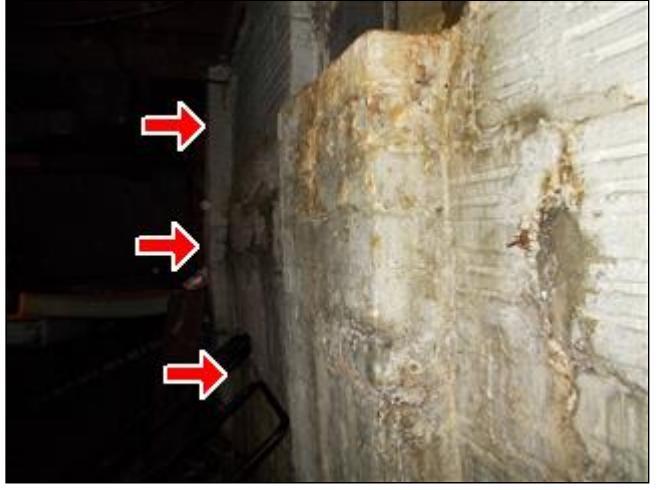
4.1 Picture 1

(1) There is a large horizontal crack along the front foundation wall of unit #1916 and the wall is heaved inward. This is an indication of excessive hydraulic pressure against the outside wall in this area. Hydraulic pressure is caused by excessive water draining in this area and from the lack of proper gutters or insufficient grade away from the foundation walls.

4.1 Picture 3 Front foundation wall heaving inward in the basement of unit #1916.

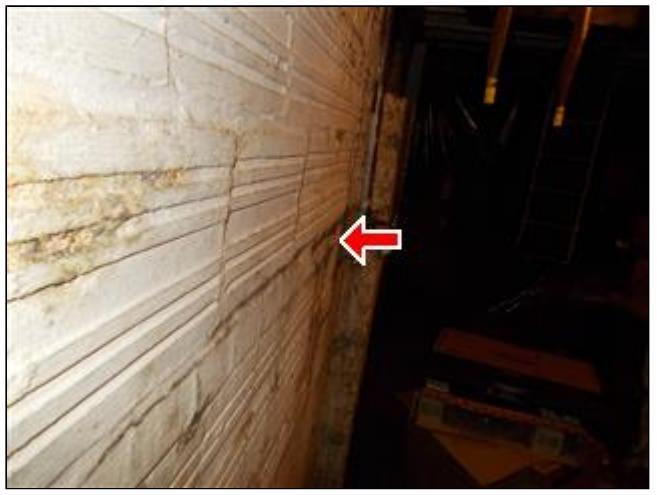
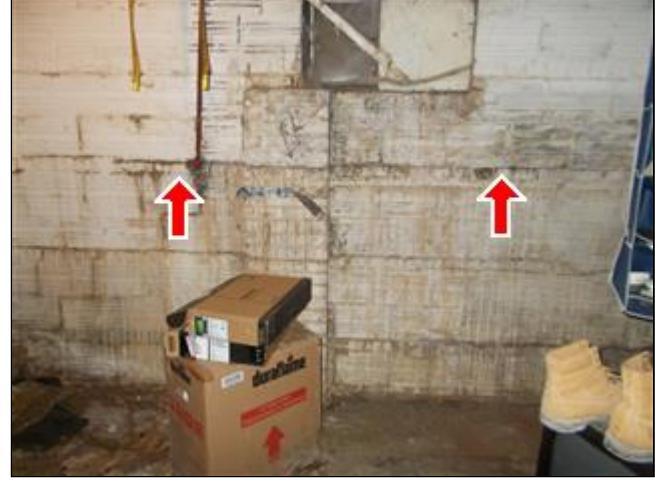
4.1 Picture 4

(2) The front foundation wall in unit #1918 is slightly heaved in with horizontal cracking. Recommend having this complete front foundation wall further evaluated by licensed structural engineer.

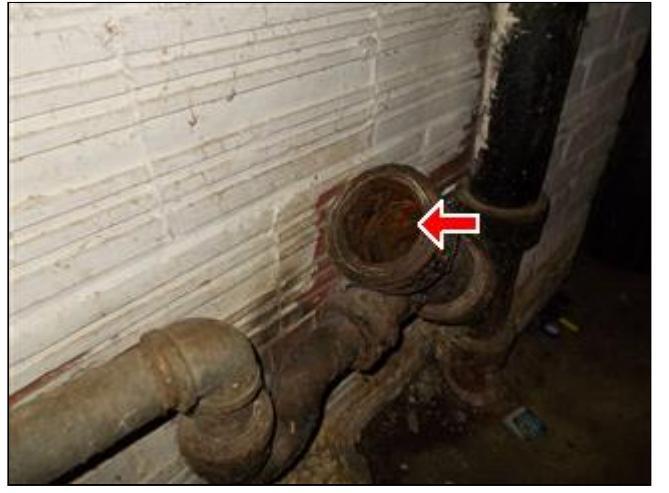
5.0 Picture 1

A clean out cap is missing on the plumbing drain system in the basement of unit #1916. This is allowing sewage water to vent into the basement area and if system has a slight back up, this will drain into the basement area.

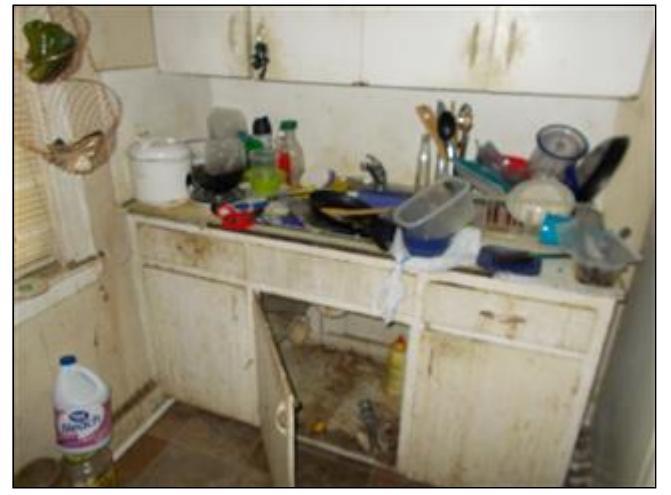
5.1 Picture 1

(1) Both of the faucets in the bathroom sink and the tub/shower in unit #1916 have a continuous drip. These faucets will not completely shut off.

(2) I did not test the plumbing fixtures in unit #1918 due to stored items in the sink.

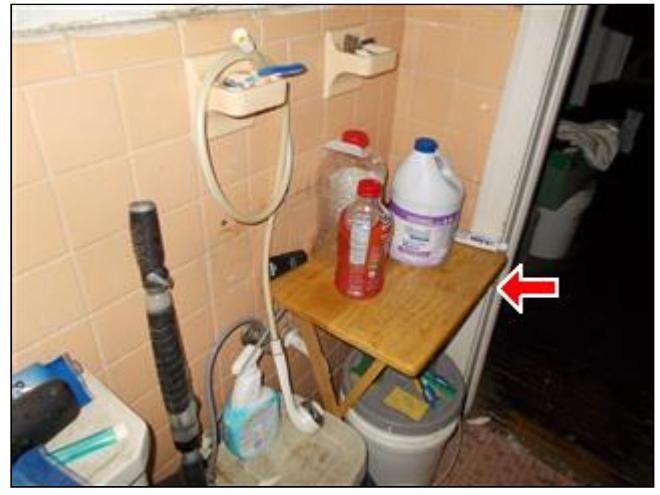
5.1 Picture 2

(3) The bathroom sink is completely missing in unit #1918. The sink has been removed from the bathroom and a tray table has been installed in this area.

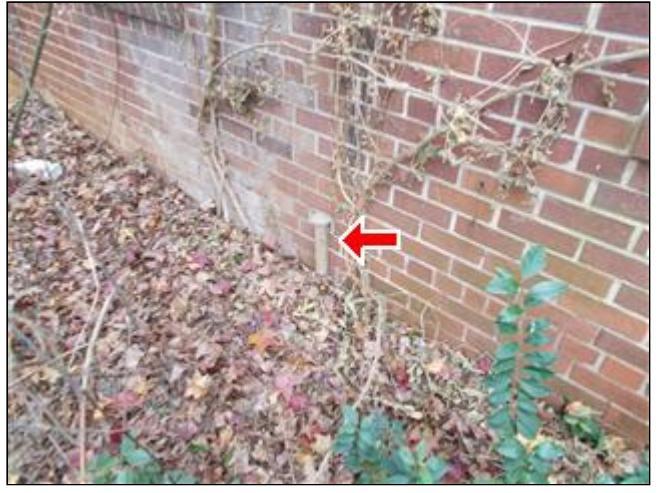
5.4 Picture 1

Check with current home owner to insure there is no oil tank still buried in the ground around this home. It was common practice to have the oil tank buried in the back yard of these homes. If this tank is not properly taken out of service and or removed it can cost thousands of dollars to have this done. I did find 2 metal pipes sticking up from the ground next to the rear foundation wall. These are the vent pipes to an underground oil tank. Typically if the oil tank is properly taken out of service, the vent pipe will also be removed. Have a licensed professional further evaluate.

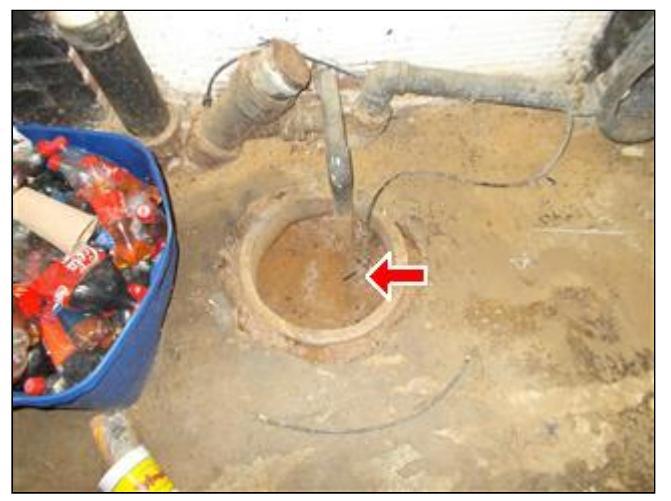
5.6 Picture 1

The sump pump was filled in with mud/dirt in the basement of #1918. Could not test this unit at time of inspection.

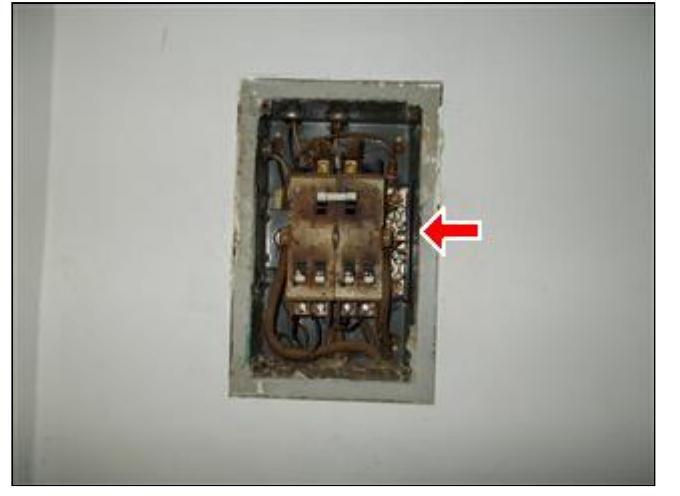
6.1 Picture 2

(2) The electrical sub-panel has not been upgraded in unit #1918.

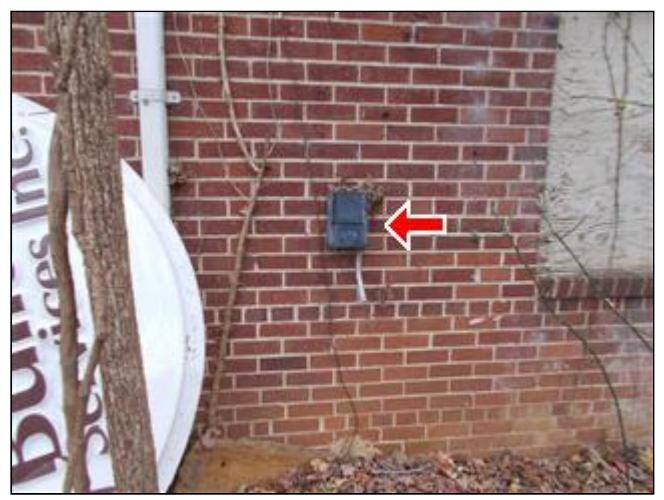
6.1 Picture 3

(3) There is an old electrical supply box on the rear wall of the house. This panel is no longer in use but recommend removing exposed wire.

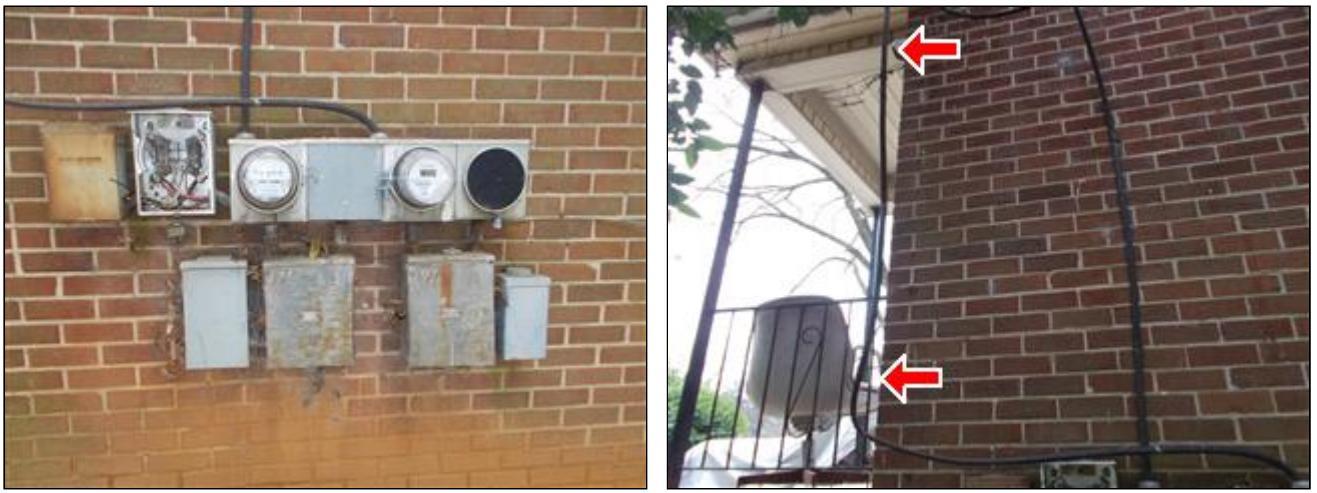
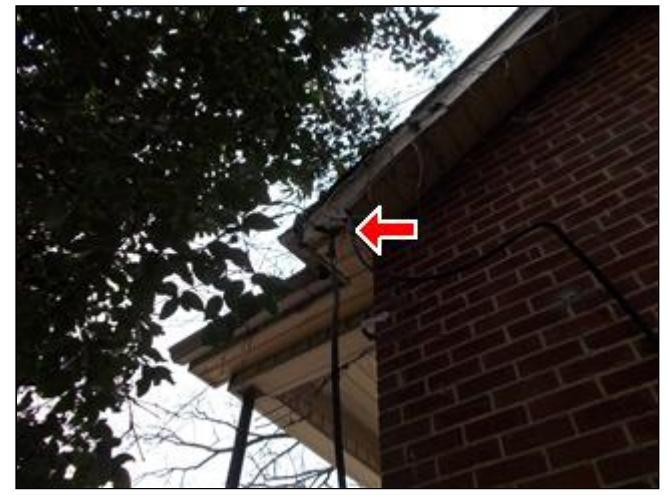
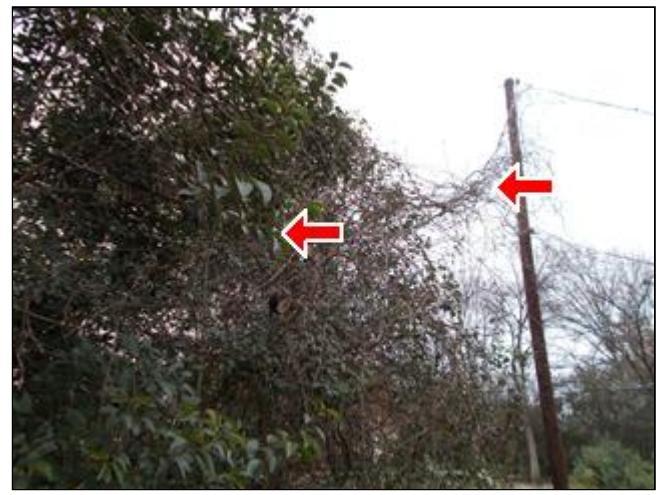
6.1 Picture 4

(4) The main meters are only 60 amp service to these units. The main electrical supply line is not properly secured to the wall of the home and is hanging loose. The line from the pole is completely over grown with branches and shrubs causing excessive strain on the supporting cable. Typically the electrical company is responsible for the supply line from the pole to the meter.

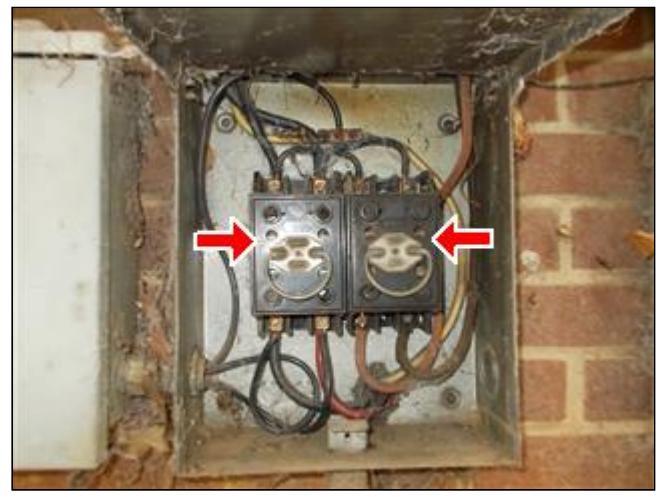
6.1 Picture 8

(5) The main electrical panel of #1916 is double tapped and supported by fuses. When a circuit is double tapped, it has 2 wires under one screw. This is typically not allowed and recommend further evaluation by licensed professional. I did not pull out the fuses to determine if they are the proper size due to tenant was home at time of inspection.

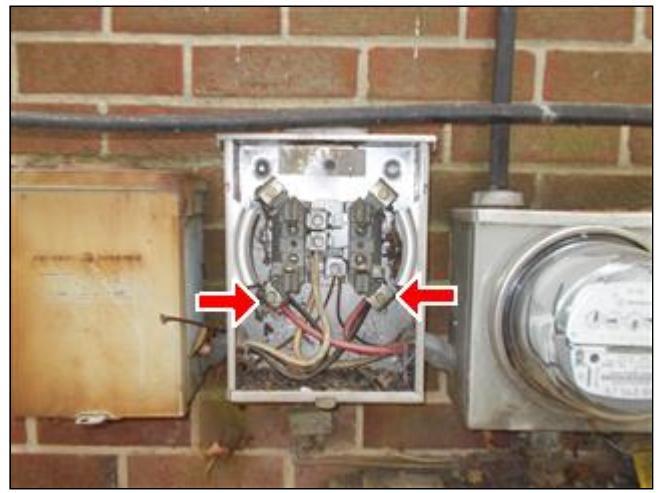
6.1 Picture 9

(6) There is an old meter base next to the existing meters that still is live 'hot'. The bottom terminals in this unit have electrical current to them. This is a safety issue as these are exposed.

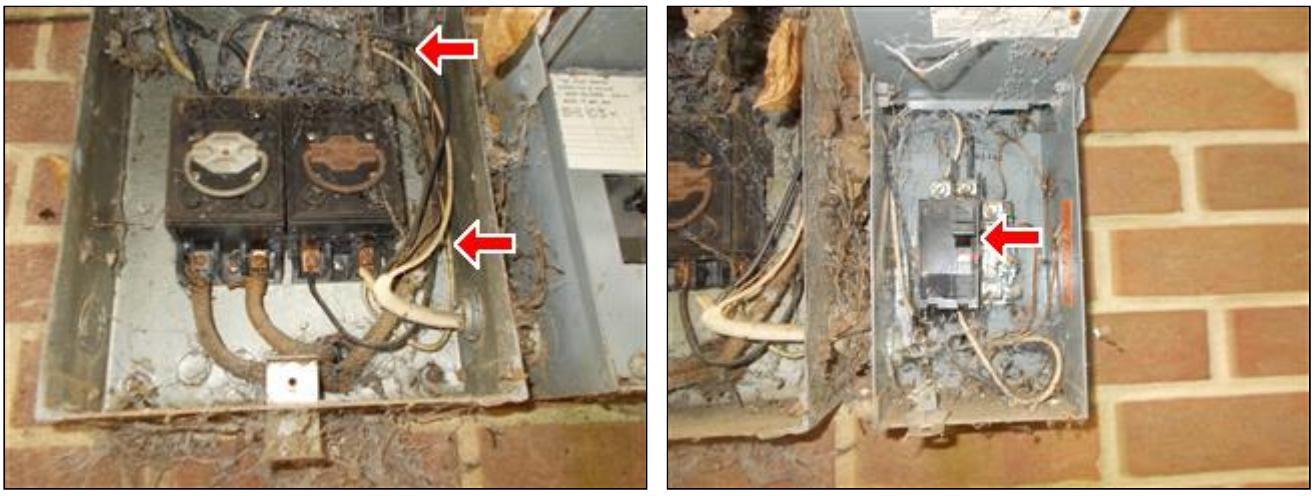
6.1 Picture 10

(7) The panel box on the far right side is double tapped on the supply line side of the fuse panel. I do not think this is allowed and recommend further evaluation by licensed professional.

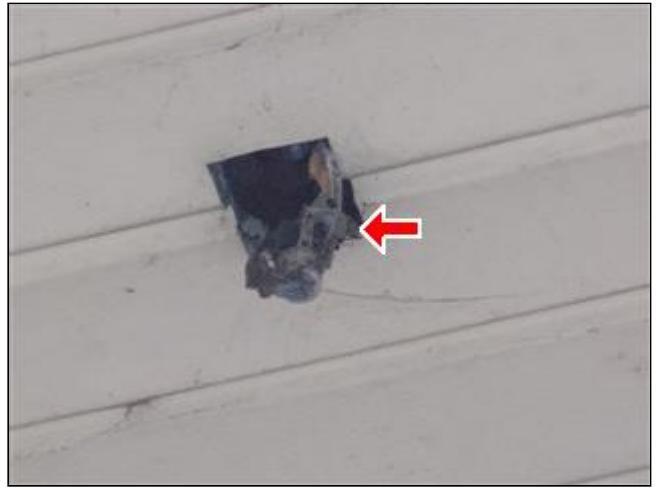
The light fixture is completely missing at the left side entry to unit #1918.

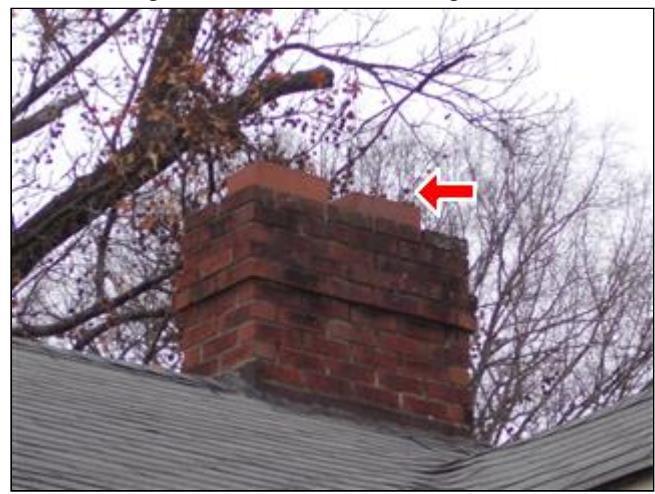
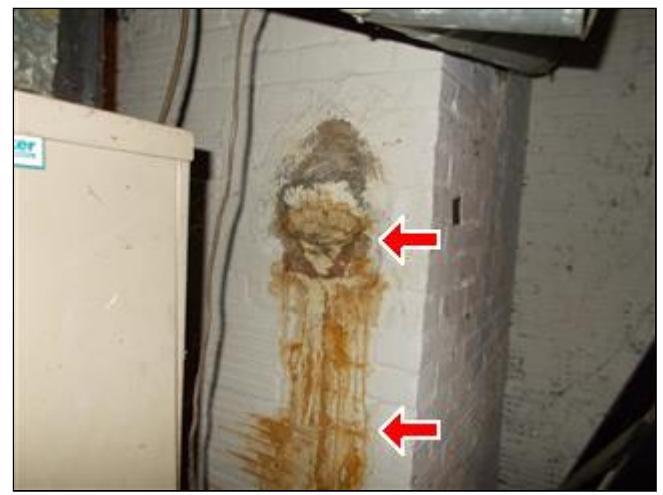
7.5 Picture 1

The metal rain cap/spark arrestor is missing on top of the chimney chase. The rain cap/spark arrestor will help keep water out of the flue area and help keep hot amber from leaving the flue area. The cap also helps keep unwanted pests from entering the flue area and coming into the home.

7.5 Picture 2 Evidence of water entering the chimney chase.

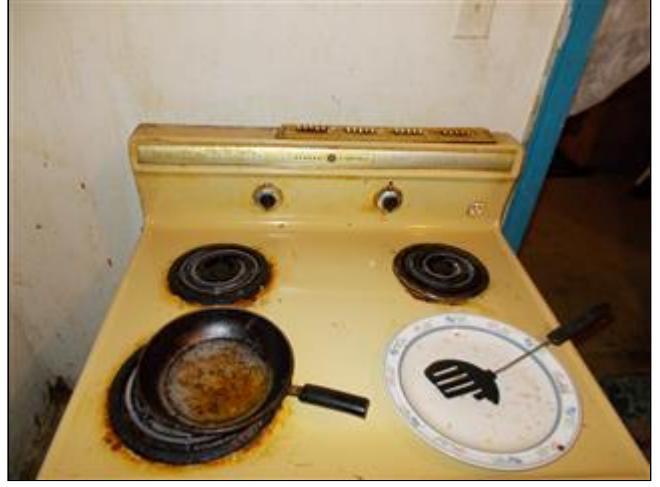
9.1 Picture 1

(1) I did not test the oven/range in #1916 due to the amount of roaches that were crawling out of the unit at time of inspection.

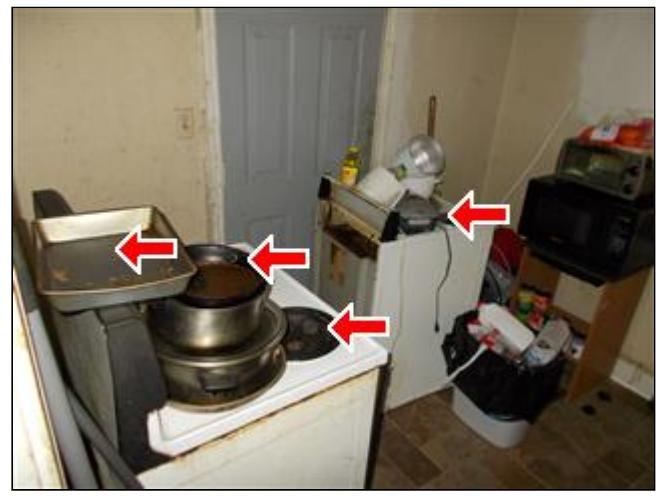
9.1 Picture 2

(2) There are missing burners in the oven/range in unit #1918. I did not test this unit for operation.

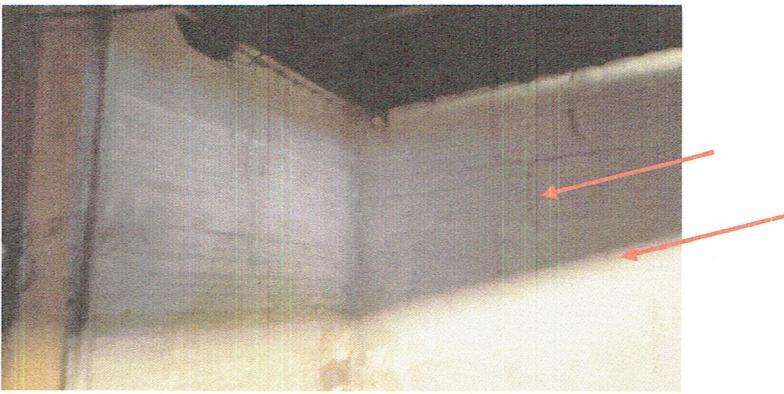
Upon inspection of the duplex unit to the left, unit 1926 was observed to have significant cracking in the block/brick on the left foundation wall (see figure 1) as well as a severe cracking starting along the front center wall (see figure 2), transposing to the concrete slab floor and continuing to the rear foundation wall (see figures 3 & 4). The crack in the left foundation wall measured to $\pm/-3/8$ " with some being slightly larger. The cracking along the slab foundation measured to be in excess of over 1" in some places with displacement between the opposing sides of the crack measuring at up to $\frac{1}{2}$ ". Additional cracking of the foundation wall was observed at the right rear corner of this unit (see figure 5). Likewise, unit 1924 was observed to have significant cracking along the front center of the foundation wall at areas around the supporting piers (see figure 6), and the rear wall of the unit and door opening is below grade allowing excessive water to intrude the basement area (see figure 7). Upon inspection of the duplex unit to the right, unit 1918 was inaccessible due to the occupant being away. Unit 1916 was observed, along the front foundation wall there was a significant bulge/bow in the wall that measured up to $1\frac{1}{2}$ " out of plane (see figure 8), along with several other cracks in the foundation wall throughout the unit.

Figure 1: Cracking along left foundation wall.

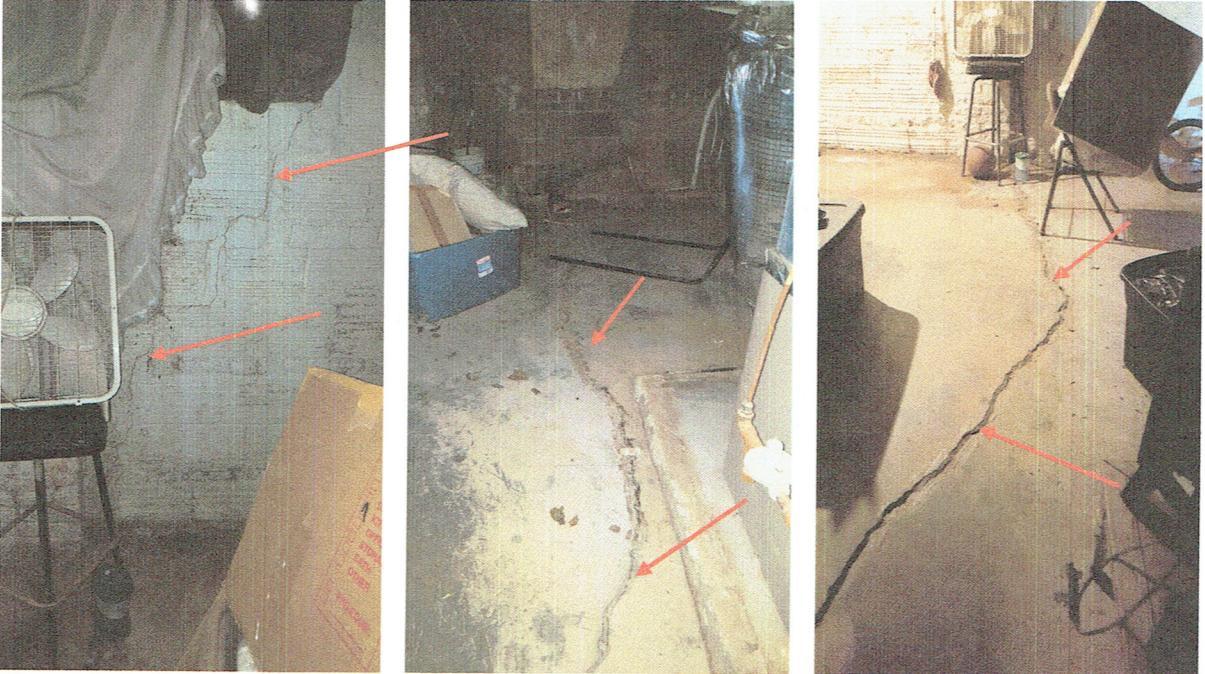
Figure 2, 3, 4 – Cracking in front foundation wall, transposing to slab

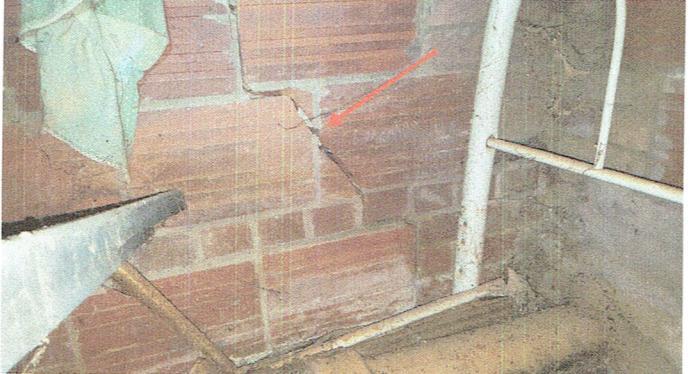
Figure 5: Cracking at right rear corner

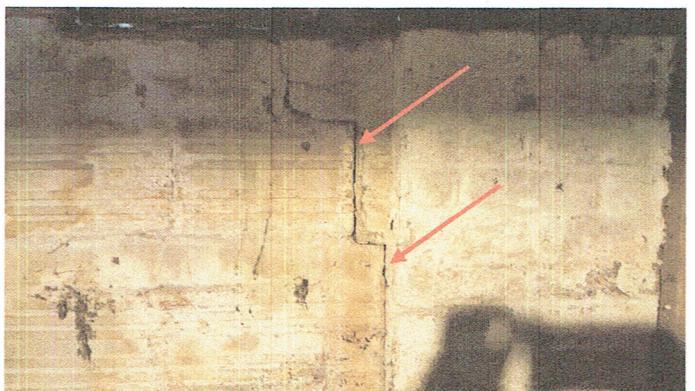
Figure 6: Cracking on front foundation wall

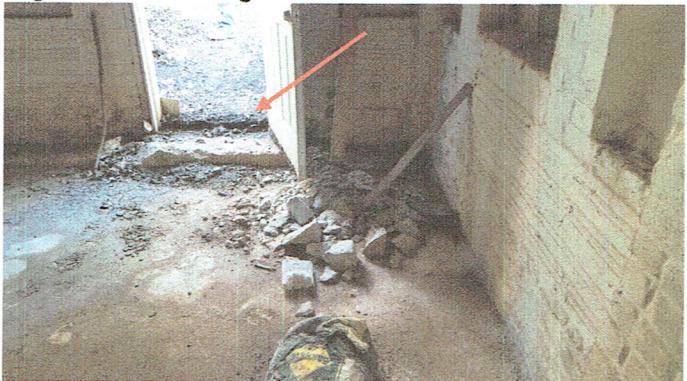
Figure 7: Door opening below grade

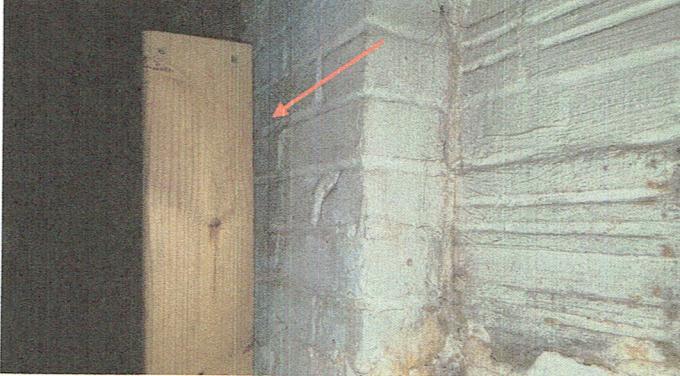
Figure 8: Bulging/bowing foundation wall

It is our opinion that the above mentioned basement foundation walls are in a declining structural state and the lack of reinforcement/construction methods necessary to support the observed levels of unbalanced backfill noted during the site visit. Poor draining and excessive moisture can cause underlying bearing soils to become "soft" and concrete to settle. Over-saturated soils can become expansive and apply increased hydrostatic pressure to the supporting wall. It is our recommendation to have the foundation structurally repaired by a company that specializes in foundation repairs. However, the cost of repair may exceed the beneficial value in the current dwellings and could still be prone to future settlement issues. After completing the repairs, water drainage features and the grading around the full house perimeter should be adjusted to allow water to positively drain away from the home.
