**LOCAL HISTORIC DISTRICT:** Wilmore

**PROPERTY ADDRESS:** 429 West Park Avenue

**SUMMARY OF REQUEST:** Painted Brick/Front Door Replacement

PROPOSED PROJECT: PAINTED BRICK/FRONT DOOR

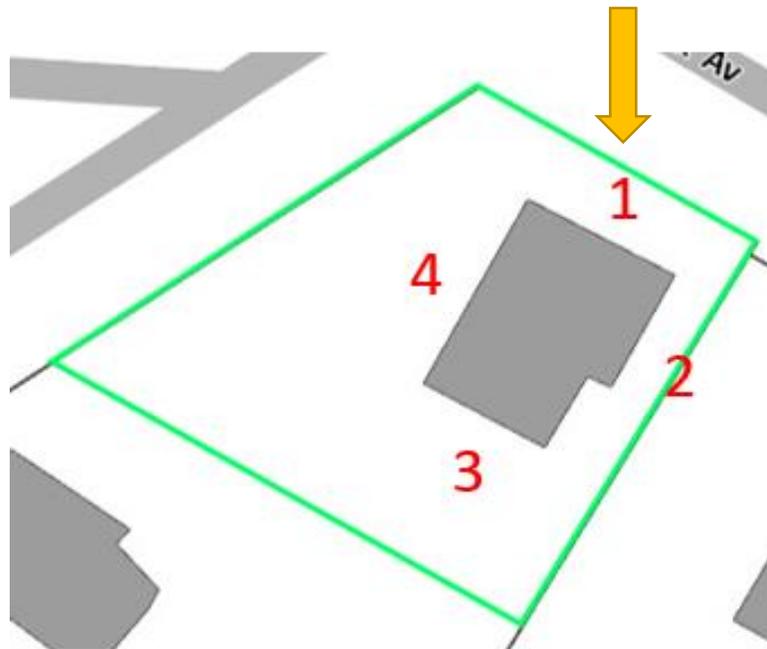
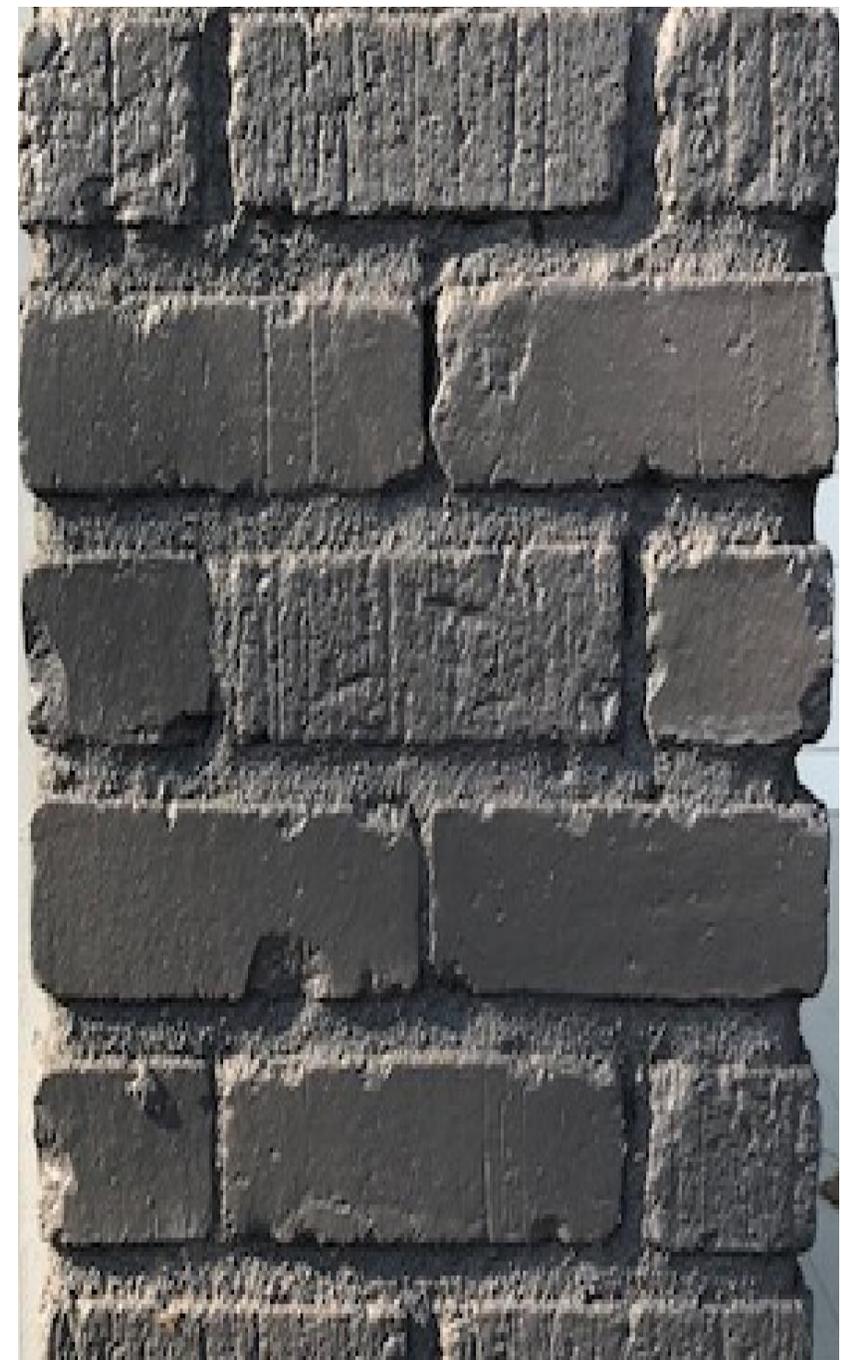
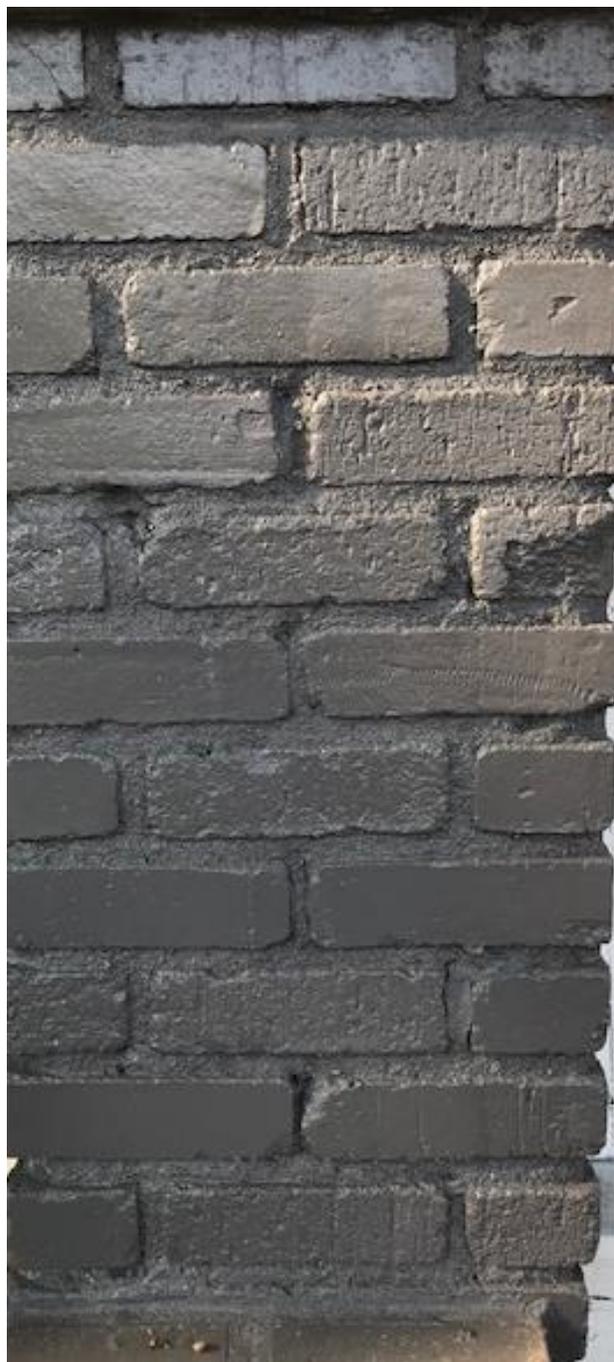
## FRONT PORCH LEFT COLUMN

- Mismatched brick (smooth and scored face)
- Inconsistent mortar head (vertical) joint widths
- Uneven & un-tooled joints
- Broken brick & mortar drips

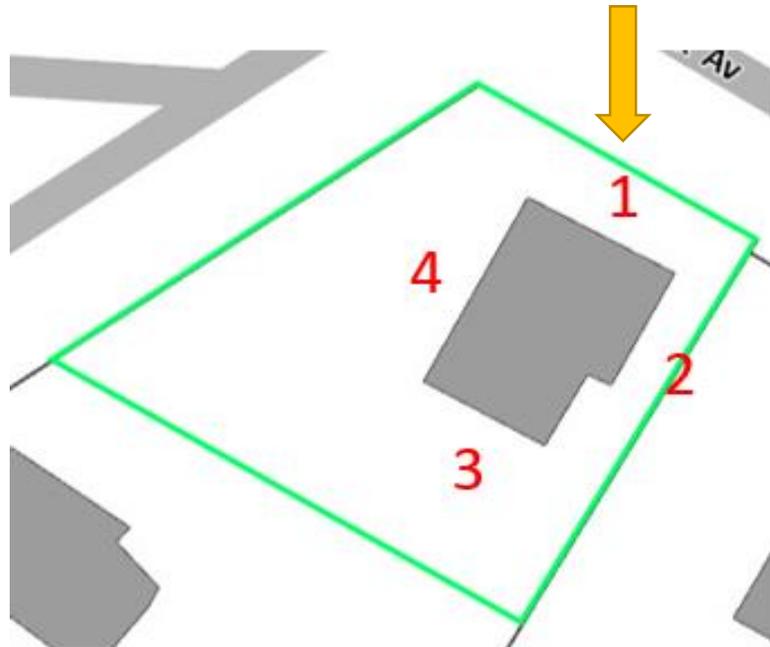
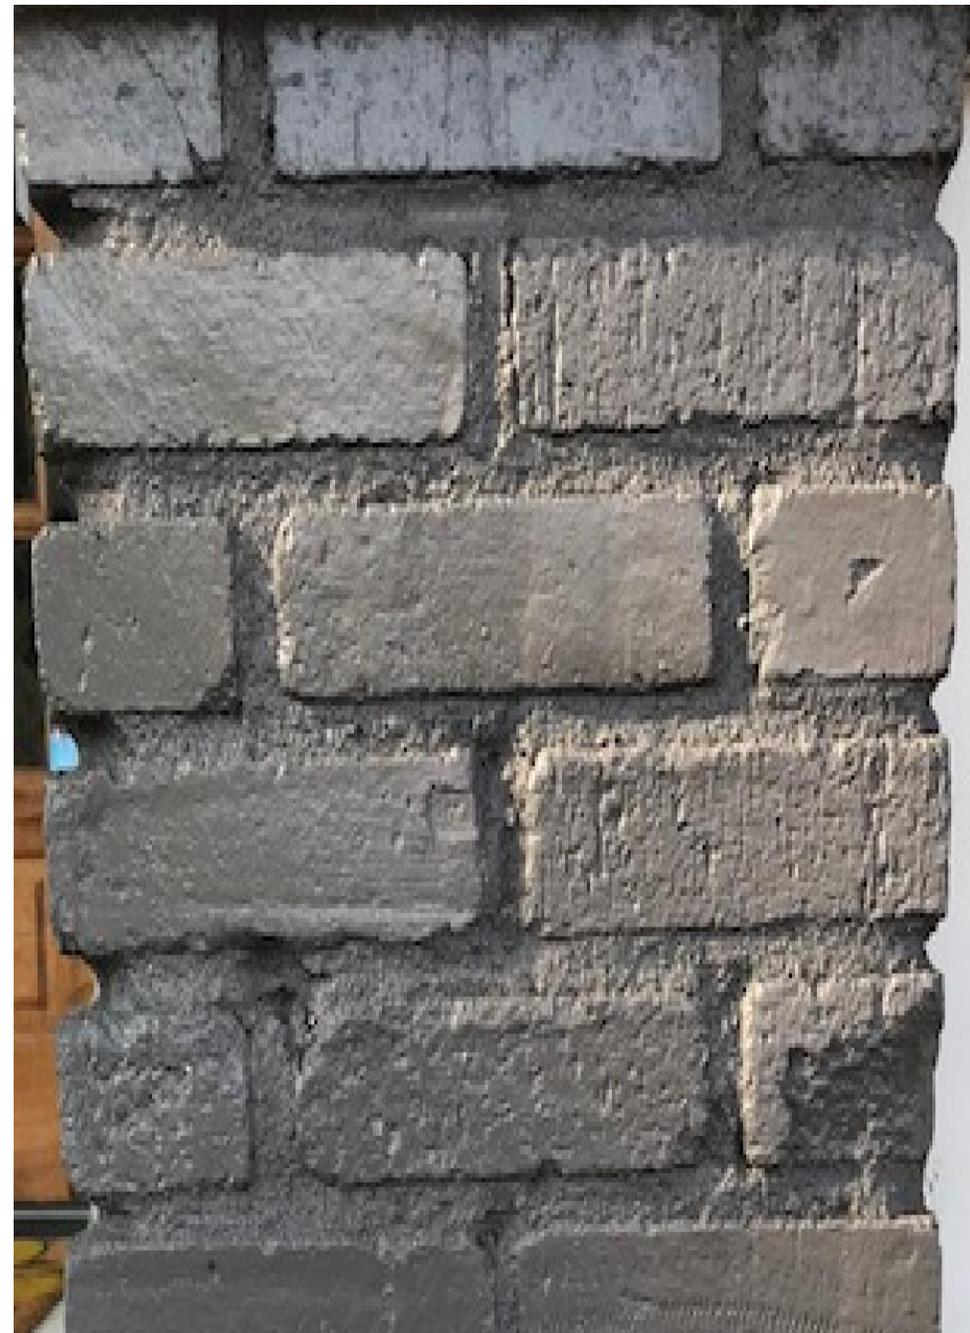
## FRONT PORCH RIGHT COLUMN

- Caved in brick
- Crooked and irregular joints
- Broken brick
- Substandard mortar and joint lines
- Inferior masonry workmanship

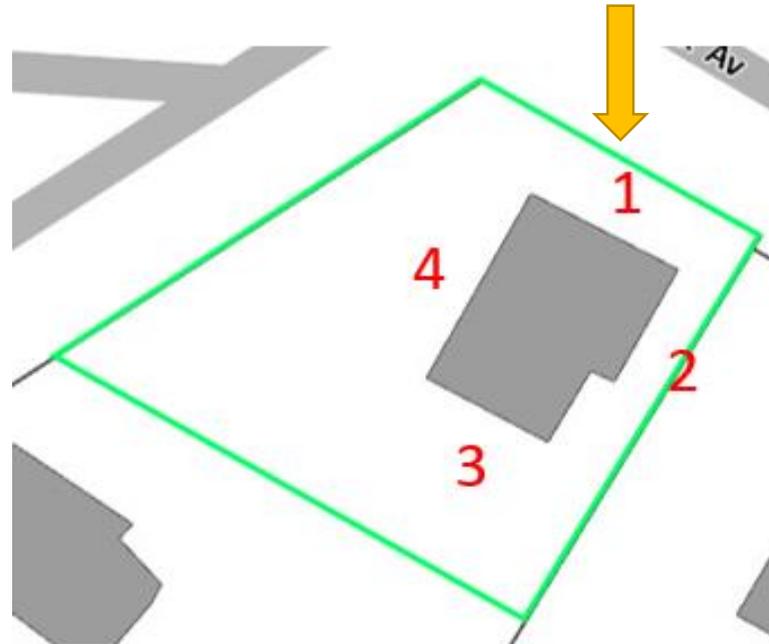
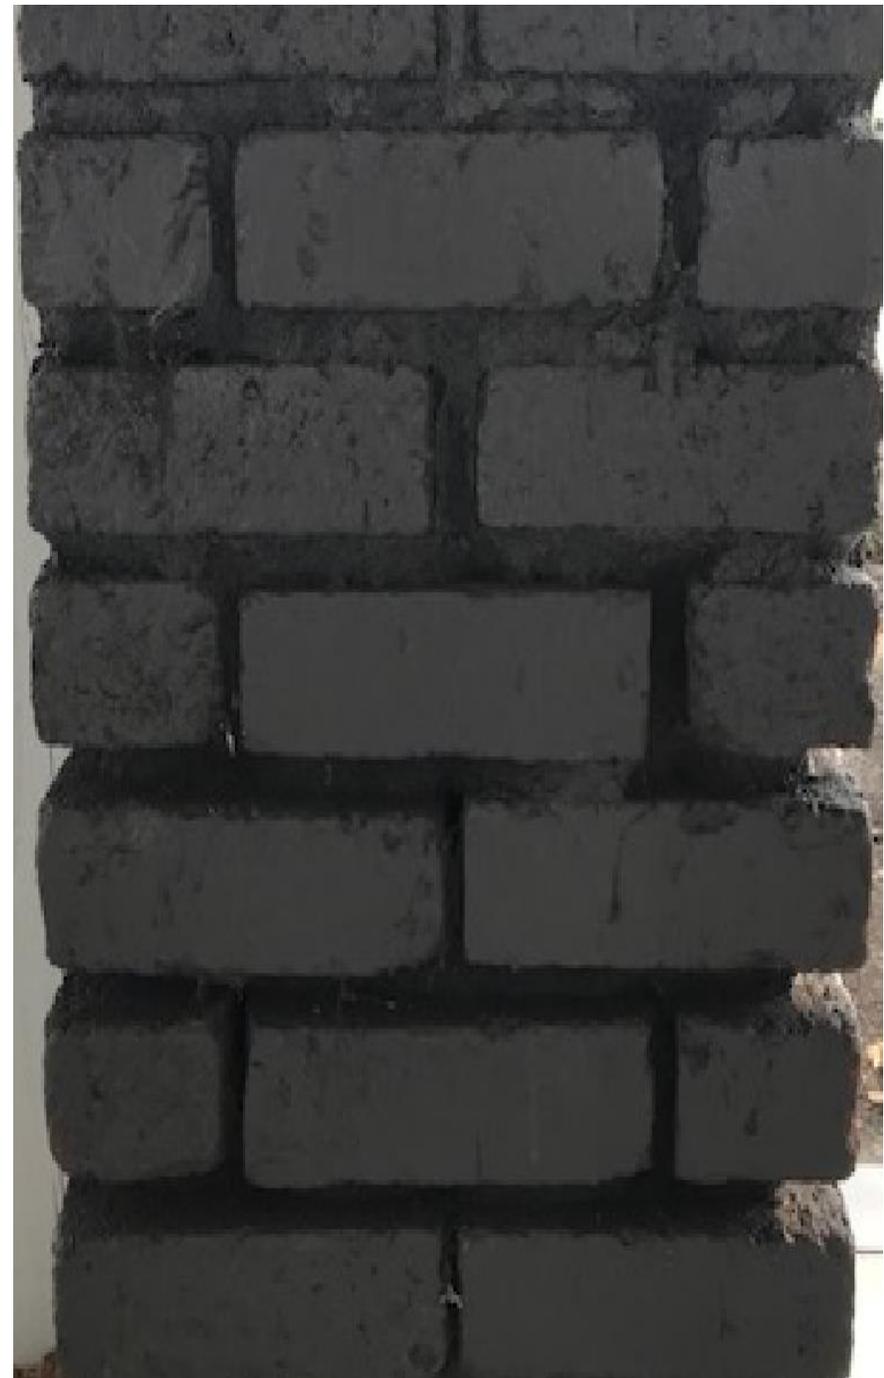
## FRONT PORCH RIGHT COLUMN

- Inconsistent mortar joints
- Crooked and irregular joints
- Substandard mortar and joint lines

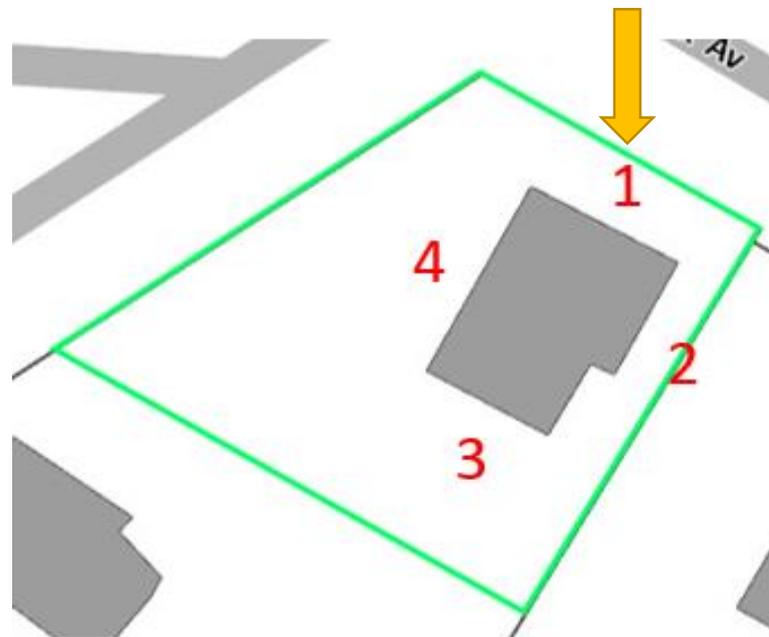
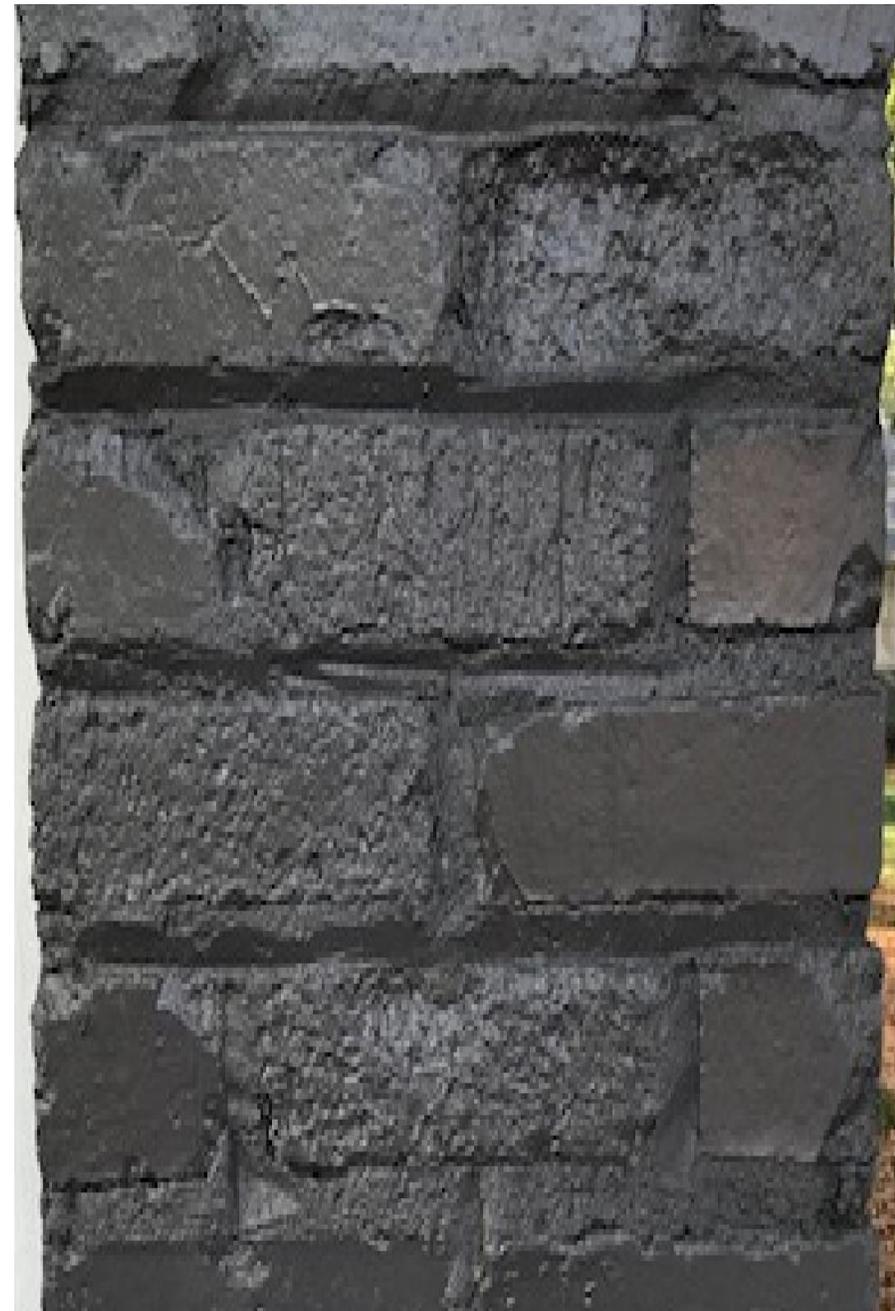
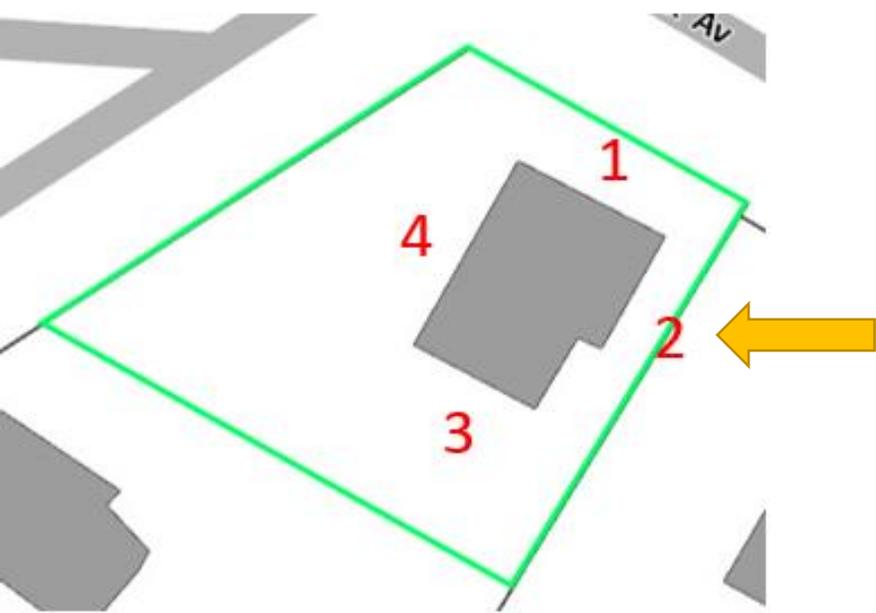
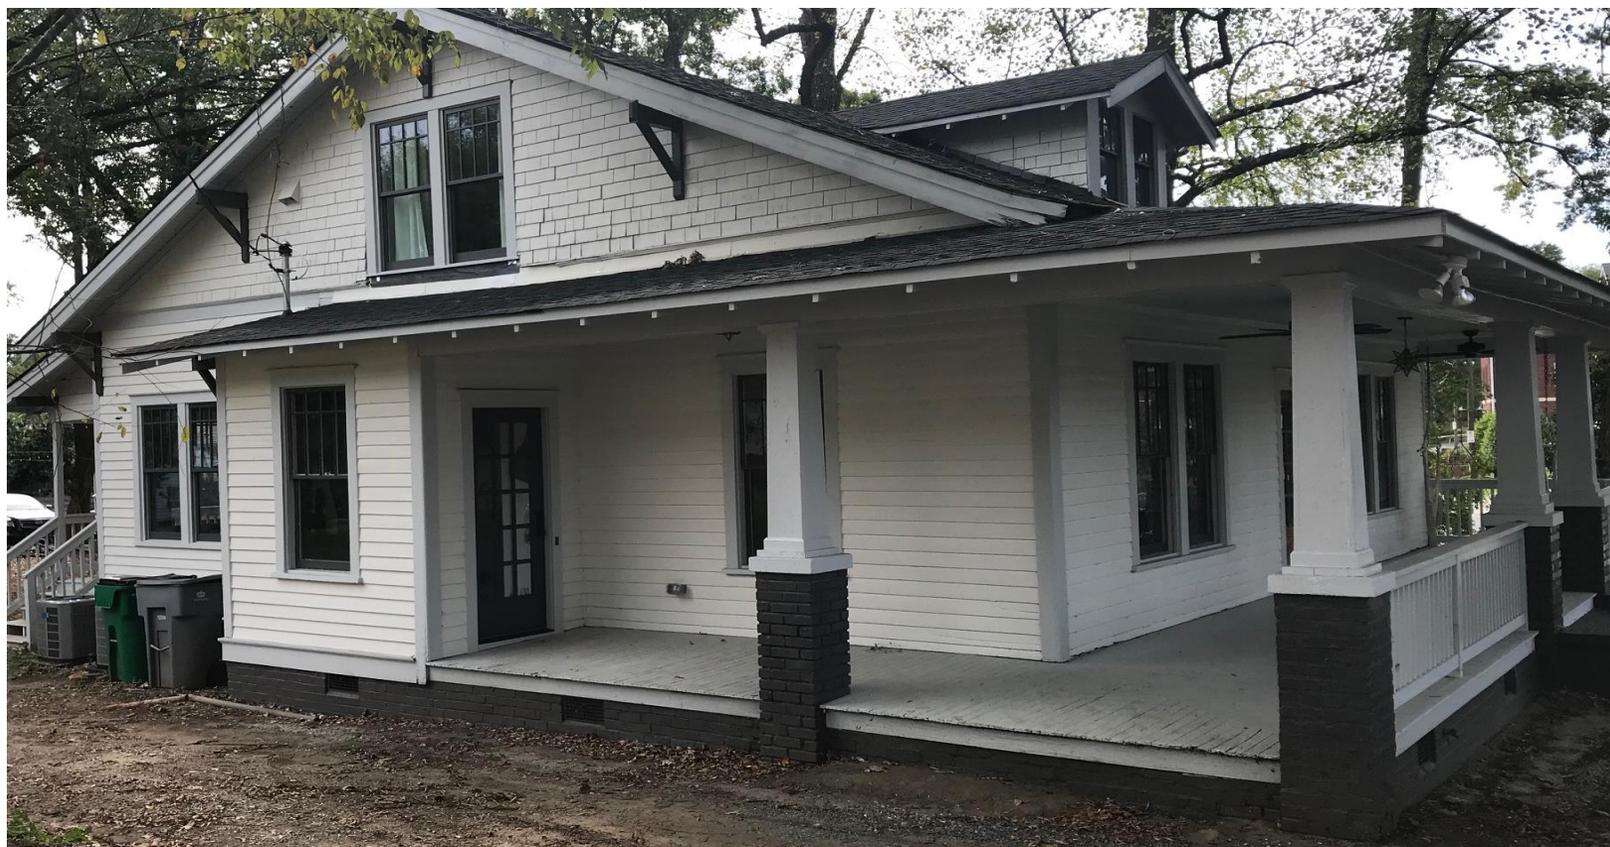
## NORTHWEST SIDE FRONT PORCH

- Overfilled mortar joints
- Mismatched brick
- Uneven rows of brick at the joint.
- Inferior masonry workmanship

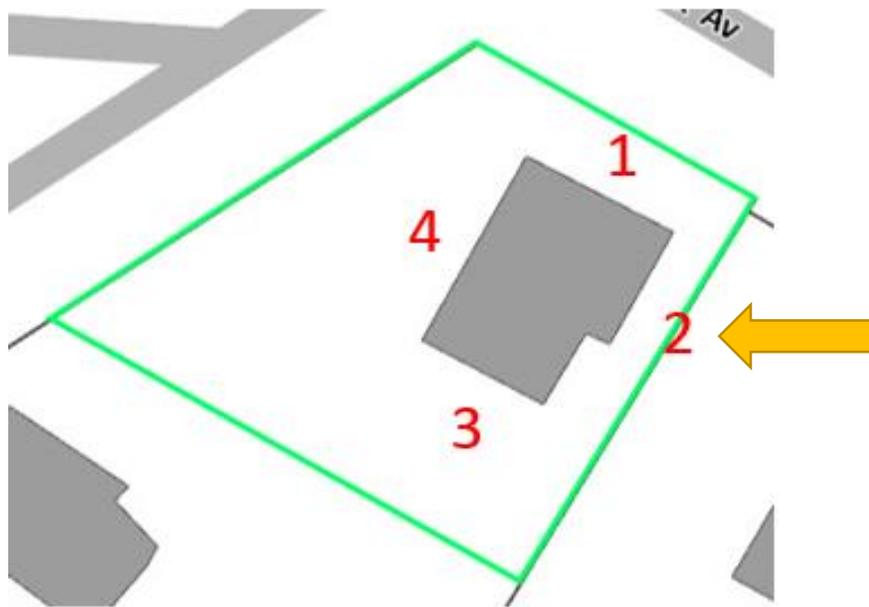
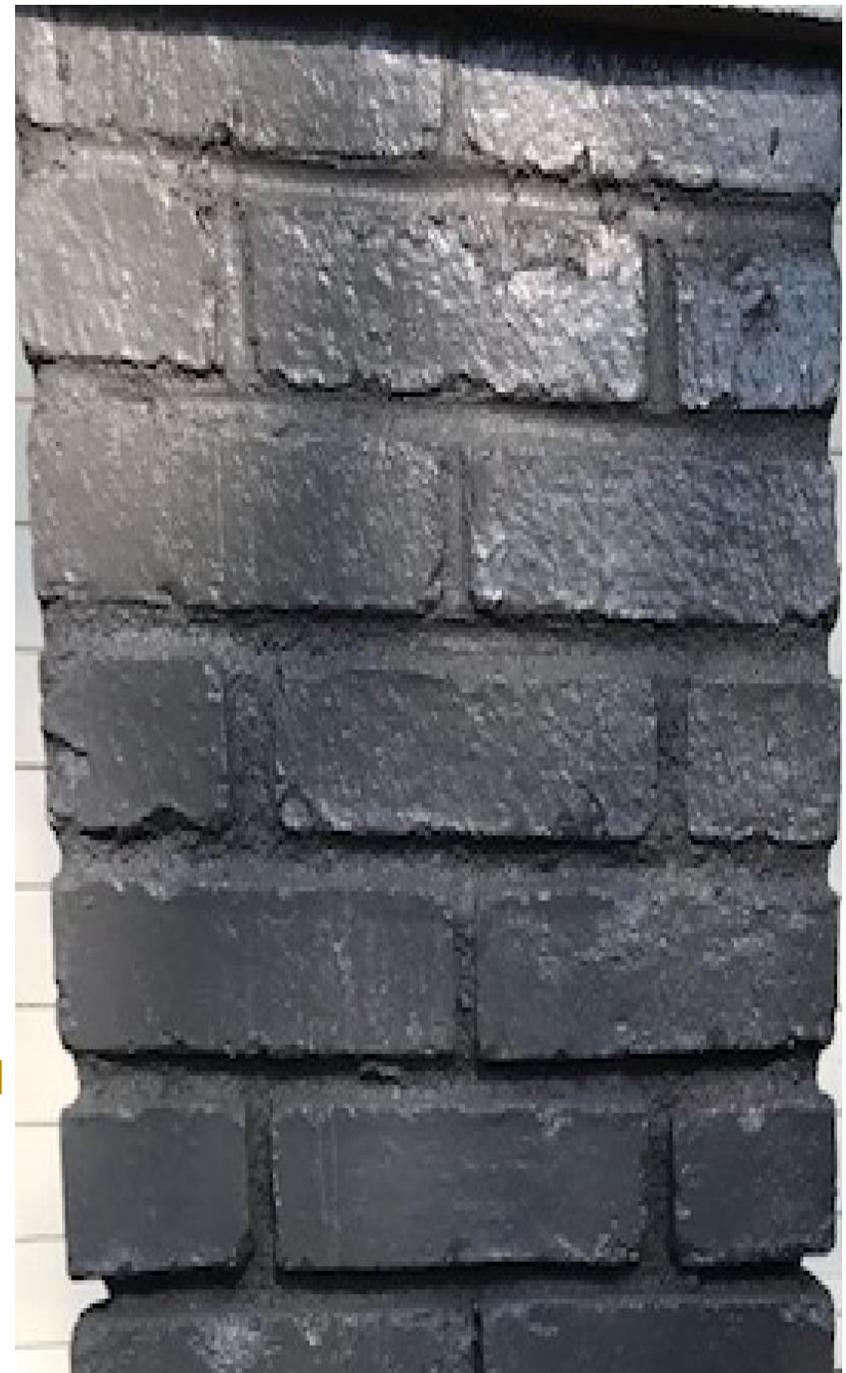
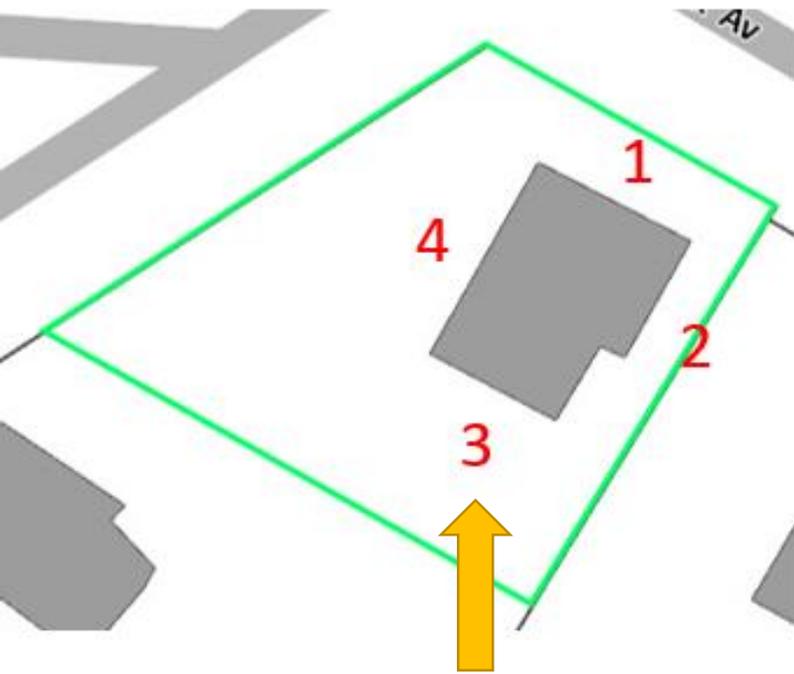
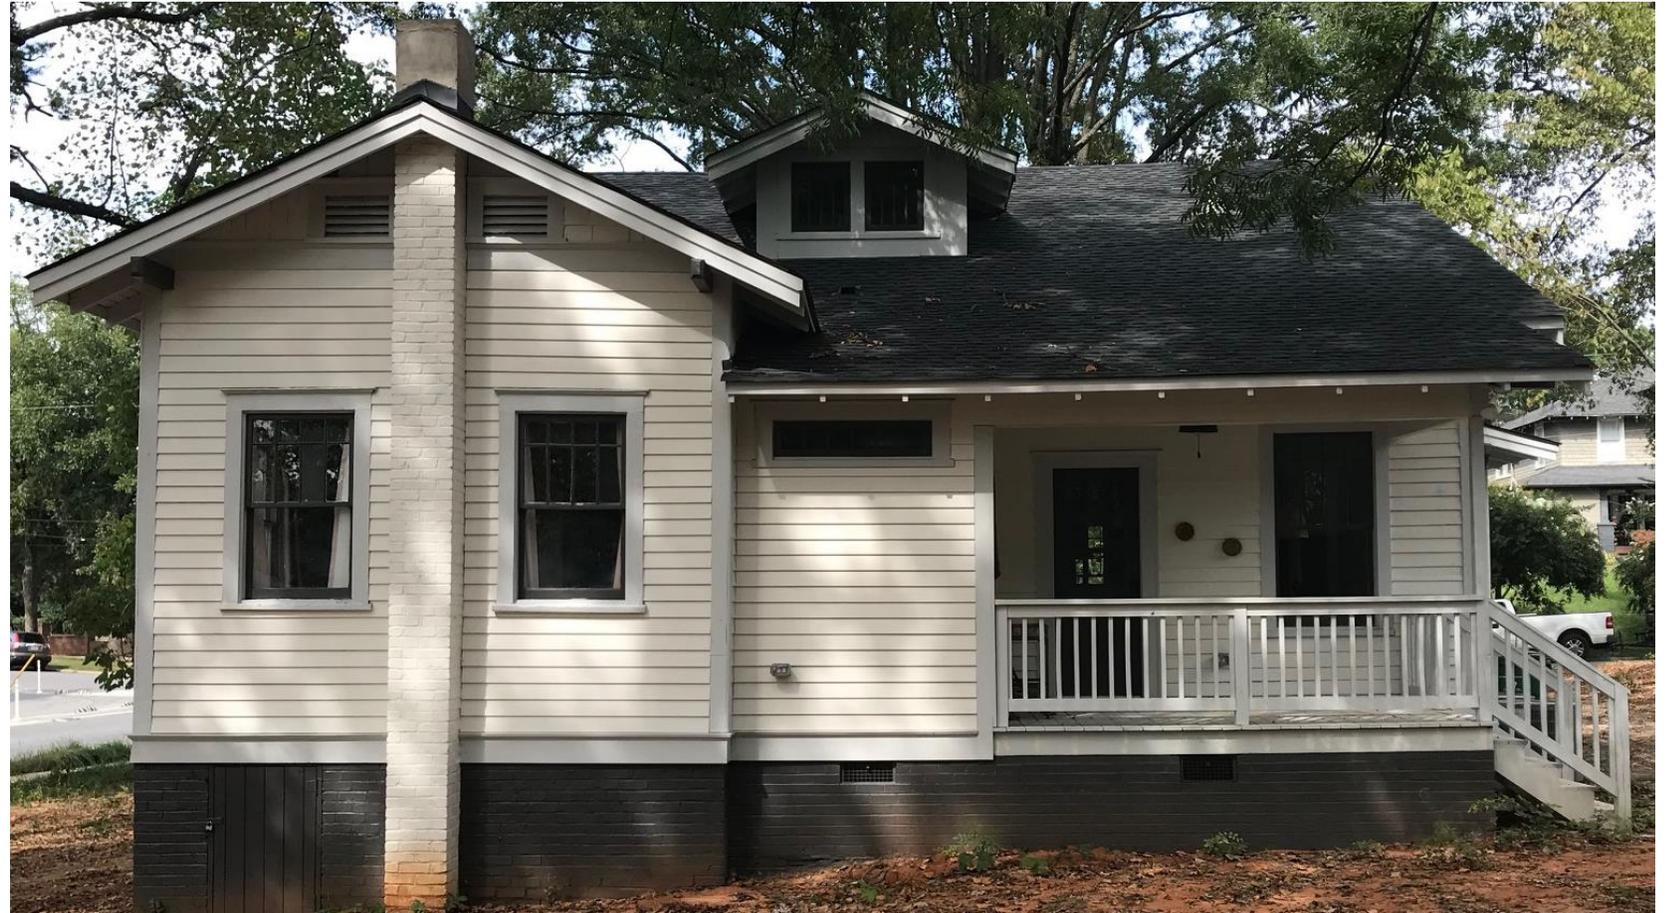
## EAST SIDE COLUMN

- Under-filled & mismatched mortar (horizontal & vertical) lines
- Inferior masonry workmanship.
- Uneven rows and substandard mortar and joint lines

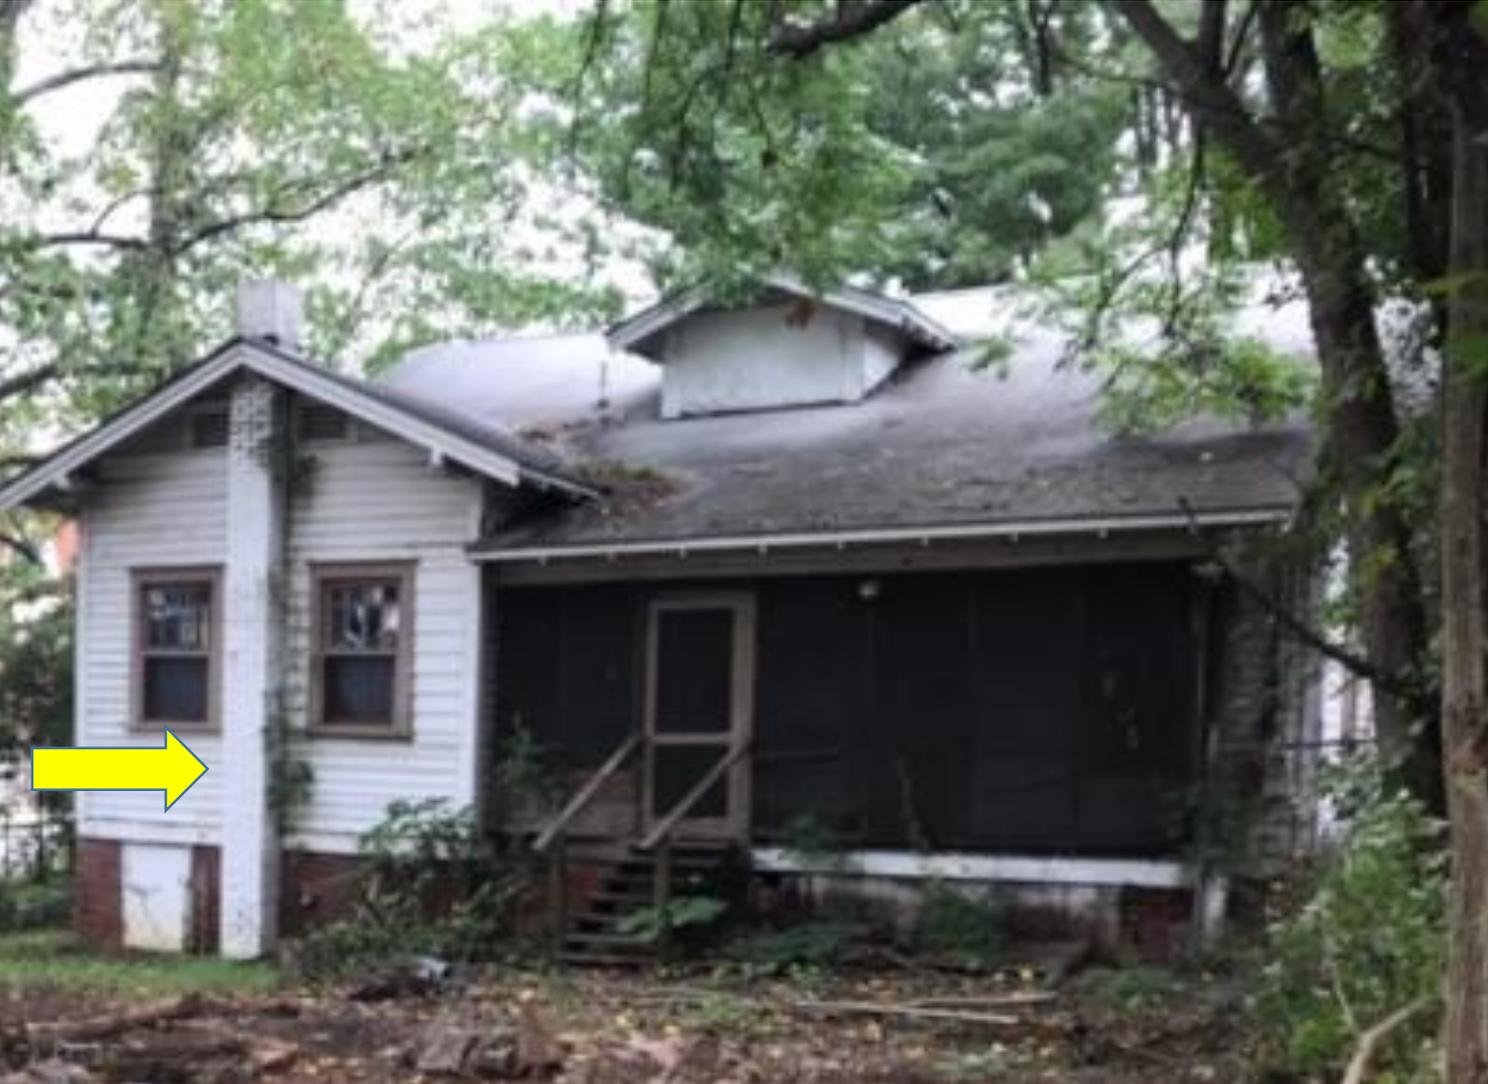
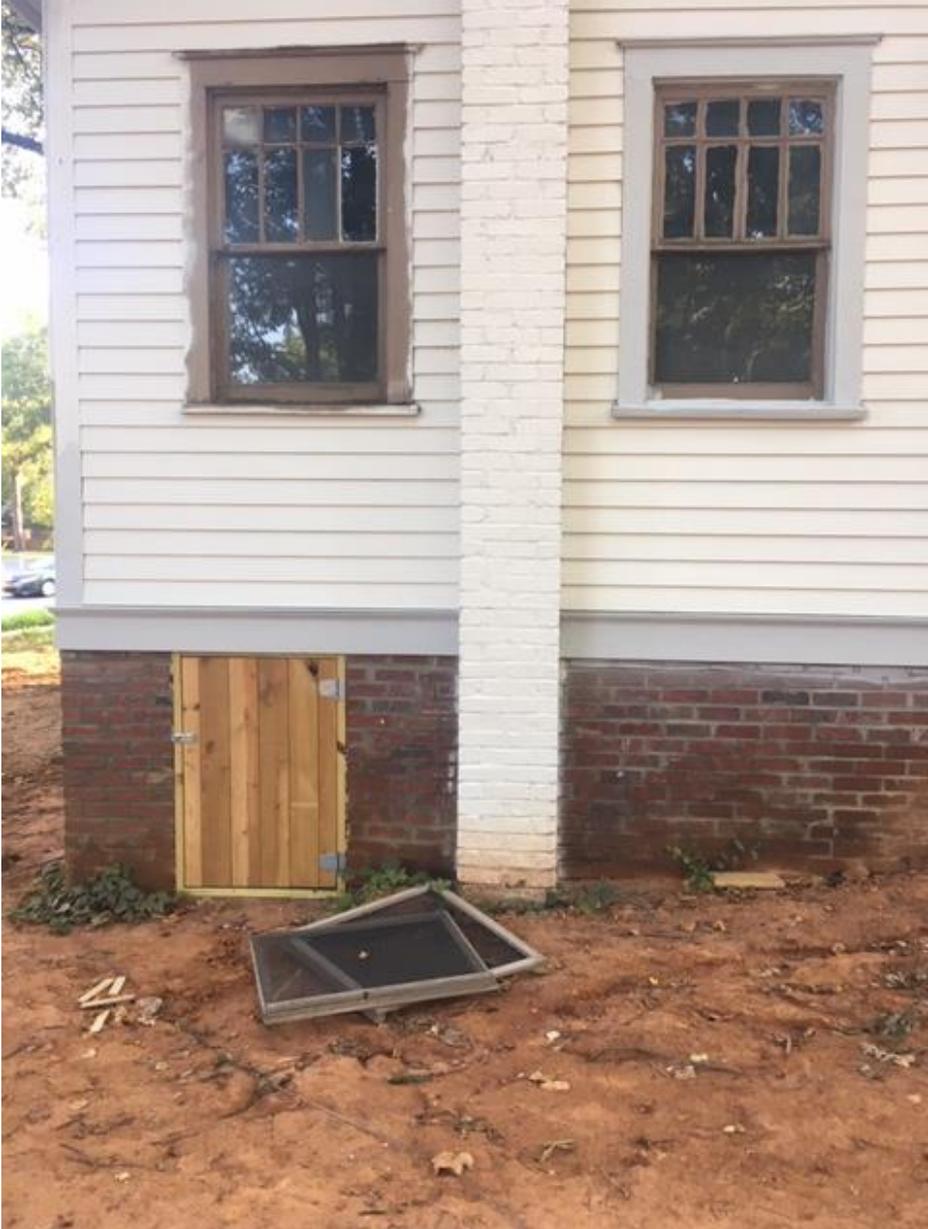
# CHIMNEY PAINTED PRIOR TO RENOVATION

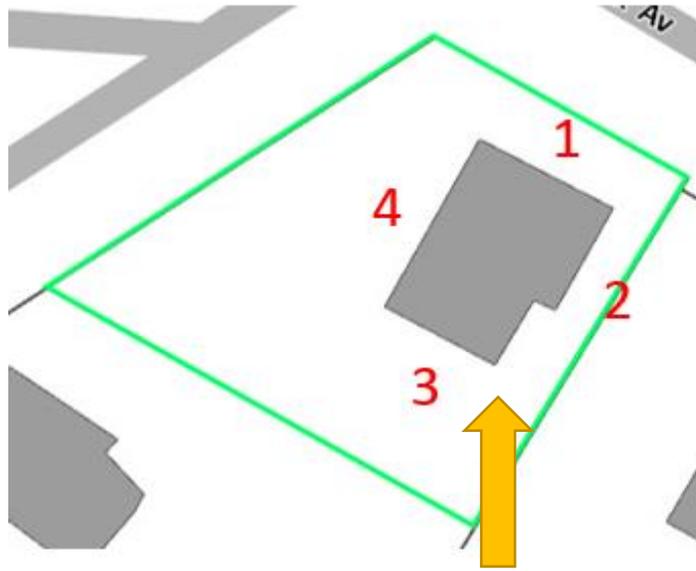
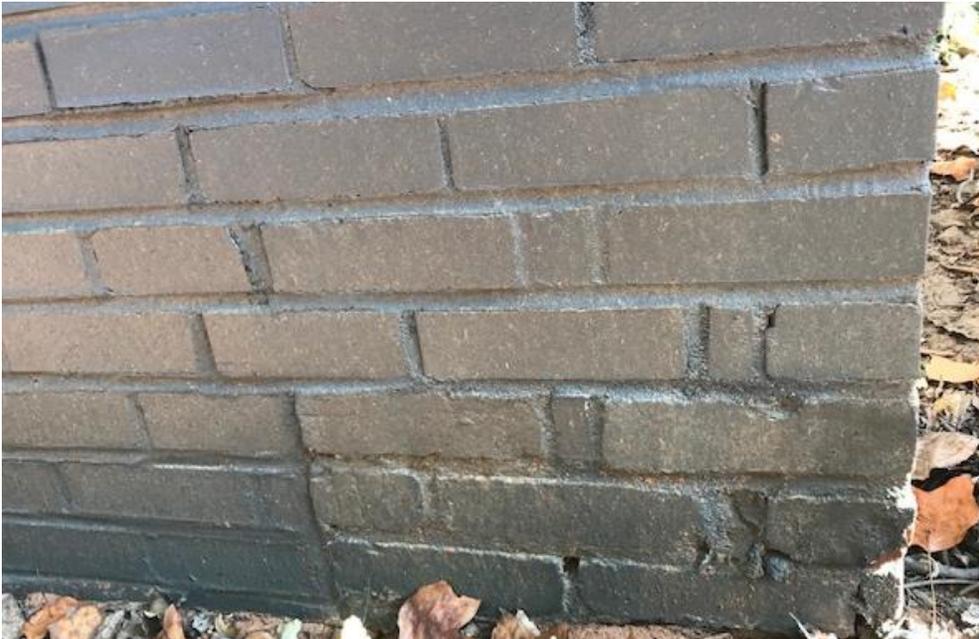
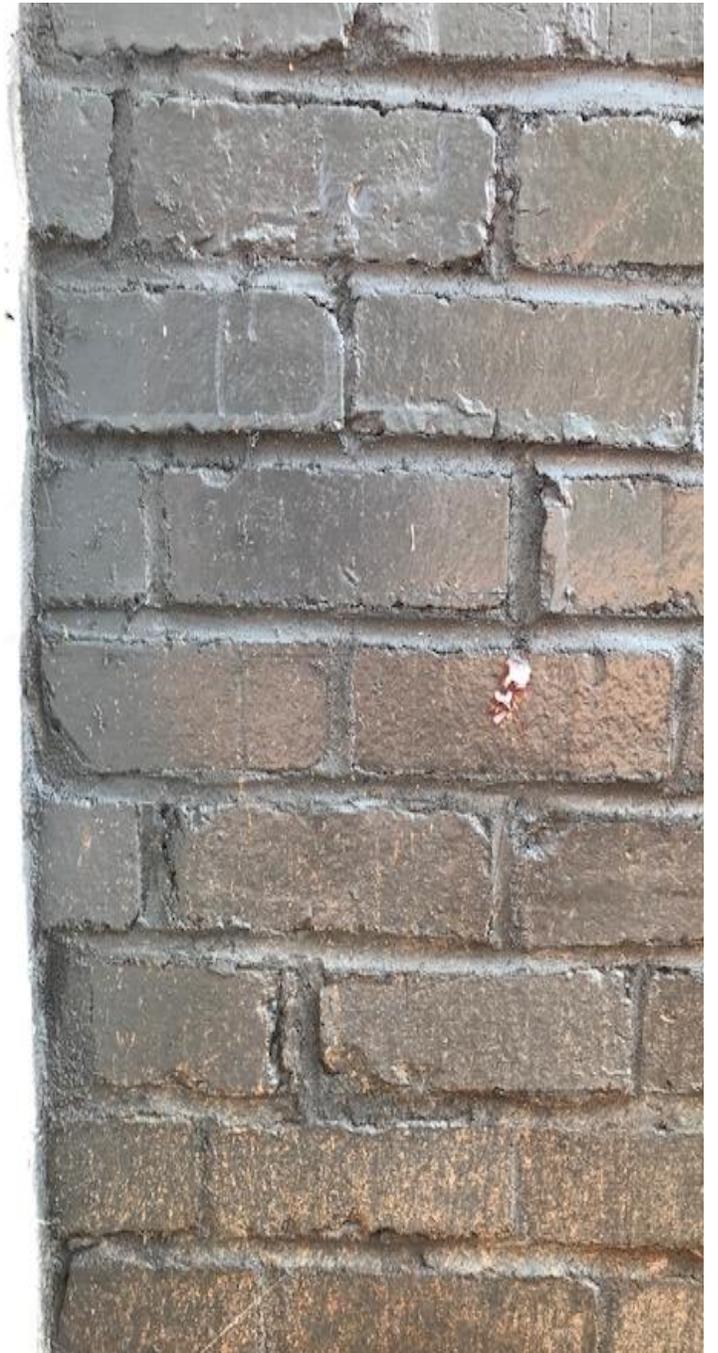
## SOUTH SIDE

- Mismatched mortar (horizontal & vertical) lines
- Joint lines don't line up in brick pattern.
- Uneven rows and substandard mortar and joint lines

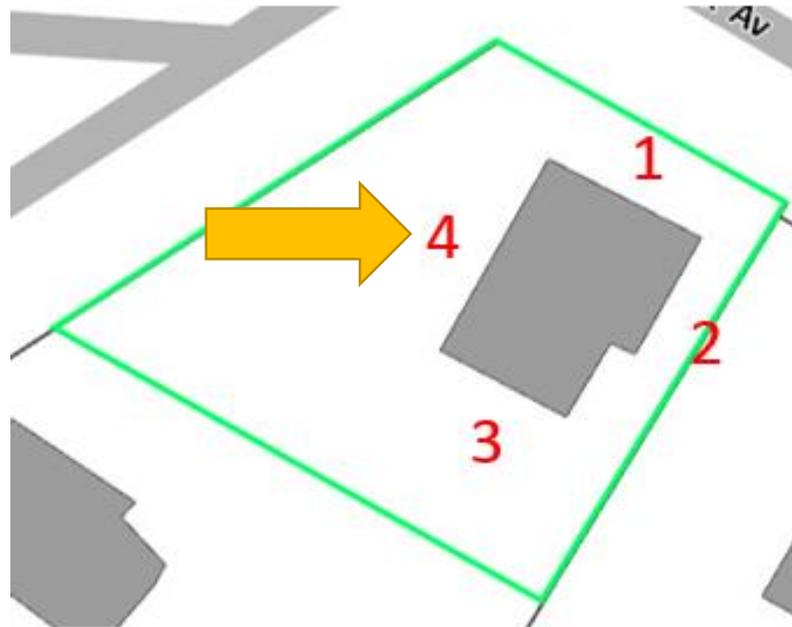
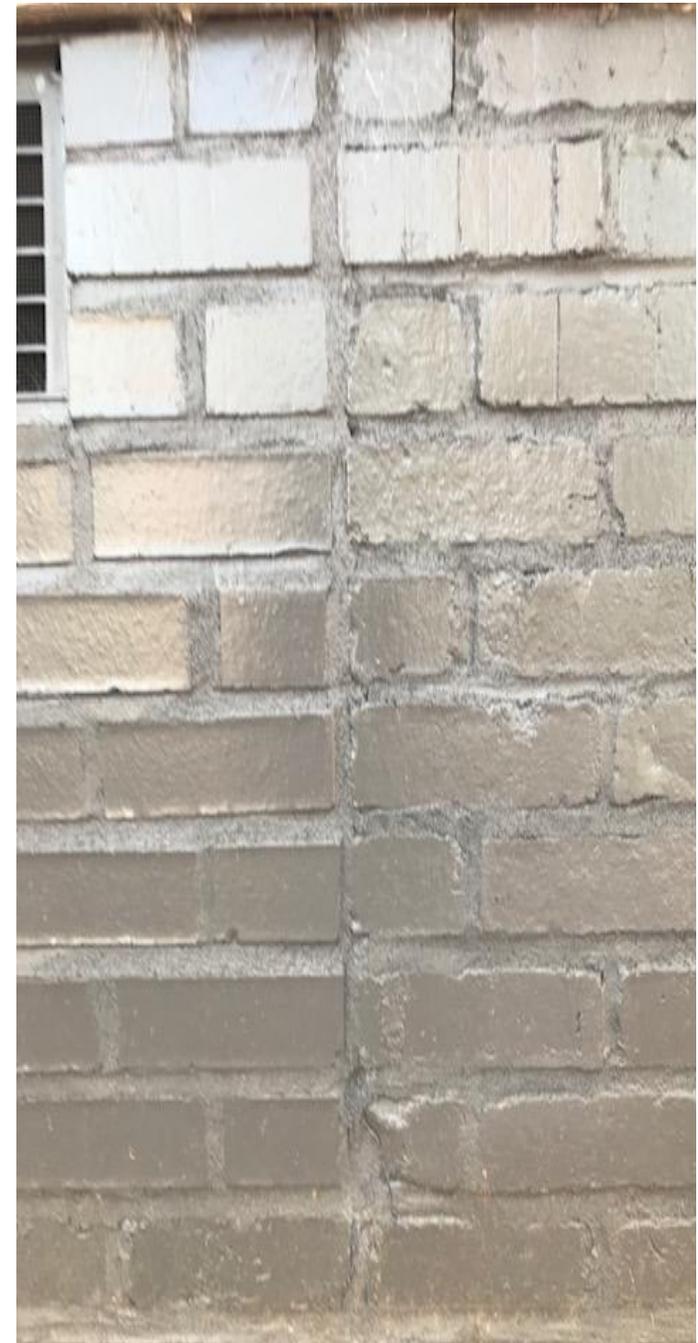
## WEST SIDE

- Excessive and sloppy mortar work
- Uneven joint lines
- Bricks don't line up

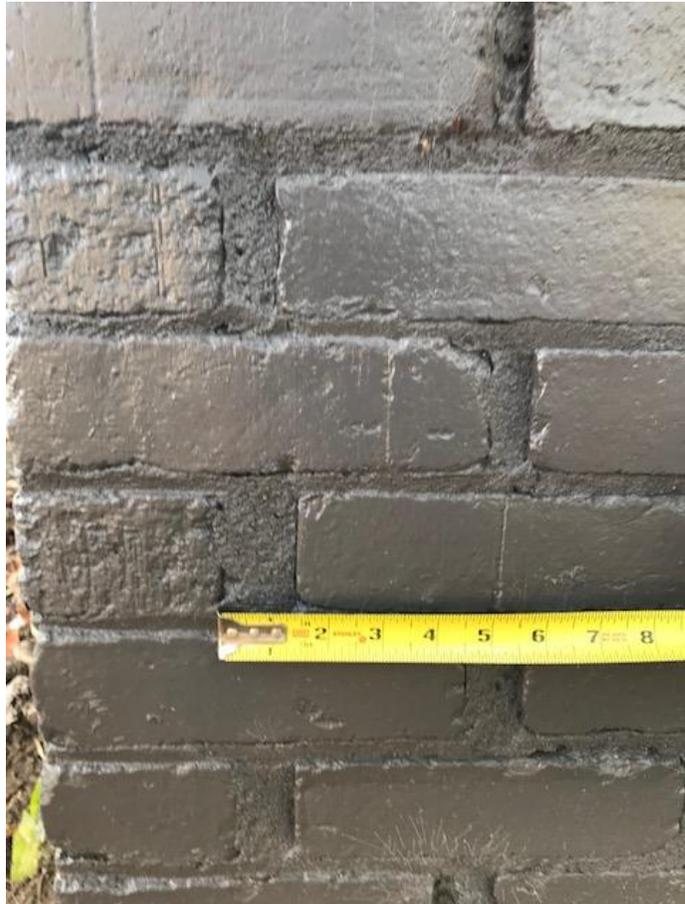
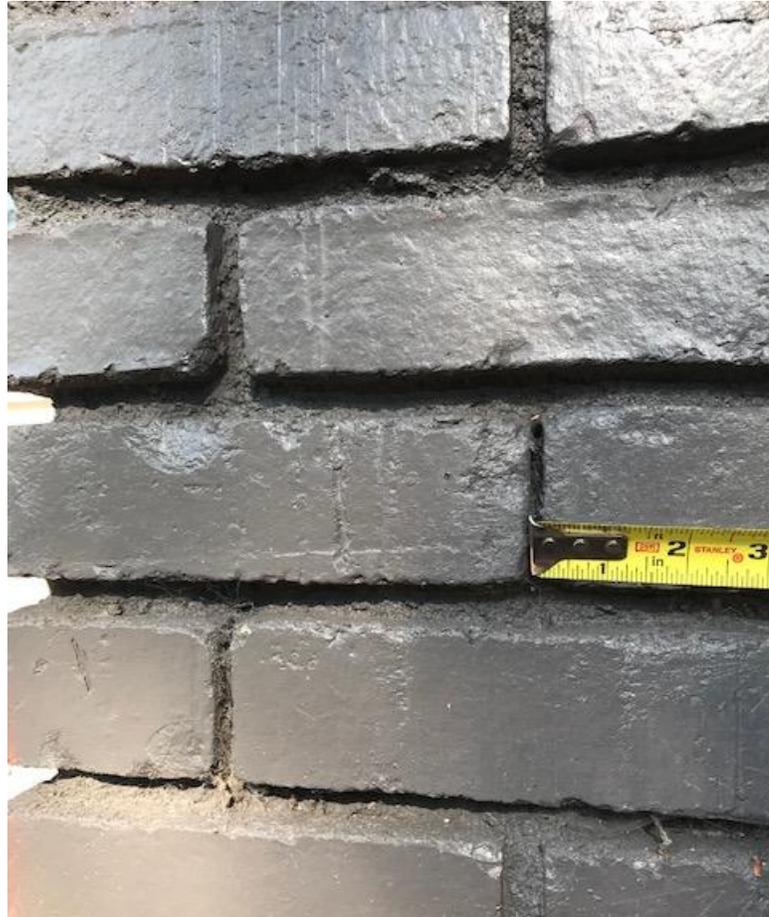
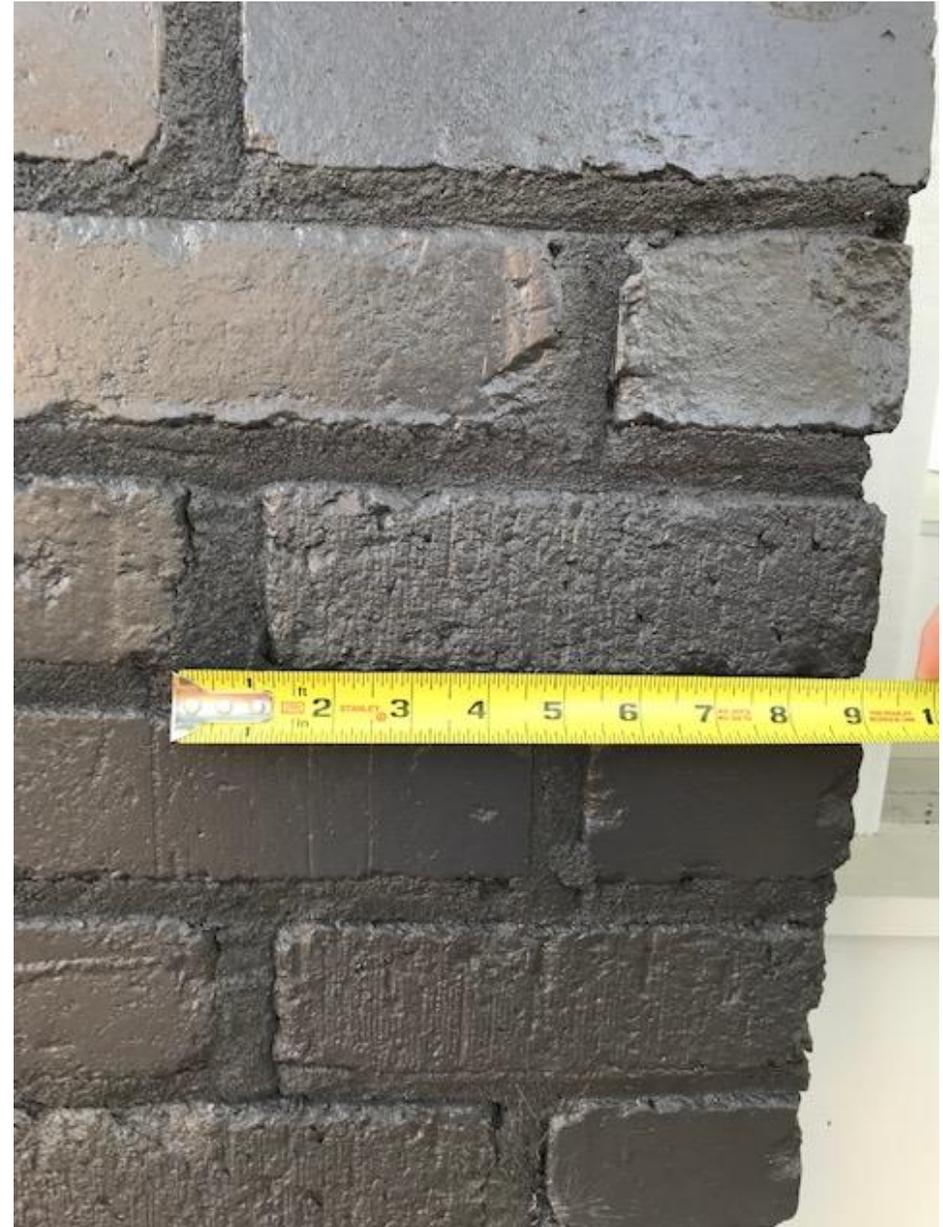
- Mortar head joints in excess of 1 inch common throughout all sides of house.
- Industry standard is 3/8"
