**LOCAL HISTORIC DISTRICT:** Wilmore

**PROPERTY ADDRESS:** 429 West Park Avenue

**SUMMARY OF REQUEST:** Painted Brick/Front Door Replacement

PROPOSED PROJECT: PAINTED BRICK/FRONT DOOR

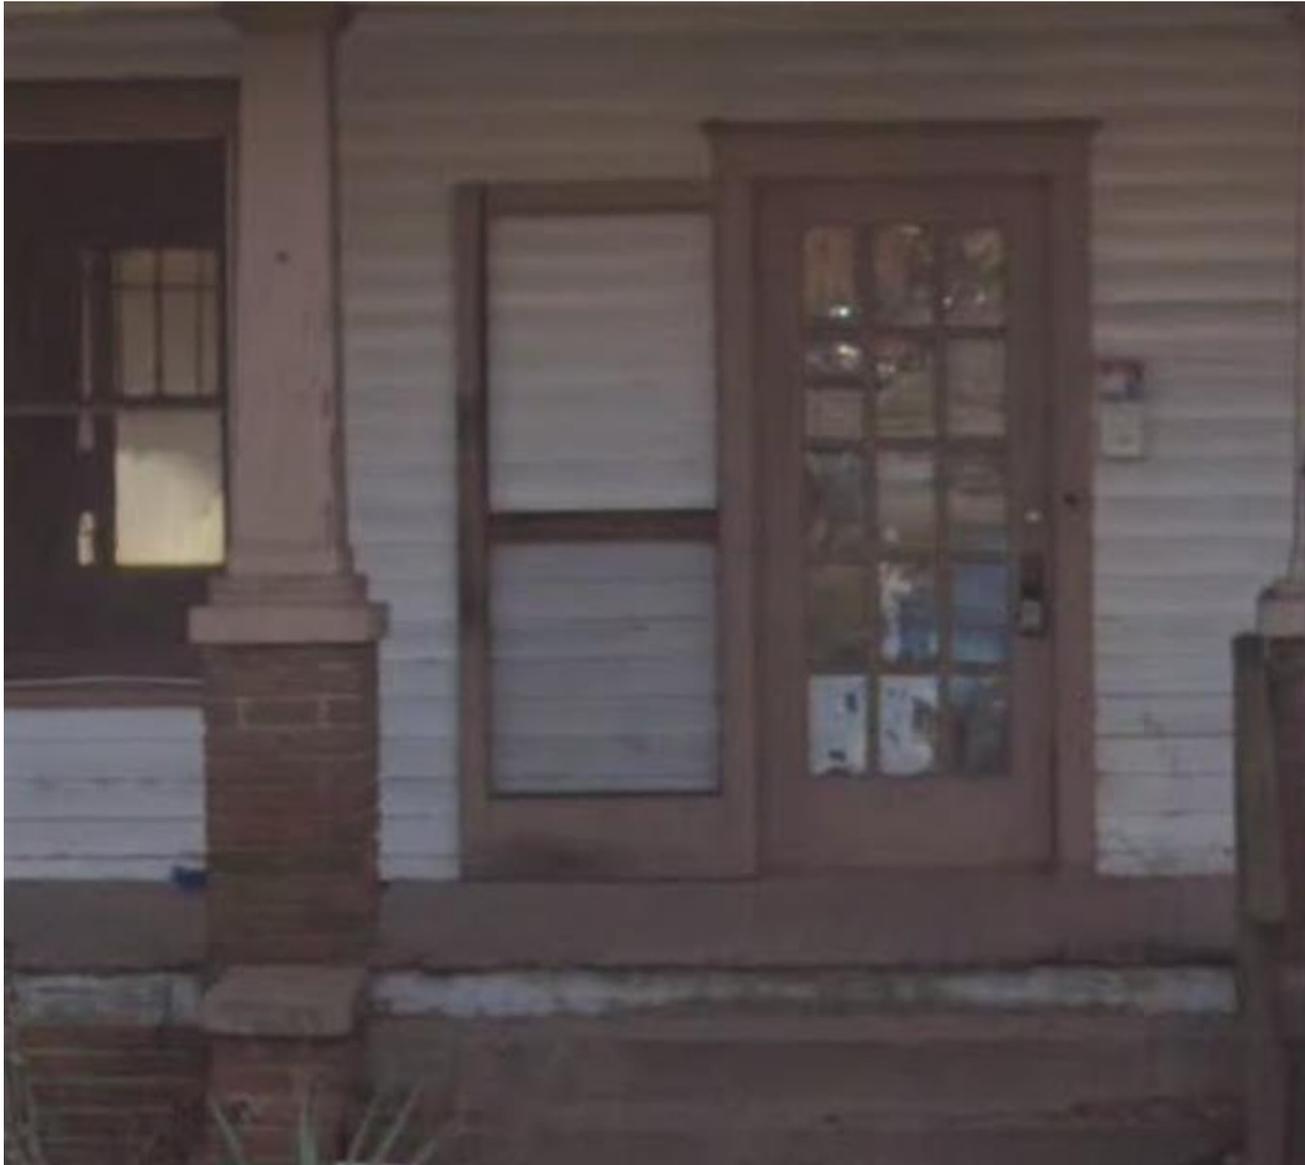
- Original front door | 15-light
- Serious disrepair with broken panes and wood rot.
