LOCAL HISTORIC DISTRICT: Dilworth

PROPERTY ADDRESS: 2114 Dilworth Road East

SUMMARY OF REQUEST: Front Door/Painted Brick

APPLICANT/OWNER: Amanda Gray, applicant

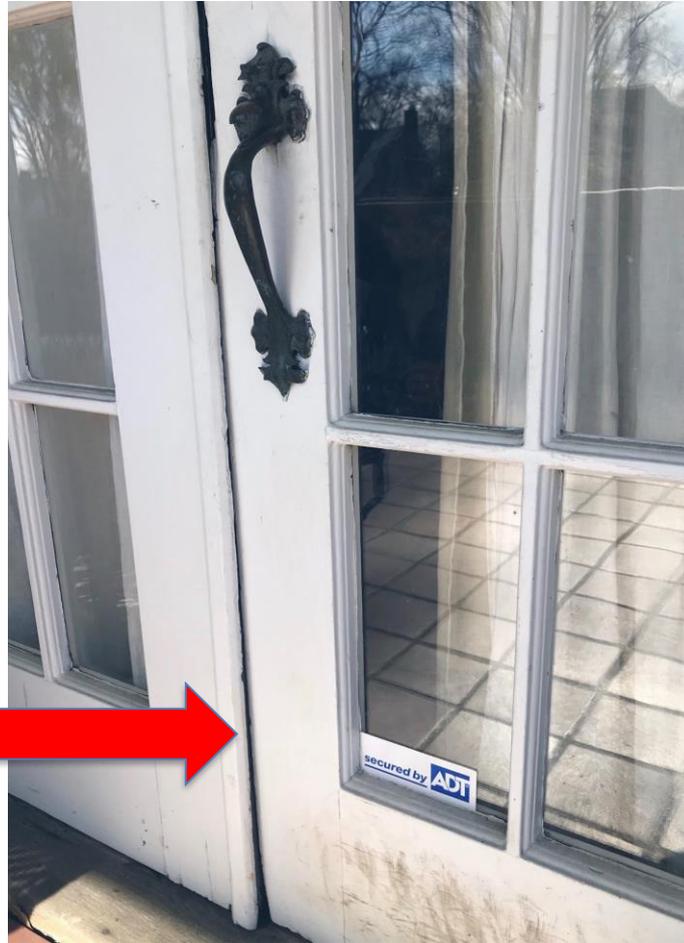
Large gap

Conditions of current doors,
exterior side...

Consistent battle to keep bugs and drafts out and heat and air in. Regular replacement of triple layers of weather stripping is maintained. Nearly impossible to remedy for longer periods of time with the constant use of the entry door. The most practical solution would be full door replacement.

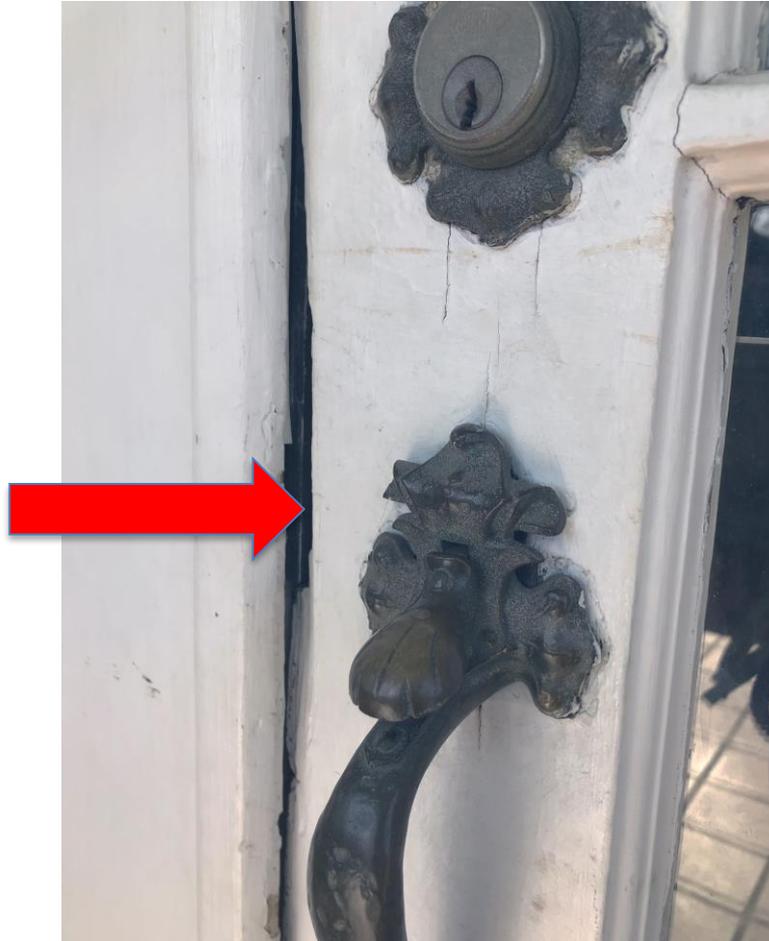
**Badly gouged
wood by the
handset (side
view-closed door).**

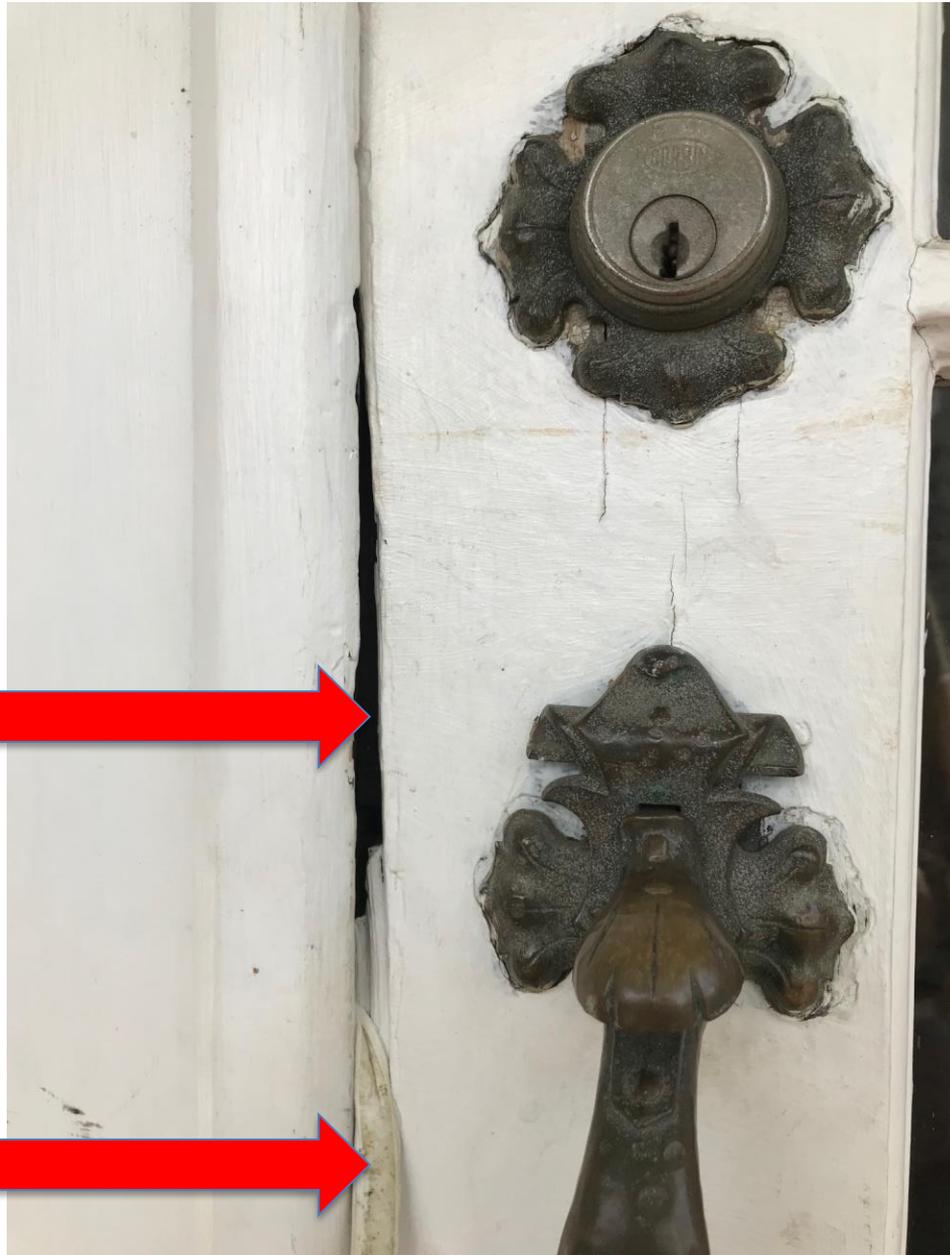
**Badly gouged
wood by the
handset (front
view-closed door).**

**Weather stripping
hanging out.**

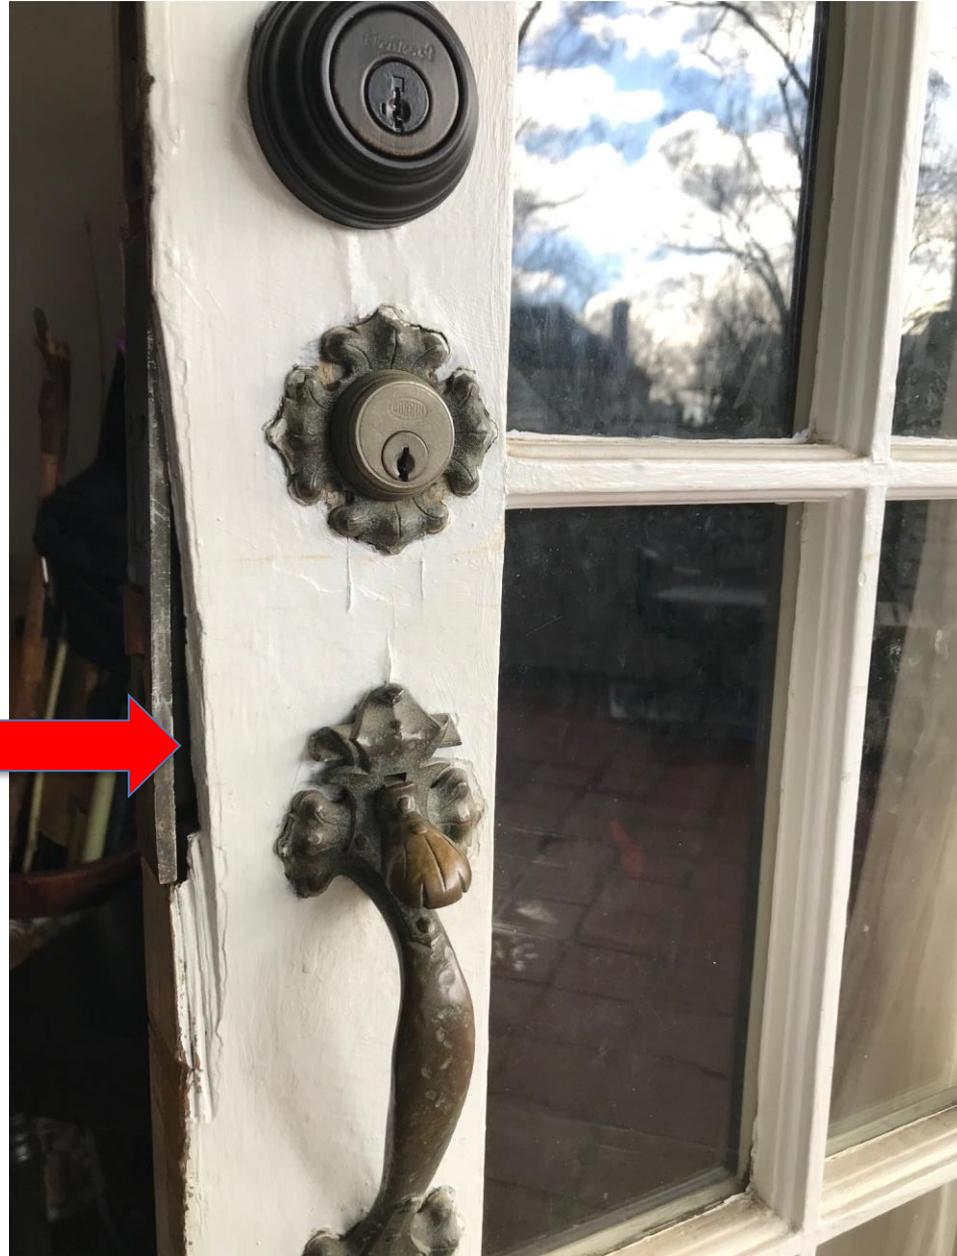
**Badly gouged
wood by the
handset (open
door view).**

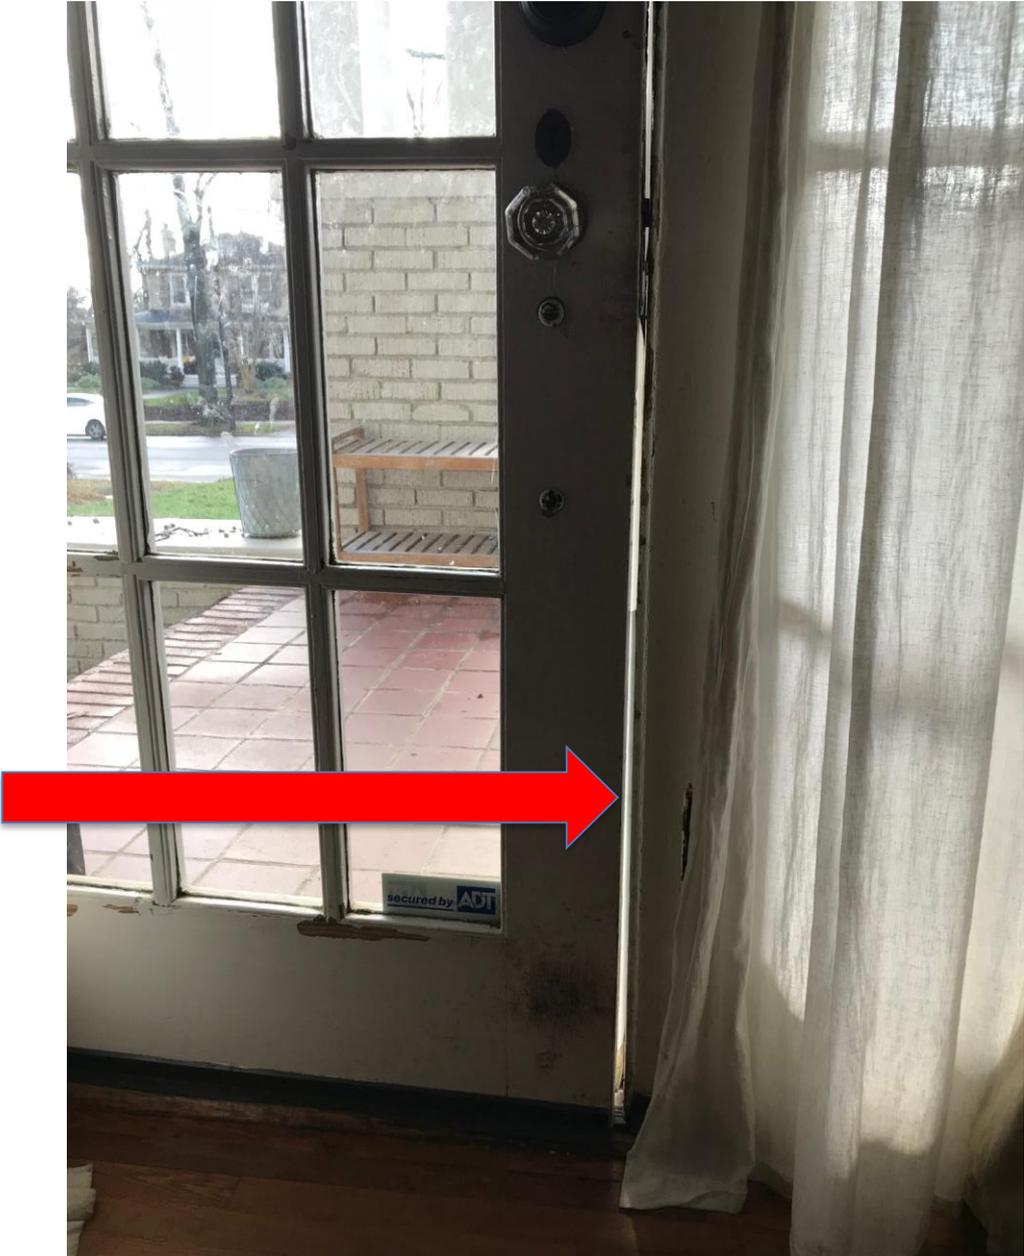
Large gap

Conditions of current doors,
interior side...

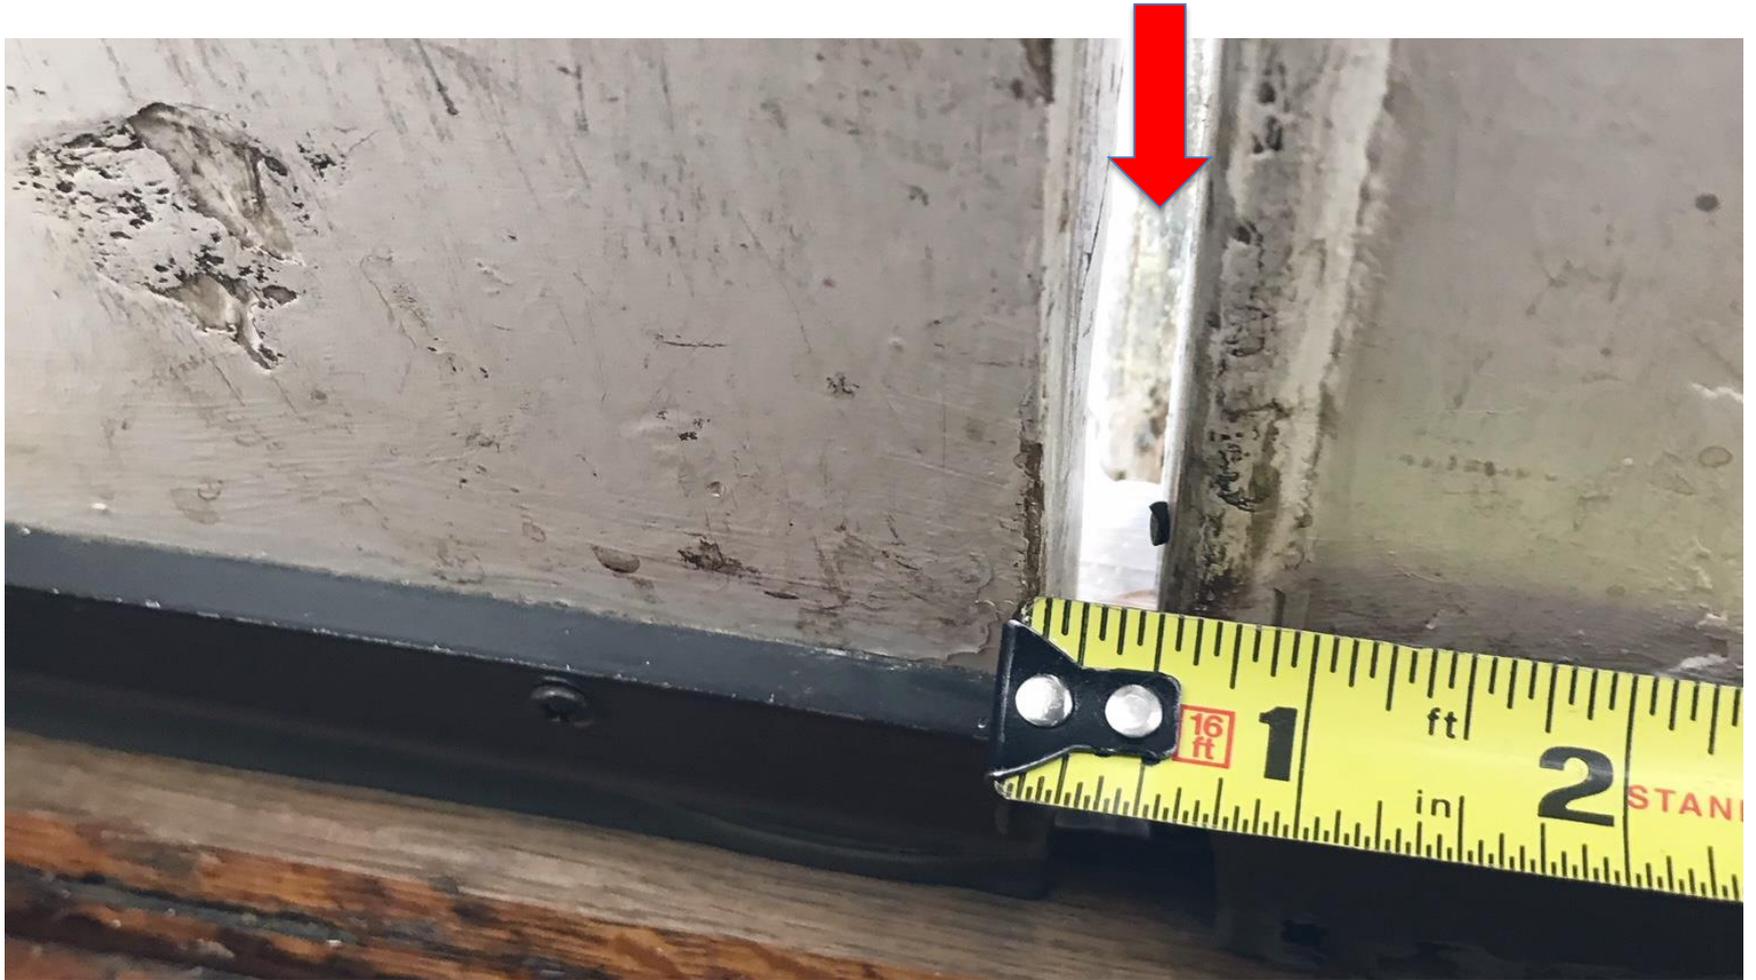
Large gap

½ inch gap

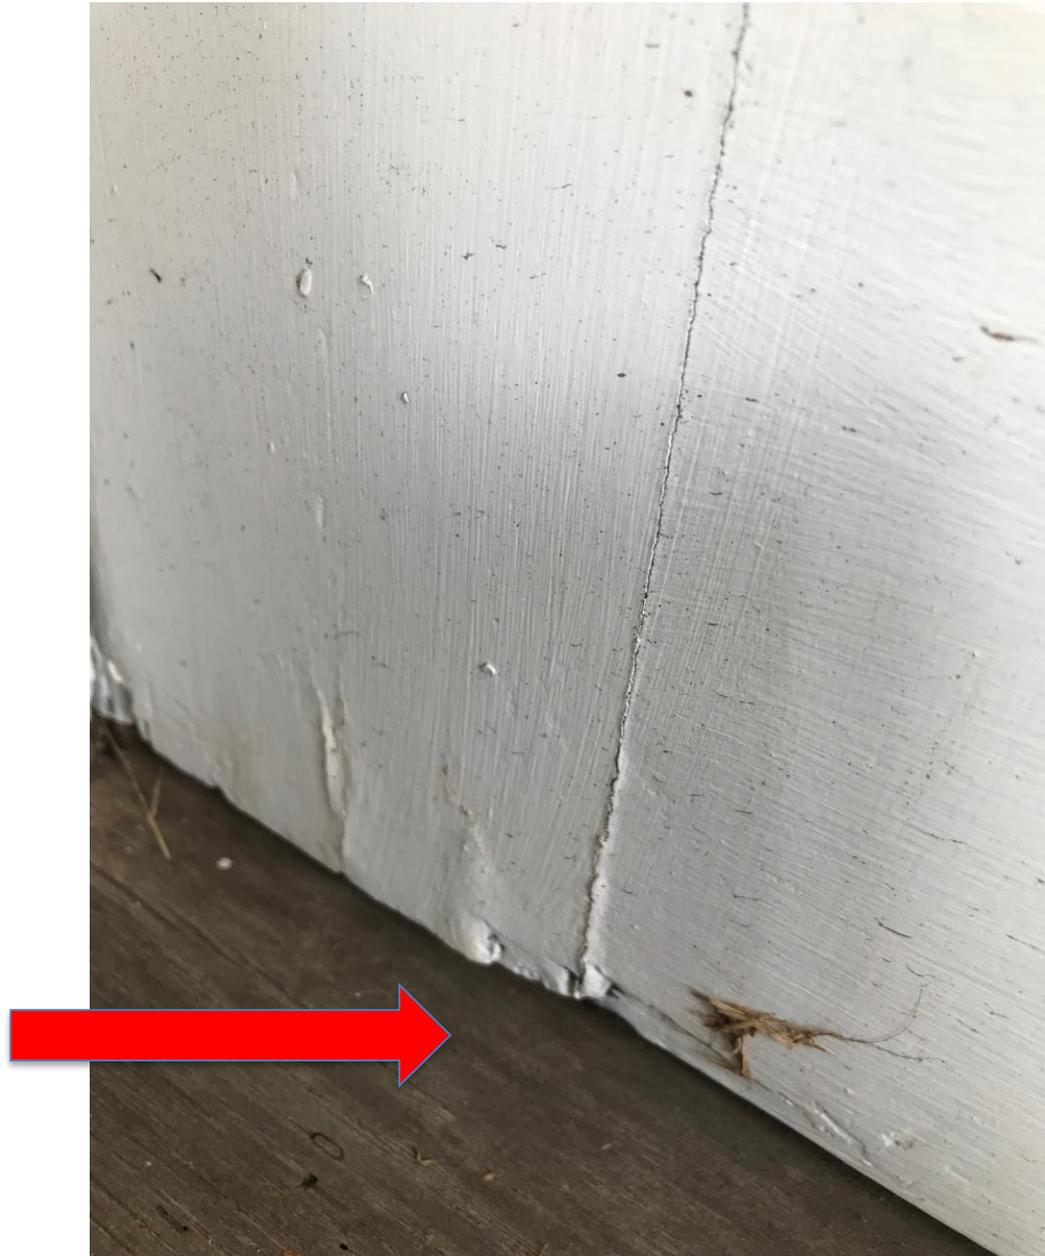
**Multiple areas
where wood has
splintered, especially
on the bottom. Had
some previous rot.**

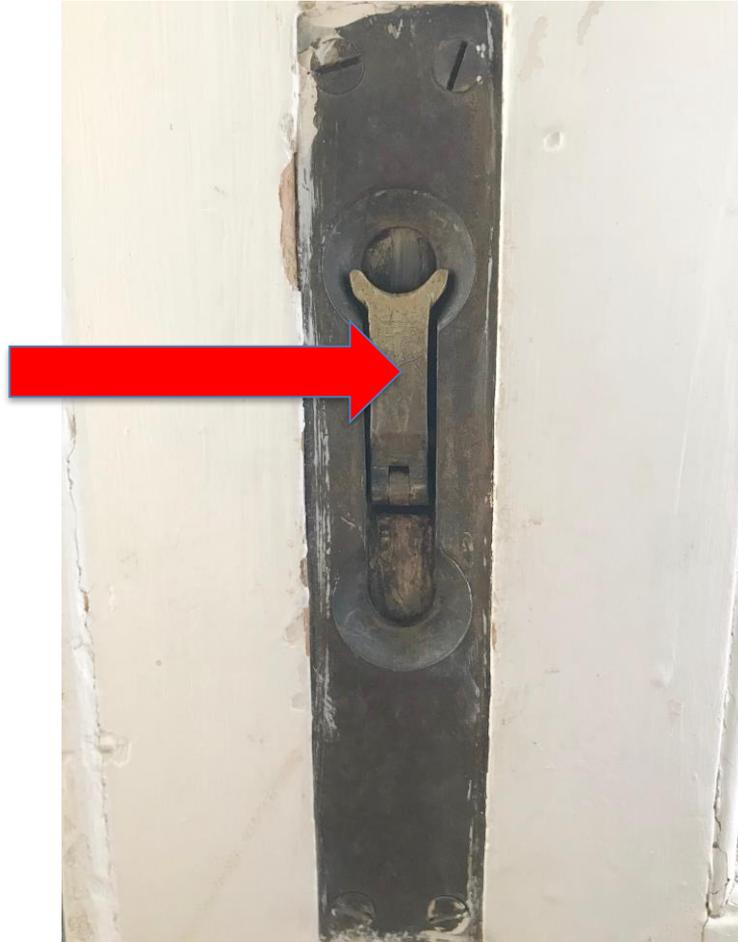
Operable stationary door lock. While this works, the door itself moves back and forth an inch in each direction.

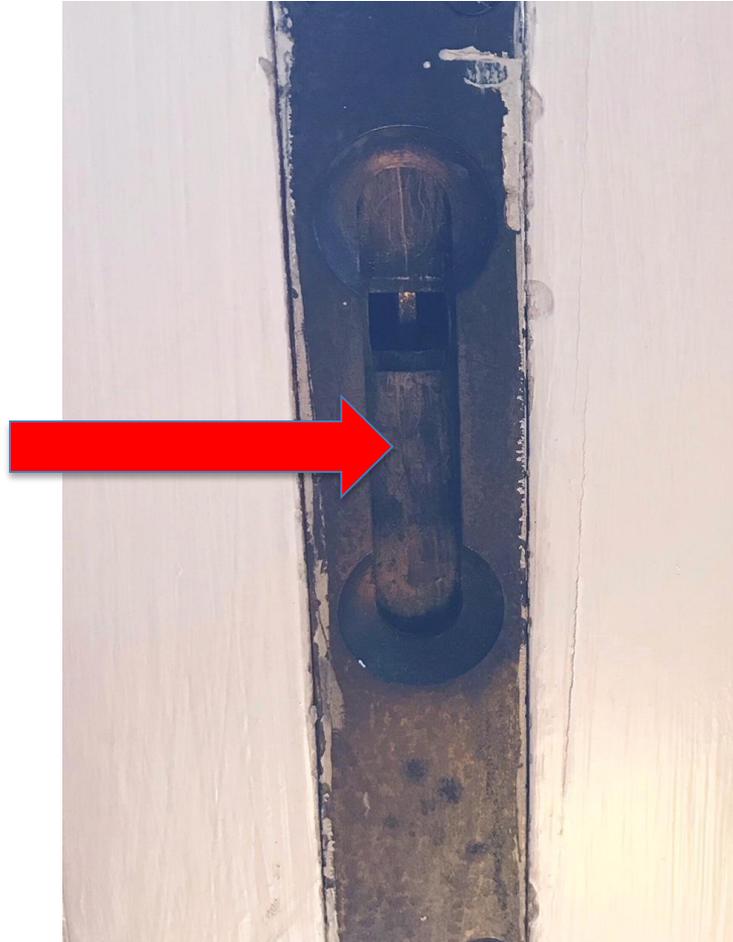
Inoperable stationary door lock. This door does not lock into place as it does not have all of it's parts. A big safety concern.

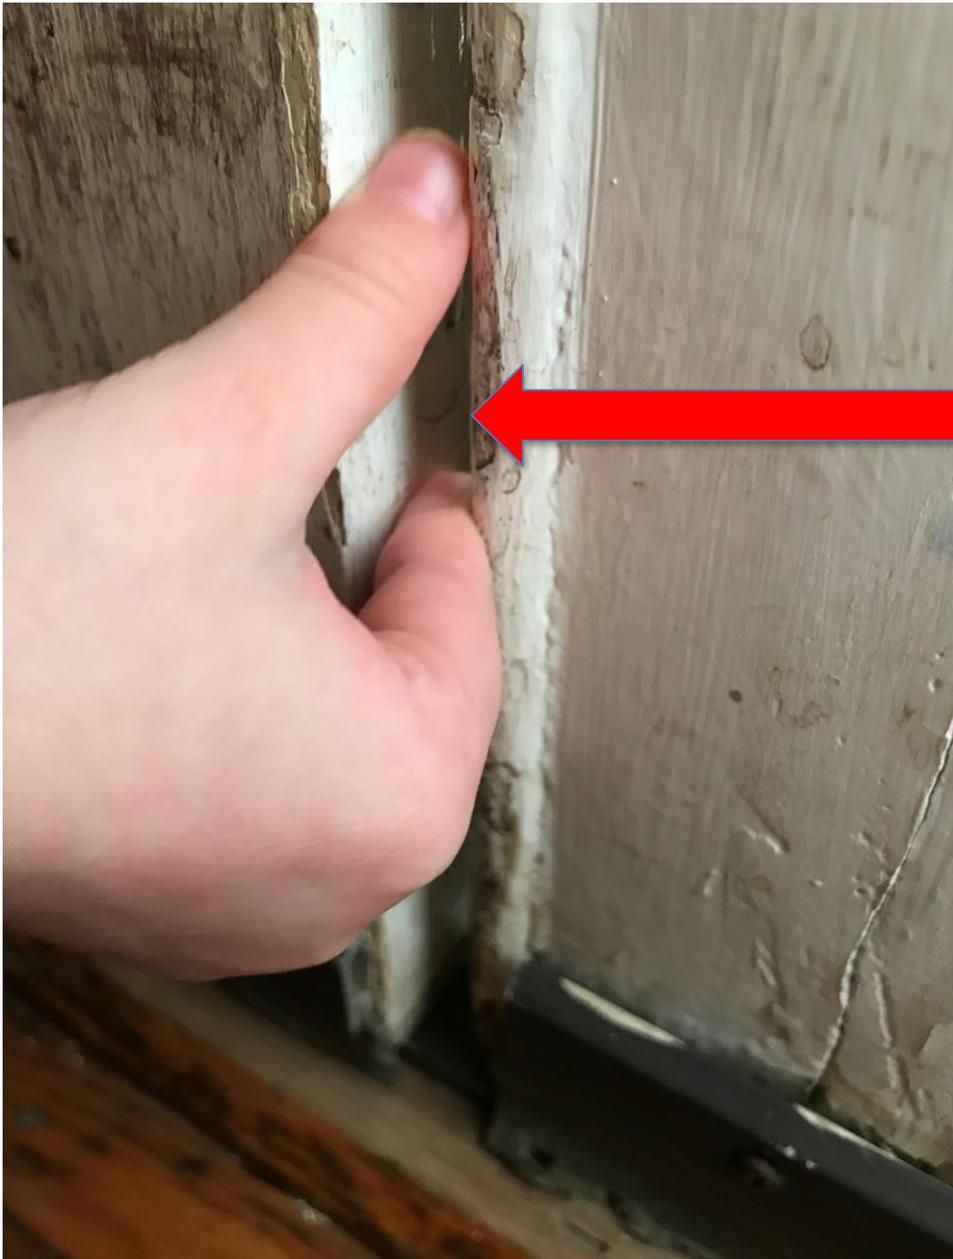
Wood is completely worn out around the entire knob. Locksmiths say our only option is to replace our doors or install a new knob set above our current set. This is not a practical option as it would be too high to comfortably operate and unreachable for our children. All around, it just would not be aesthetically pleasing.
