**LOCAL HISTORIC DISTRICT:** Dilworth

**PROPERTY ADDRESS:** 815 Berkeley Avenue

**SUMMARY OF REQUEST:** Tree Removal

LOCAL HISTORIC DISTRICT: DILWORTH  
PROPOSED PROJECT: TREE REMOVAL

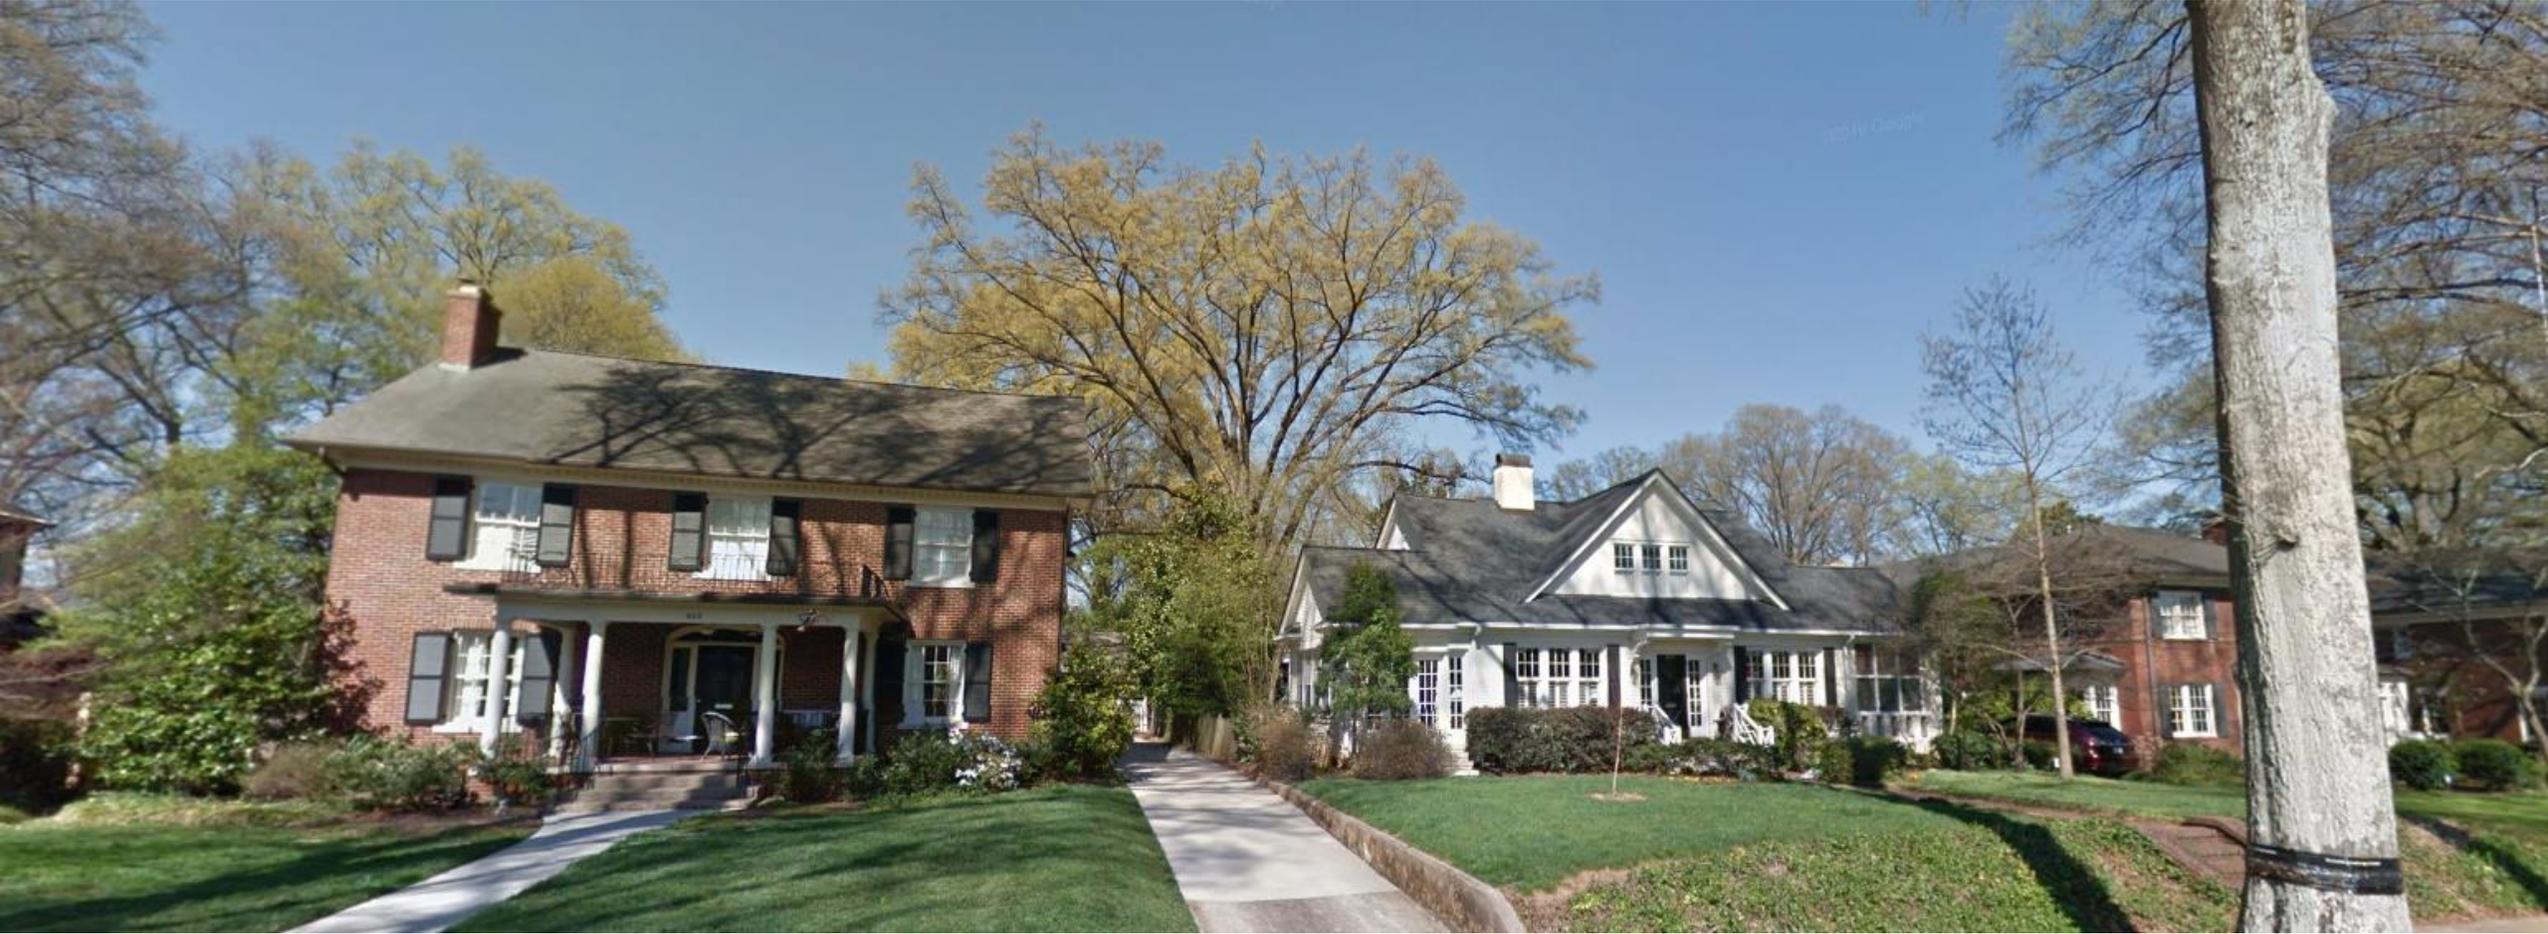
Existing Conditions:  
Houses and Willow Oak Canopy

In addition, approximately 80% of the canopy is growing directly over the trunk or to the south, over our house and our neighbor's house. Our neighbor's daughter has expressed her concern about sleeping in her upstairs bedroom with our tree hanging over her roof.

Mr. Kabia with Heartwood noted that if the tree falls, it is going to fall directly onto our and the neighbor's houses, because of the way the tree grows and because there is nothing in the way to break its fall other than the houses. We are attaching a photograph to give you a clearer understanding of this risk.

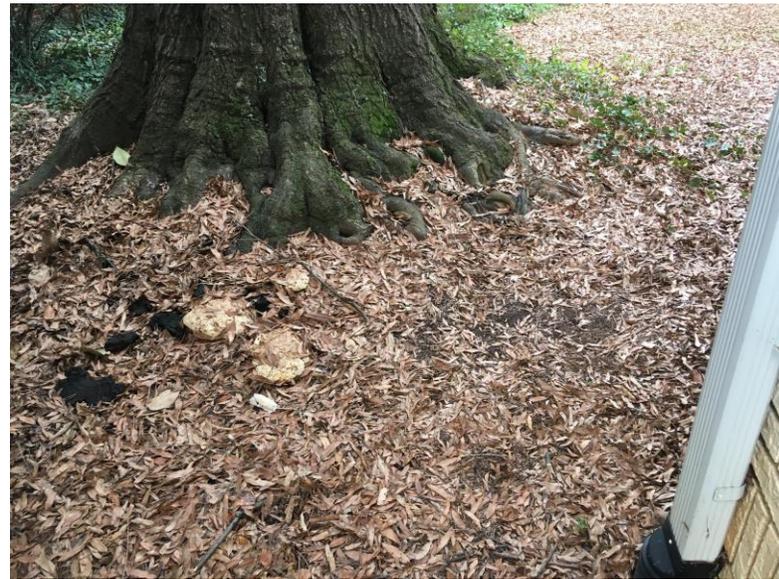
By November of last year, new mushrooms were appearing in multiple locations at the base of the tree. One has now also appeared 45 feet up on a large limb in the canopy over the back of our house. There are many massive limbs, many as big as tree trunks, any of which could do significant damage when they give way. Resistograph testing of the main trunk tells us very little if anything about the structural integrity of these limbs.

Mushrooms

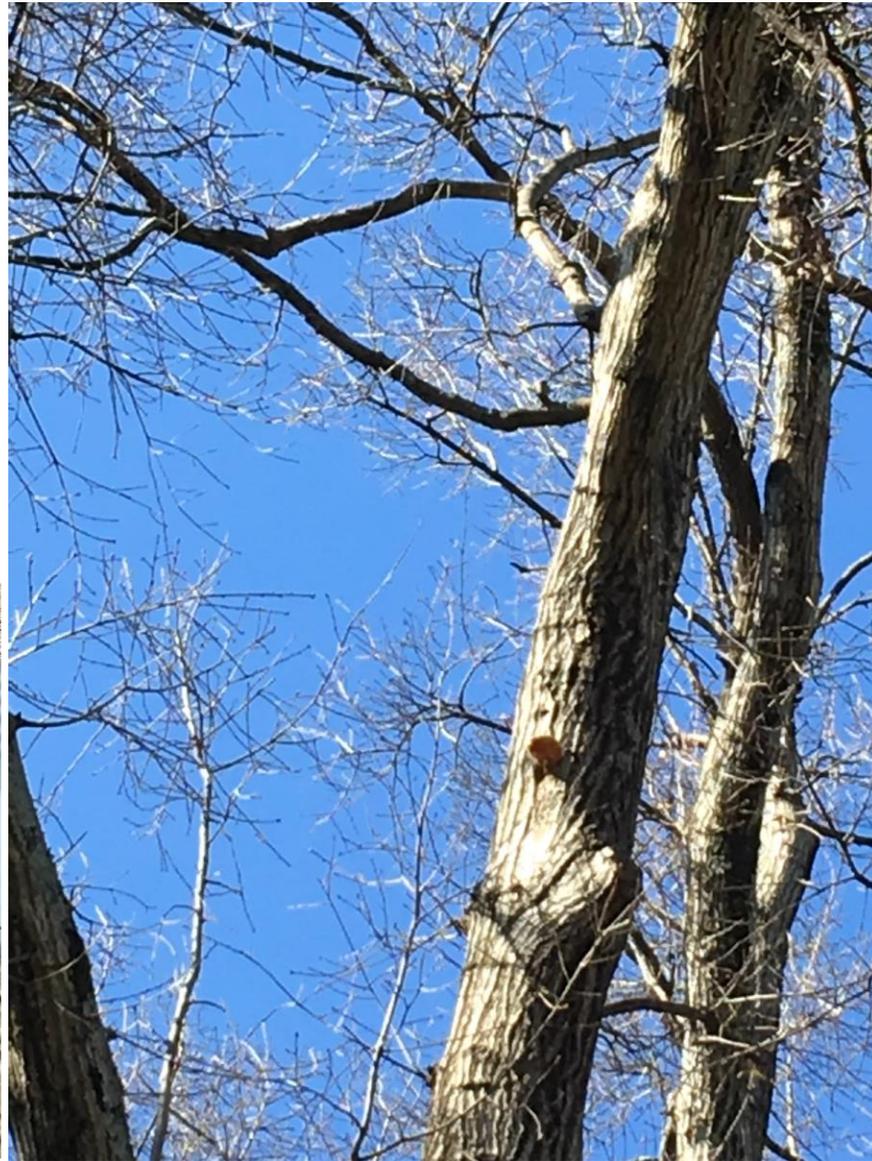
One mushroom
