**LOCAL HISTORIC DISTRICT:** Dilworth

**PROPERTY ADDRESS:** 1230 East Worthington Avenue

**SUMMARY OF REQUEST:** Tree removal

*Charlotte Historic District Commission Case 2017-075*  
**HISTORIC DISTRICT: Dilworth**  
**TREE REMOVAL**

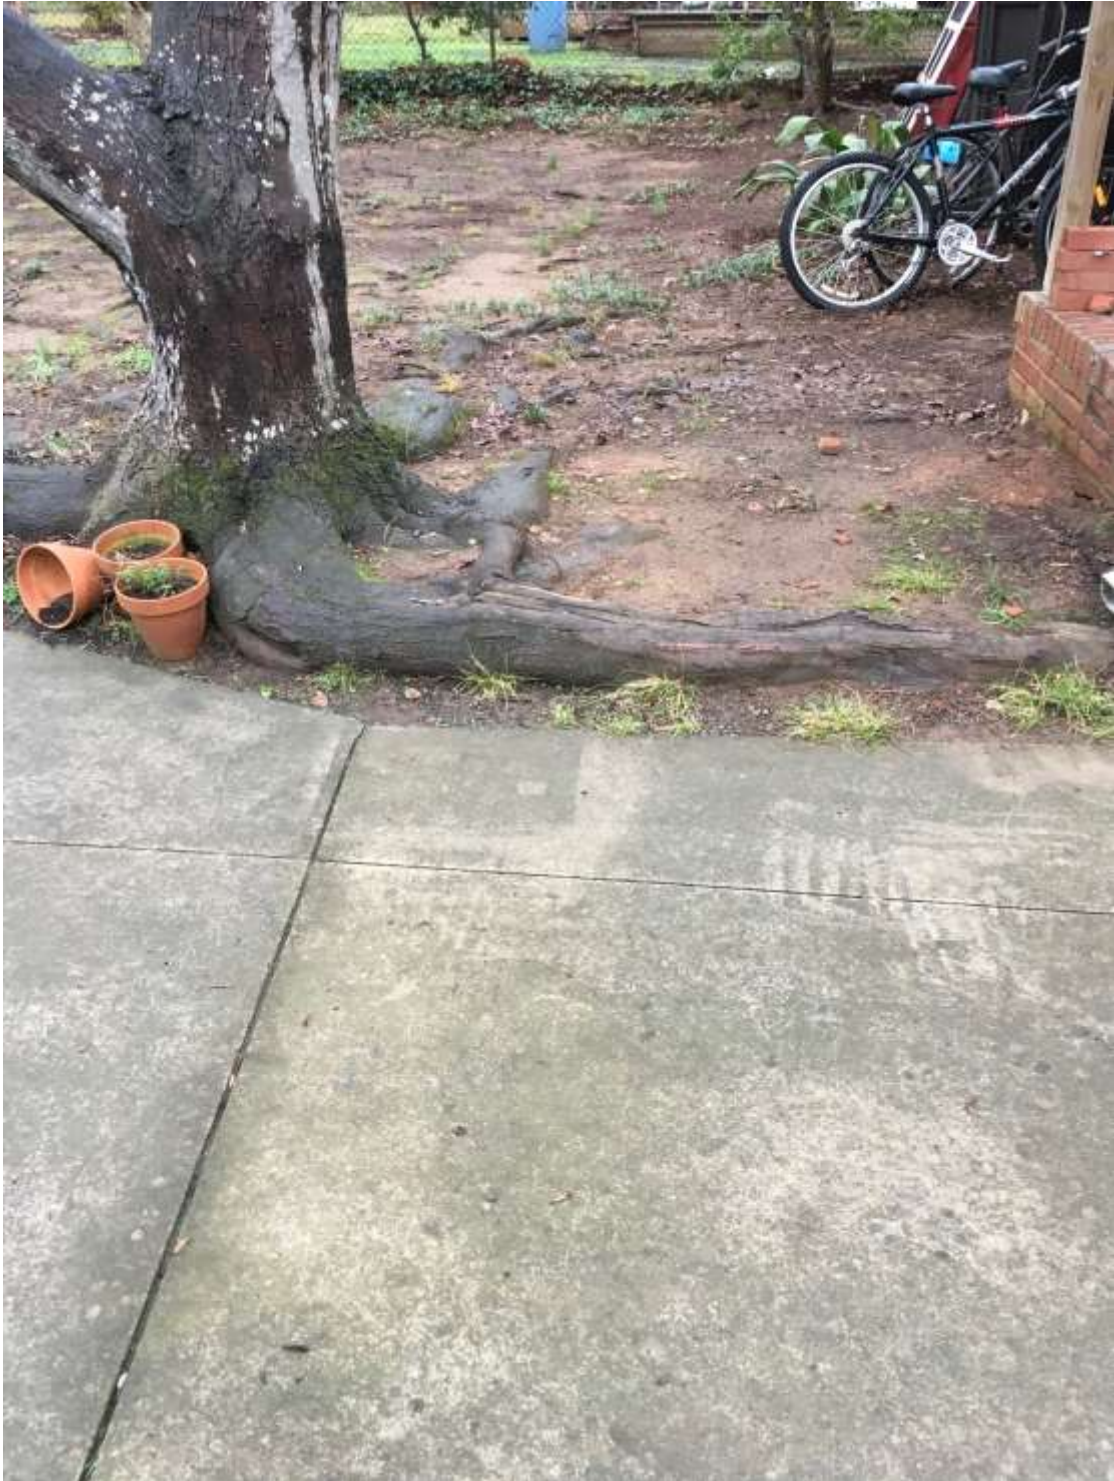
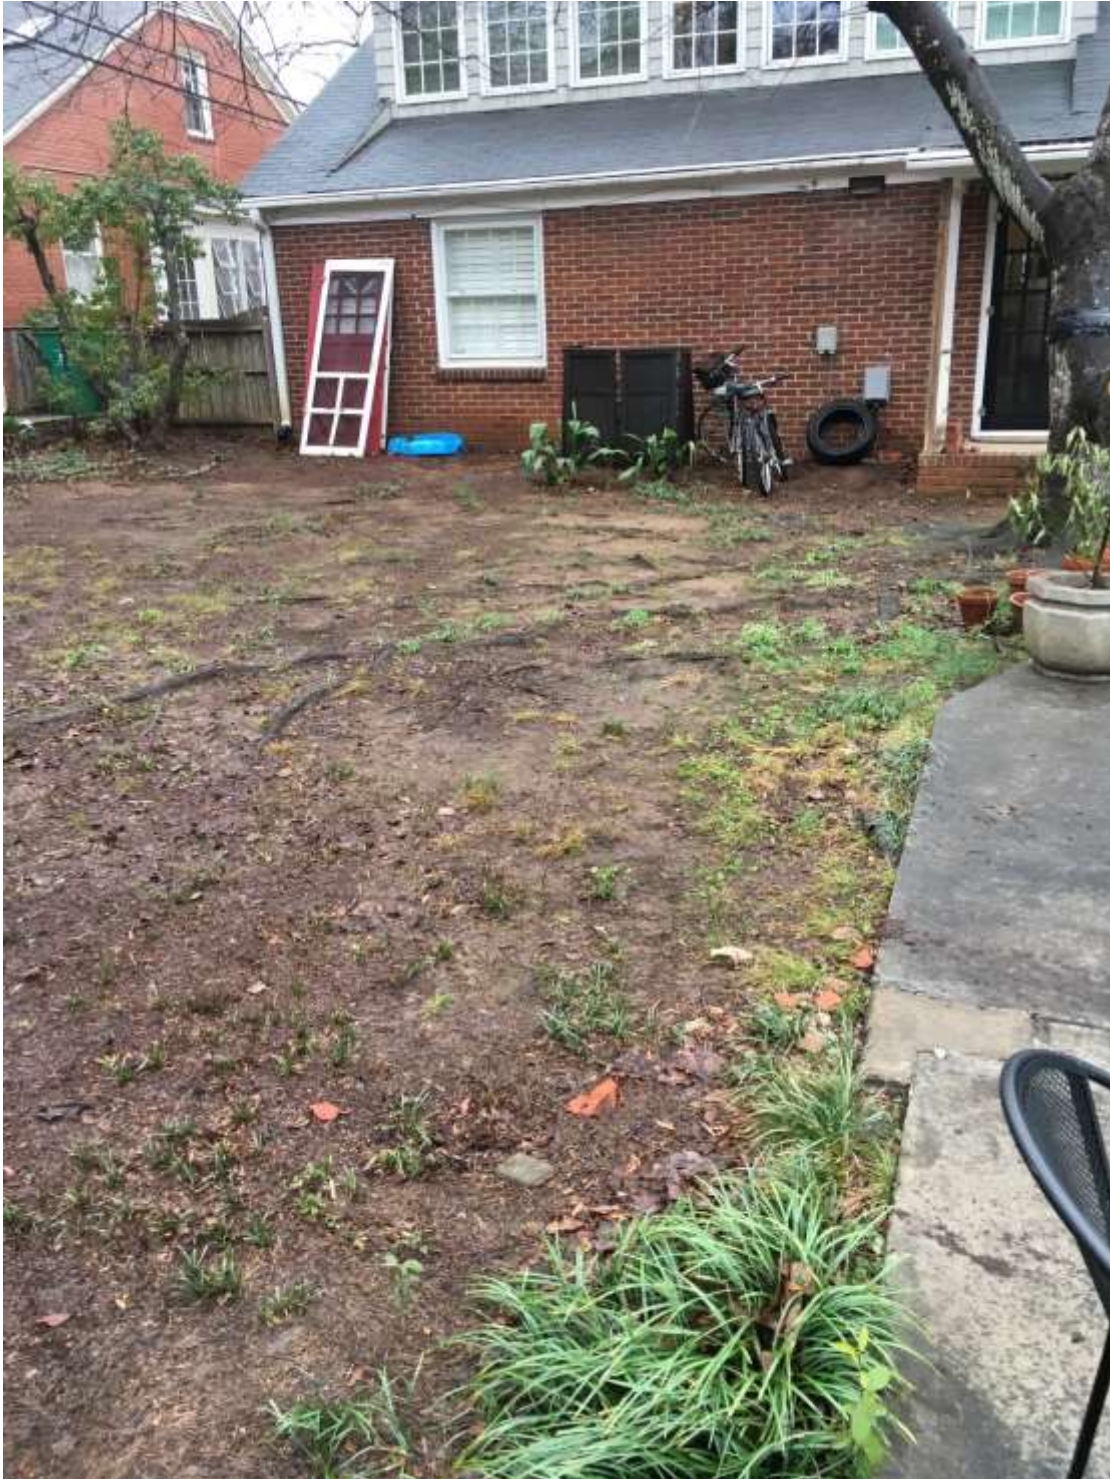
I am contacting you to request permission to remove a (21") Red Maple located at the left rear foundation of 1230 E. Worthington Ave. This tree was installed in very close proximity to the house and has a codominant branch structure. Codominant stem unions are structurally compromised as they are attached by included bark and have a high risk of splitting/separating at the seam. The exposed surface roots throughout the rear yard present significant tripping hazards. There is also a reasonable concern of the aggressive roots causing damage to the foundation.

The aggressive root pruning necessary to mitigate the hazards would result in severe stress and the likely decline/death of the tree. Another mitigation action would include building the soil level up over the roots with retaining walls; however, this too will be counter-productive for the tree's long-term health. The established root system will suffocate as the soil pore (air) space will collapse. Maple roots require oxygen in the soil for feeder root production, and root suffocation will result in tree decline/death.

The property owner, Elizabeth Zimmerman, has requested that the tree be removed. I've attached a couple photos (below) to document the concerns. She has been advised to replant a shade tree species in the far right rear of her property to replace the lost canopy. Please advise me with any questions, concerns, or how to move forward.

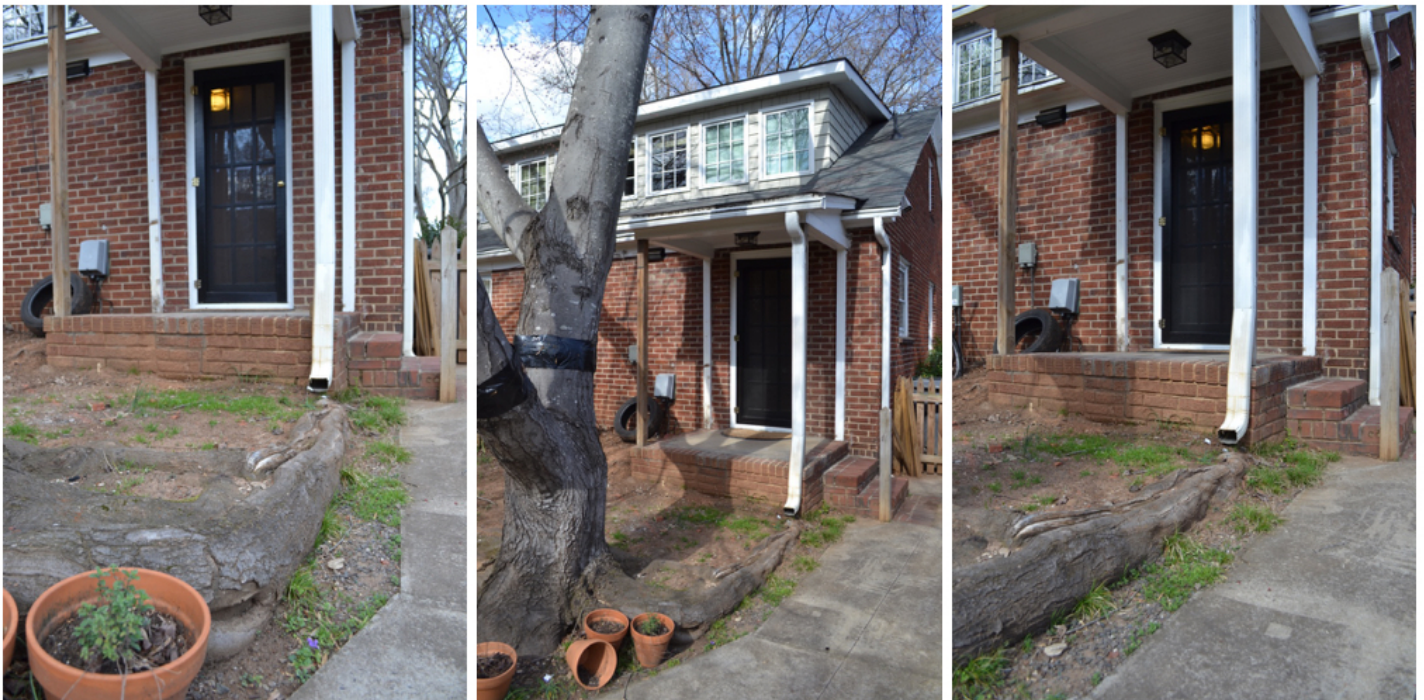
## Additional Photos - Roots Encountering Foundation

\*Photos taken from rear left of yard looking towards to the house

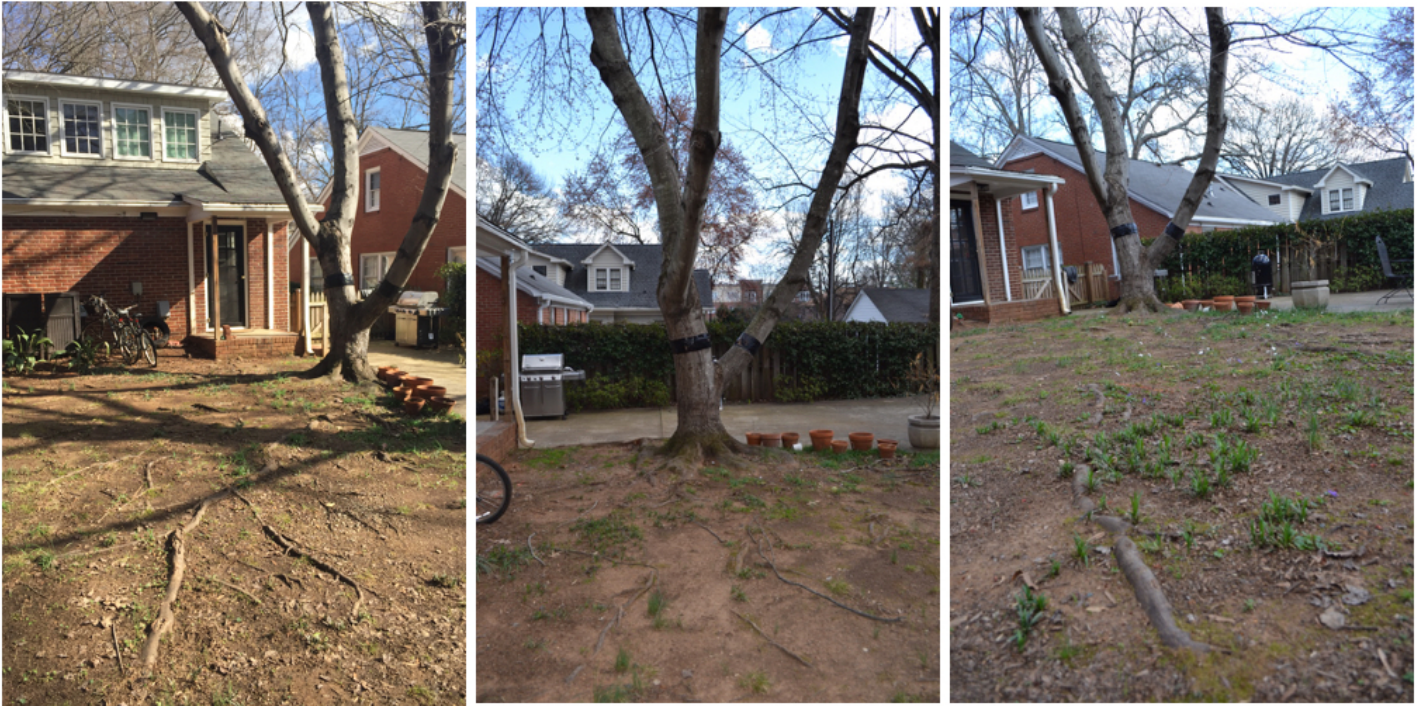
## Additional Photos - Surface roots in the yard

\*Photos taken from rear right of yard looking towards to the tree/house
