## Charlotte Historic District Commission

### Application for a Certificate of Appropriateness

December 14, 2011

ADDRESS OF PROPERTY	1924 Park Road, Dilworth Local Historic District	HDC 2011-121
SUMMARY OF REQUEST	Restoration of Front Porch	
OWNERS	Euclid LLC	
APPLICANTS	Nathaniel & Riky Sittema

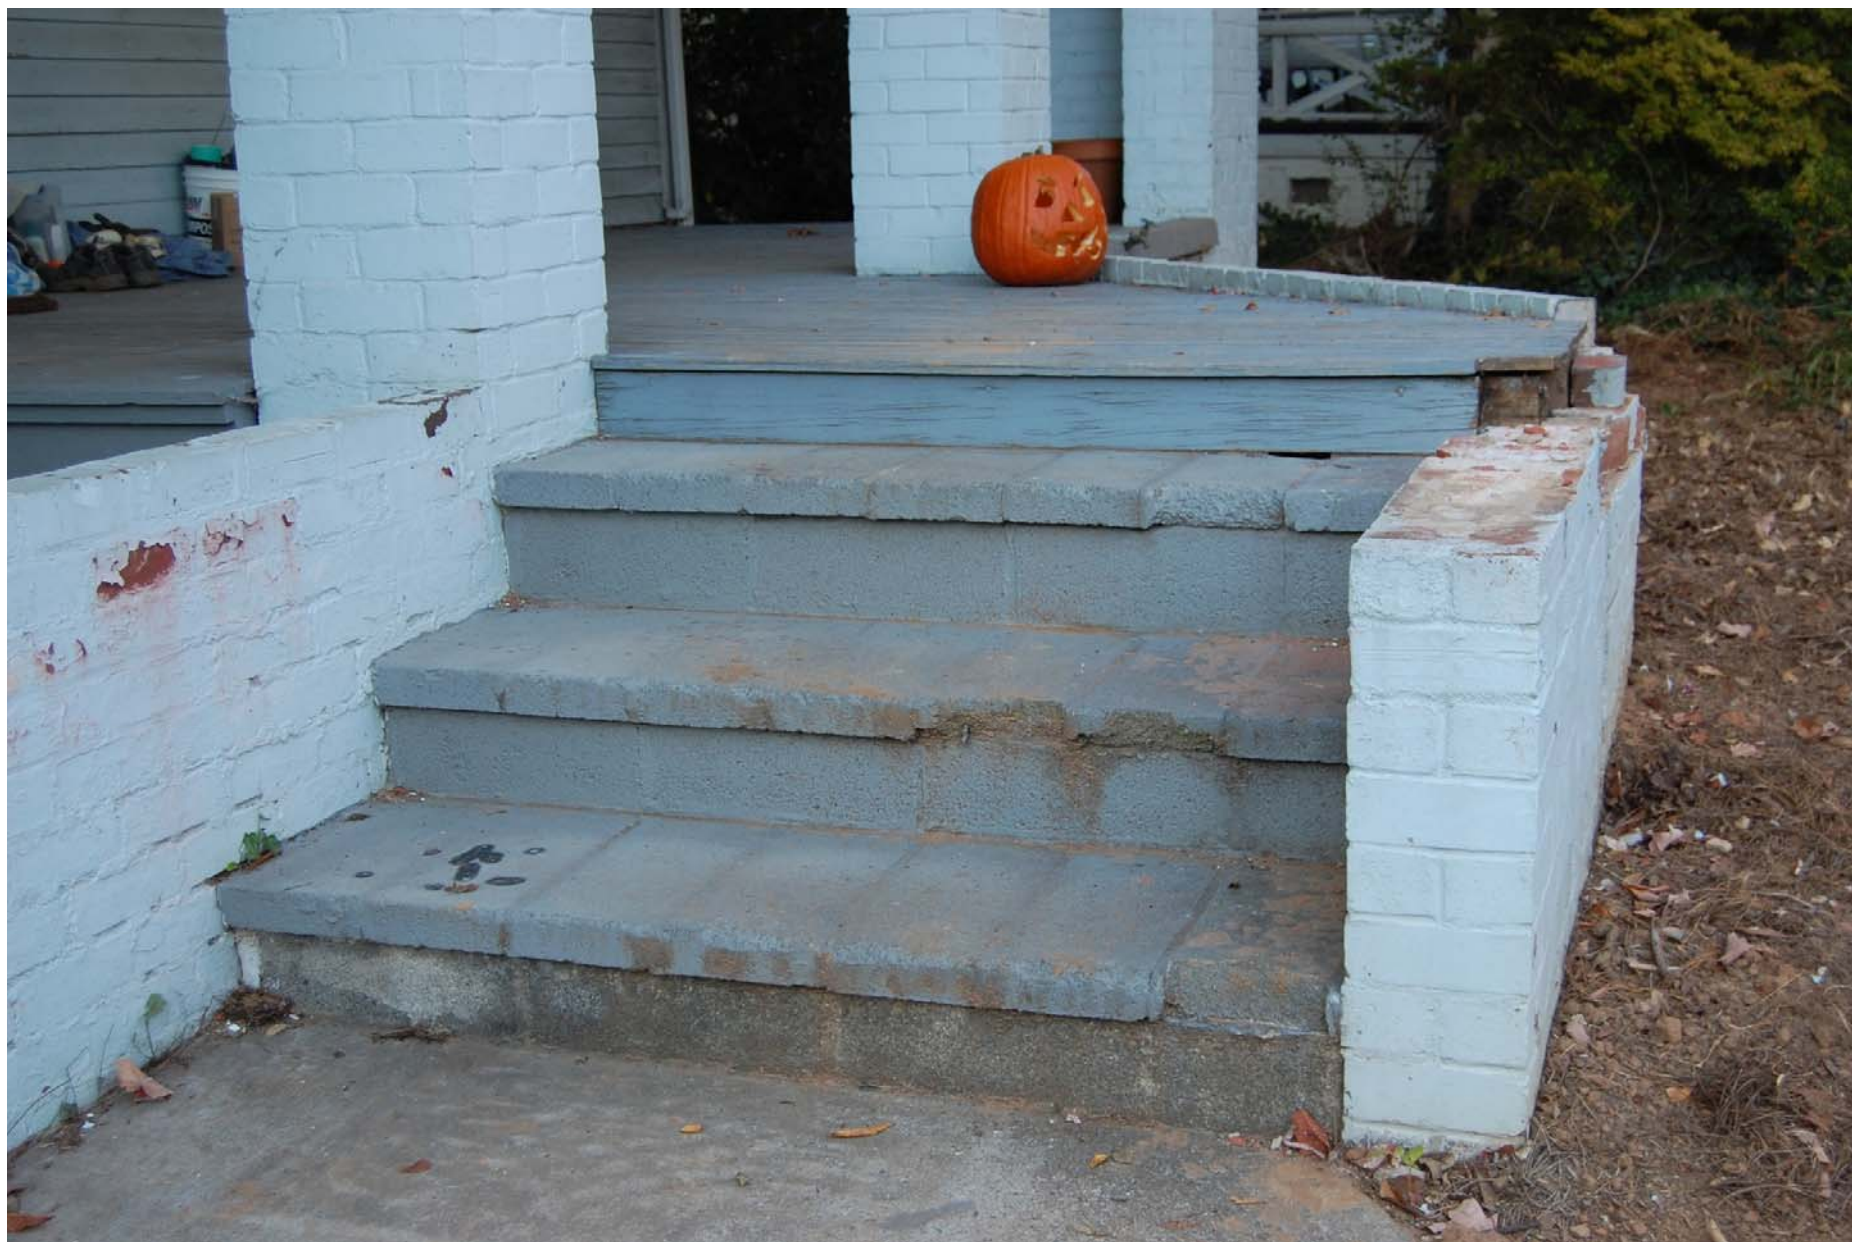
1924 Park Road – Front Steps

The existing front porch steps appear to have been constructed by a prior homeowner/builder back in the early 80's. The steps were constructed extremely poorly without a foundation or pad of any kind supporting them, and no appropriate means of attachment to the actual structure of the porch. As a result the steps have pulled away from the house and are independently crumbling beyond repair. Additionally, they were constructed with cinder block treads without a brick fascia and do not face the street, but rather the existing driveway. We have received estimates to construct new front porch steps entirely. The new steps will face the street directly (in line with the neighborhood and historical continuity) and consist of four steps surrounded by two cheek walls with masonry caps. The width of the steps will be 7 feet and cover the full breadth of the gap between out porch's two central columns. The cheek walls will be 16 inches on either side of the steps matching the exact width of the two central porch columns. Immediately below the steps will be a masonry landing equal in width with the steps. The landing will then taper into a 5 foot wide front walkway that will lead directly to the sidewalk and meet up with the current city supplied curb cut for a front walkway. At the sidewalk, the walkway will have one step down with cheek walls on either side, consistent with the street and the neighborhood.

It is our intention to remove the existing front steps and replace them with more period specific steps. Additionally we will be rectifying the poorly constructed front porch flooring to create a more historically accurate porch that is one level and consistent with the neighborhood.

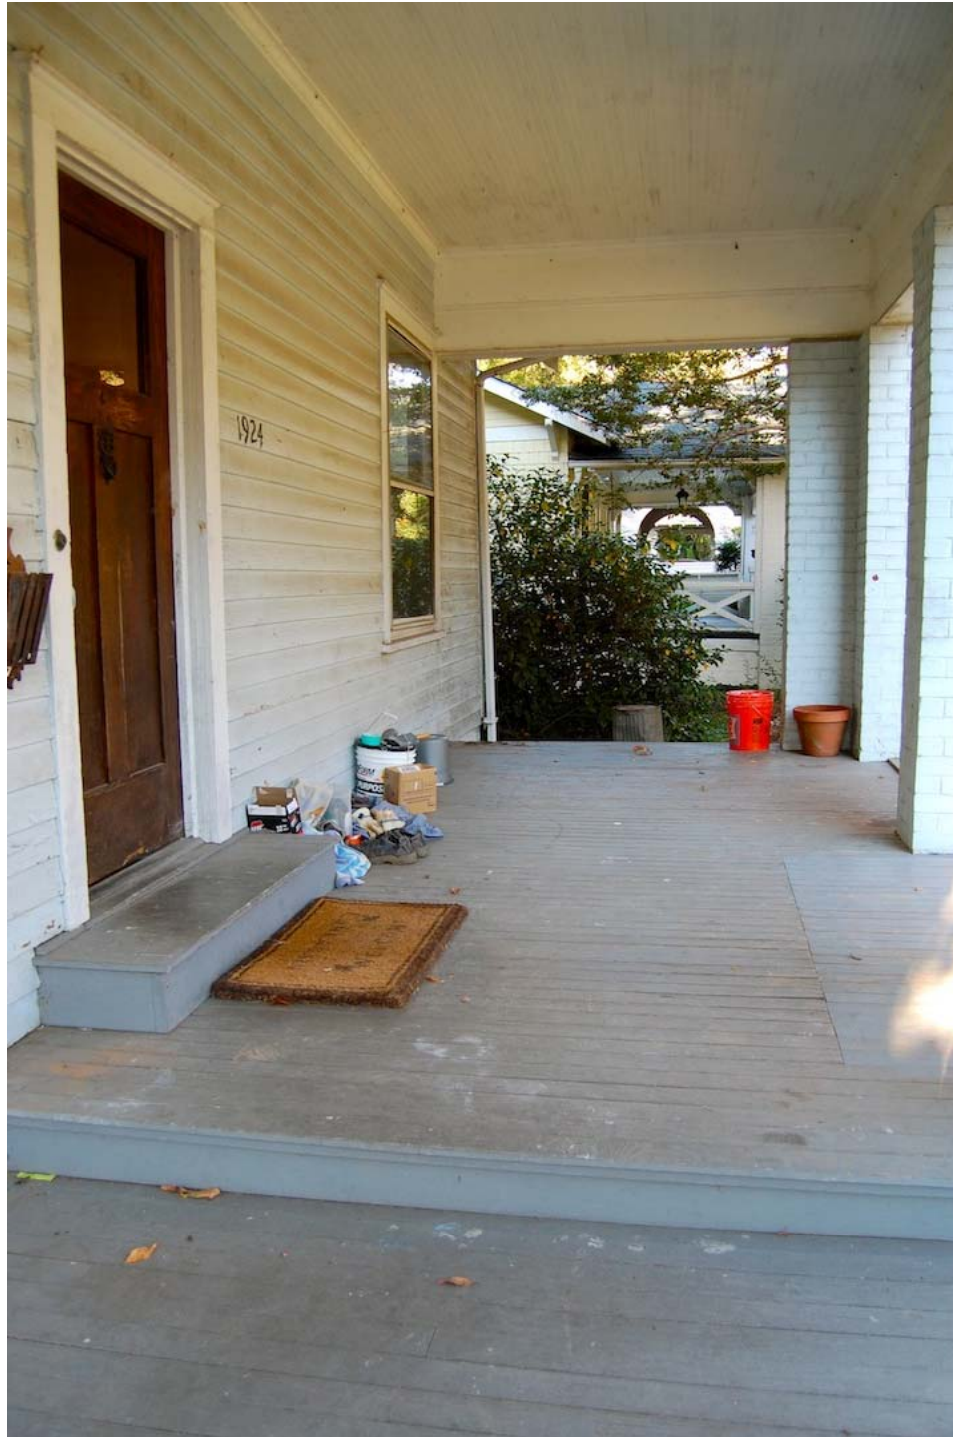
The Front porch appears to have been rebuilt at the same time as the front porch steps by the same builder. The builder removed the previous front porch railing (railing outlines can be clearly seen in the existing porch columns remaining paint) and lowered the porch floor creating a tiered porch and an awkward step up into the front door. We will be building directly on top of the existing flooring a one level front porch with Tongue and Groove hardwood flooring, consistent with the neighborhood, and re-installing a porch railing. This will result in a more uniform and historically accurate front porch that will more appropriately reflect the surrounding neighborhood.

1924 Park Road –  
View of tiered  
front porch –  
new porch floor  
will be level with  
the current step  
that leads up to  
the front door

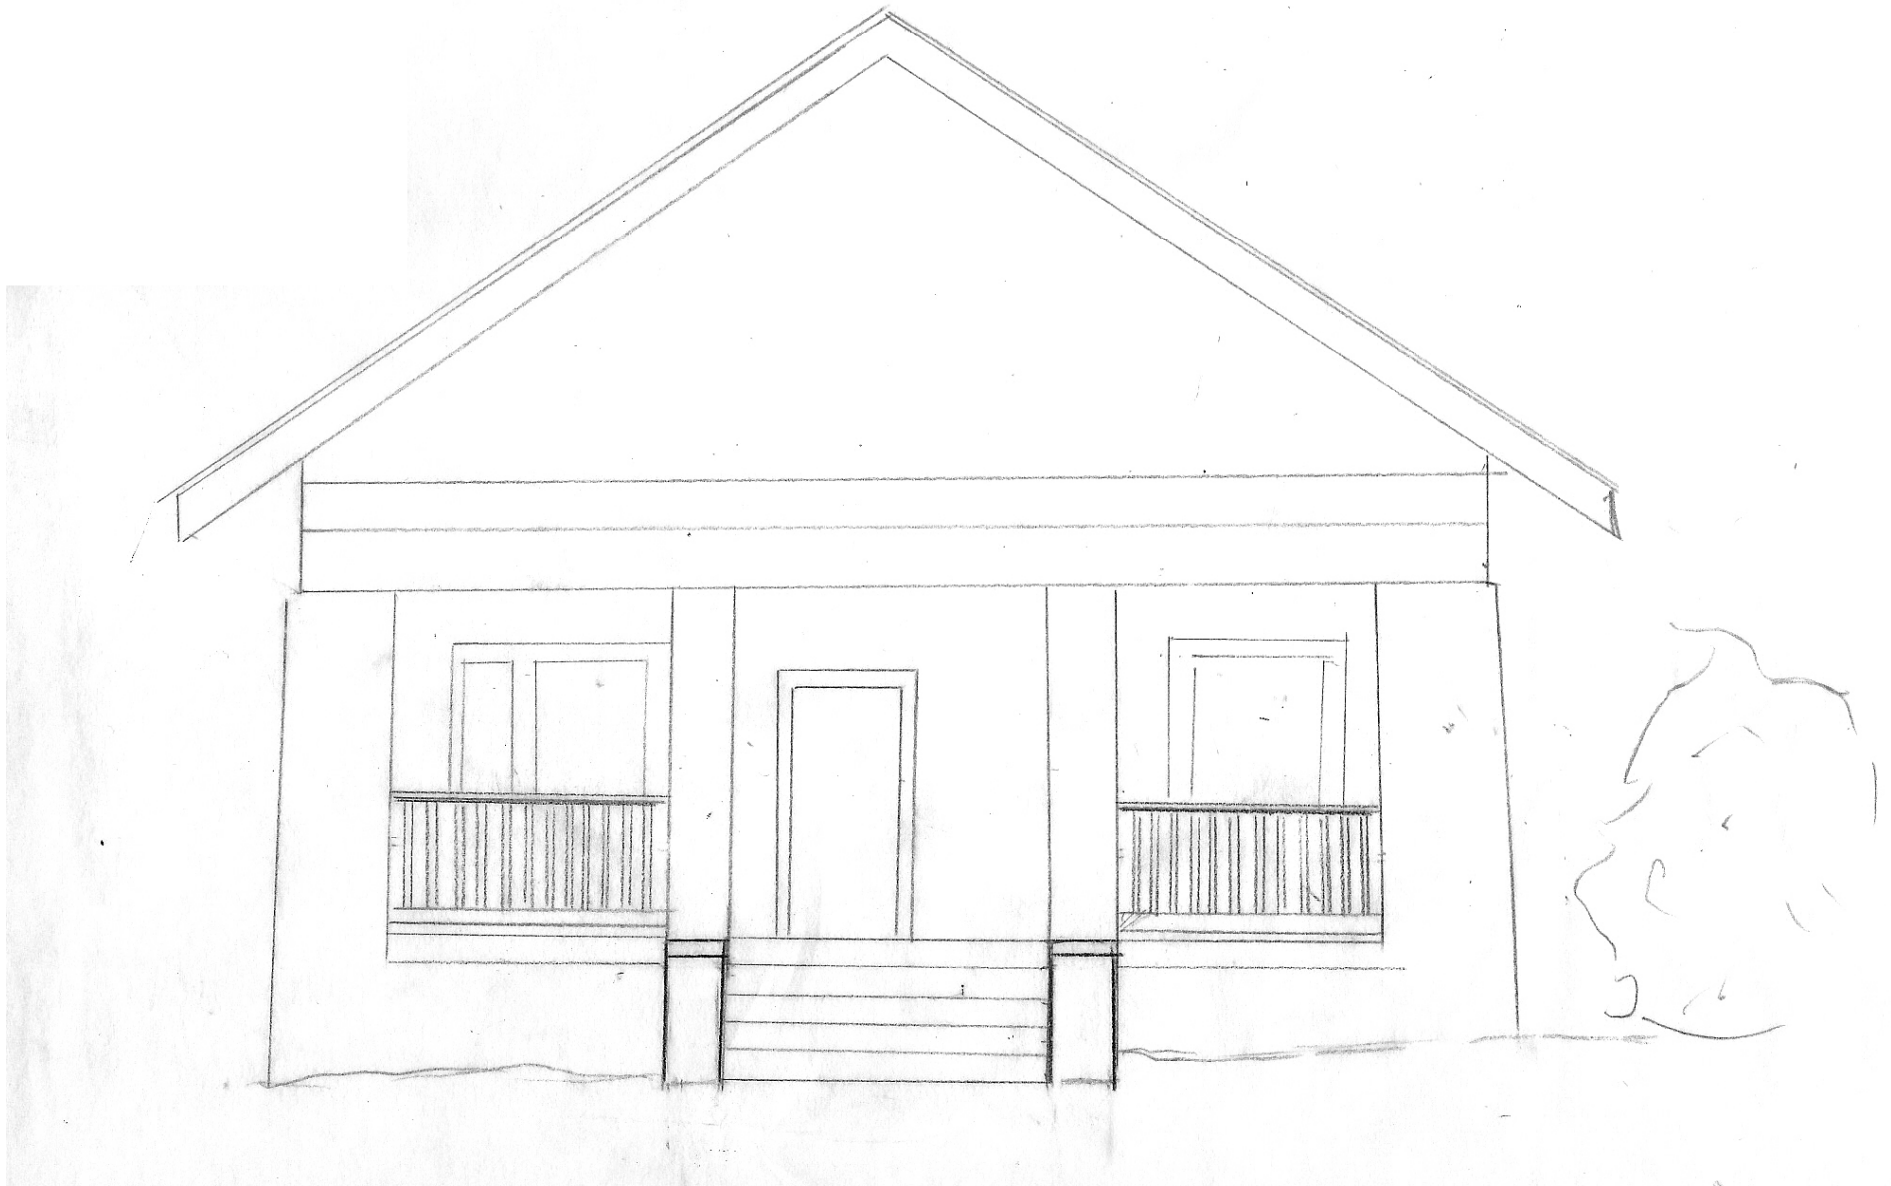
1924 Park Road – Drawing of Front Elevation after repair
