**PROPERTY ADDRESS:** 1816 Wickford Place

**SUMMARY OF REQUEST:** Demolition

# Charlotte Historic District Commission - Case 2015-257

Re: 1816 Wickford Place

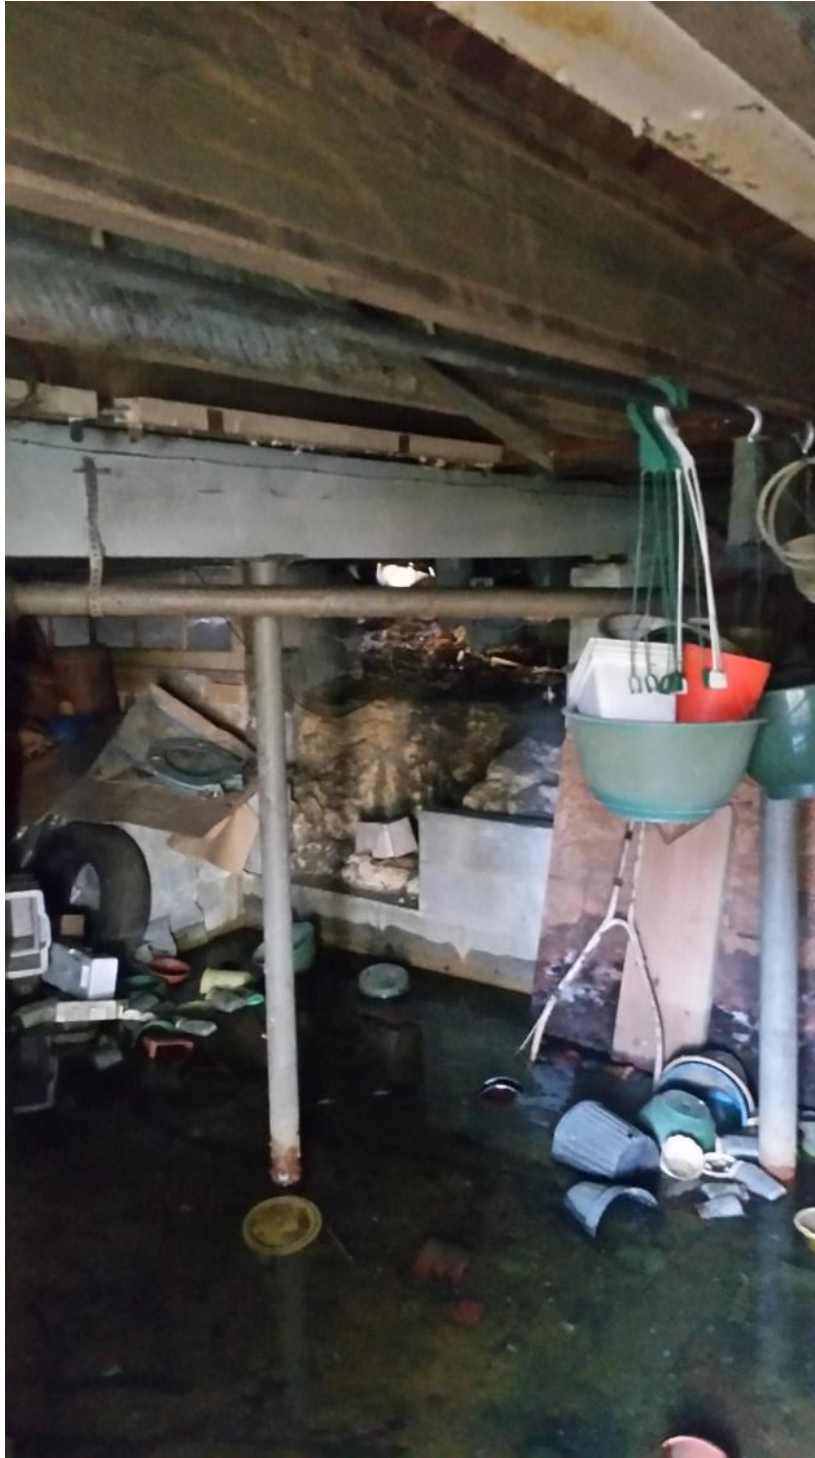
Standing Water in the Crawl Space

At the time of the inspection, the house was found to have been built as a typical mill house found in this region. Unfortunately, there was no attic access to inspect the roof and ceiling framing, but there is evidence of significant water intrusion in the ceilings that would suggest that the three tab shingles are falling and a new roof would be required. The roof was found to have noticeable deflections which is typically the result of a lack of bracing. The house was found to have been built on a lot that slopes down from the front to the back and from the right to the left without an adequate fall in the grade away from the foundation. As a result, water has continually entered the foundation and has result in the rear cellar section of the foundation being under several inches of water. Therefore, a thorough inspection of the foundation could not be performed. However, there are significant settlement cracks in the foundation as a result of these drainage conditions. The front porch slab was also found to have settled and would need to be completely replaced. A section of the siding on the right side of the house was missing and the exterior band and framing in the area was found to be significantly damage from water and insects. The extent of the damage to the house framing cannot be determined but it is likely that the majority of the floor and wall framing is no longer structurally sound. Therefore, it is our recommendation that the house be demolished and a new house built in its place.
