LOCAL HISTORIC DISTRICT: Plaza Midwood

PROPERTY ADDRESS: 1513 Belvedere Avenue

SUMMARY OF REQUEST: Replacement windows

Charlotte Historic District Commission Case 2017-519
HISTORIC DISTRICT: PLAZA MIDWOOD
REPLACEMENT WINDOWS

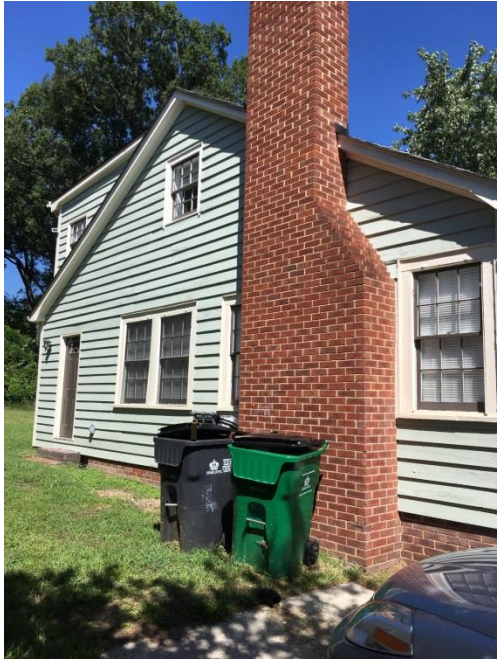
Left side from
driveway (6
double hung
windows, with
5 visible from
the street)

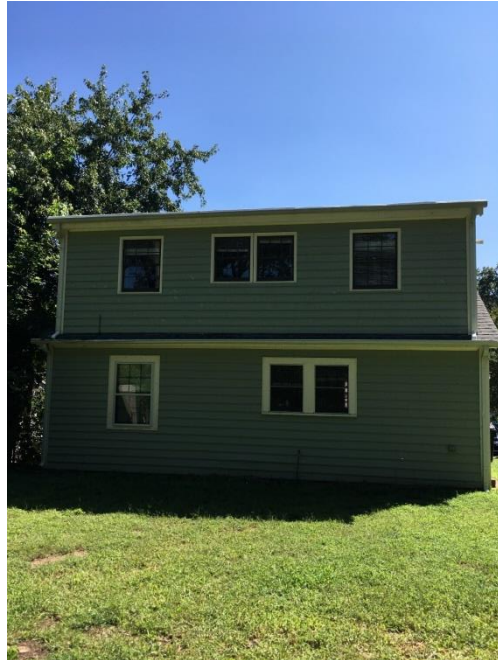
Back (7 double
hung windows,
none of which
are visible from
street)

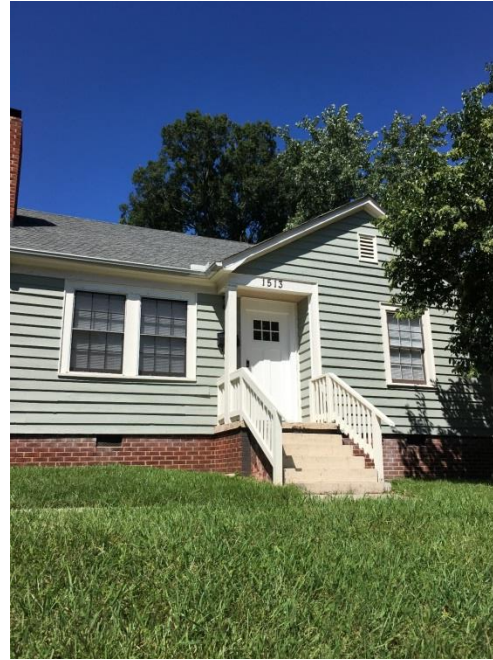
Front (3 double
hung windows
visible from street)

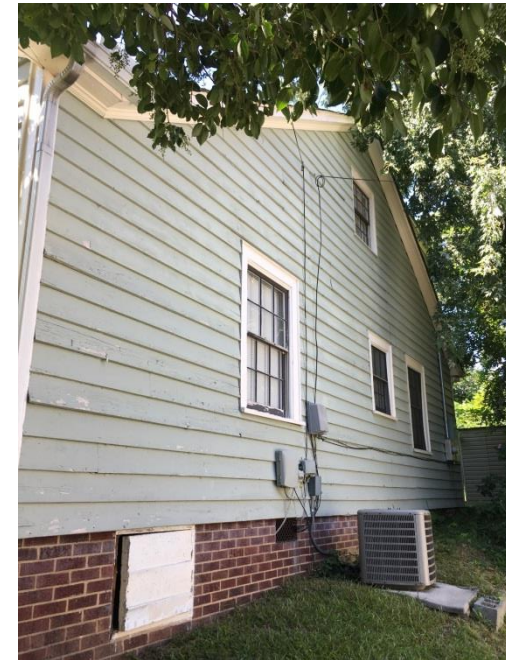
Right side from side
of house (5 double
hung windows with
4 visible from the
street)

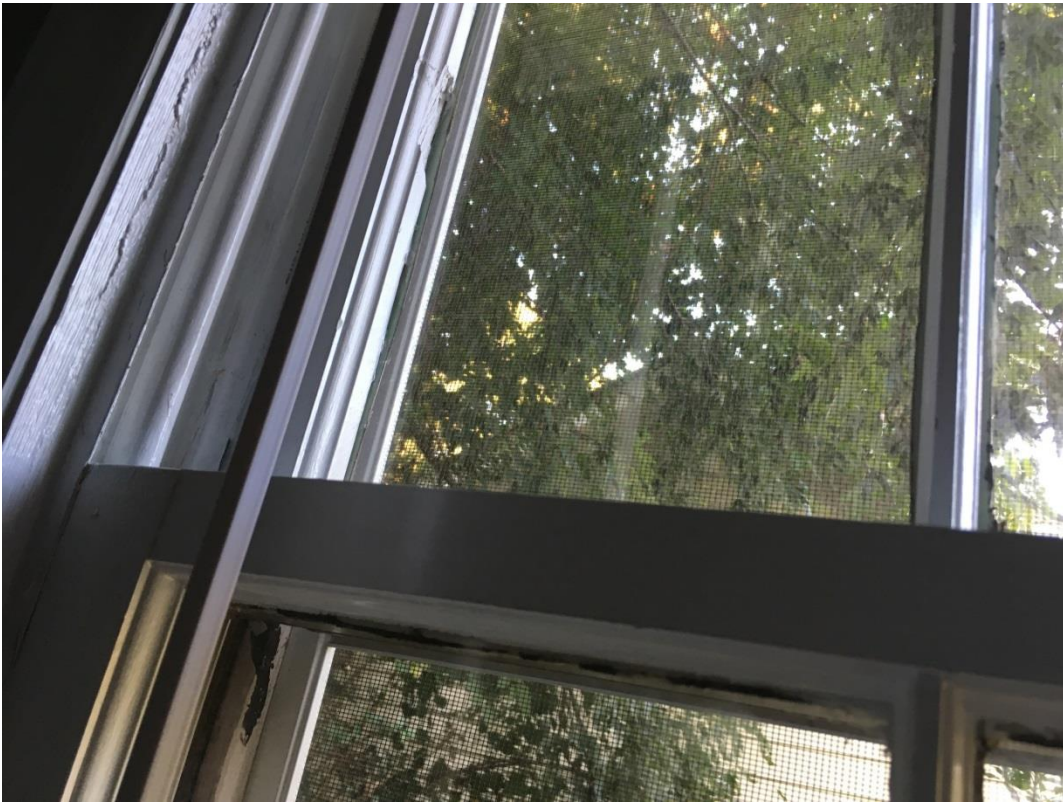
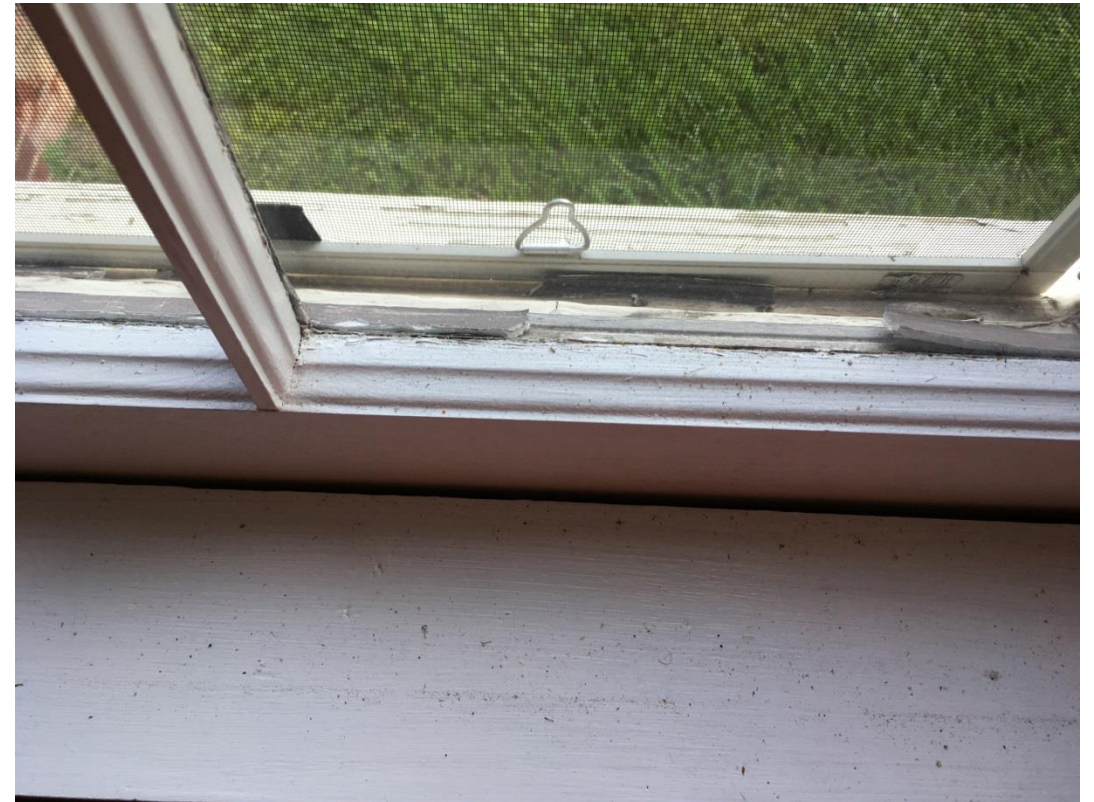
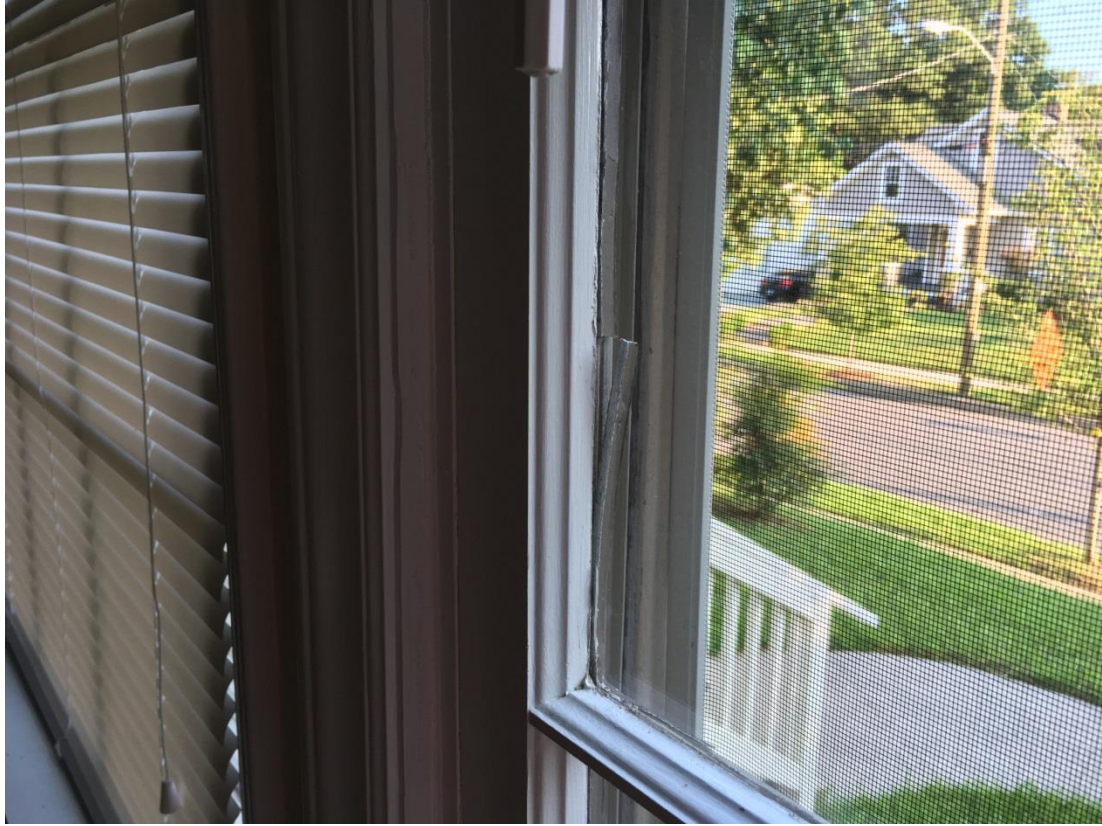
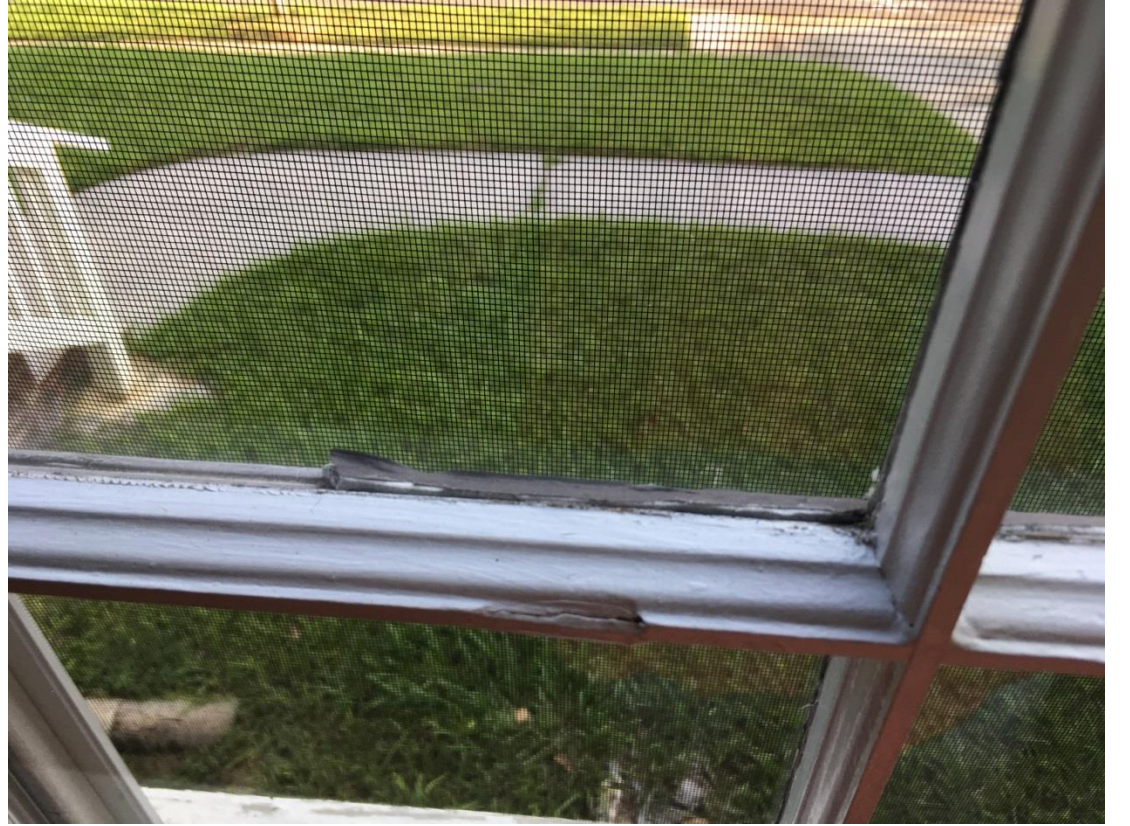
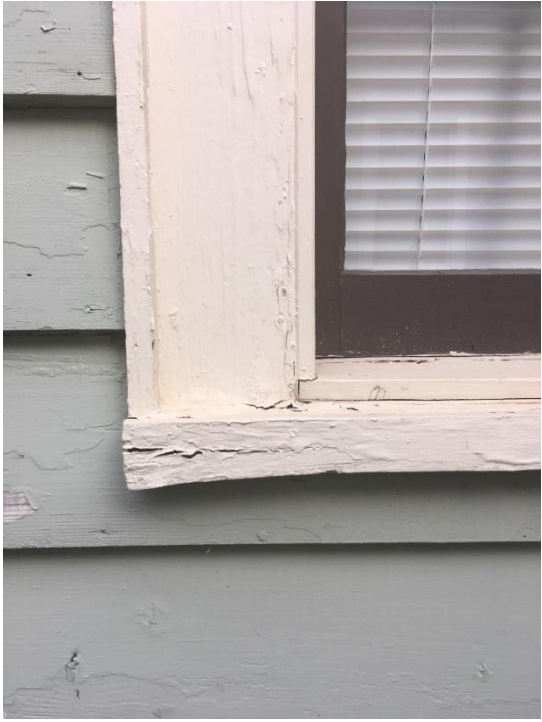
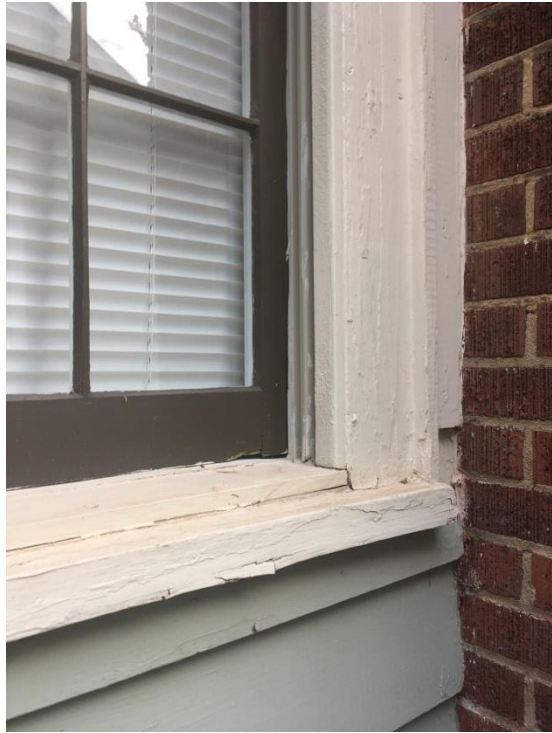
Current Condition of the Windows (interior and exterior views):

- 21 total windows, with 9 not visible from the street
- 6 windows part of a recent addition. All 6 are not visible from the street.
- All windows are wood single pane windows.
- Window panes are cracked in several windows (master bedroom and living room)
- Several windows were painted shut by the last owner and cannot be opened
- Almost all windows that can be opened require more effort than they should and need to be propped open in many cases
- Several of the inoperable windows are in the master bedroom (addition) on the second floor and are therefore a safety hazard
- Exterior trim has severe wood rot
- Many windows are missing glazing.

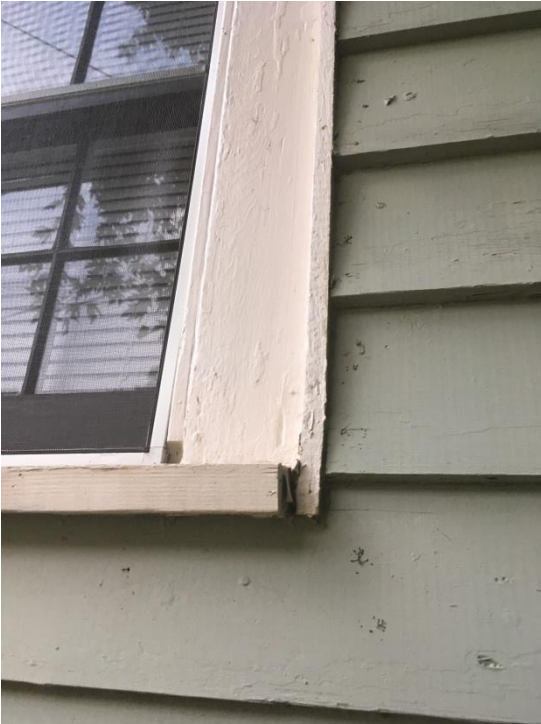
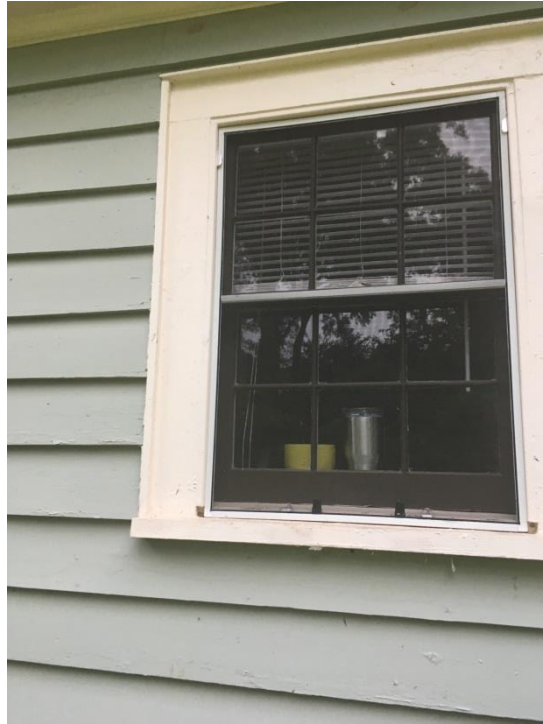
Various window(s) have missing/peeling glazing. Recommend re-glazing to increase comfort levels inside home and prevent glass from falling out.

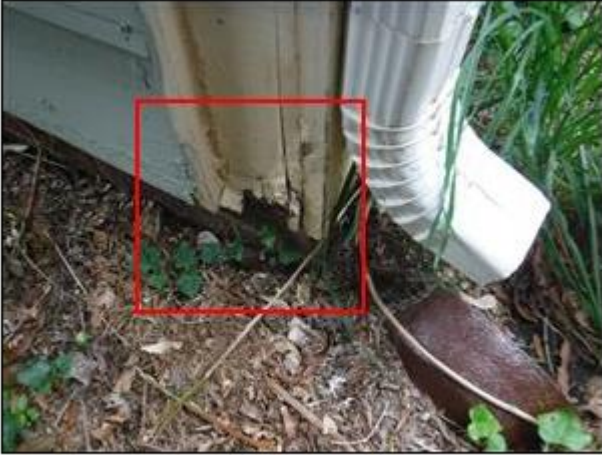
2.0 Picture 4

Lots of rotted wood

-replace wood and cap to match in vinyl (w/ or w/out wood grain finish) white.
