LOCAL HISTORIC DISTRICT: Plaza Midwood

PROPERTY ADDRESS: 2101 The Plaza

SUMMARY OF REQUEST: Painted Brick

Paint Removal Test – November 2019

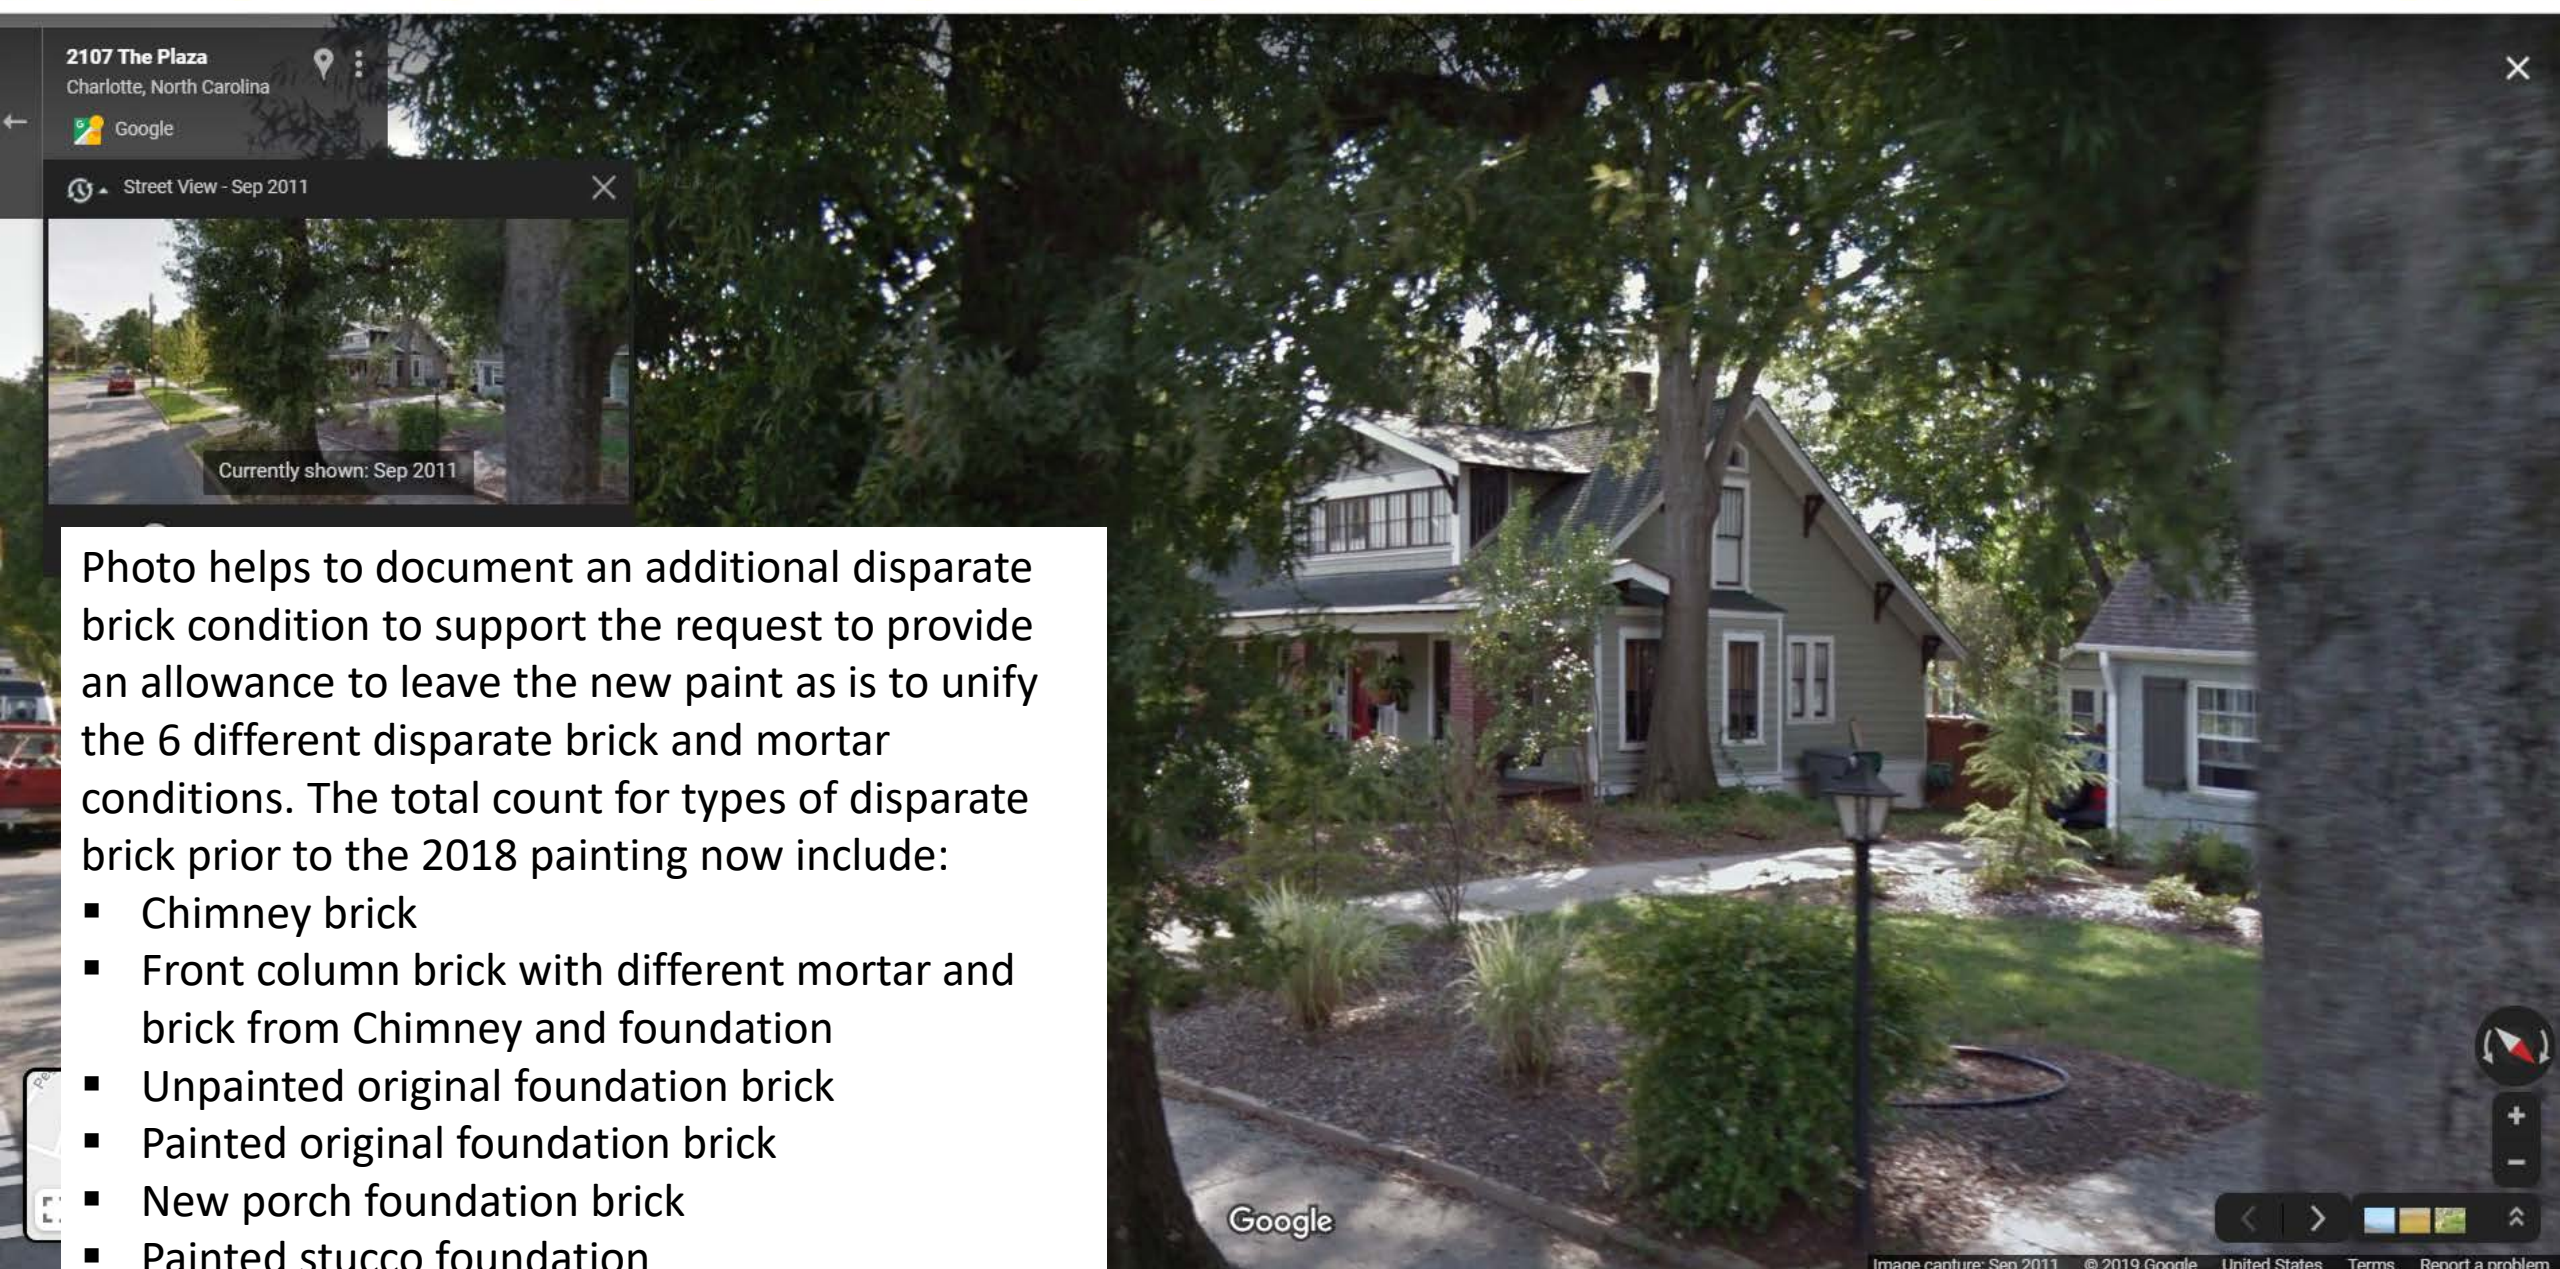
Photo helps to document an additional disparate brick condition to support the request to provide an allowance to leave the new paint as is to unify the 6 different disparate brick and mortar conditions. The total count for types of disparate brick prior to the 2018 painting now include:

- Chimney brick
- Front column brick with different mortar and brick from Chimney and foundation
- Unpainted original foundation brick
- Painted original foundation brick
- New porch foundation brick
- Painted stucco foundation

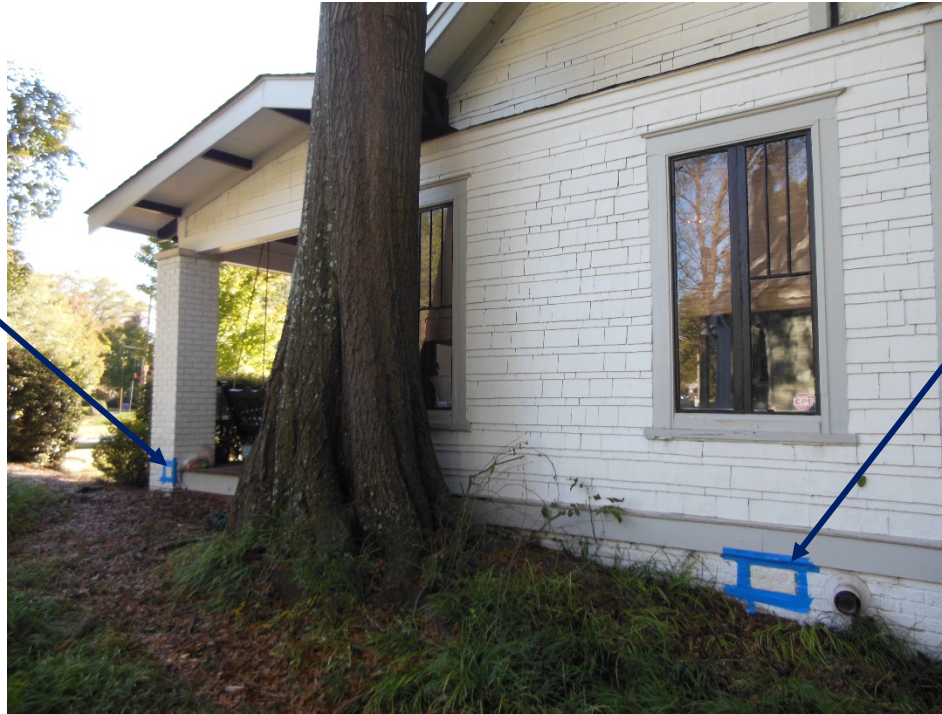
Sample Area 2

Bricks: The bricks in this area are new textured bricks.

Paint: At first sight, the applied paint was the first application. No other layers exist below.

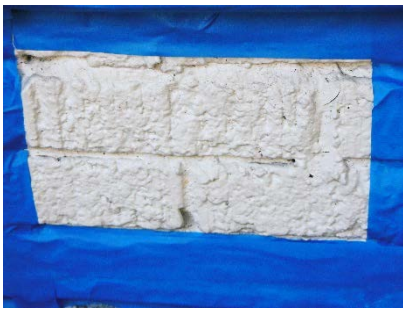
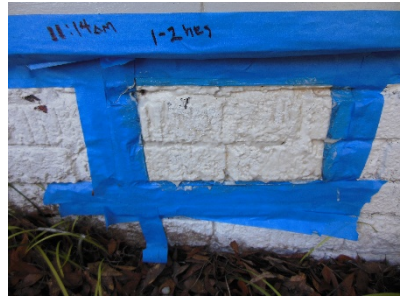
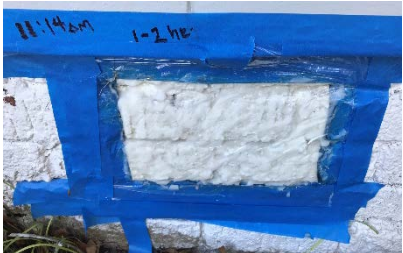
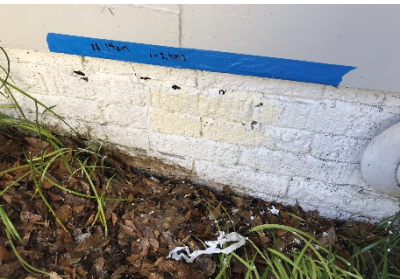
Sample Area 1

Bricks: The bricks in this area are older/original and most likely match the bricks on the chimney.

Paint: At first sight, area seems to have multiple-layers of paint.

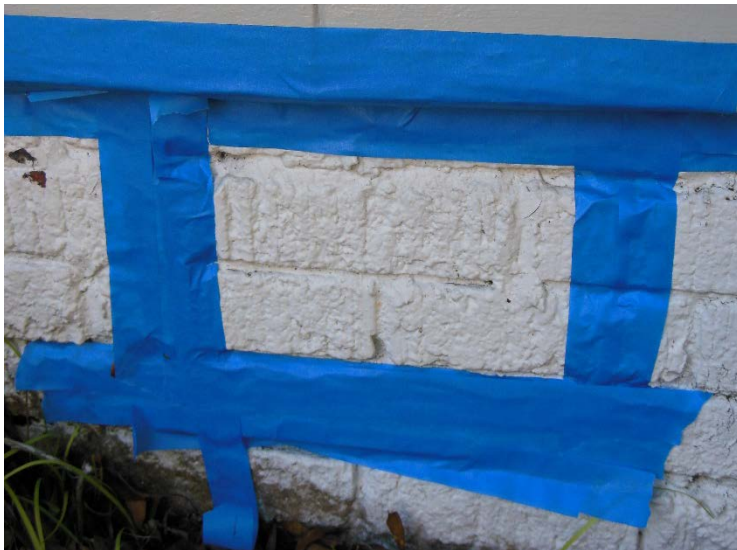
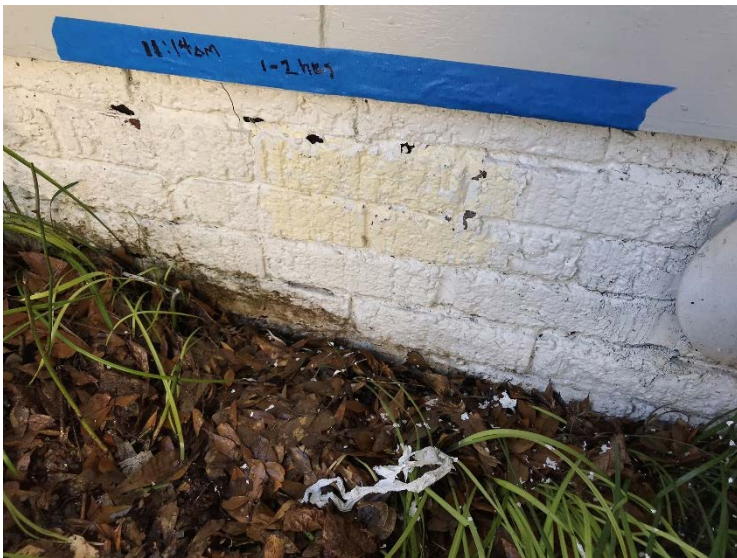
Sample Area 1: Before

Right-side Original Foundation: After approximately 23hrs, the paint stripper was removed using a plastic scraper and a garden hose. As suspected an additional layer of paint was reveled. Additional applications, with long dwell times, and a low psi pressure washer will be needed to remove all the applied paint from the brick surface.

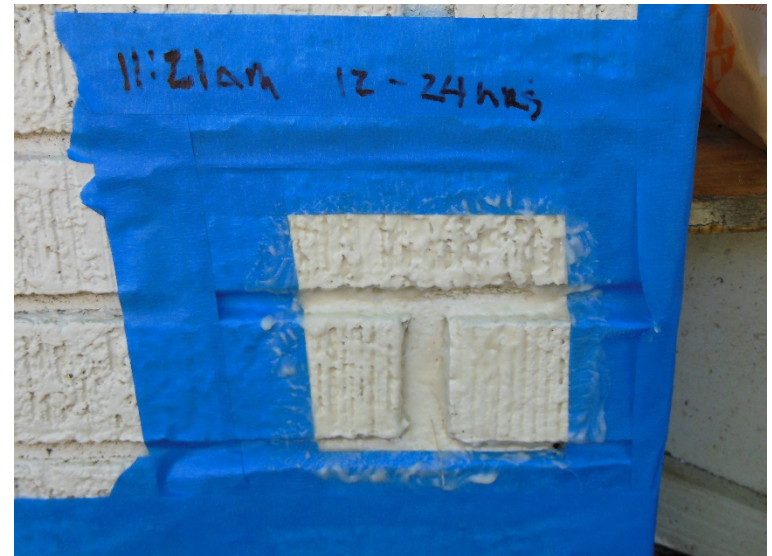
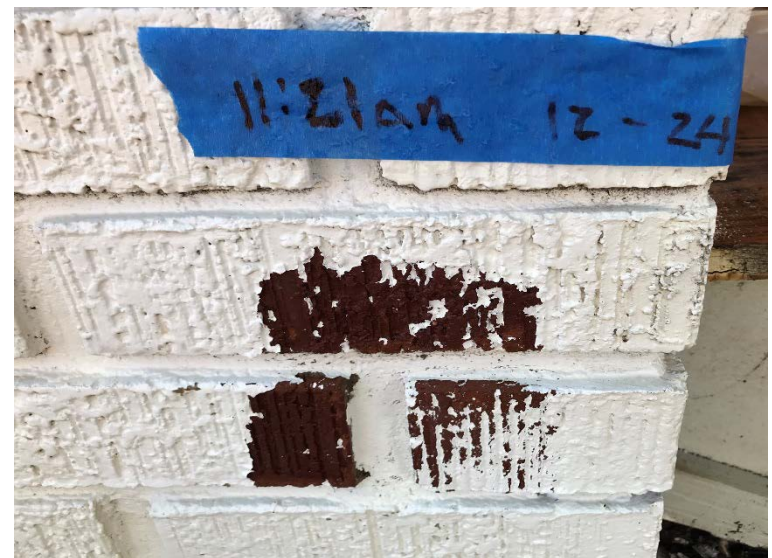
Sample Area 2: Before

Right-side Front Column: After approximately 23hrs the paint stripper was removed using a plastic scraper and a garden hose. A low psi pressure washer and additional applications with long dwelling times should remove a majority of the paint.

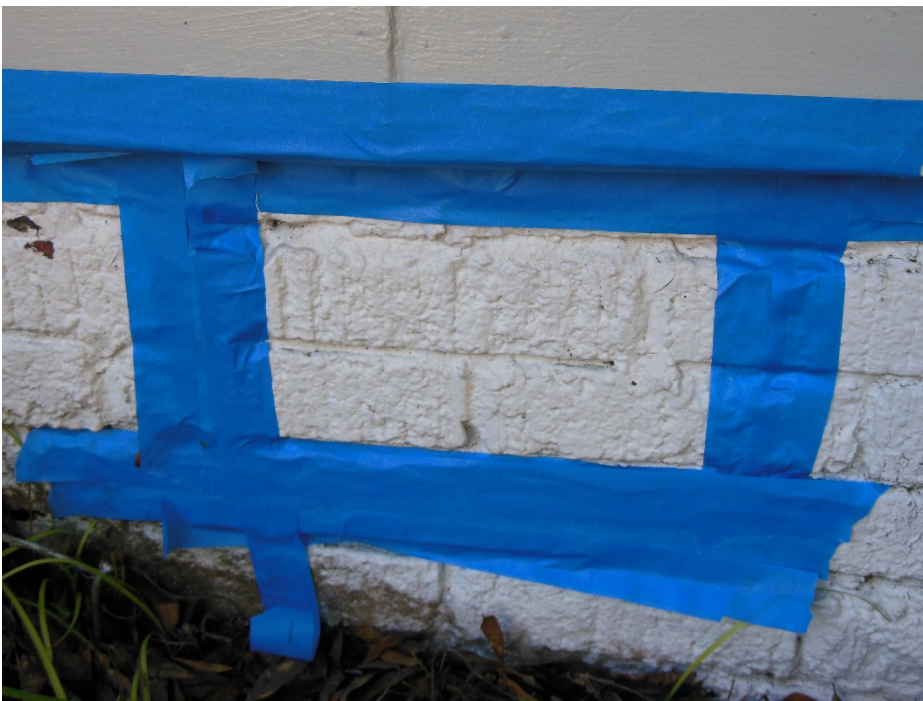
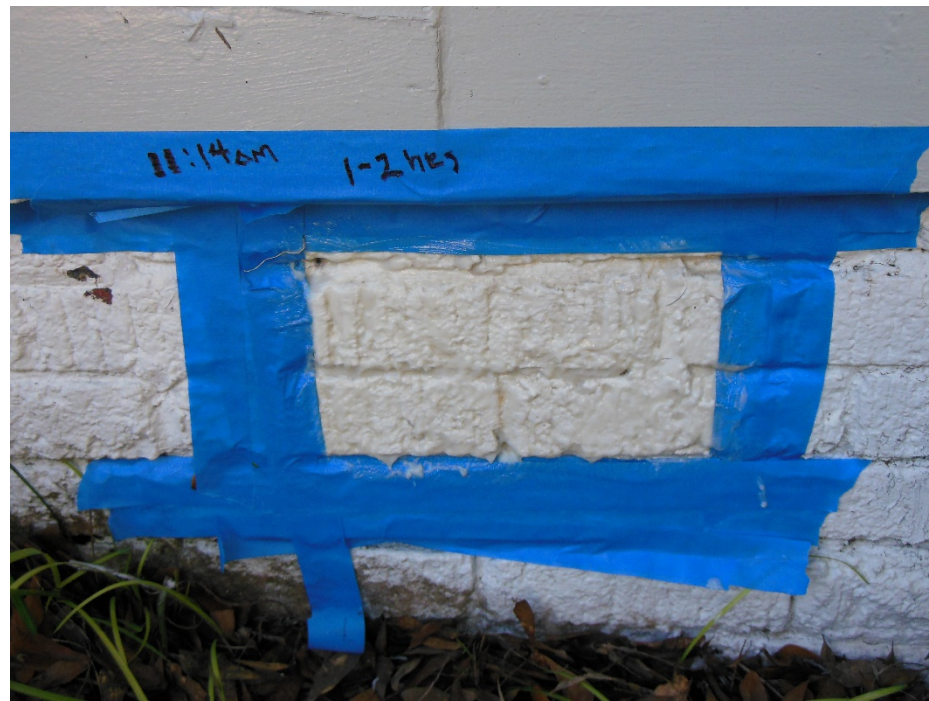
Sample Area 1 – 11:14am

Right-side Original Foundation: The area was selected by the homeowner. Once the area was taped off, a soft bristle brush was used to remove any loose dirt from the surface. Using a disposable paintbrush, the paint striper was applied and left to dwell for approximately 1hr-10mins.

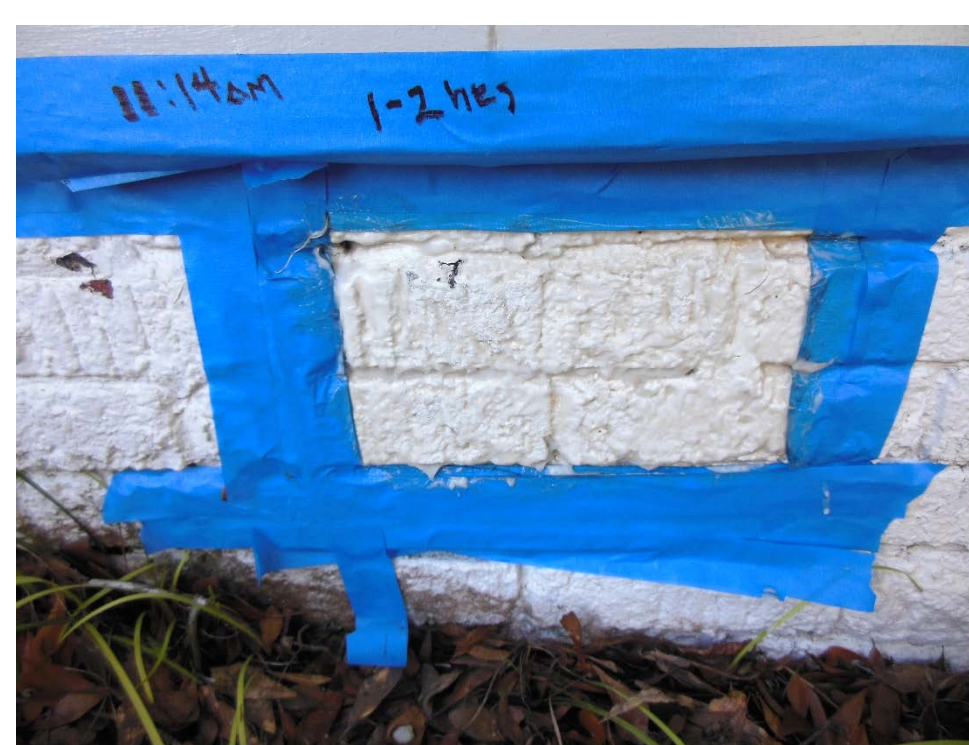
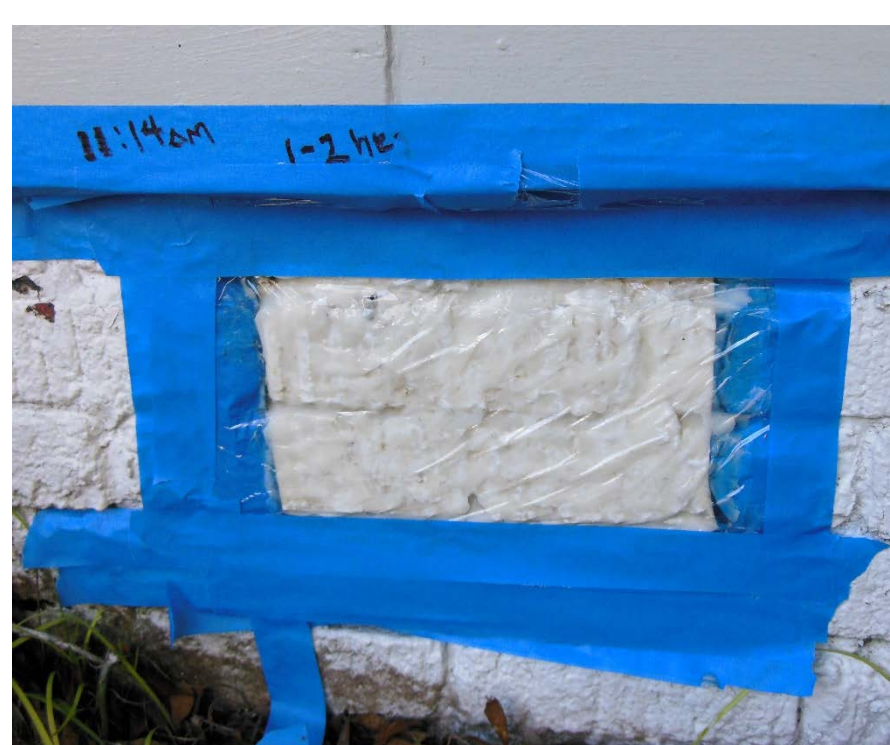
Sample Area 1 – 11:14am

Right-side Original Foundation: After a little over an one hour there was noticeable movement of the paint but not enough to do a complete removal of the product. A longer dwell time was needed. An additional layer of the paint striper was applied. A piece of plastic was added for insulation and to protect the sample area through the night.

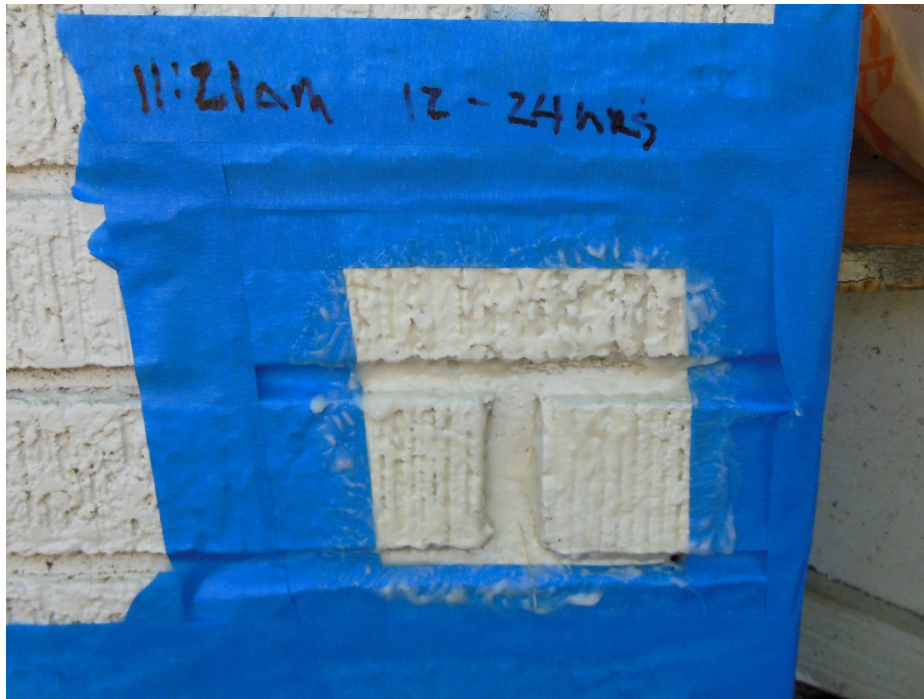
Sample Area 2 – 11:21am

Right-side Front Column: The area was selected by the homeowner. Once the area was taped off, a soft bristle brush was used to remove any loose dirt from the surface. Using a disposable paintbrush, the paint stripper was applied and left to dwell for approximately 1 hr-10mins.

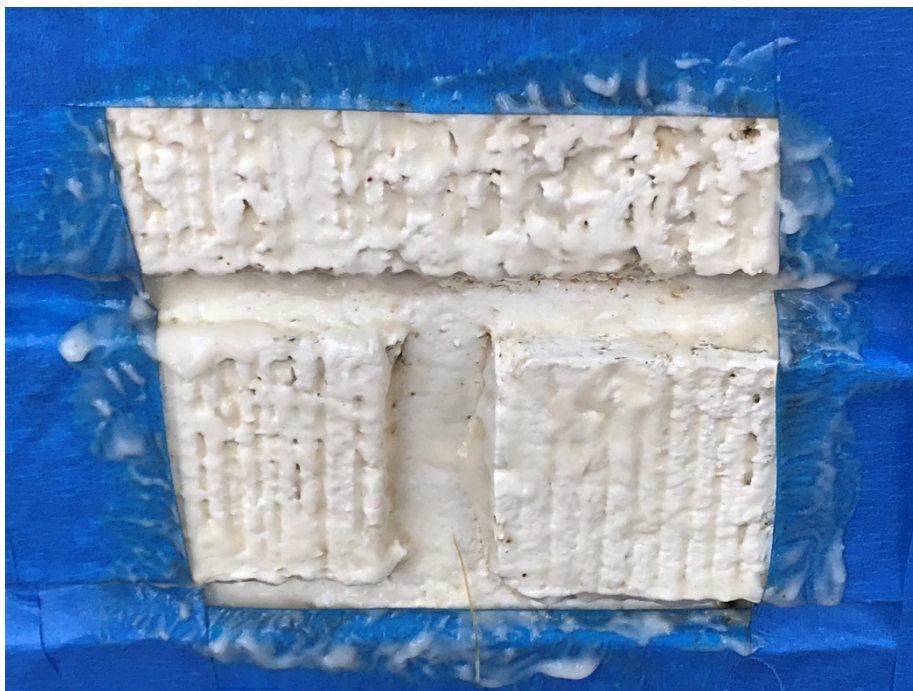
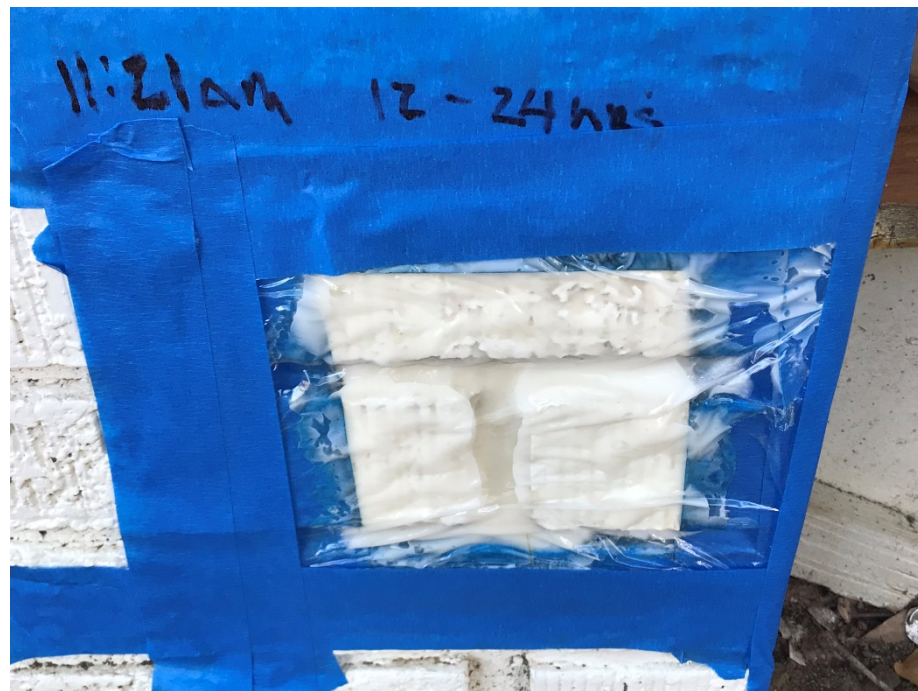
Sample Area 2 – 11:21am

Right-side Front Column: After a little over an one hour there was no noticeable movement of the paint. A longer dwell time was needed. An additional layer of the paint striper was applied. A piece of plastic was added for insulation and to protect the sample area through the night.
