LOCAL HISTORIC DISTRICT: Dilworth

PROPERTY ADDRESS: 1508 Dilworth Road

SUMMARY OF REQUEST: Detached garage addition, tree removal and tree replacement

Charlotte Historic District Commission Case 2018-024
HISTORIC DISTRICT: DILWORTH
ACCESSORY BUILDING

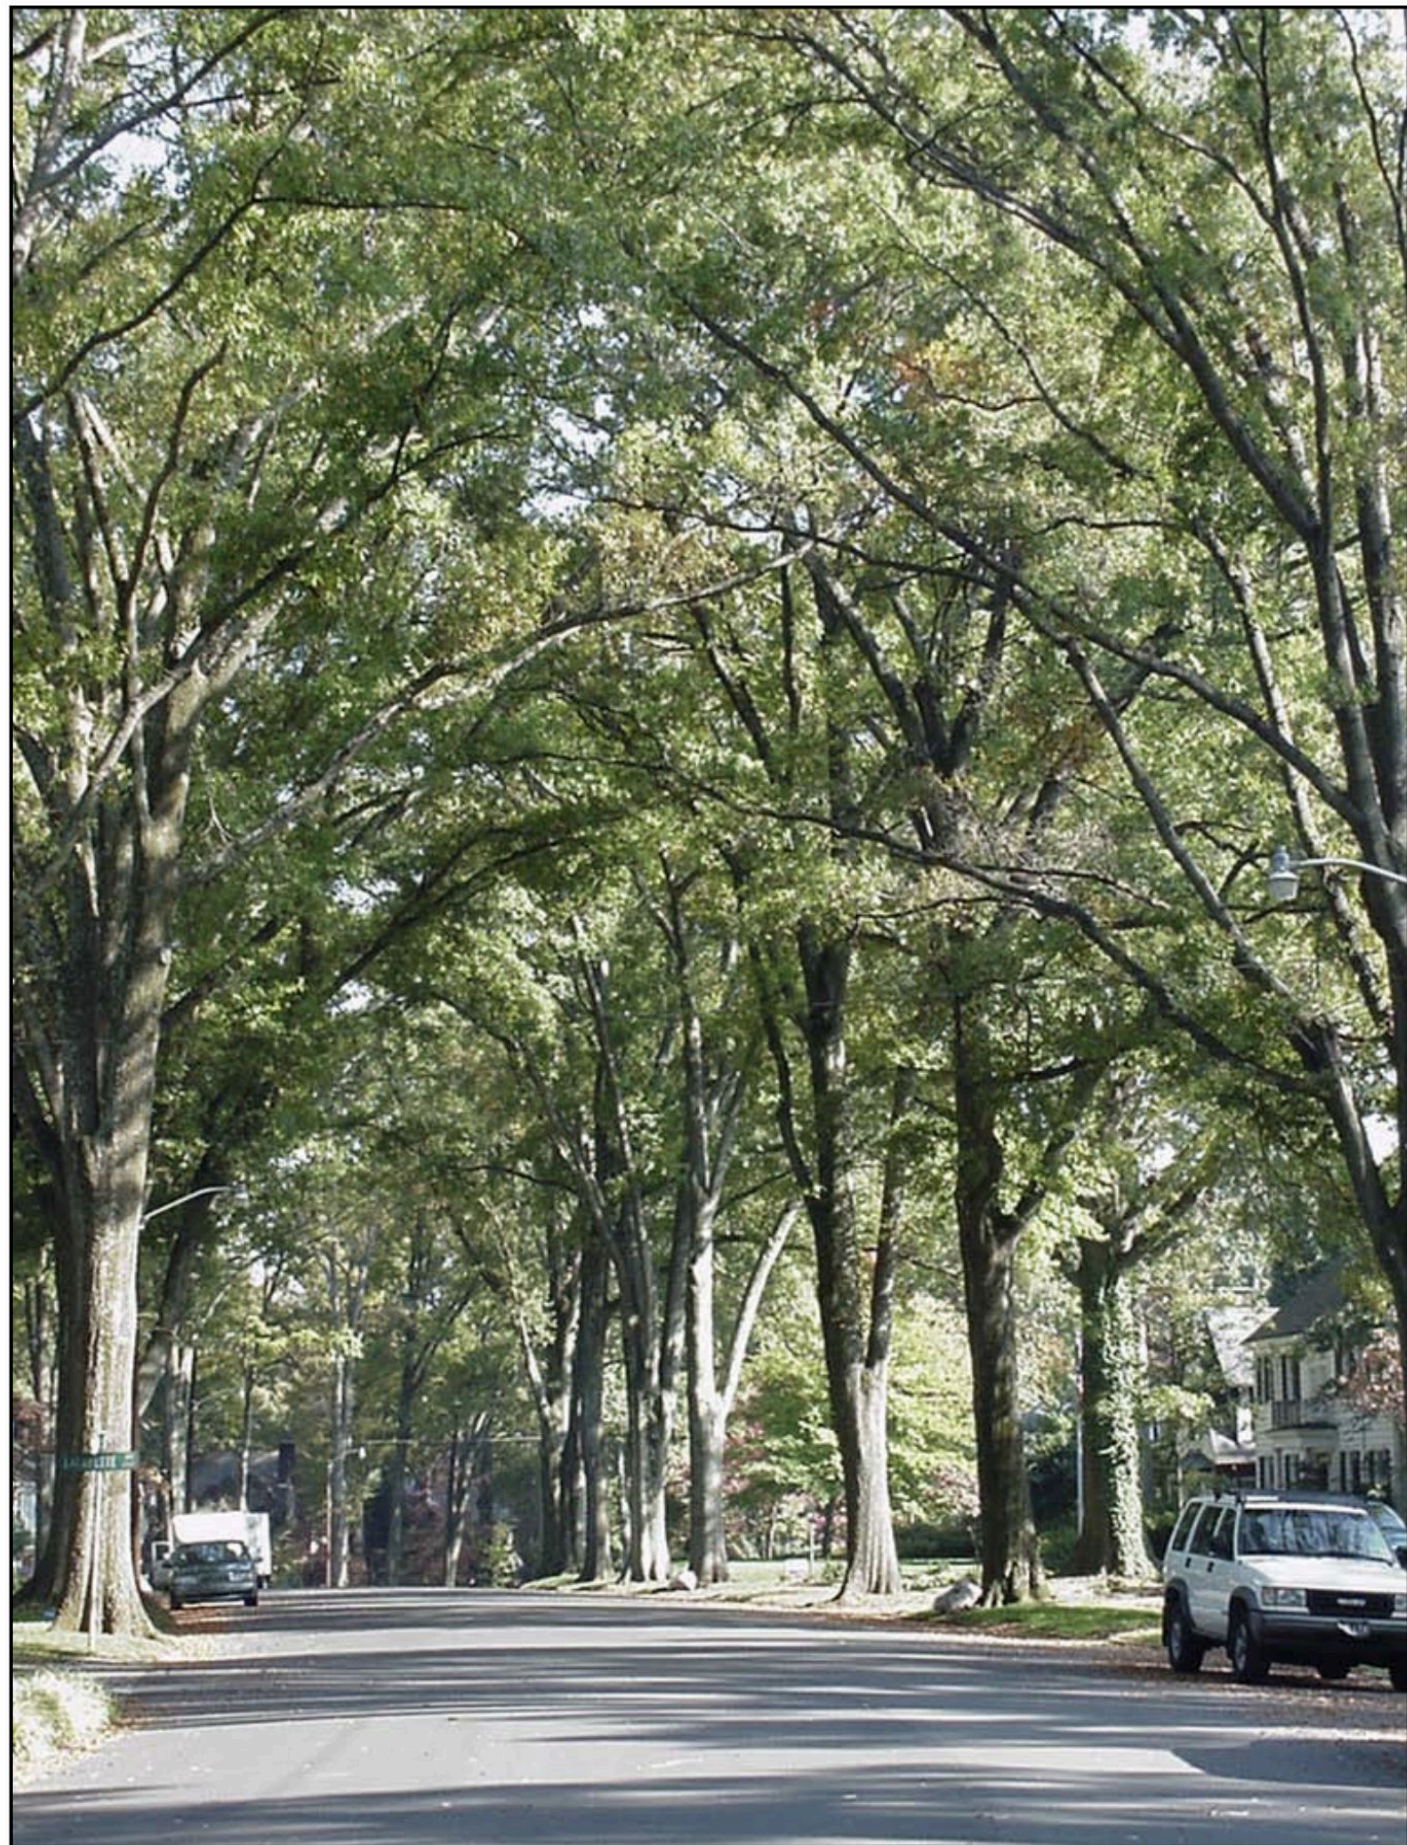
Many Street Trees are 40"-50"+ with full, well balanced crowns and straight trunks

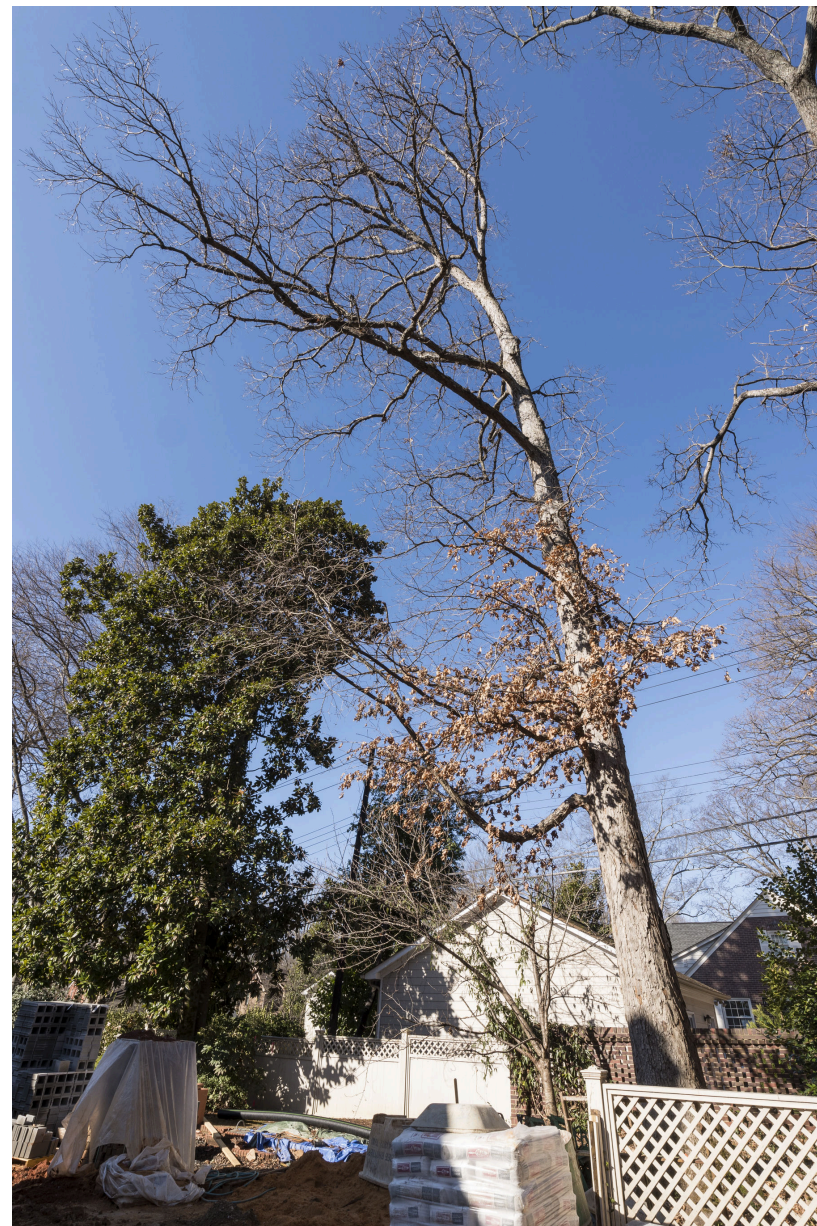
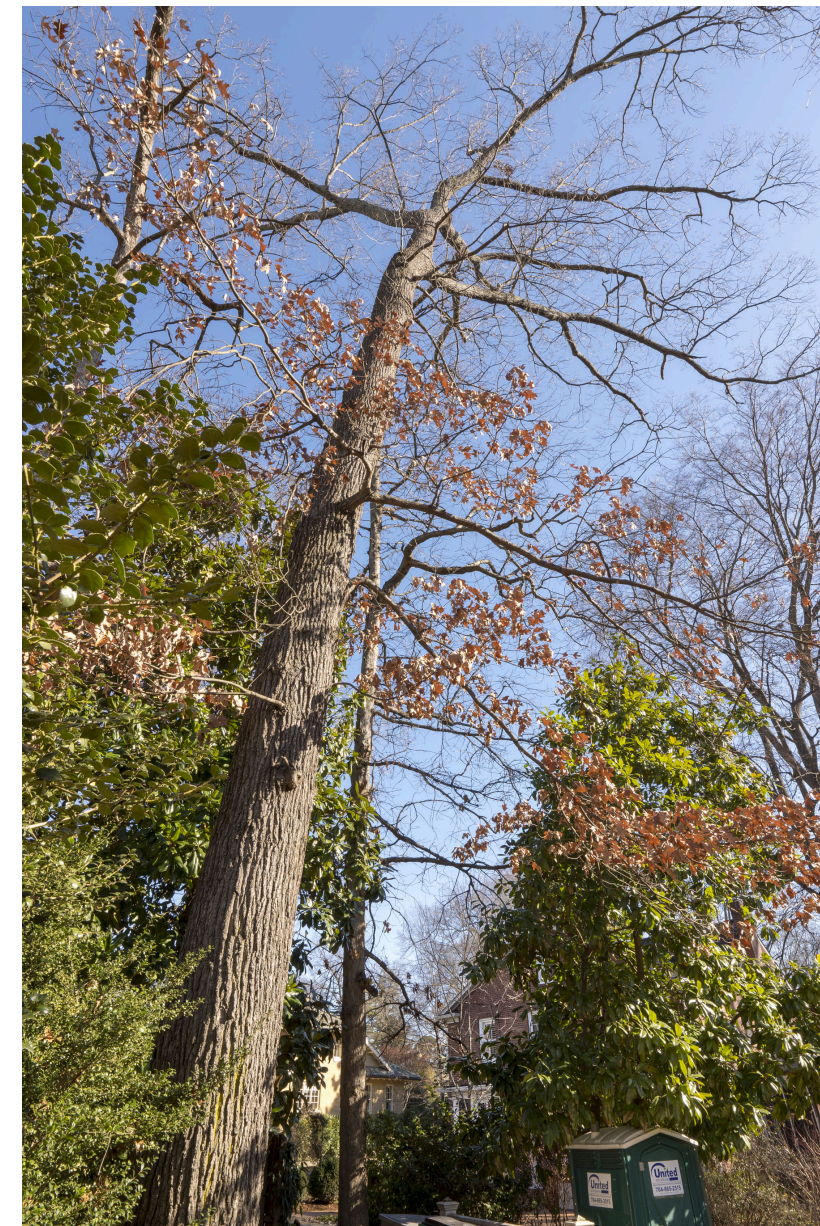
30" Oaks in Question are leaning dangerously, with unbalanced crowns due to repeated trimming for utility clearance, as well as the loss of a 3rd tree between them

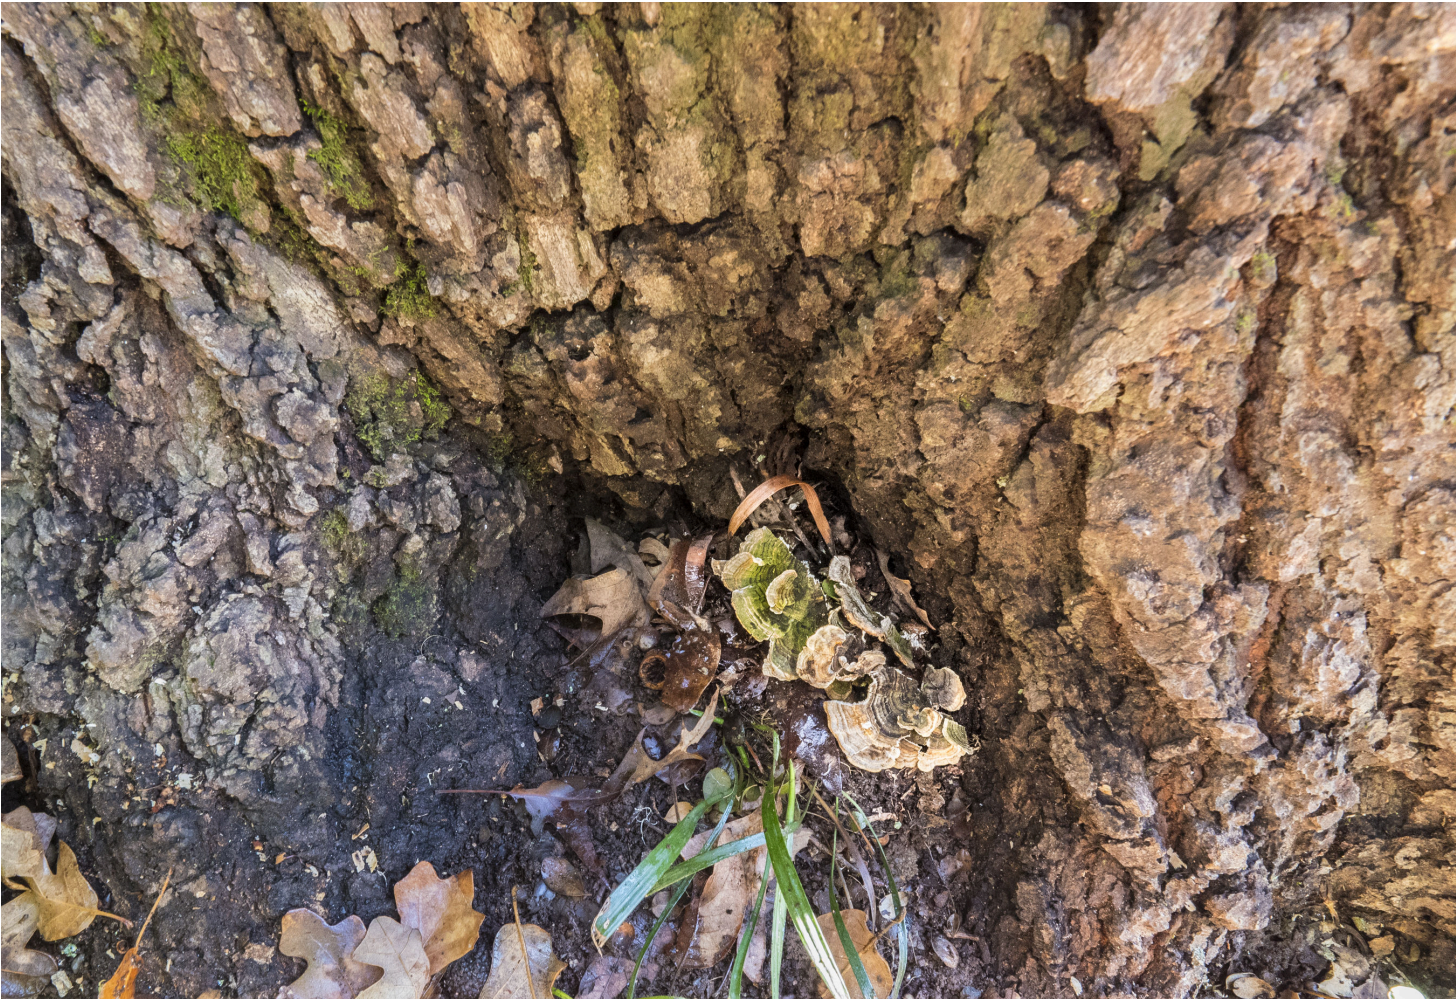
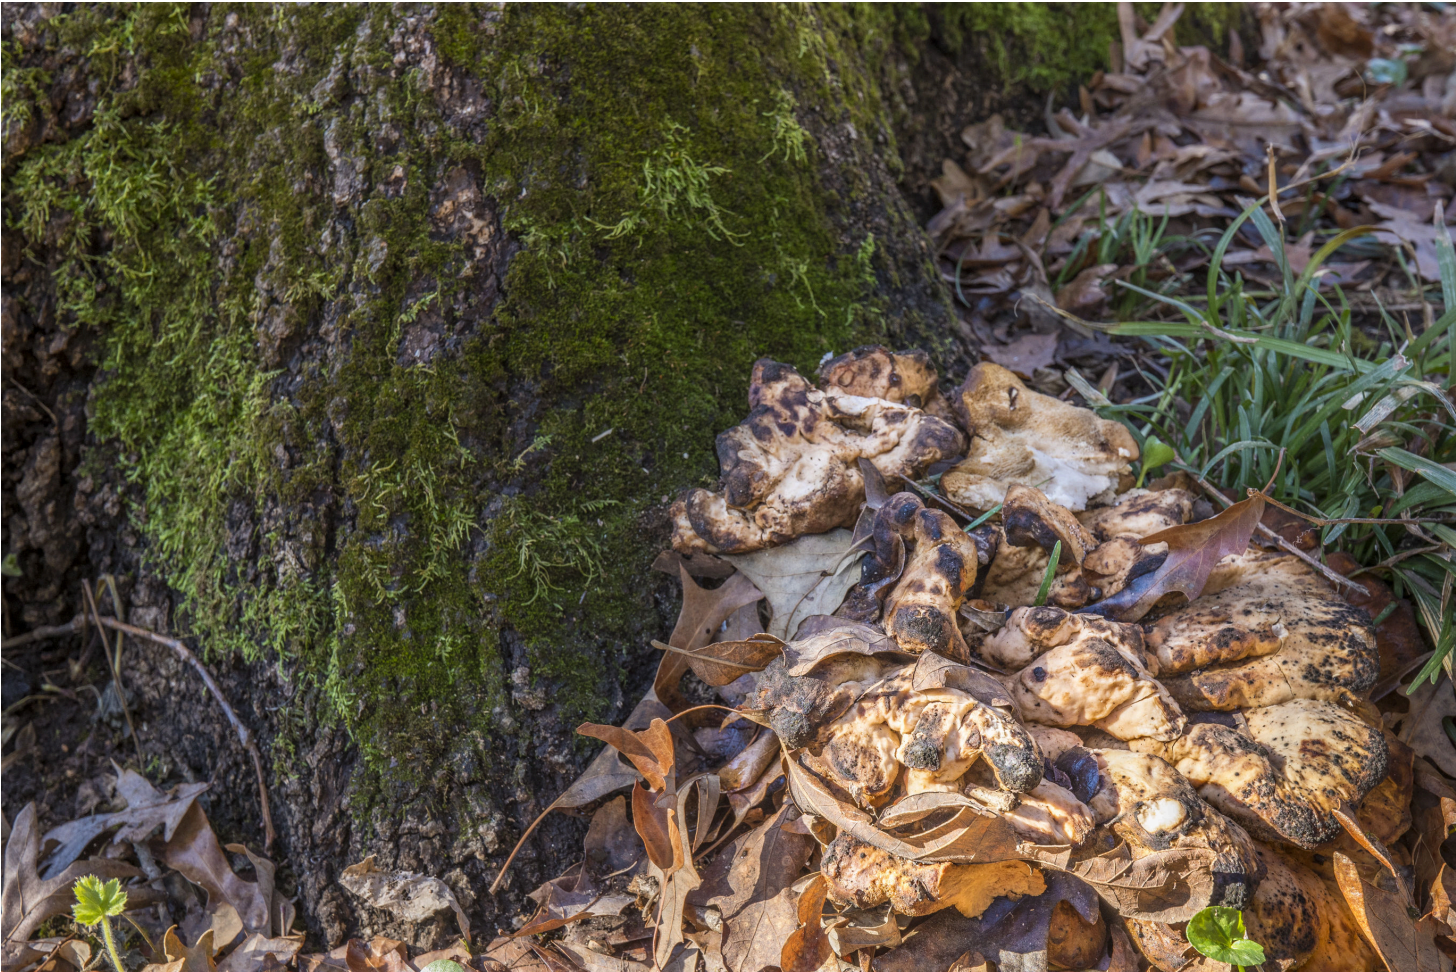
- 1 - 30” + White Oak – heavy lean, old wounds, lesions, unbalanced canopy **and reproductive bodies of root & butt rot fungi**
- 1 - 30” + Red Oak – noticeable lean, old wounds, lesions, unbalanced canopy **and reproductive bodies of root & butt rot fungi**

Comments – The lean of these two trees is certainly concerning and the loss of the center tree canopy has left the remaining (2) affected Oaks unbalanced and more susceptible to wind damages and blow-down. Lesions and old wounds are present on both the White Oak and Red Oak, which are concerns, but not all that uncharacteristic with geriatric trees and their existence in the urban landscape. What is more specifically problematic is that these two of the twelve trees are hosts to the reproductive bodies of root and butt rot fungi, which is currently present and identified. These trees are located in a confined 20’x 45’area that is directly related to several family residences, other structures and frequently traveled locations by persons, which are all additional concerns. **Please be advised. Ornamental Gardens llc. recommends immediate consultation with a qualified professional arborist, for further absolute and positive identification of these Armillaria spp. reproductive bodies, which are present. Referencing NC State University Plant Pathology Extension Services data, this is a very serious matter and it is recommended that the trees should be removed, as soon as possible. NC State University is our regulation authority and the most knowledgeable resource to be obtained, on all agricultural, horticultural and arboricultural information and practices. It is strongly advised that any and all concerned persons or parties involved with matters regarding the safety of these trees, please refer to attached documents for detail description and be informed of critical information provided by NC State Plant Pathology Extension Services.**
