**LOCAL HISTORIC DISTRICT:** Wilmore

**PROPERTY ADDRESS:** 429 West Park Avenue

**SUMMARY OF REQUEST:** Painted Brick/Front Door Replacement

**HDCRMI 2019-00444**

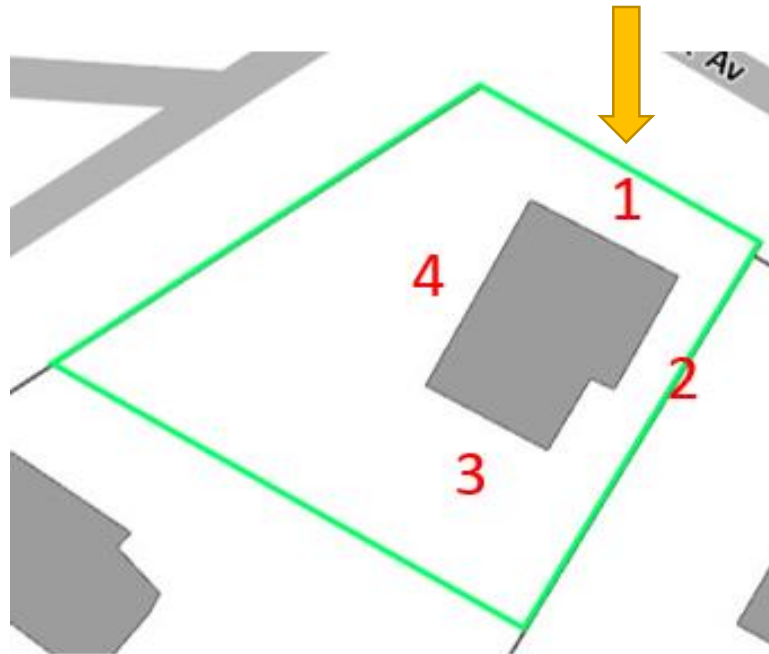
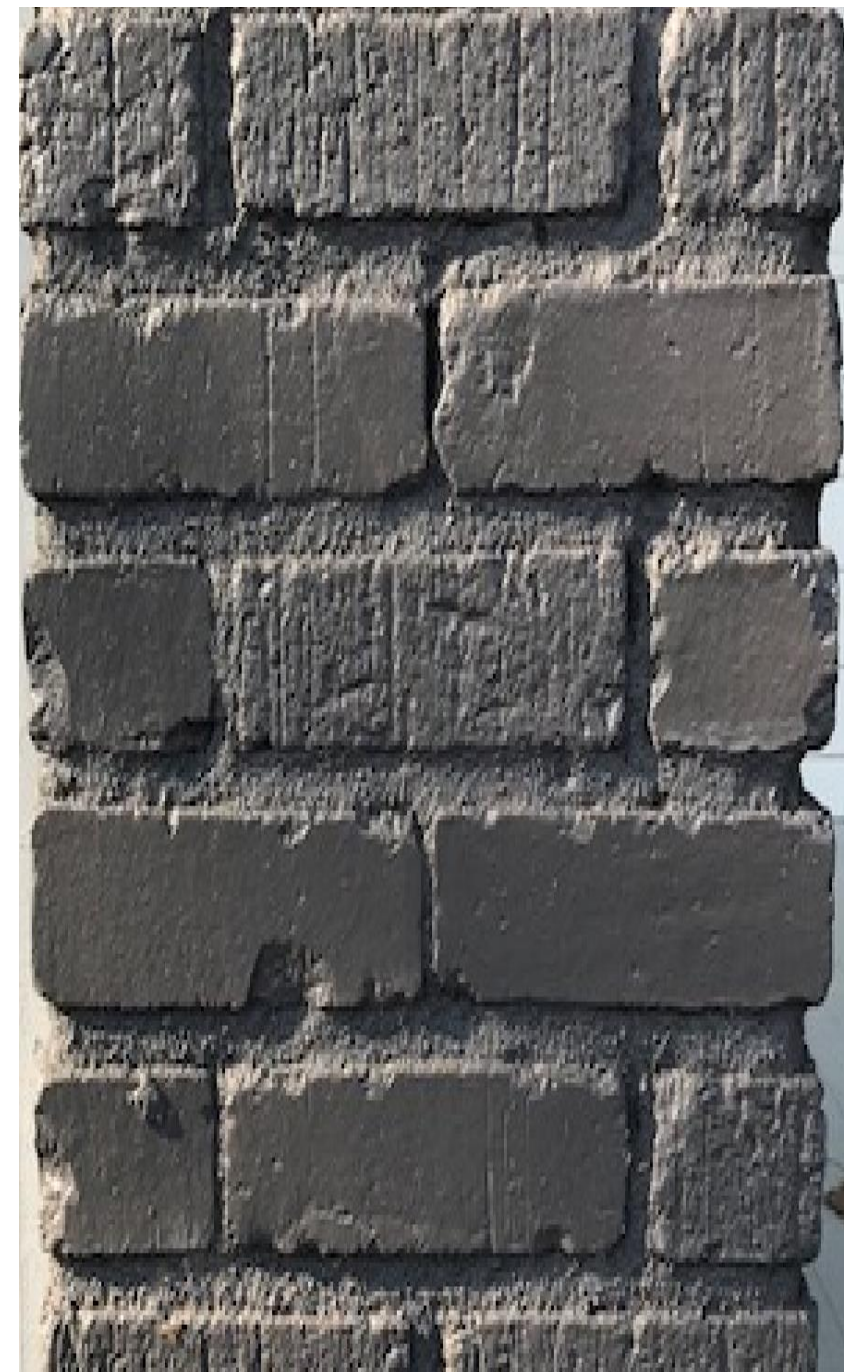
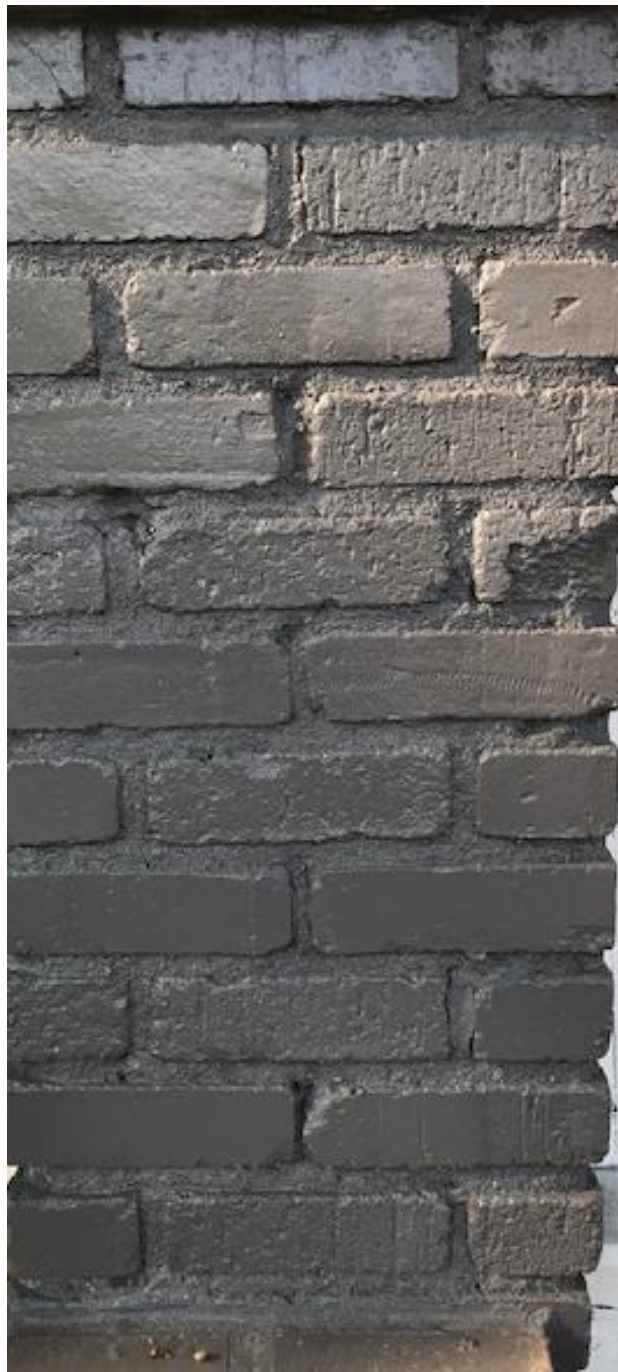
## FRONT PORCH LEFT COLUMN

- Mismatched brick (smooth and scored face)
- Inconsistent mortar head (vertical) joint widths
- Uneven & un-tooled joints
- Broken brick & mortar drips

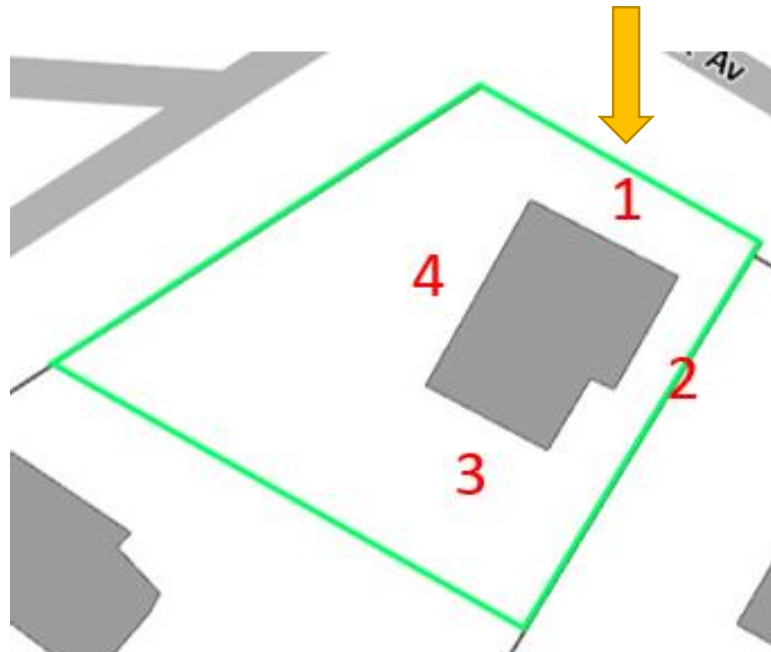
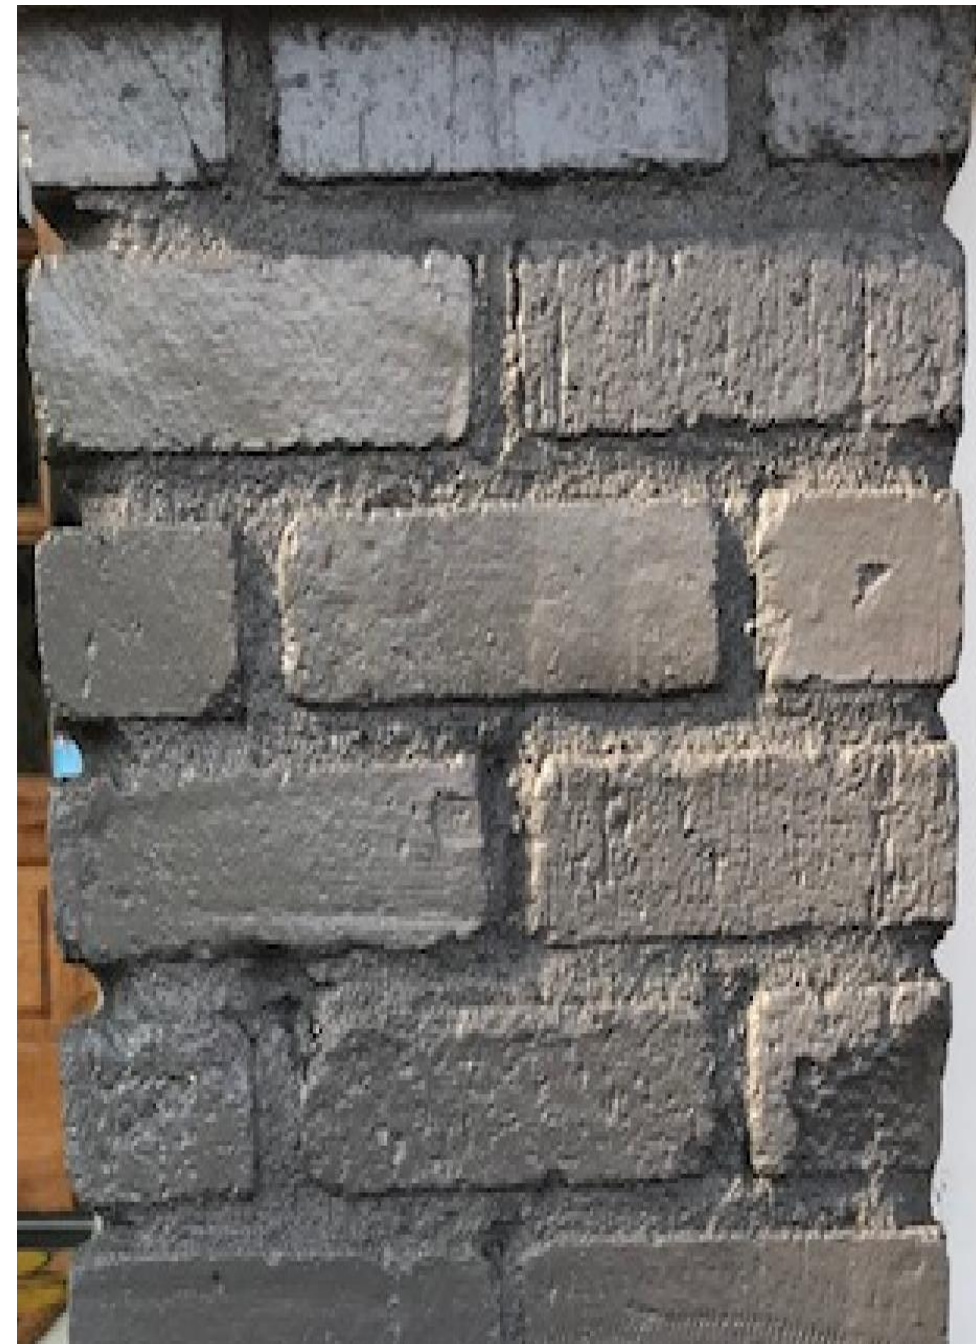
## FRONT PORCH RIGHT COLUMN

- Caved in brick
- Crooked and irregular joints
- Broken brick
- Substandard mortar and joint lines
- Inferior masonry workmanship

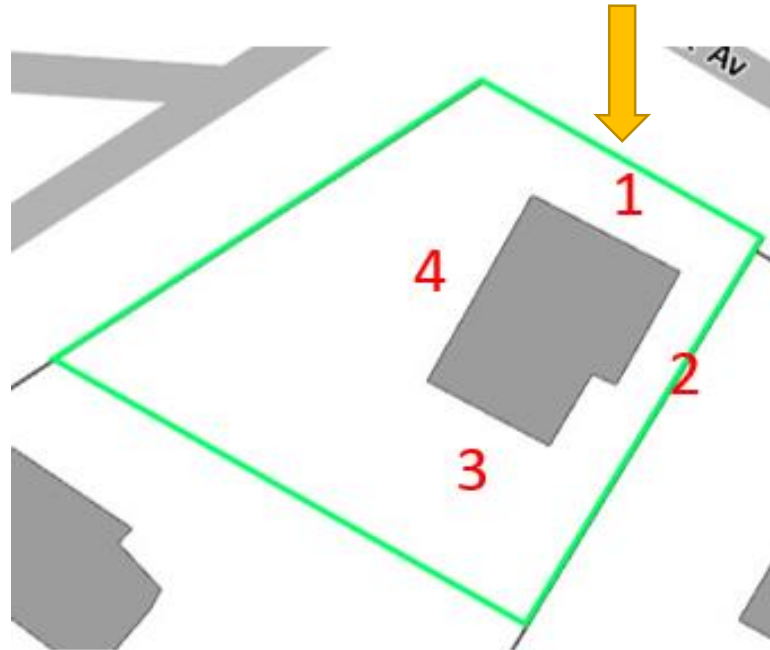
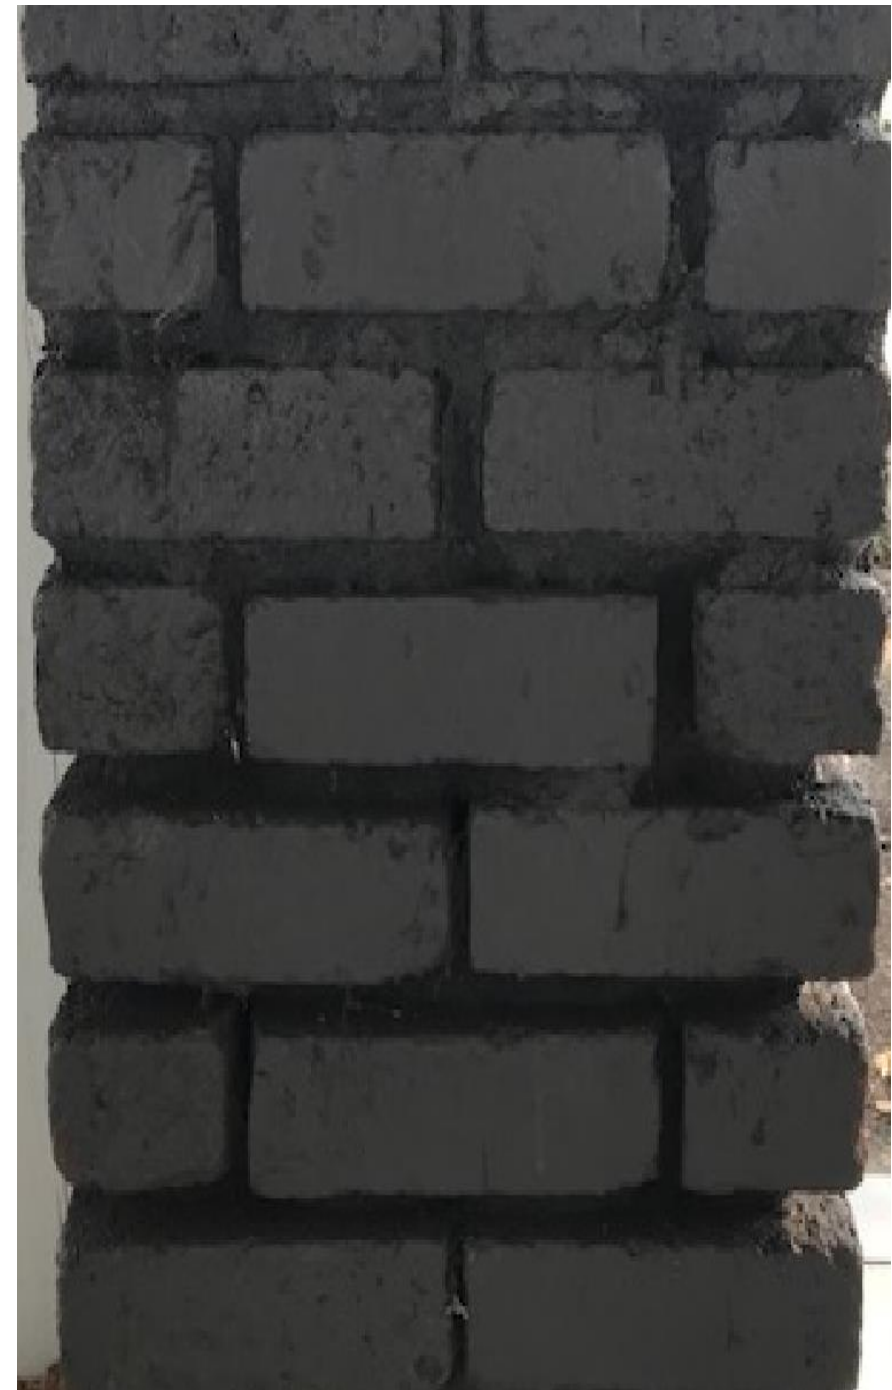
## FRONT PORCH RIGHT COLUMN

- Inconsistent mortar joints
- Crooked and irregular joints
- Substandard mortar and joint lines

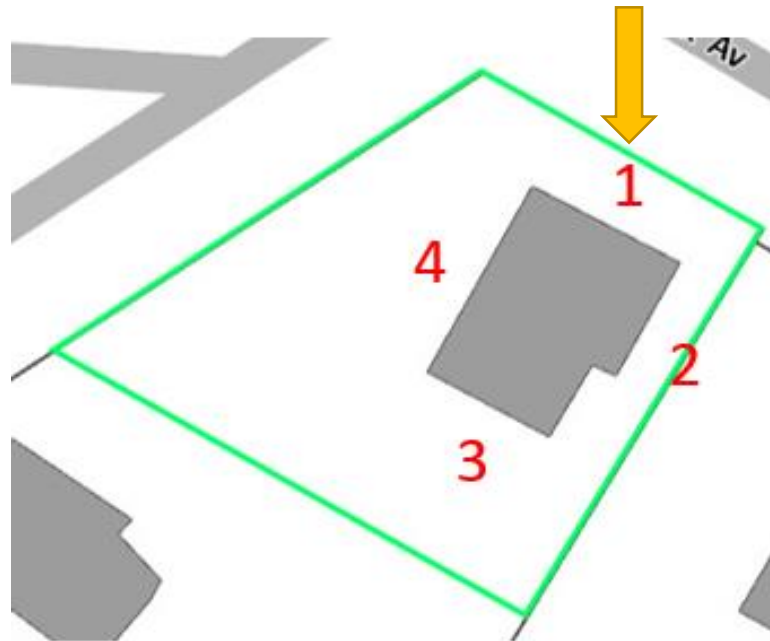
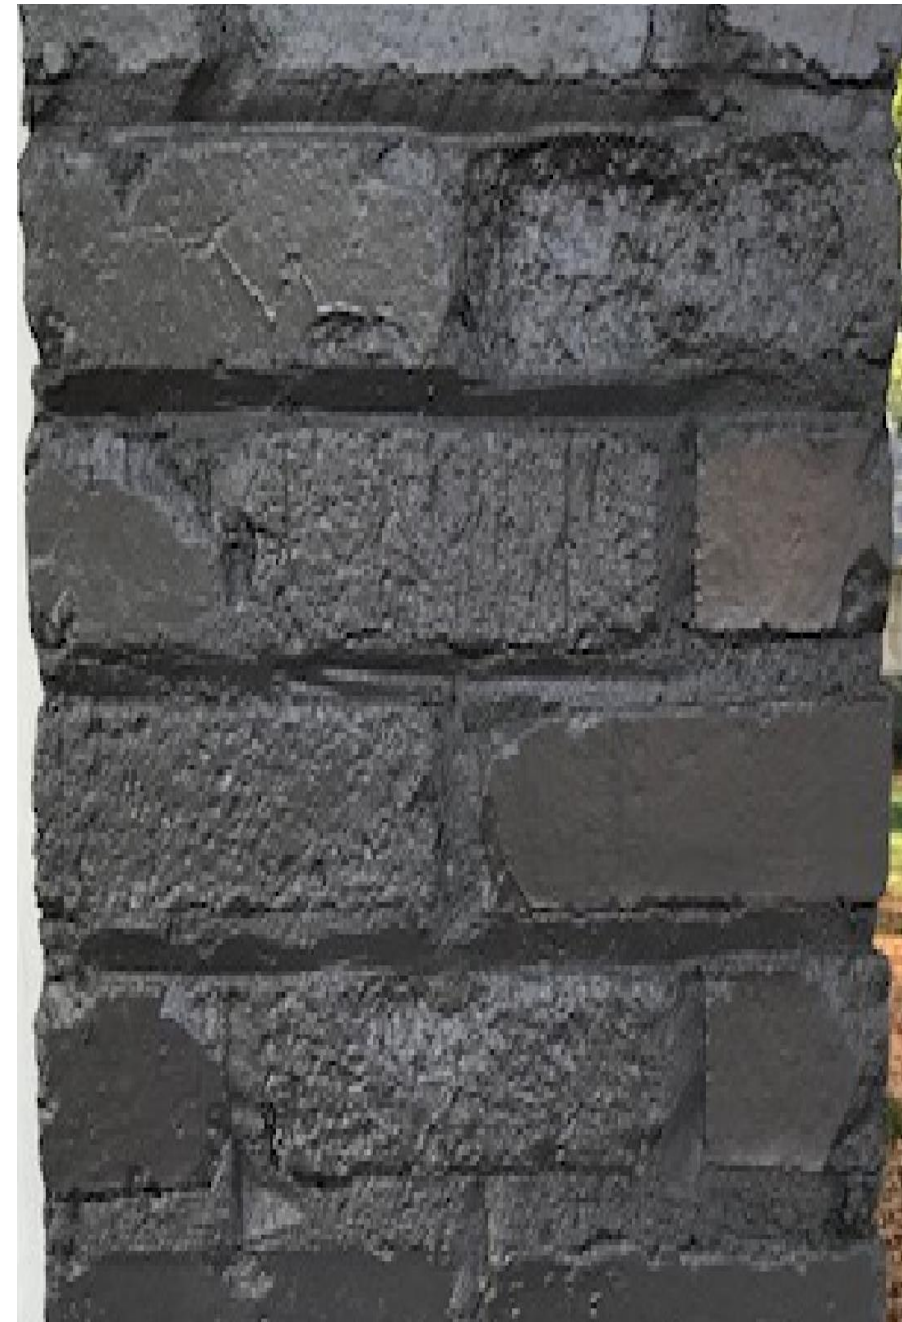
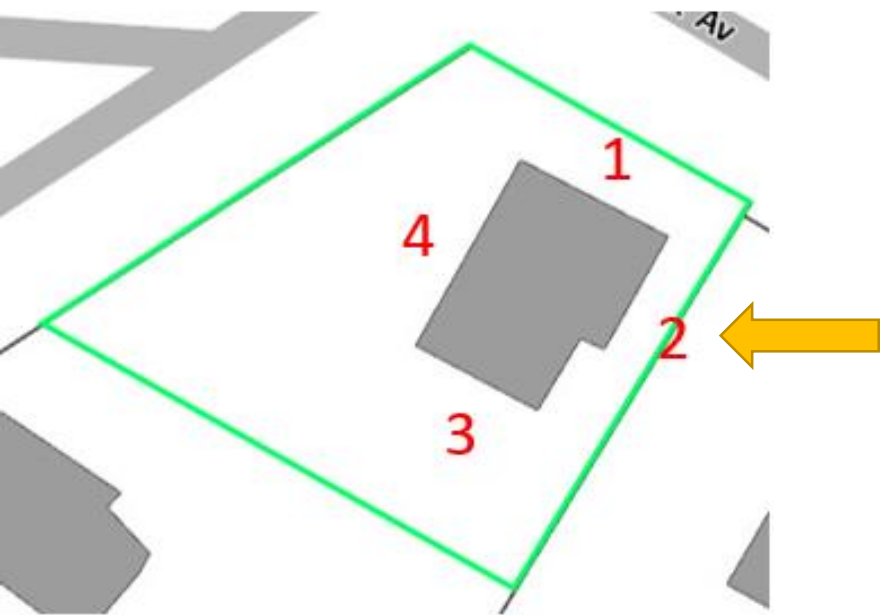
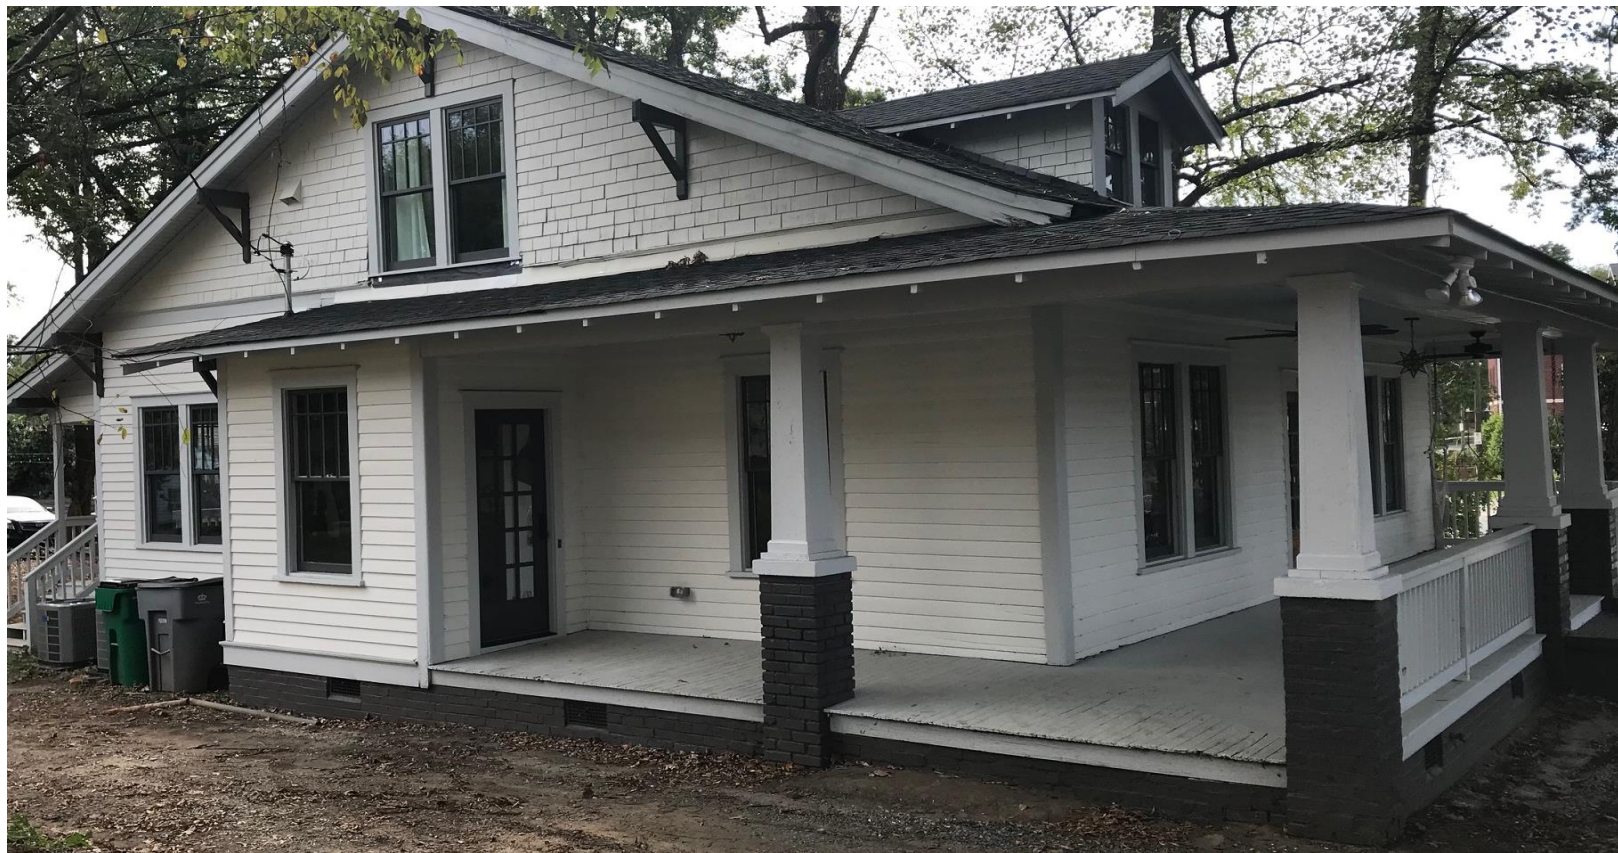
## NORTHWEST SIDE FRONT PORCH

- Overfilled mortar joints
- Mismatched brick
- Uneven rows of brick at the joint.
- Inferior masonry workmanship

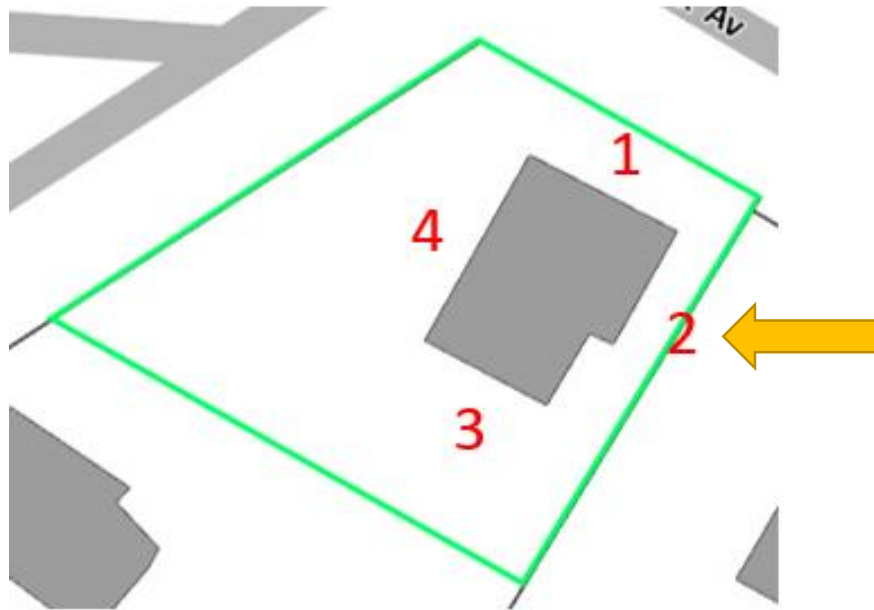
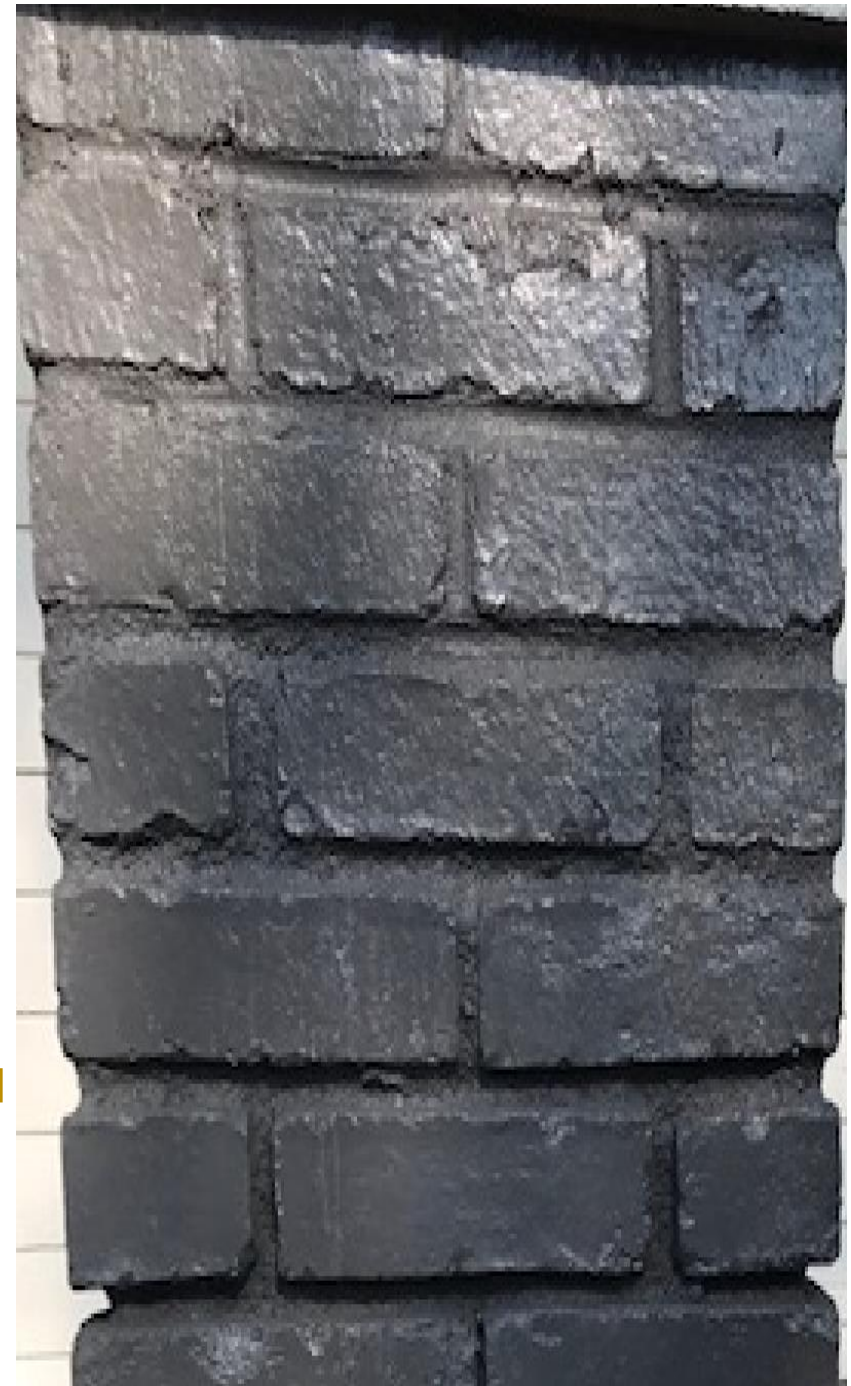
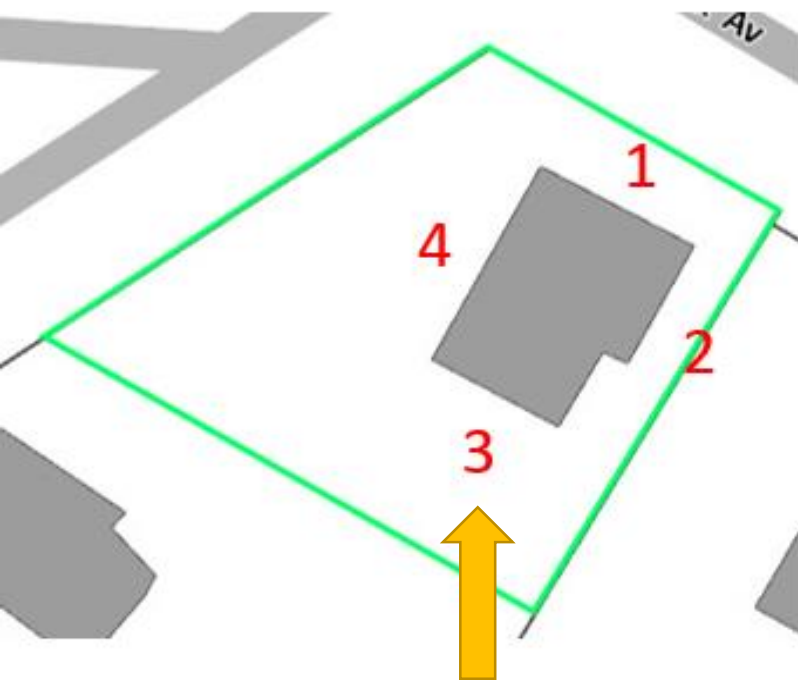
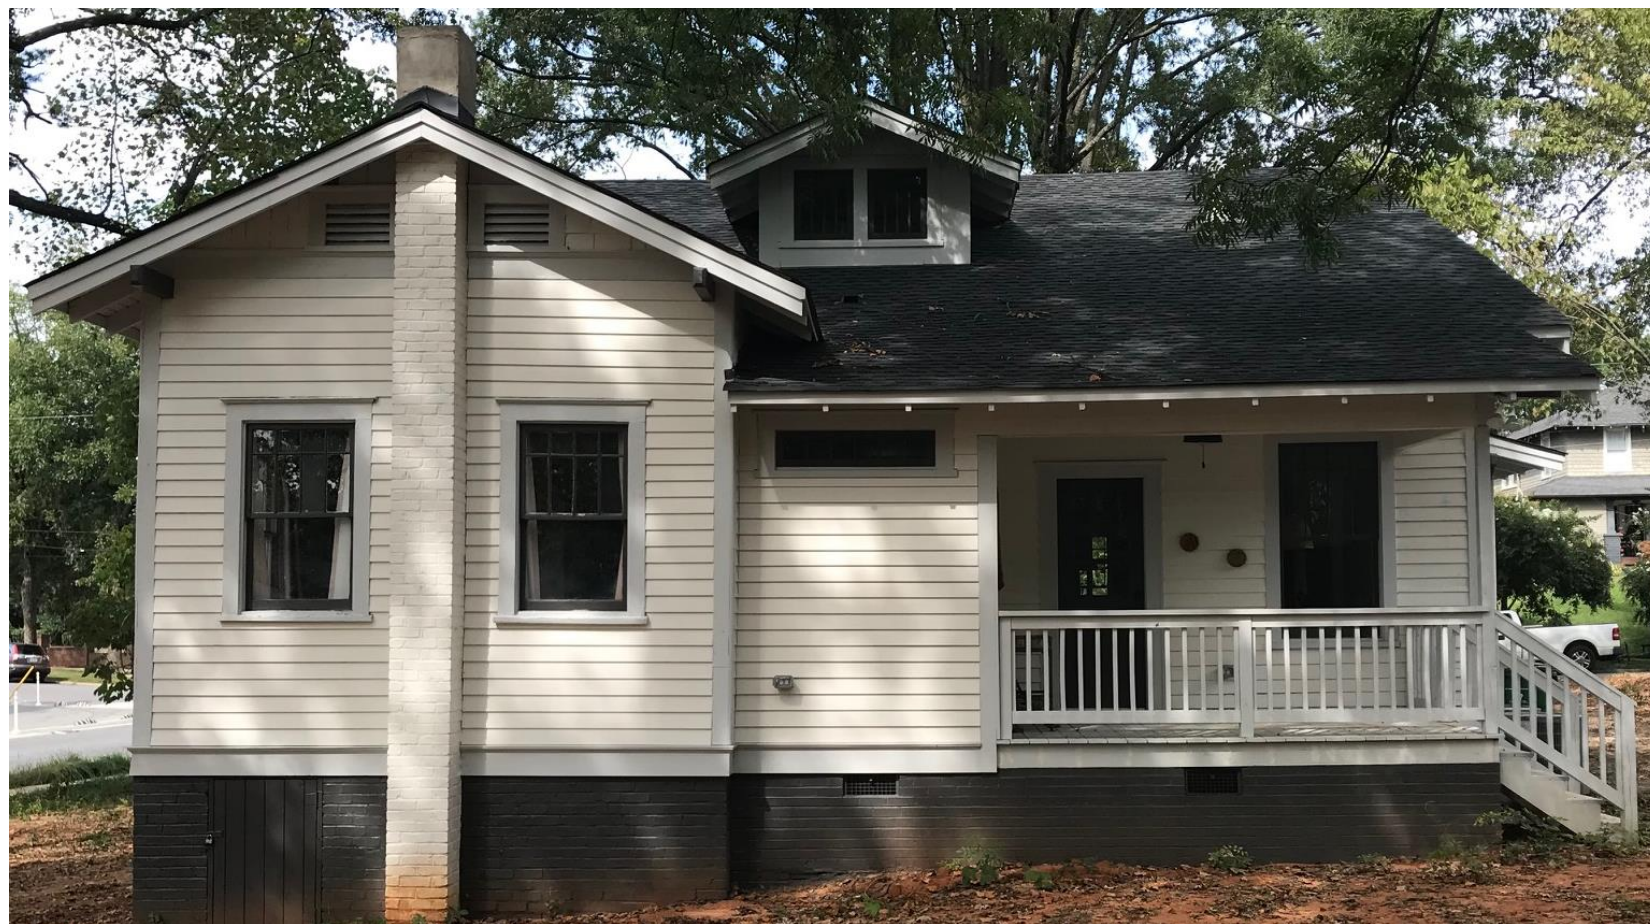
## EAST SIDE COLUMN

- Under-filled & mismatched mortar (horizontal & vertical) lines
- Inferior masonry workmanship.
- Uneven rows and substandard mortar and joint lines

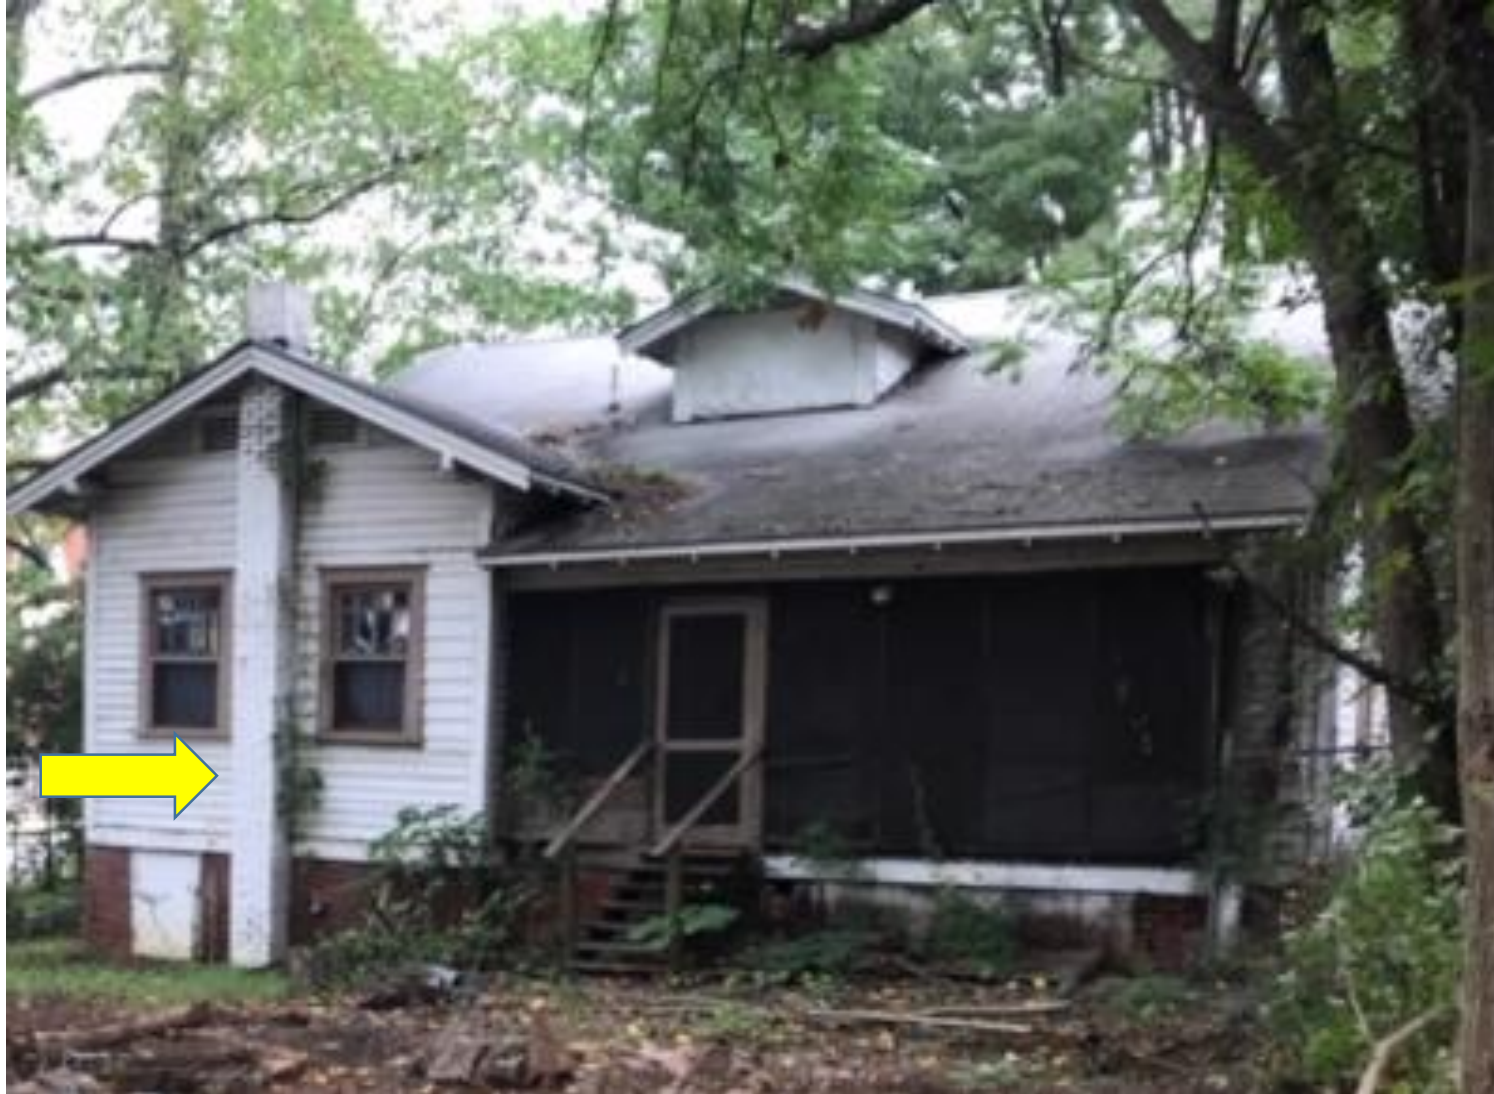
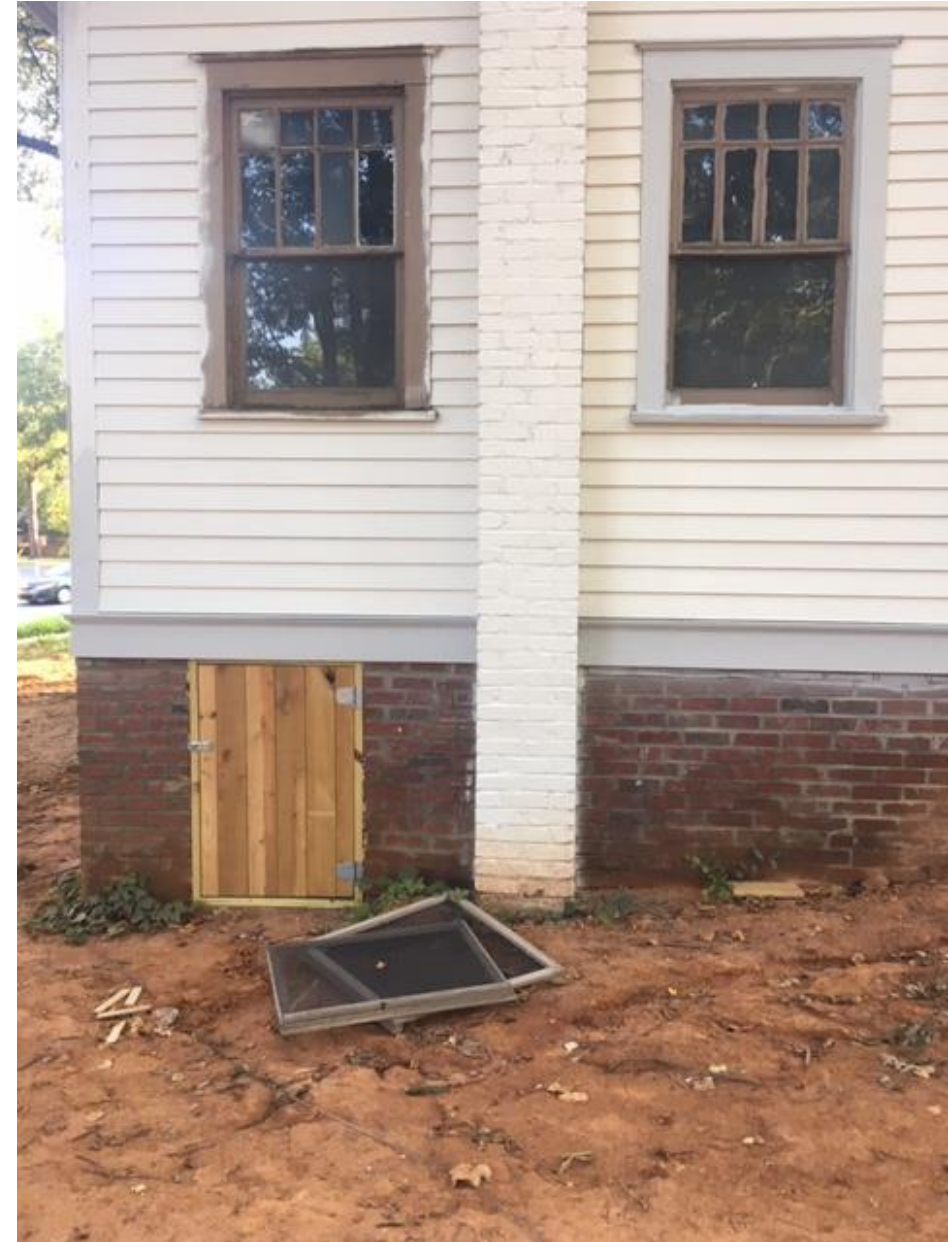
# CHIMNEY PAINTED PRIOR TO RENOVATION

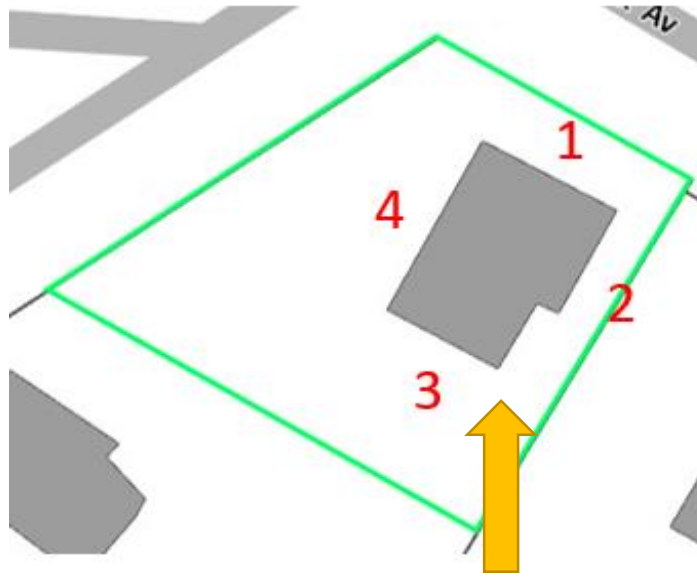
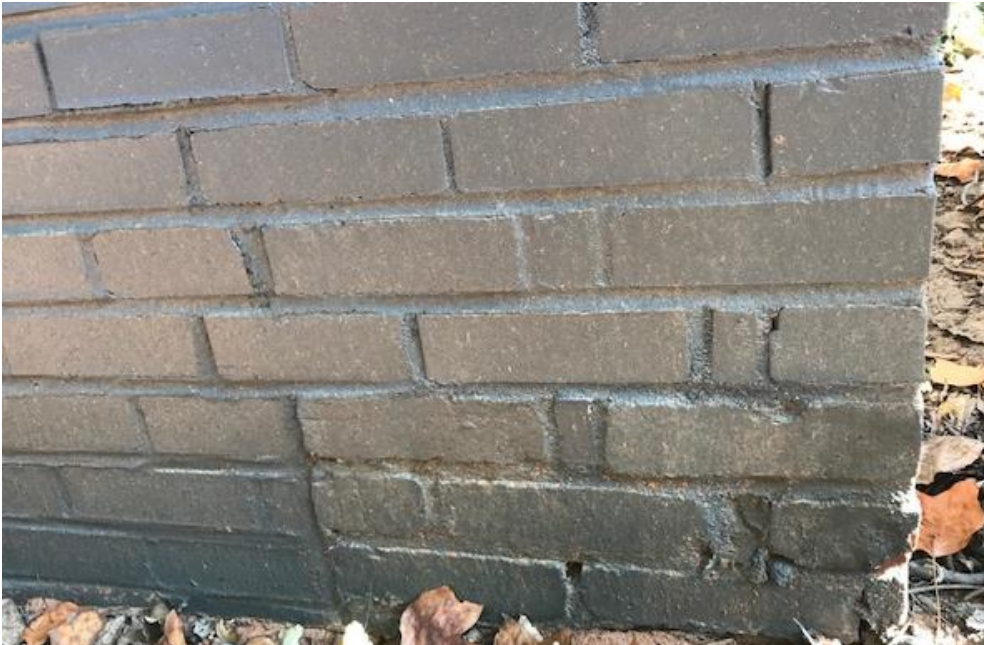
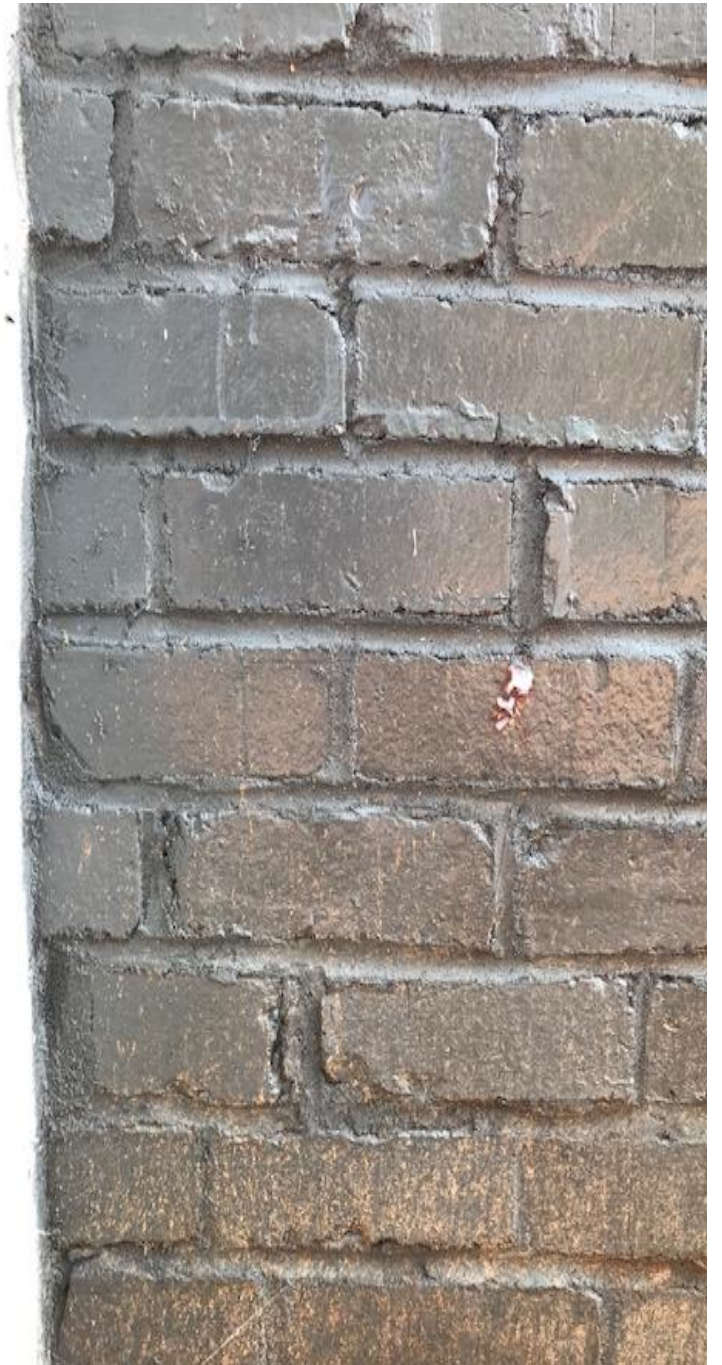
## SOUTH SIDE

- Mismatched mortar (horizontal & vertical) lines
- Joint lines don't line up in brick pattern.
- Uneven rows and substandard mortar and joint lines

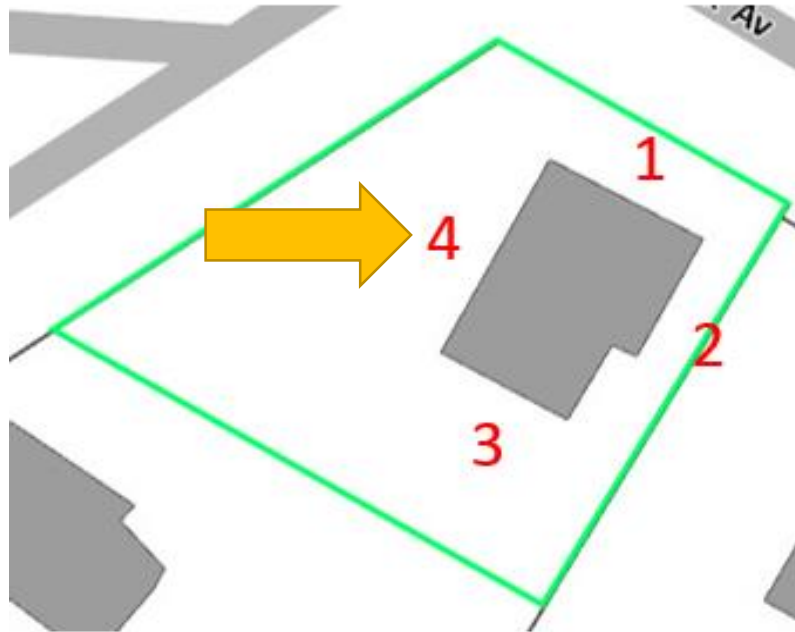
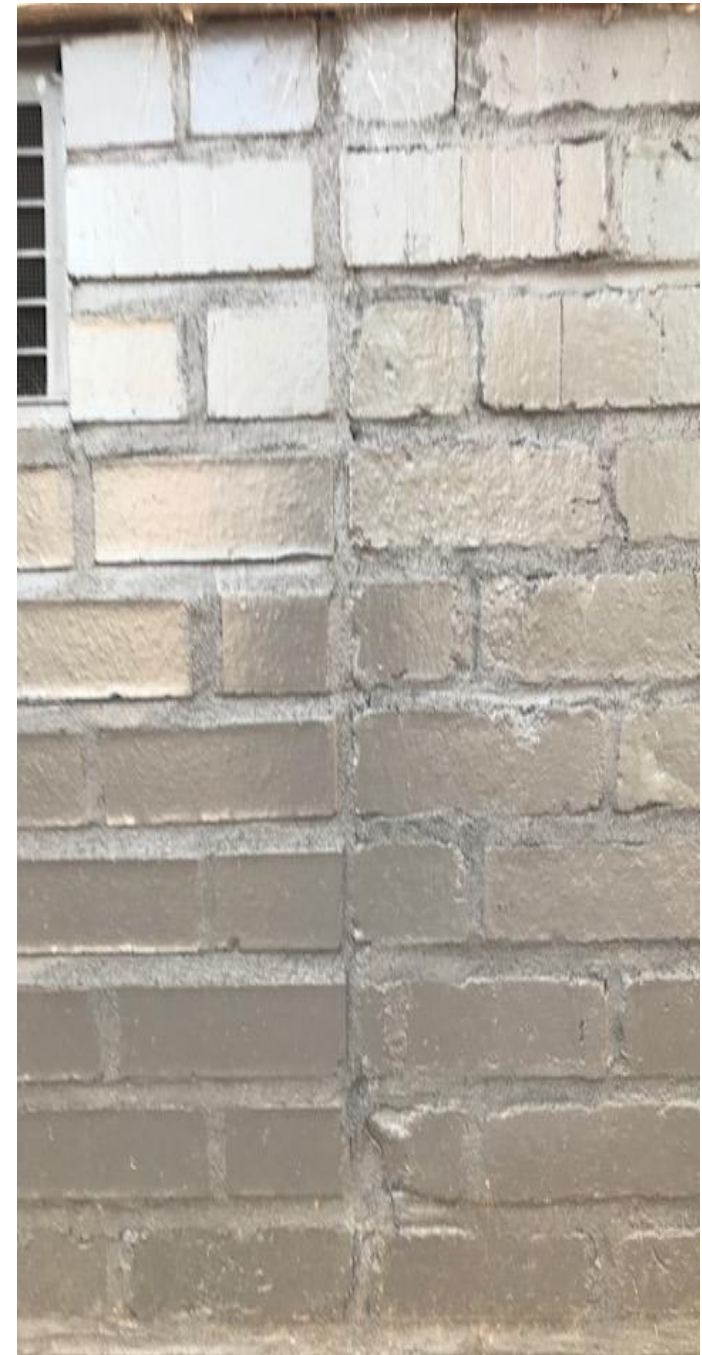
## WEST SIDE

- Excessive and sloppy mortar work
- Uneven joint lines
- Bricks don't line up

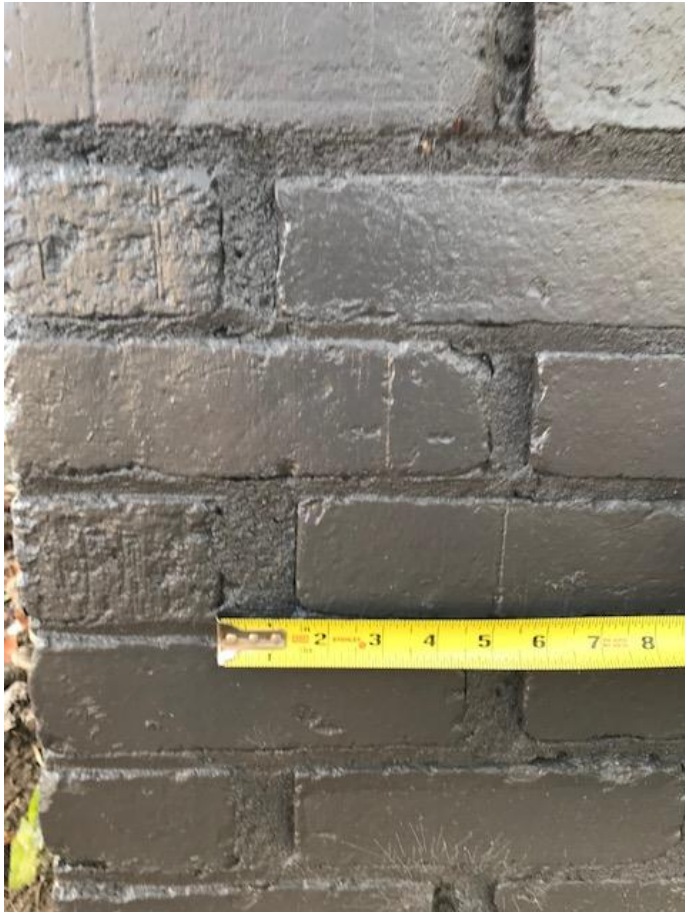
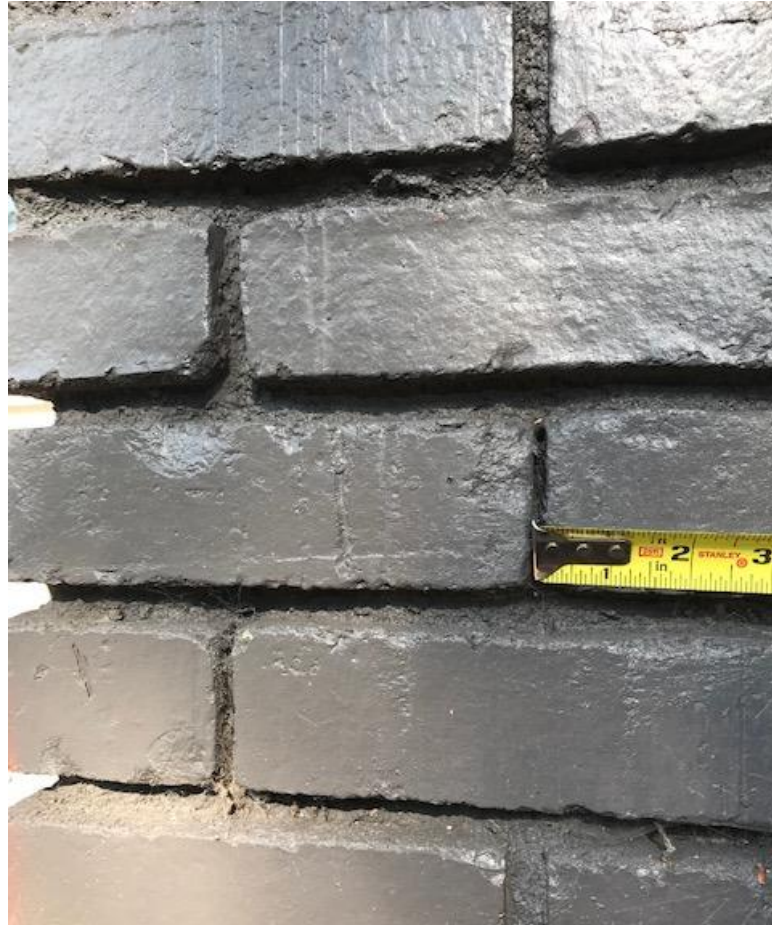
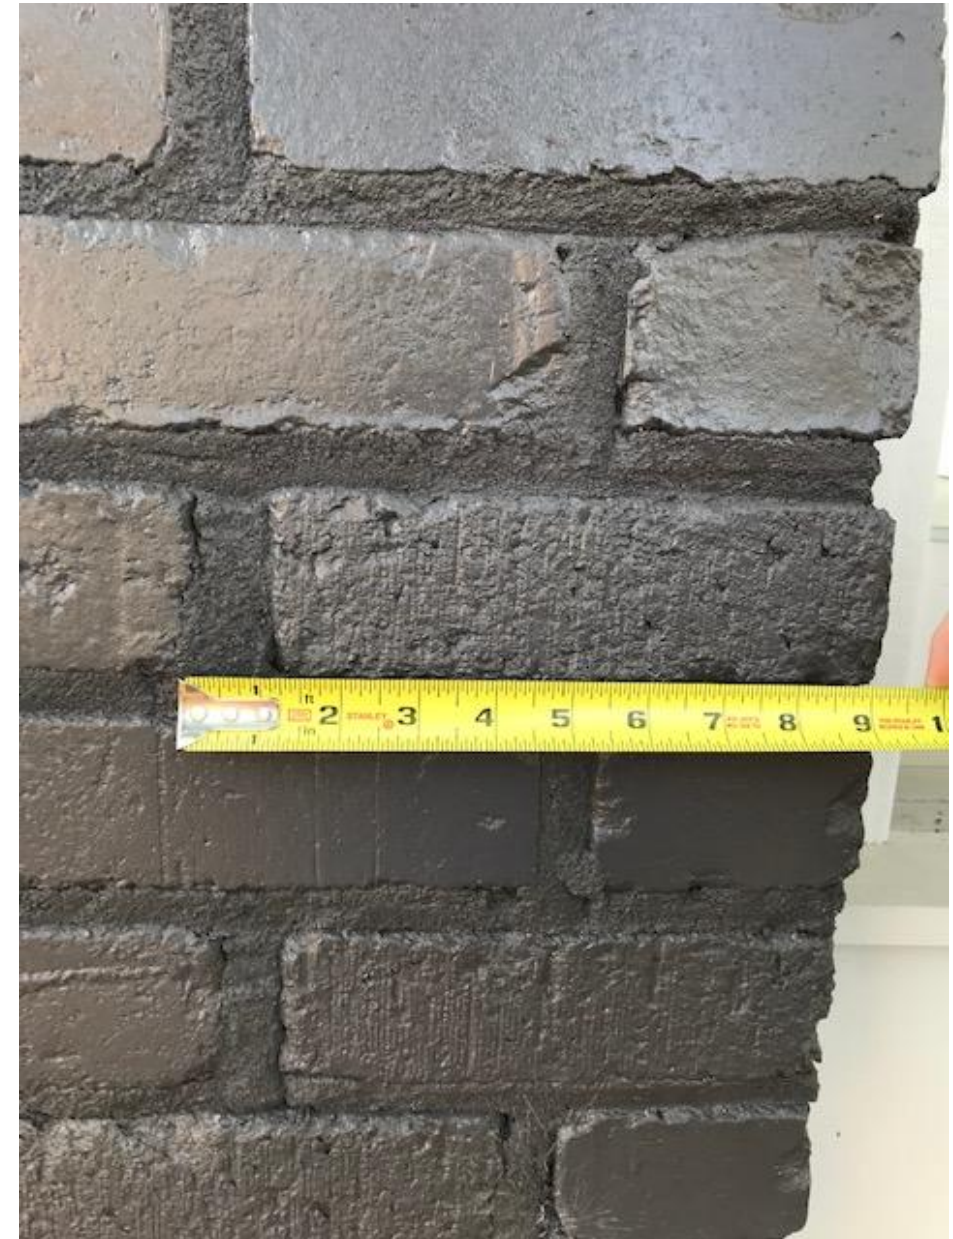
- Mortar head joints in excess of 1 inch common throughout all sides of house.
- Industry standard is  $\frac{3}{8}$ "
