**LOCAL HISTORIC DISTRICT:** Wilmore

**PROPERTY ADDRESS:** 429 West Park Avenue

**SUMMARY OF REQUEST:** Painted Brick/Front Door Replacement

**HDCRMI 2019-00444**

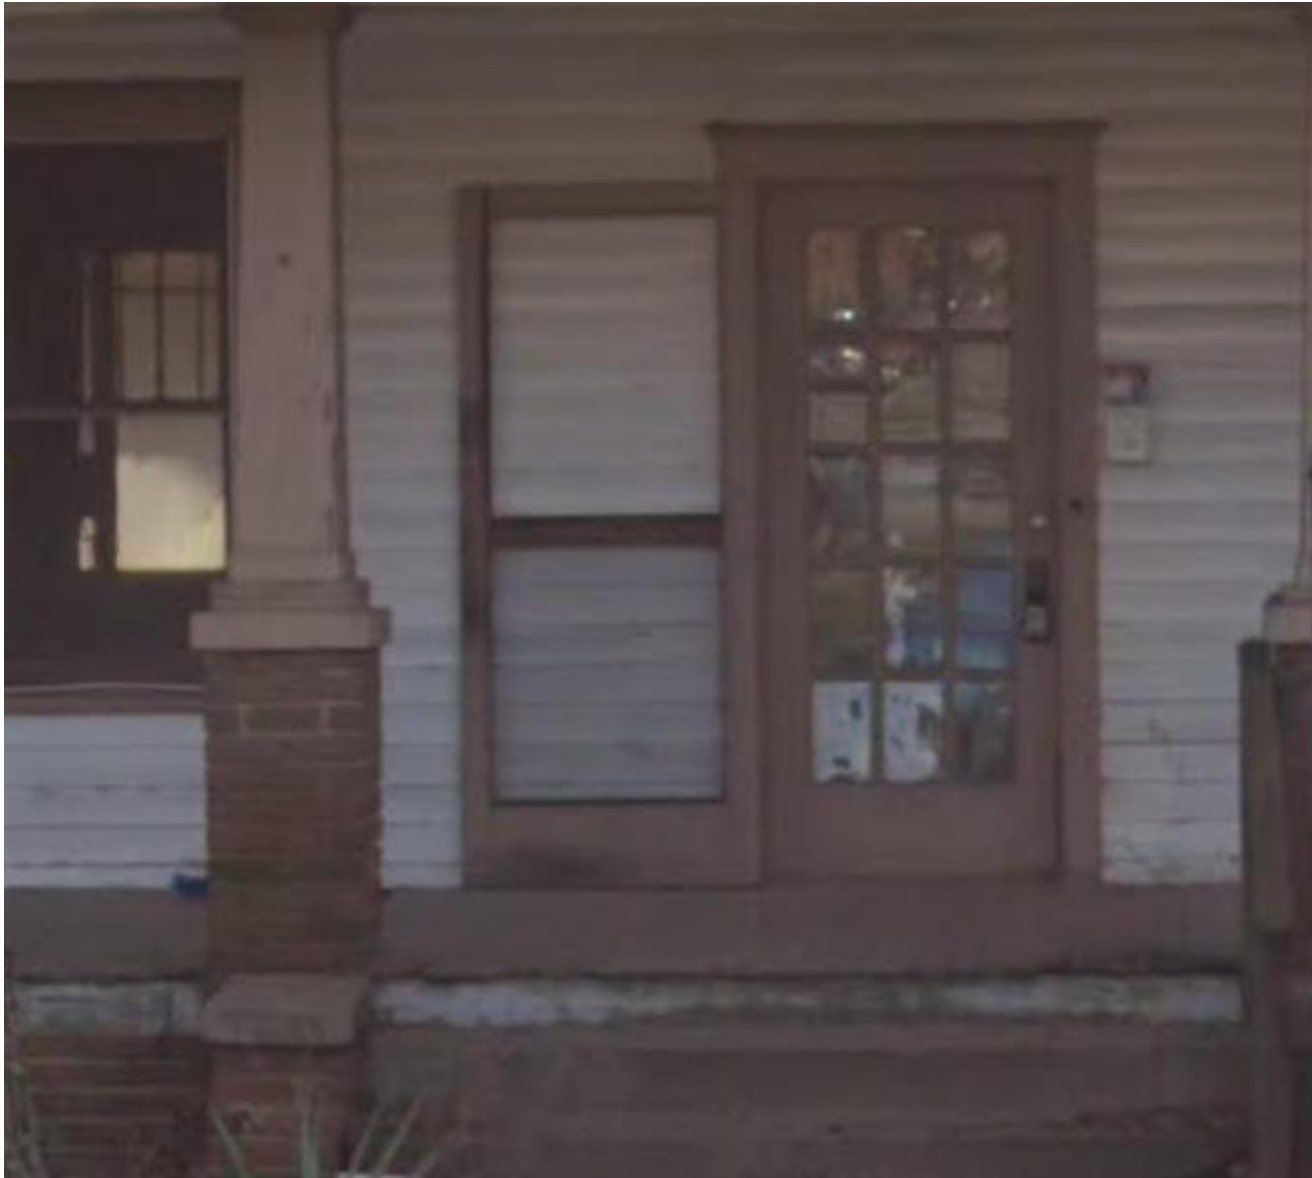
- Original front door | 15-light
- Serious disrepair with broken panes and wood rot.
