**LOCAL HISTORIC DISTRICT:** Wilmore

**PROPERTY ADDRESS:** 1740 Wilmore Drive

**SUMMARY OF REQUEST:** Siding Changes

# HDCRMI 2019-00517

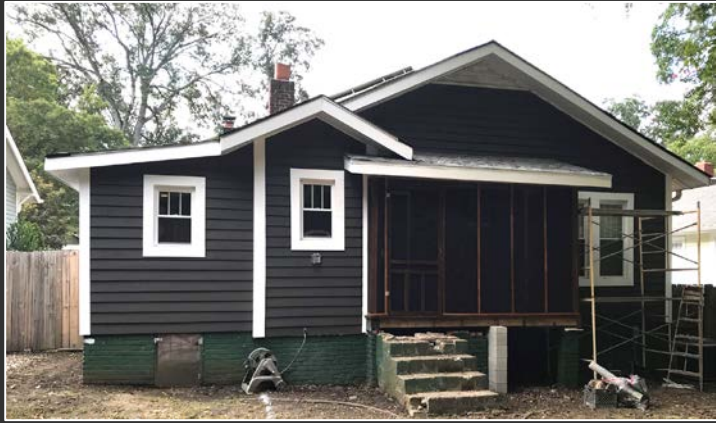
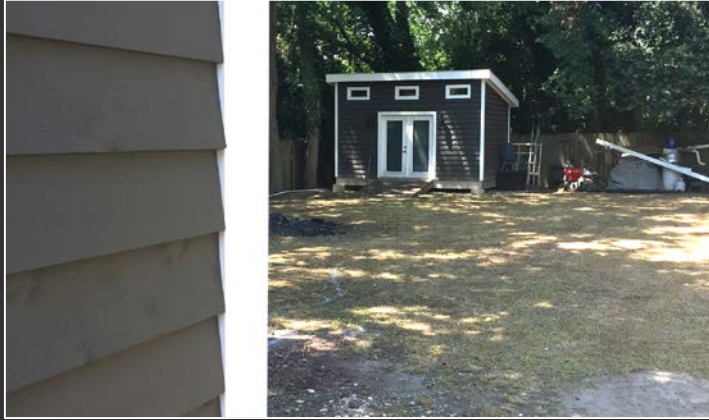
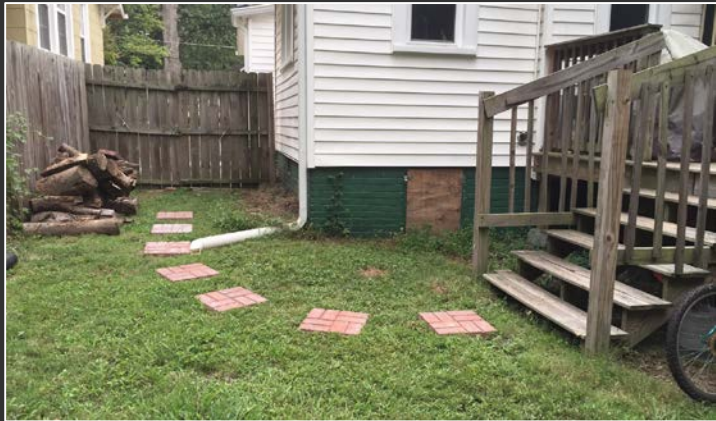
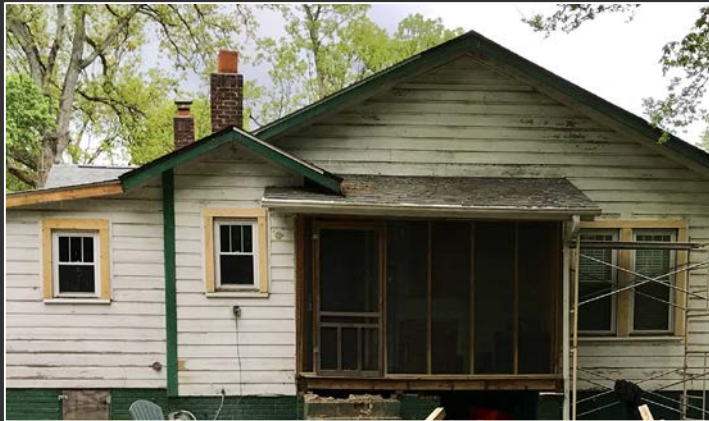
Above: Rehabilitation that is already complete to  $\frac{1}{3}$  of the home.

Below: Home with vinyl and once vinyl was removed.

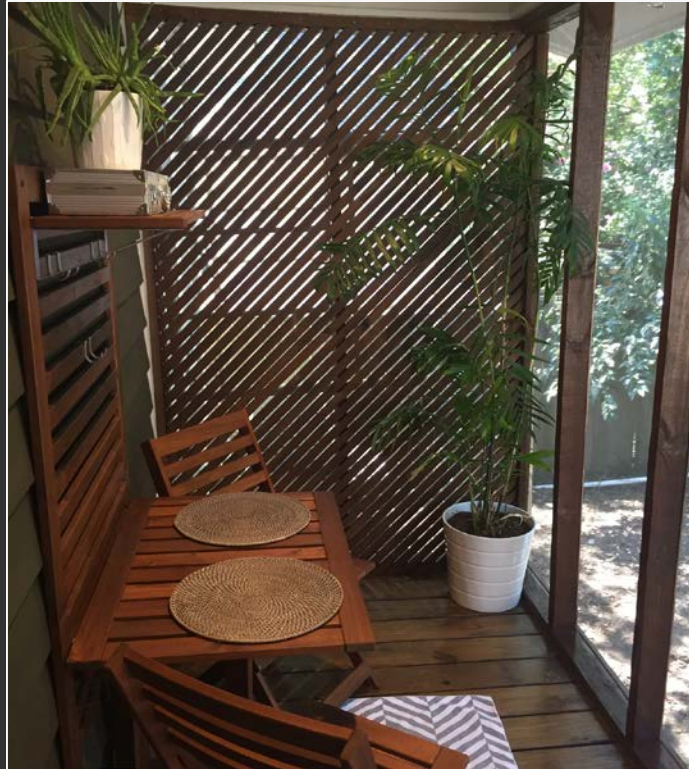
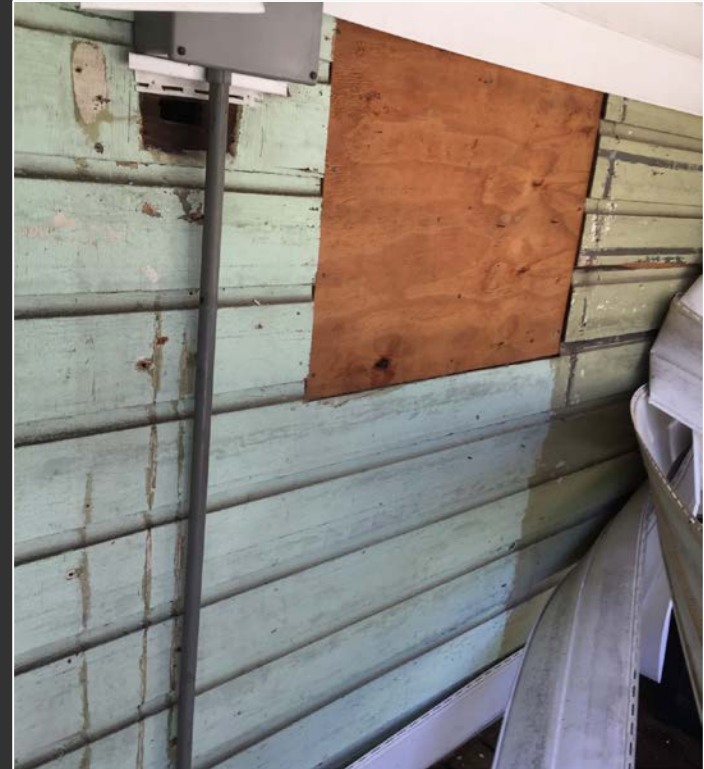
Left: Cedar lap siding used in combination with wood trim and wood flooring.

Right: Original siding with large patched areas, large holes, and lead paint

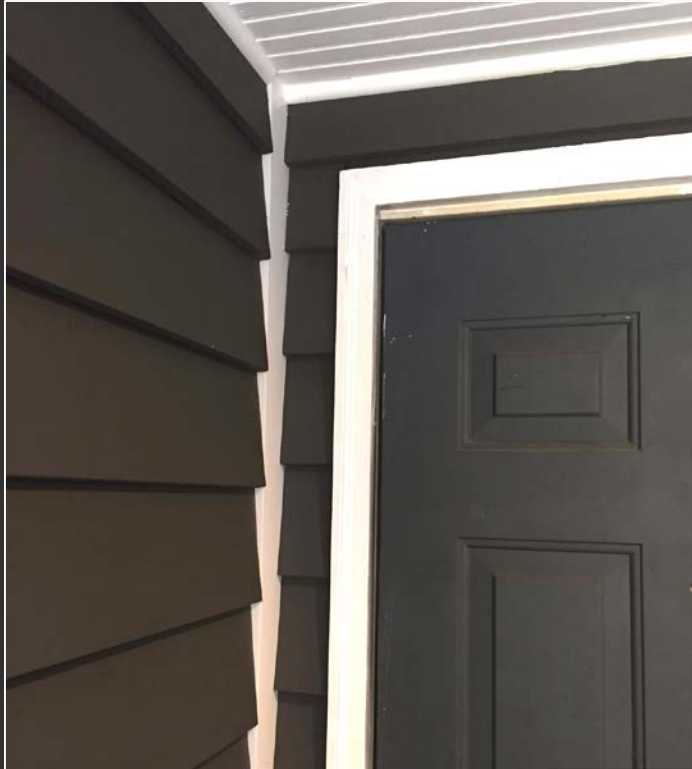
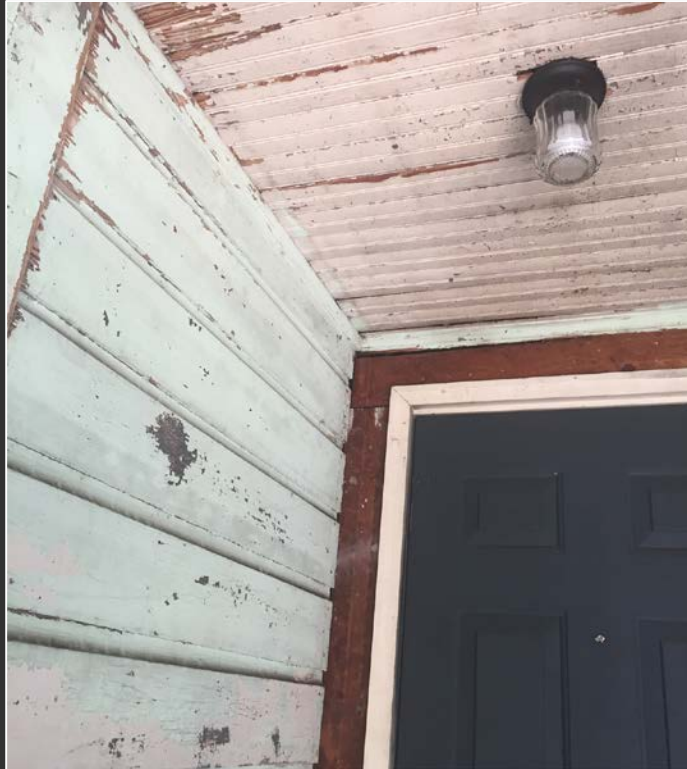
**Left:** Traditional cedar lap siding used in combination with wood trim and traditional 1 inch beadboard

**Right:** Original siding with missing trim and rotting and sagging beadboard

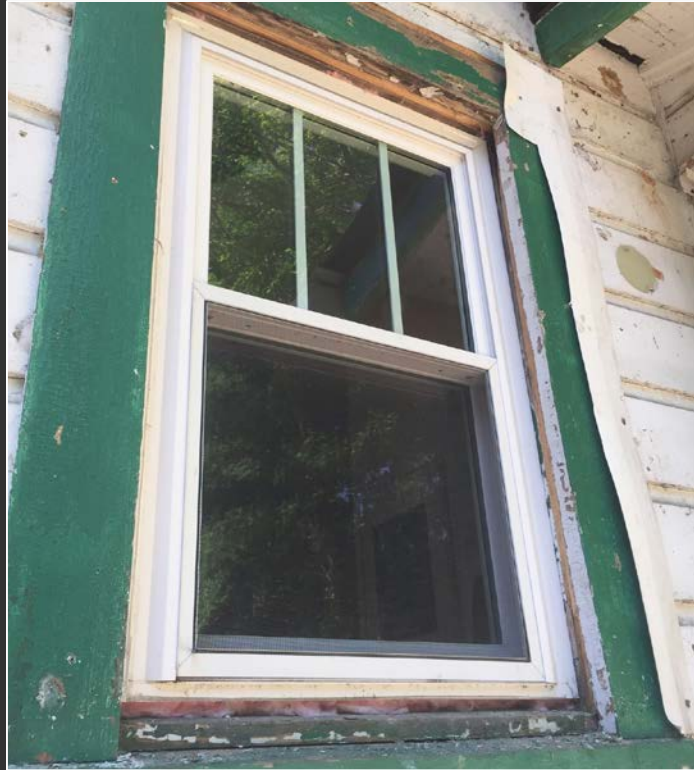
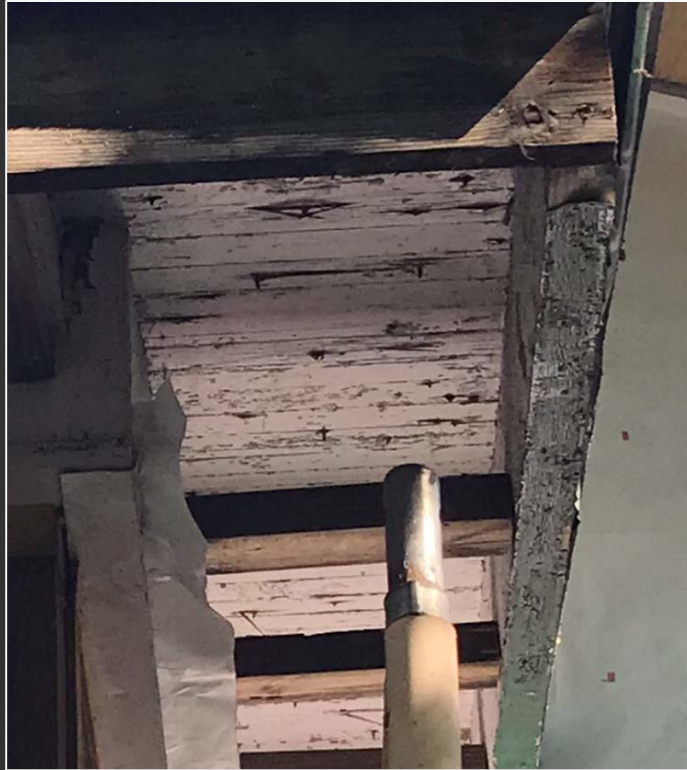
**Left:** This photo highlights the variety of trim we found once we removed the vinyl. Some windows had pieces of original trim which were rotten, some were not. Other newer trim was mixed in with old trim.

**Right:** Fascia completely dry rotted and soffits ruined by improper installation.

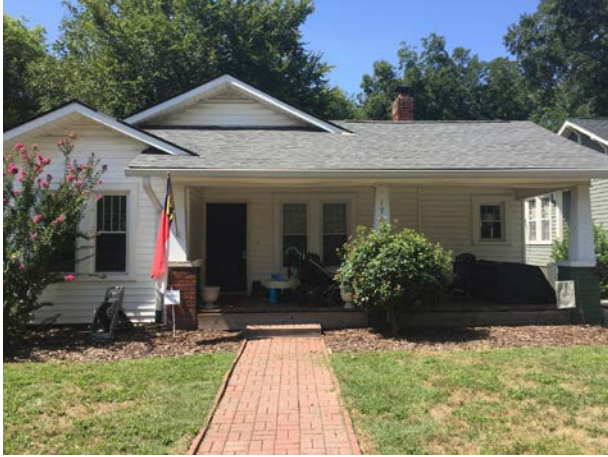
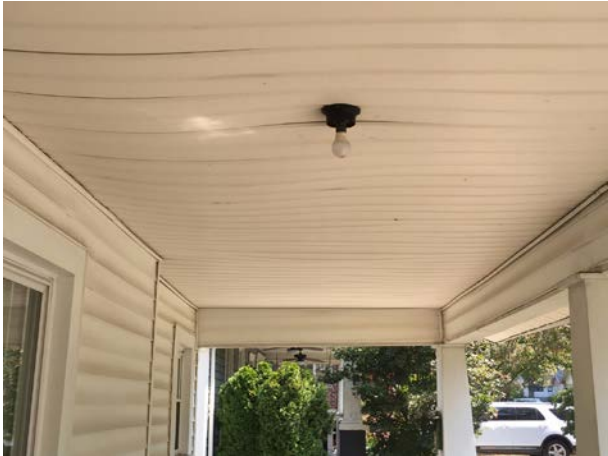
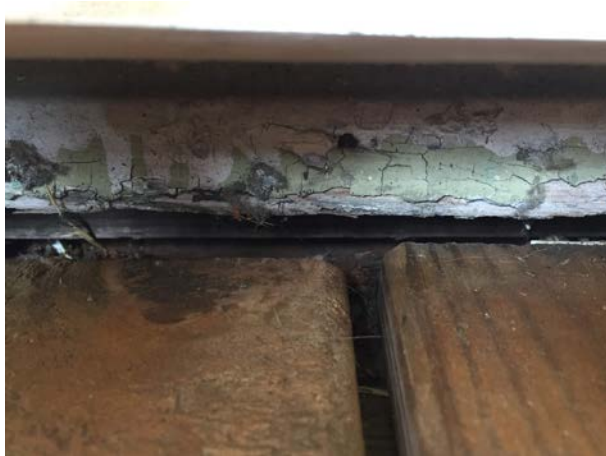
## — Front Exterior

**Top left:** Vinyl siding mostly intact. The right portion of the home was an addition to the home (not added by ourselves), thus is not original. Like in areas of the rear of the home that were not original, we expect areas of the siding to be missing or different to that of the original. In addition, all of the vinyl siding lacks a water resistant barrier underneath leading to rot and failing materials of home.

**Bottom left:** Vinyl ceiling is sagging in many areas, just as the back screened in porch was prior to rehabilitation. Due to this, we can assume it is rotten and water damaged, which would result in a loss of structural integrity to the original beadboard and siding because of moisture.

**Bottom right:** This area connects to the porch and the front wall. As with other areas, it is not properly installed and invites water moisture, mold, mildew, and bugs due to this fact.

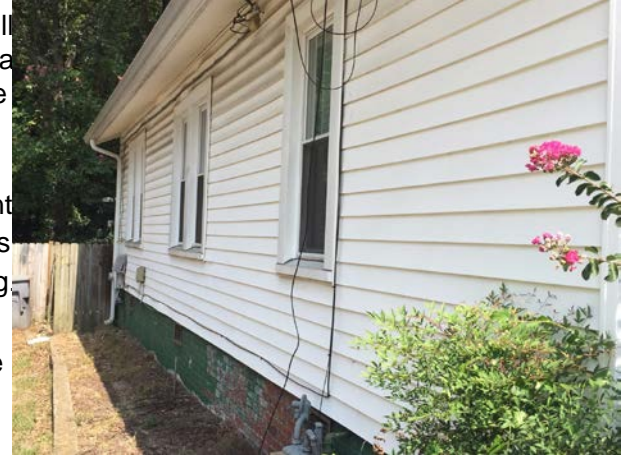
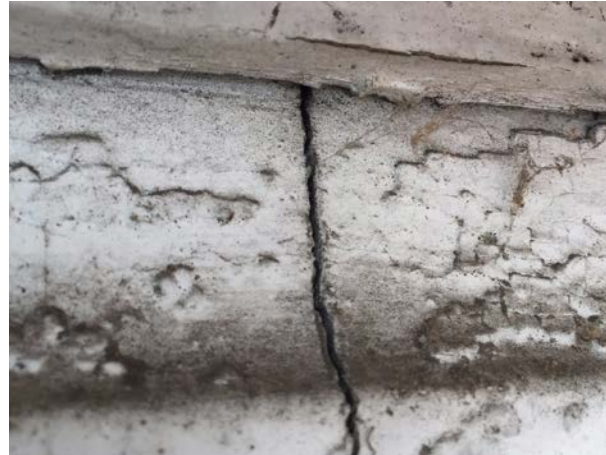
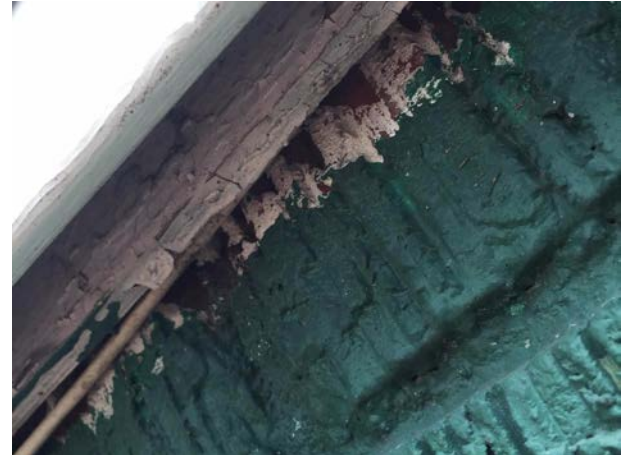
# Front Left

**Top right:** The left side of the home is covered in the vinyl. It also houses various drill holes from previous owners and internet and phone companies that no longer serve a purpose to the home. No water resistant barrier was used between the vinyl and the original siding, allowing for rot to potentially be present as was with other areas.

**Bottom left:** In several sections the vinyl has splayed. Underneath you can see segments of the wood beneath. This section highlights the condition of the wood, the seams between boards, and the layers of hazardous lead paint that are on the siding.

**Bottom right:** This view is from the foundational brick leading to the siding. Again, the vinyl was not correctly installed, thus did not protect the original siding from rot, mold, or invasive bugs.

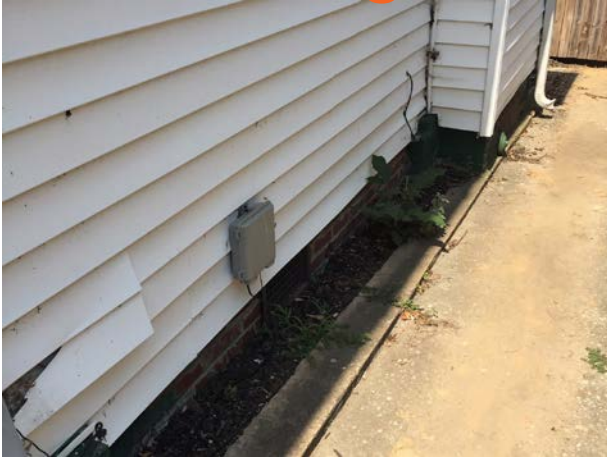
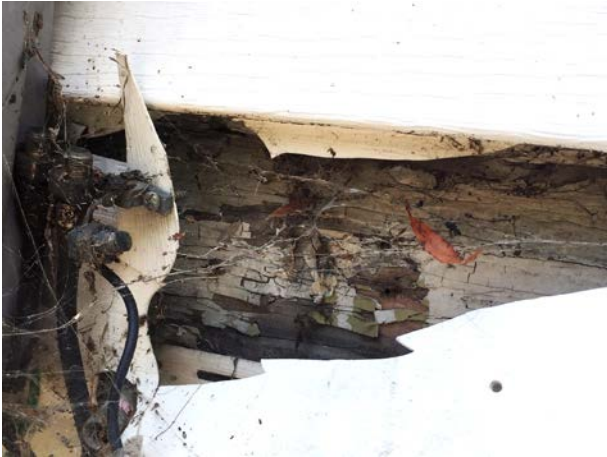
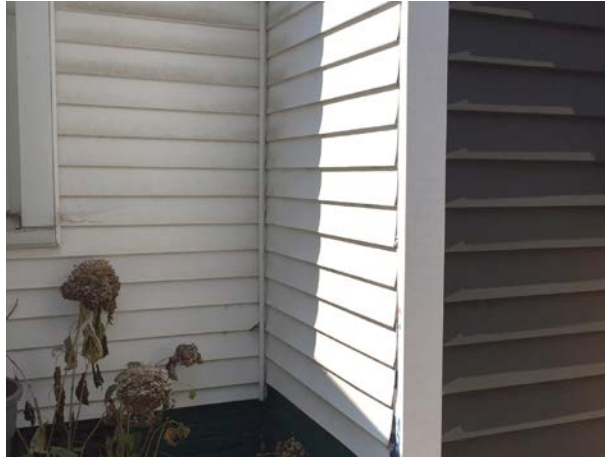
## – Front Right

**Top left:** Vinyl remains on ½ of the right side. Like other areas of the home, the vinyl is splaying in certain areas. This invites a host of dangers to the siding underneath.

**Bottom left:** This section shows what the wood looks like underneath the vinyl. It is rotten, damaged from previous owner work, and covered in lead paint.

**Bottom right:** This compares and contrasts the vinyl with the cedar lap siding that has been used on the rehabilitated portion of the home.
