LOCAL HISTORIC DISTRICT: Wilmore

PROPERTY ADDRESS: 1740 Wilmore Drive

SUMMARY OF REQUEST: Siding Changes

1740 Wilmore Dr.

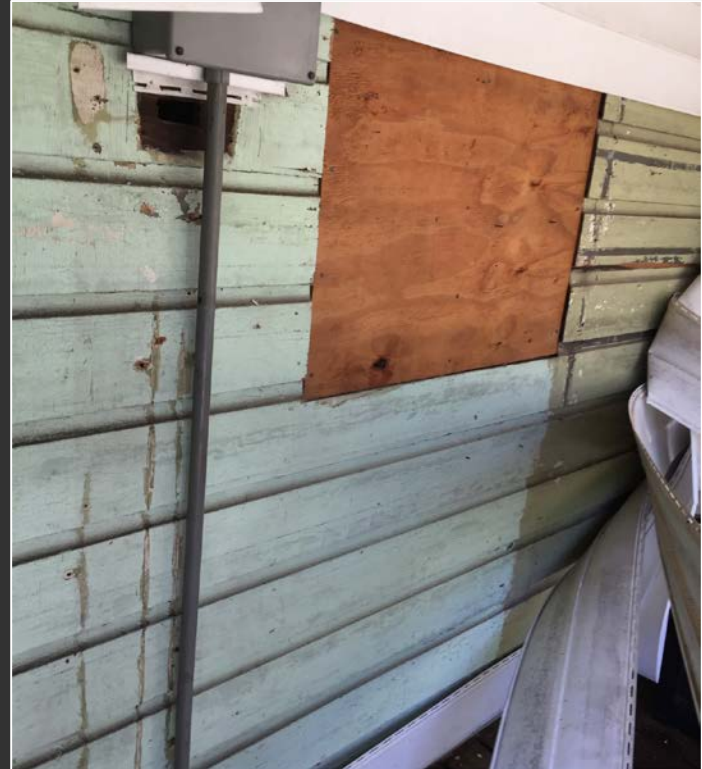
Right: Original siding with large patched areas, large holes, and lead paint

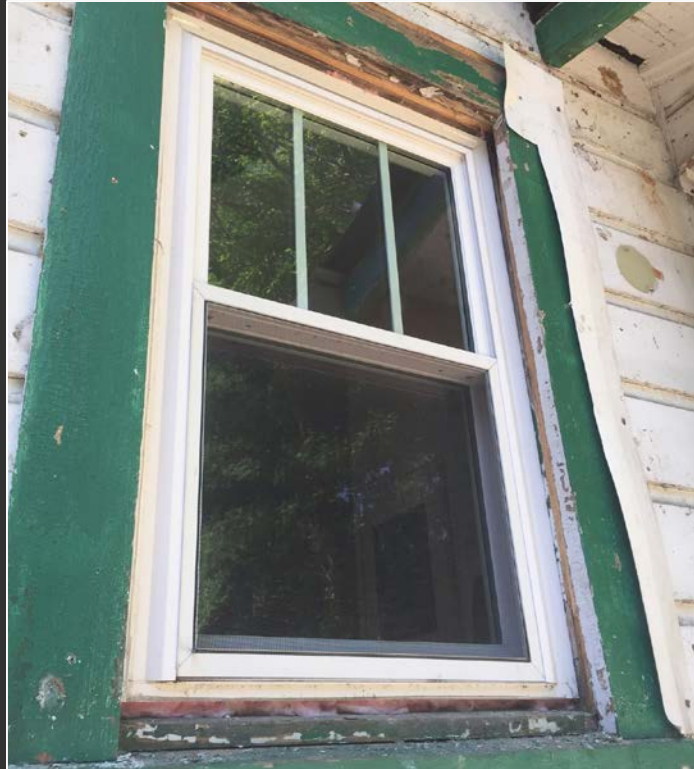
Left: This photo highlights the variety of trim we found once we removed the vinyl. Some windows had pieces of original trim which were rotten, some were not. Other newer trim was mixed in with old trim.

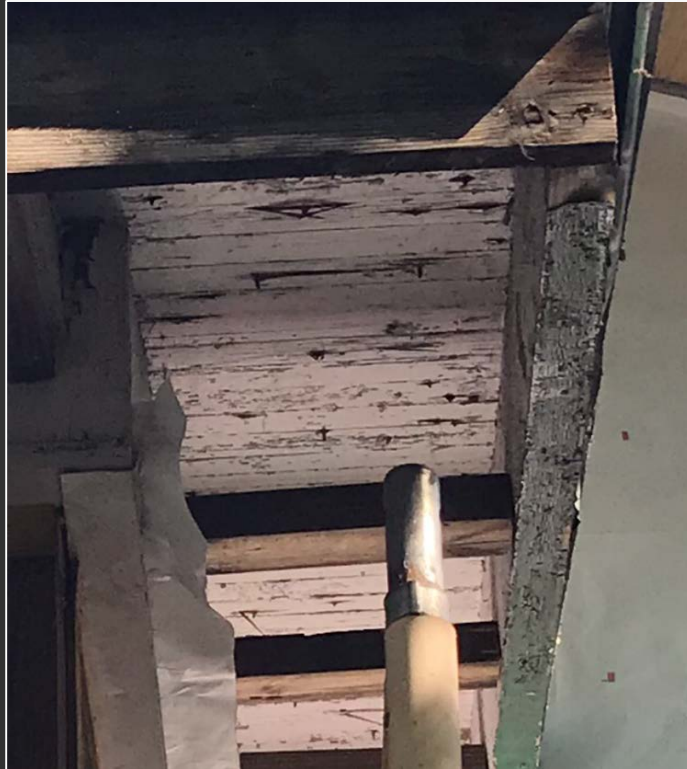
Right: Fascia completely dry rotted and soffits ruined by improper installation.

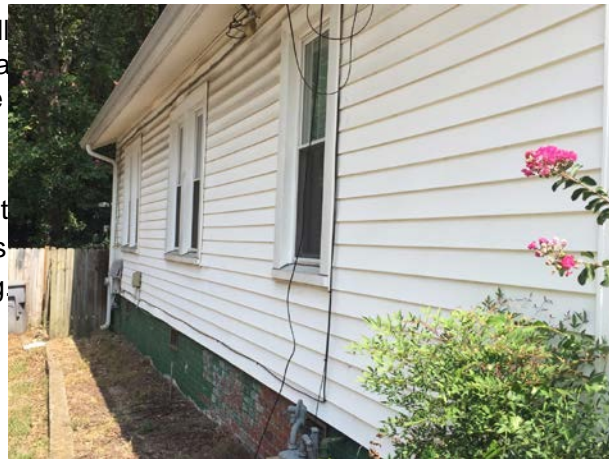
Top right: The left side of the home is covered in the vinyl. It also houses various drill holes from previous owners and internet and phone companies that no longer serve a purpose to the home. No water resistant barrier was used between the vinyl and the original siding, allowing for rot to potentially be present as was with other areas.

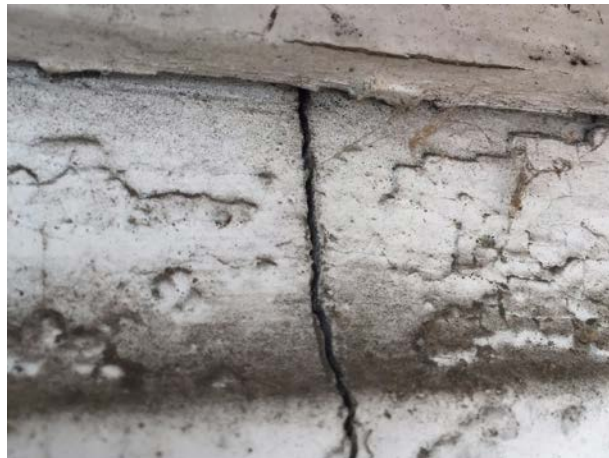
Bottom left: In several sections the vinyl has splayed. Underneath you can see segments of the wood beneath. This section highlights the condition of the wood, the seams between boards, and the layers of hazardous lead paint that are on the siding.

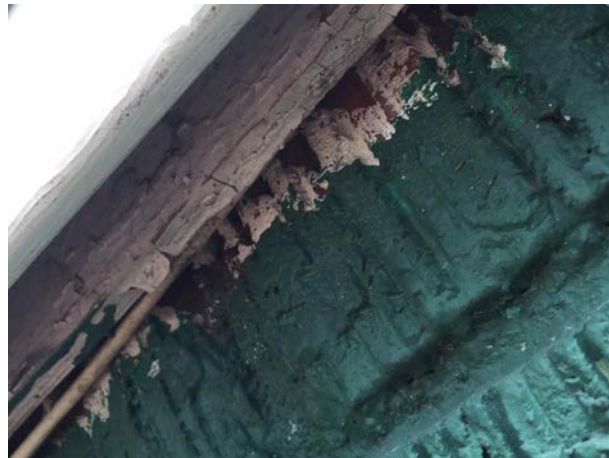
Bottom right: This view is from the foundational brick leading to the siding. Again, the vinyl was not correctly installed, thus did not protect the original siding from rot, mold, or invasive bugs.

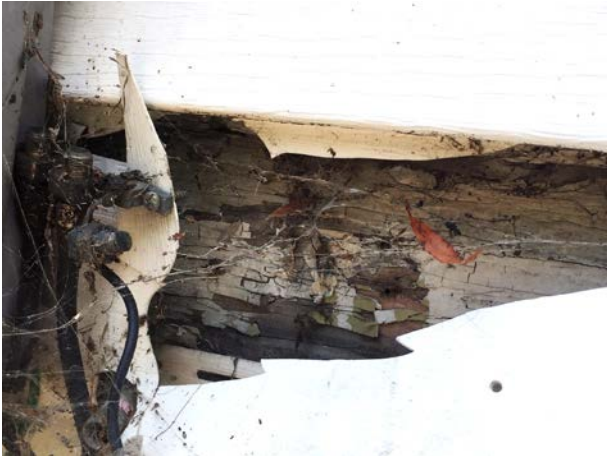
Bottom left: This section shows what the wood looks like underneath the vinyl. It is rotten, damaged from previous owner work, and covered in lead paint.

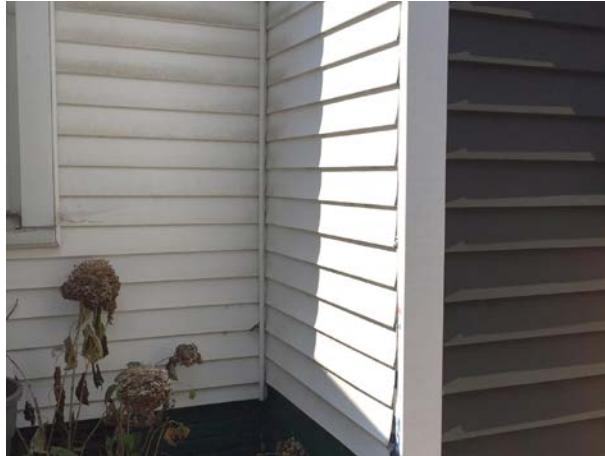
Bottom right: This compares and contrasts the vinyl with the cedar lap siding that has been used on the rehabilitated portion of the home.
