LOCAL HISTORIC DISTRICT: Fourth Ward
ADDRESS OF PROPERTY: 420 West 5th Street
SUMMARY OF REQUEST: Addition
APPLICANT: Neal Kanipe

Charlotte Historic District Commission - Case 2016-103
HISTORIC DISTRICT: FOURTH WARD

Charlotte Historic Commission Submittal

C.F.D.
**4th Ward
Fire House**

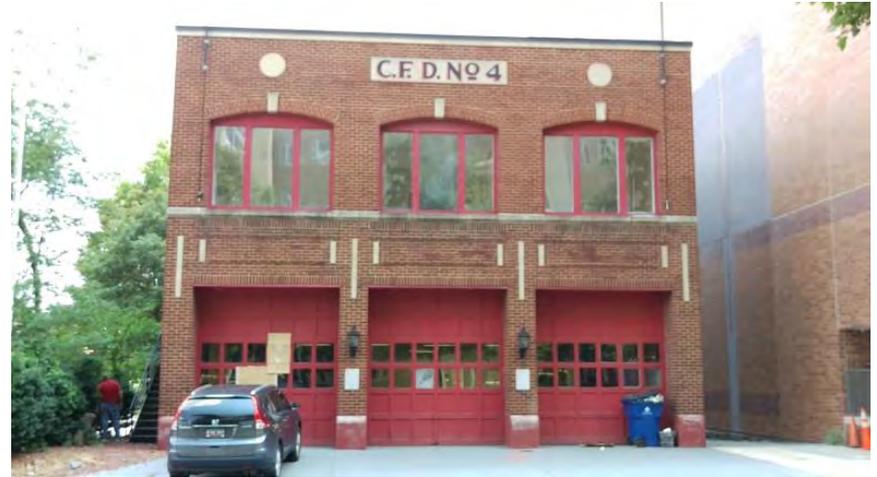
2016 – Front Elevation

Charlotte Fire Station Number 4 is a flat-roofed, three-bay, two-story brick building on West Fifth Street in Fourth Ward and adjacent to a high rise and mid-rise multi-family buildings. The proposed addition has been approved by the Mecklenburg County Historic Landmarks Commission, a COA was issued May 20, 2016. A previous proposal for an addition was approved in concept July 2013 by the HDC.

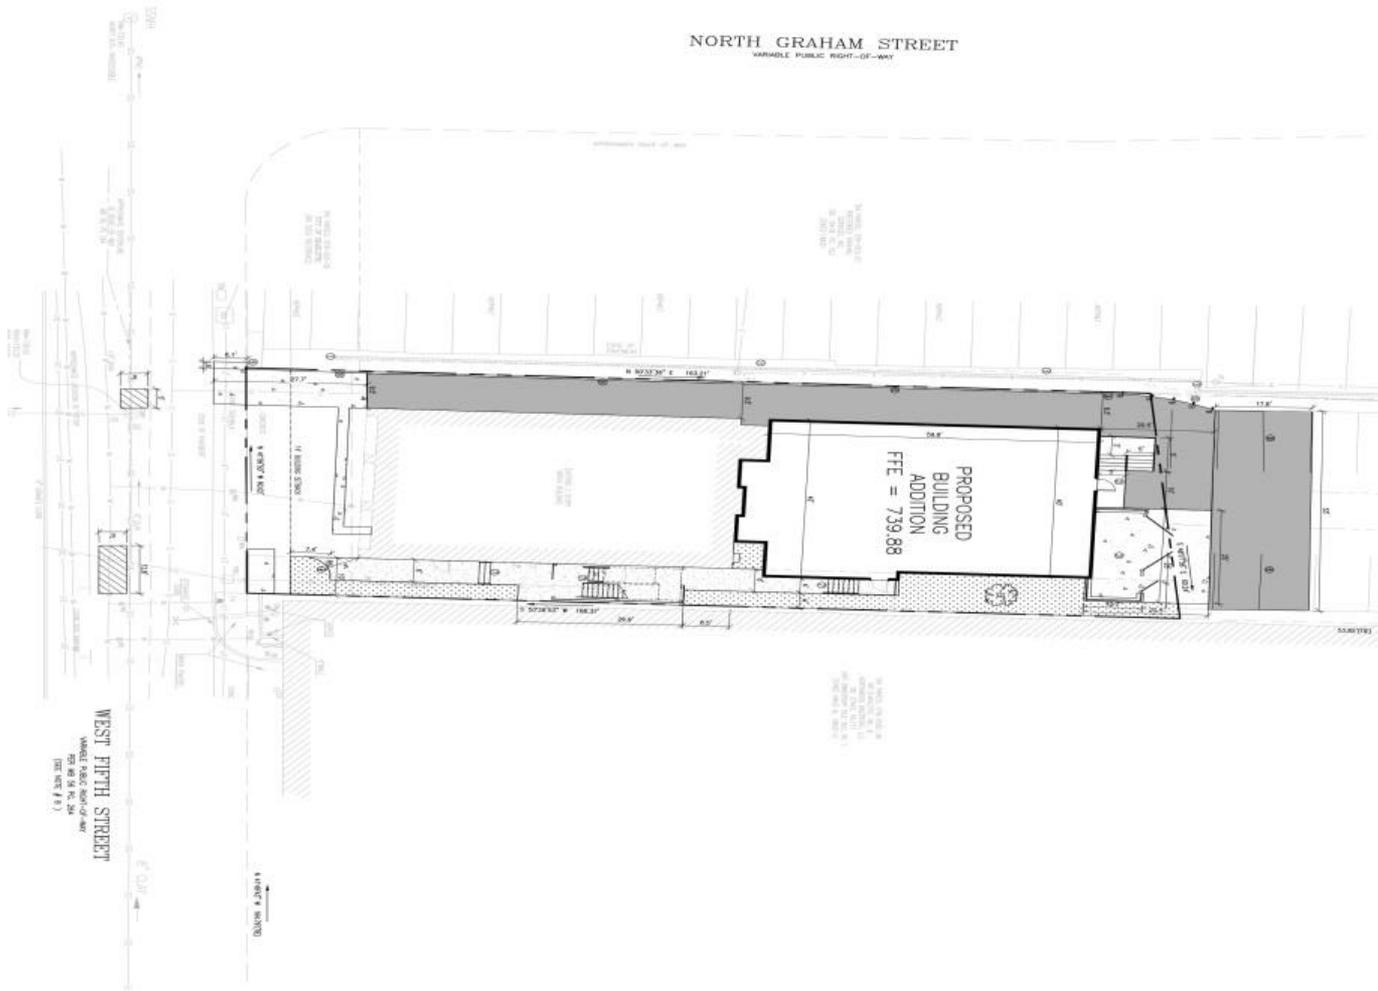
Total Site:
0.228 acres (9932 sf)

Impervious:
0.210 acres (9131 sf)

Pervious:
0.018 acres (801 sf)

**Front setback is 14' from
face of curb**

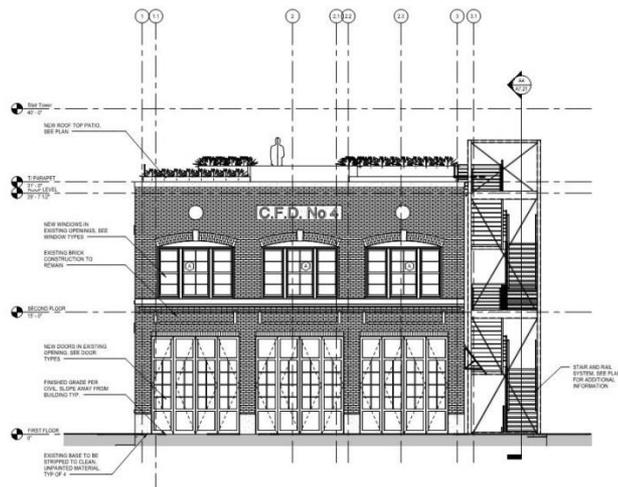
Front Elevation - Renovation

The application was continued for additional information on windows and doors. Further details on the fenestration and materials - The three large bi-fold doors on the front elevation, the main entry door on the right side rear elevation, samples of the new materials they are introducing on the new construction, and the windows on the front façade.

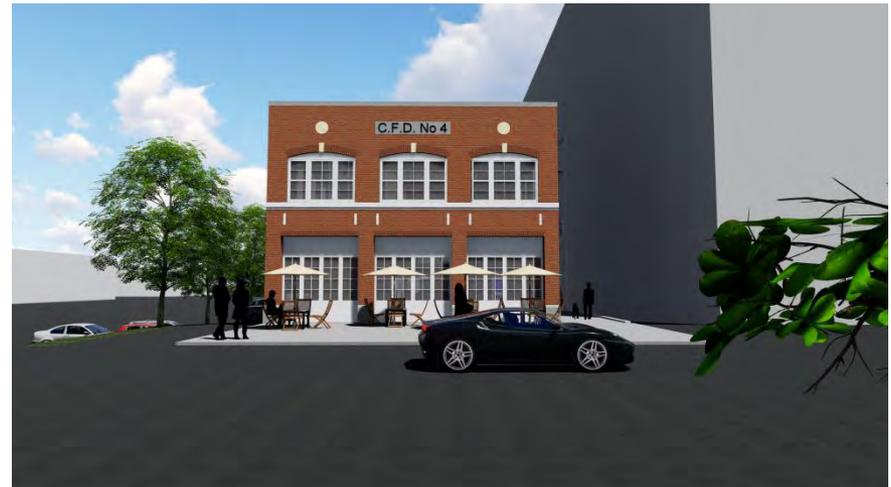
Rendering of proposed renovation & addition

The proposal is an adaptive re-use project with an addition to rear and right side. A rooftop terrace will also be added. The façade materials will be brick and metal. The exterior stairs will be enclosed with metal panels.

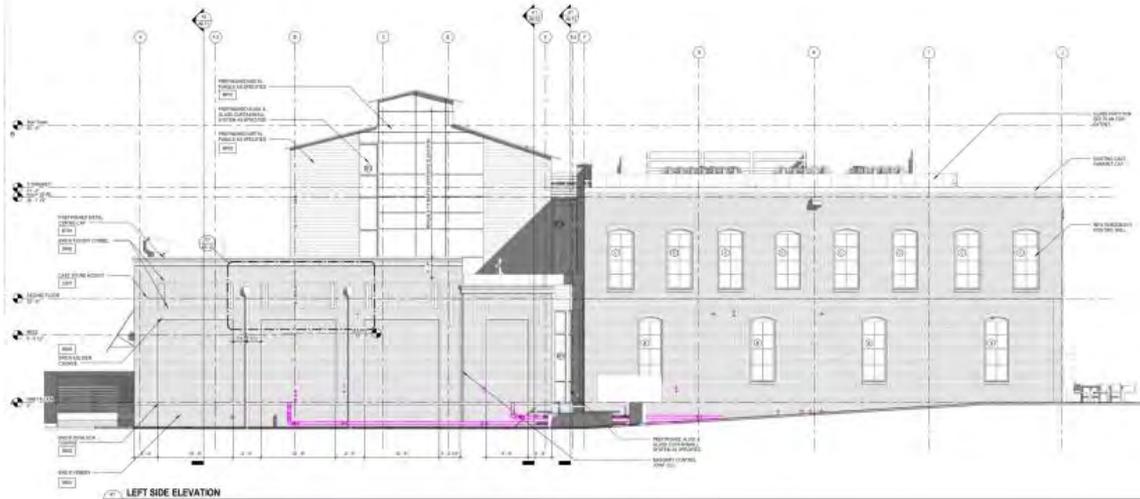
Left Side Elevation – Renovation & Addition

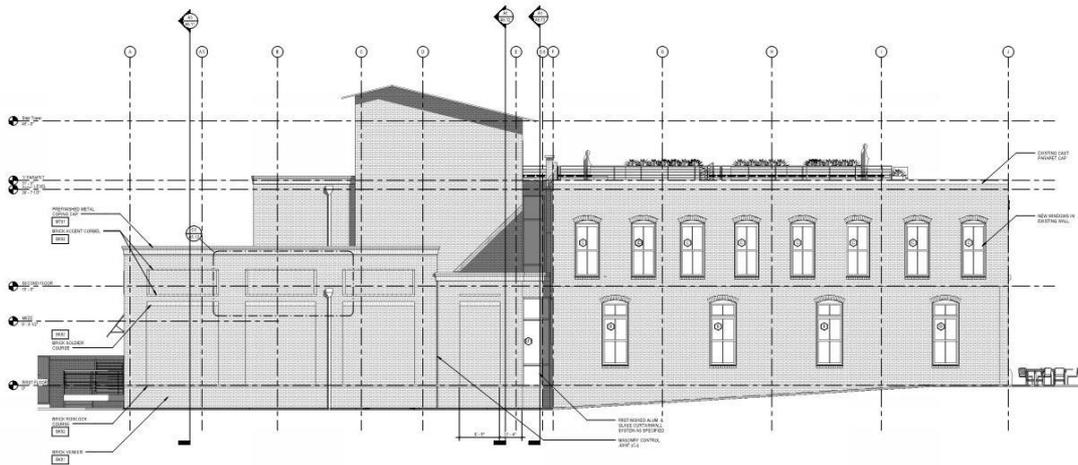
Left Side Elevation – Renovation & Addition

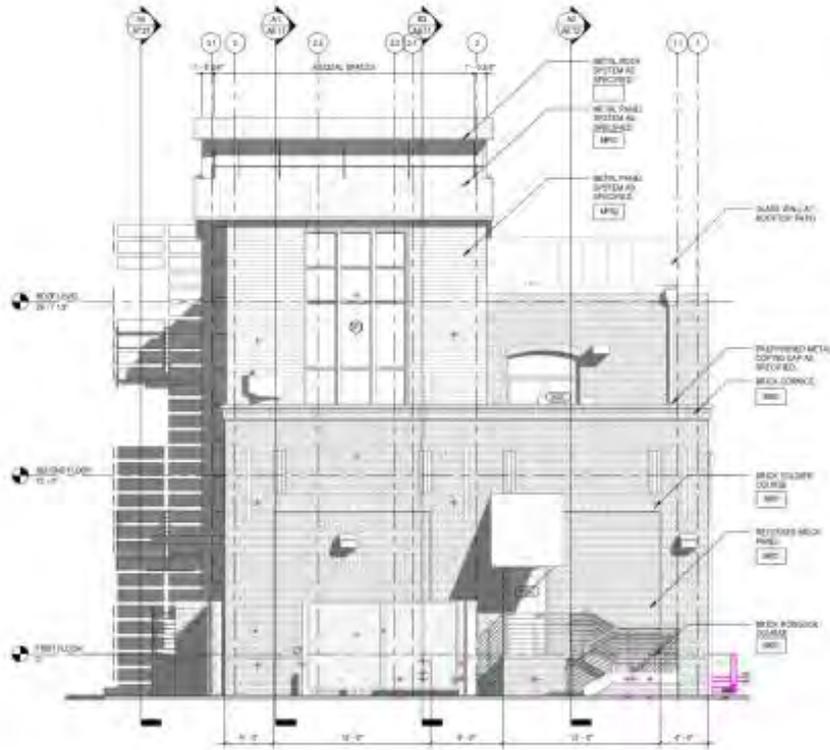
REAR ELEVATION
STEP 4.11E

Rear Elevation – Renovation & Addition

- The metal panels covering the exterior stairs have been removed.
- The roof of the rear addition has been modified.
- The material of the addition is brick.

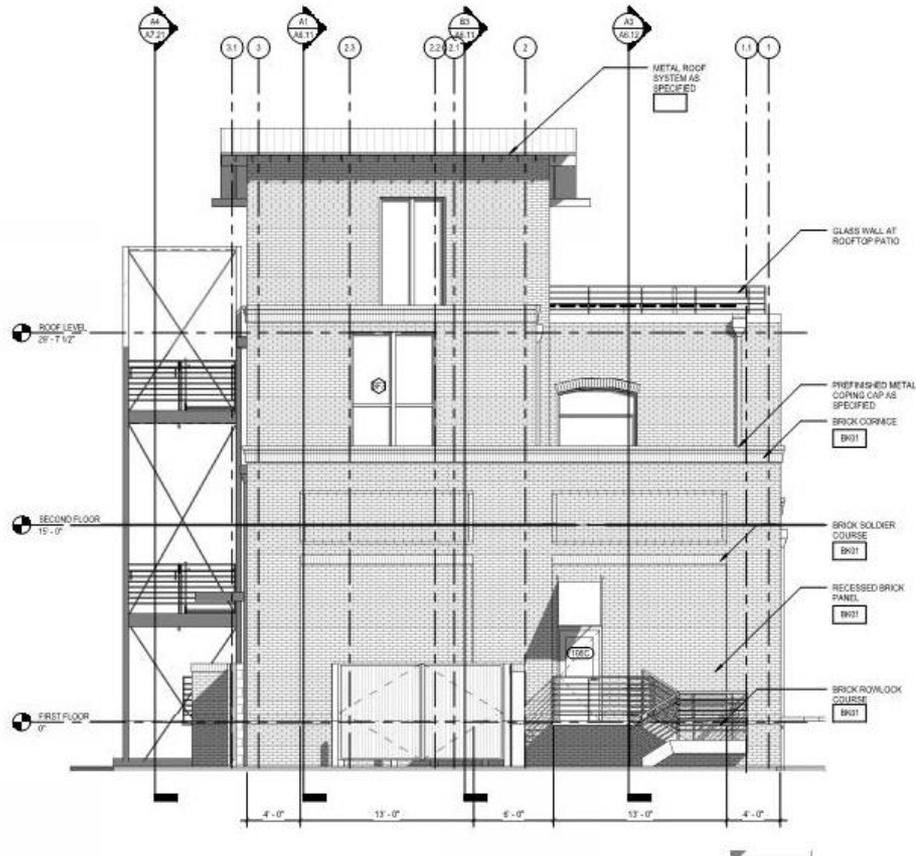
Rear Elevation – Renovation & Addition

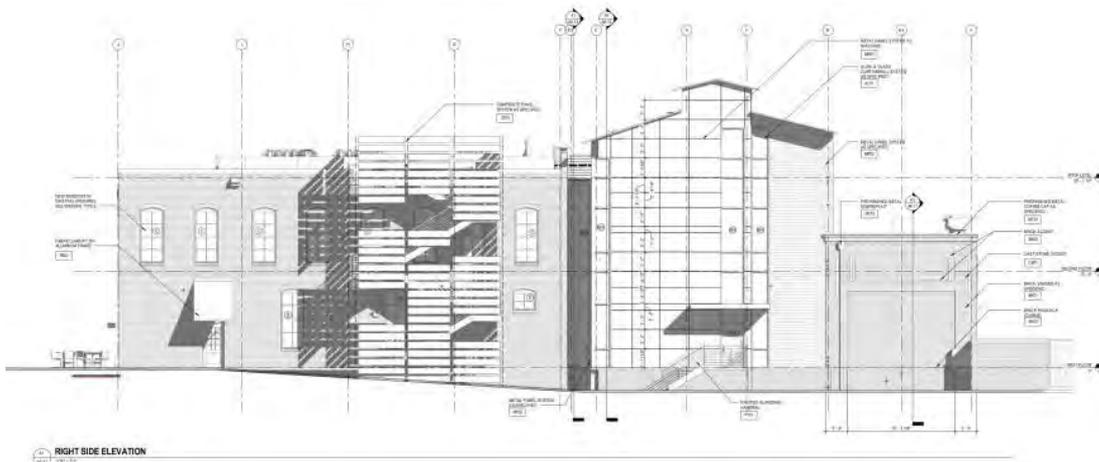
Right Side Elevation - Renovation & Addition

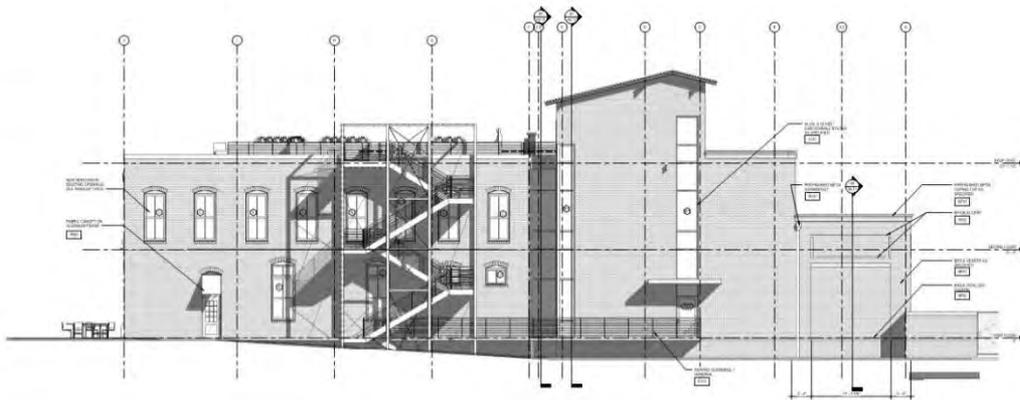
Right Side Elevation - Renovation & Addition

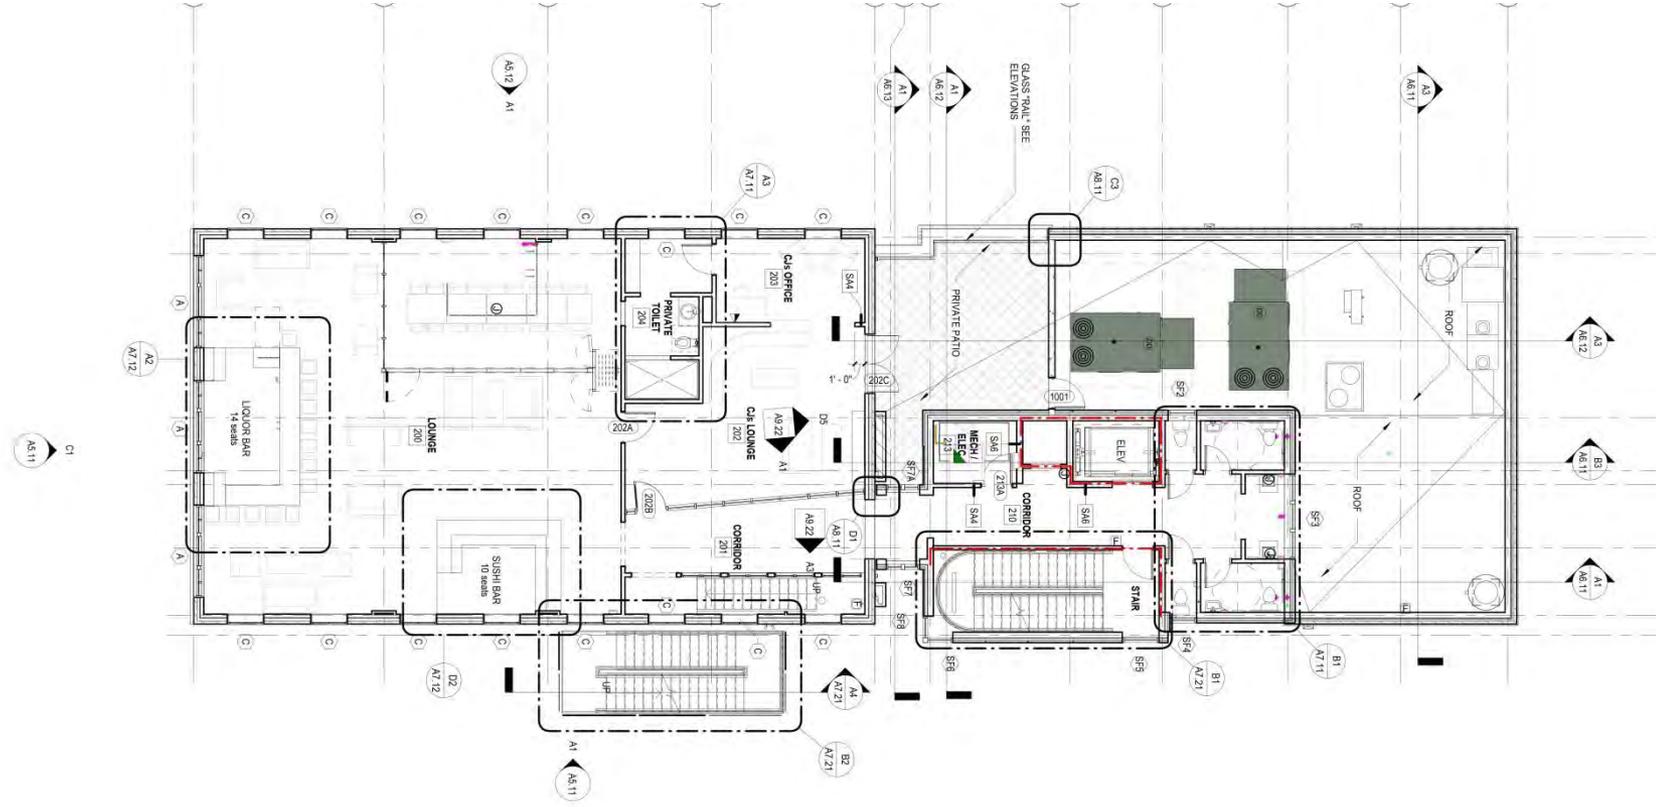
1 SECOND FLOOR
1/8" = 1'-0"

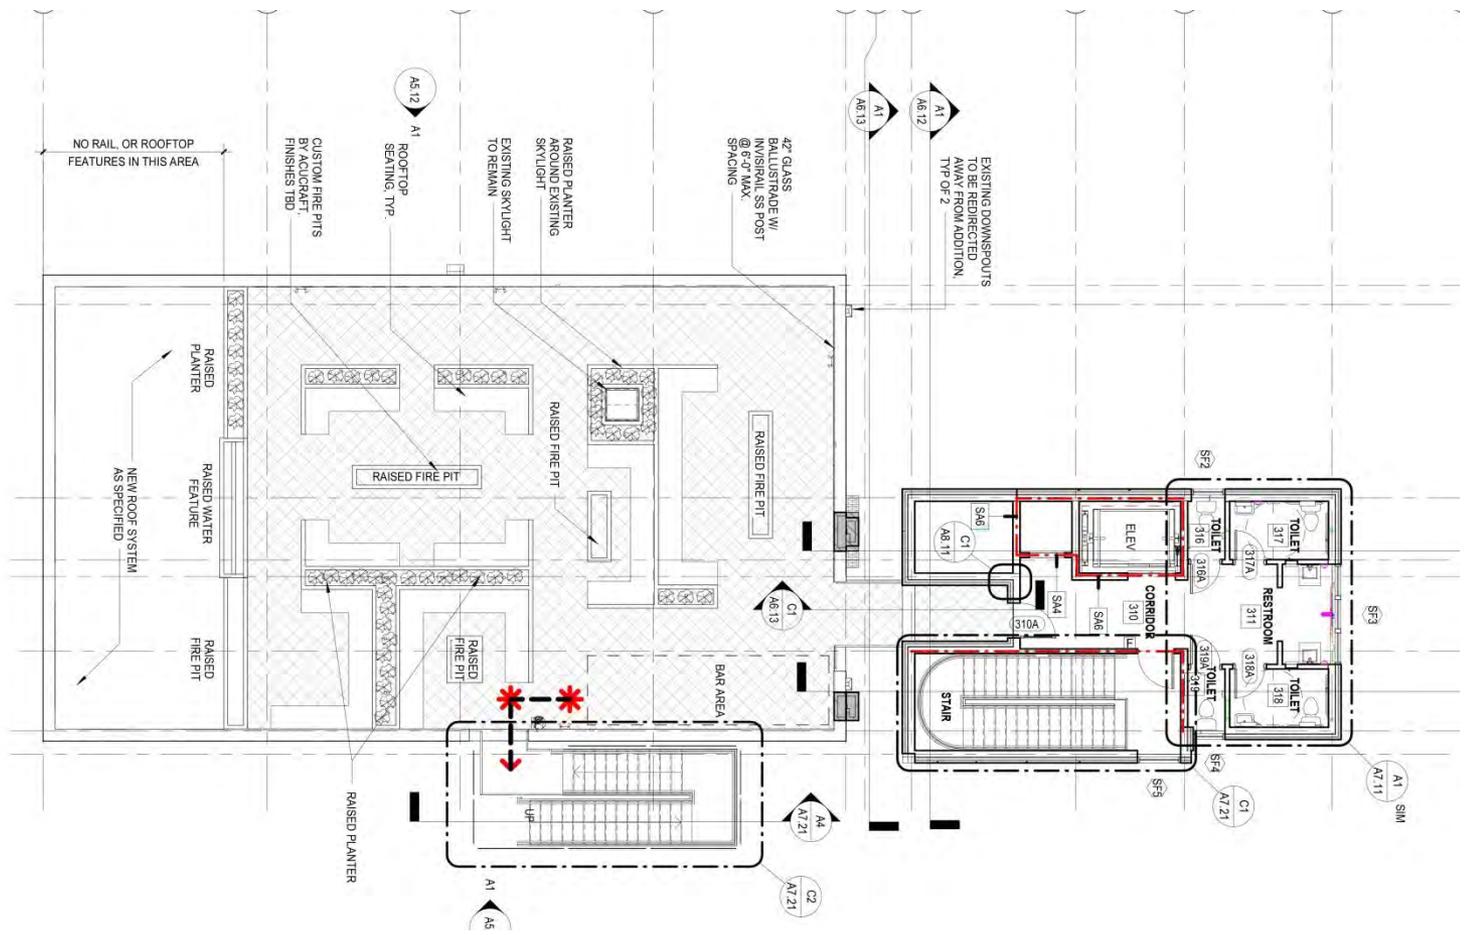
ROOF PATIO
1/8" = 1'-0"
