## Charlotte Historic District Commission Application for a Certificate of Appropriateness

ADDRESS OF PROPERTY	1600 South Mint Street, Wilmore Local Historic District	HDC 2011-002
SUMMARY OF REQUEST	Partial Demolition	
OWNERS	Weldeghebriel Haile	
APPLICANT	Weldeghebriel Haile

# Charlotte Historic District Commission - Case 2011-002

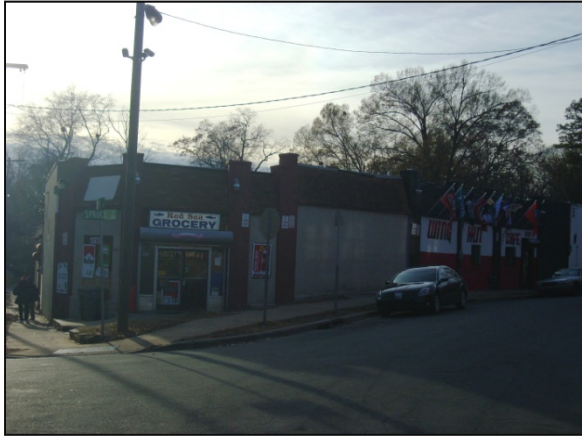
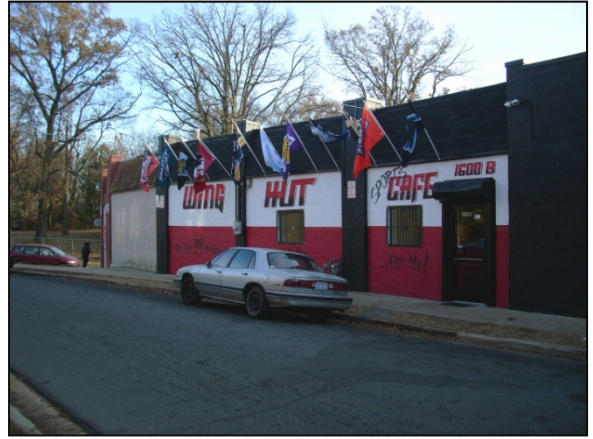
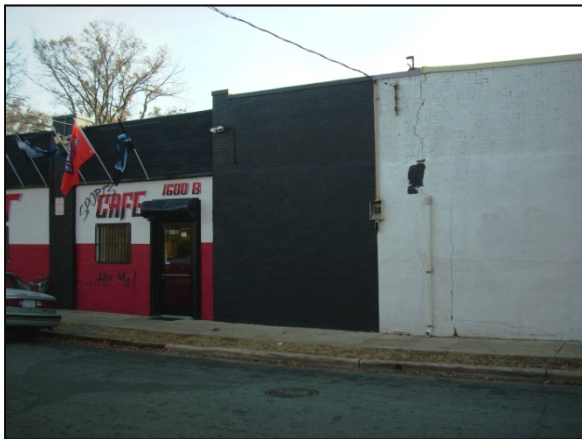
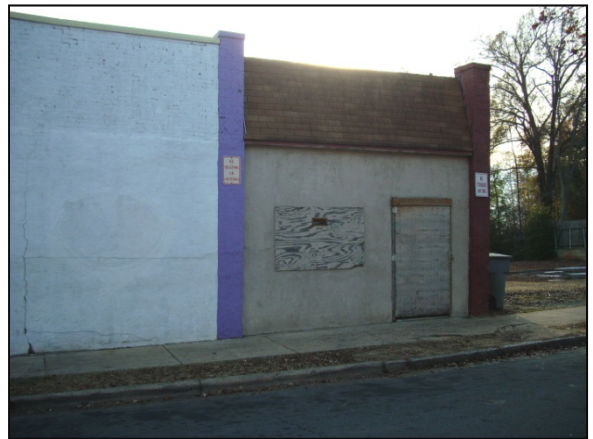
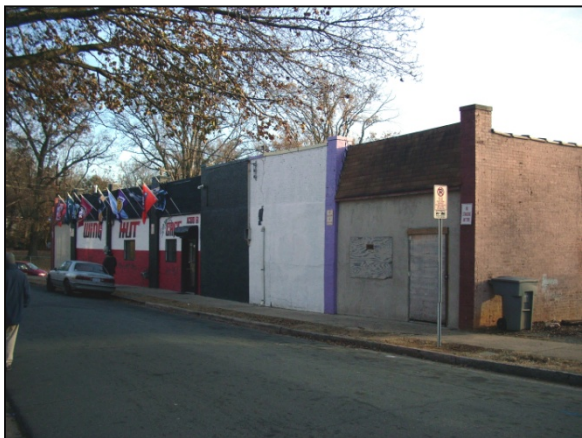
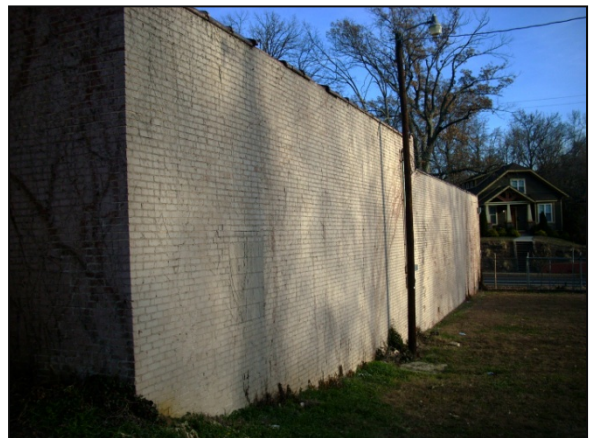
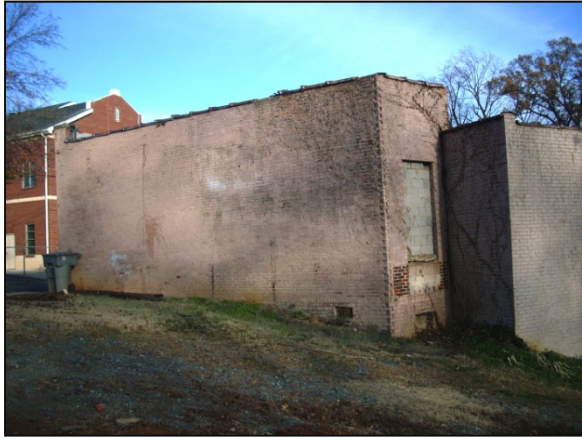
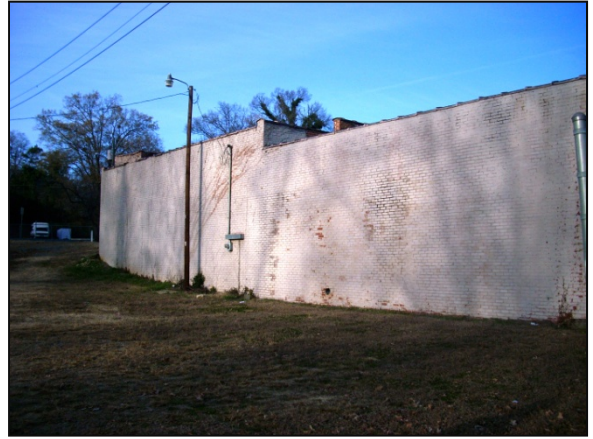
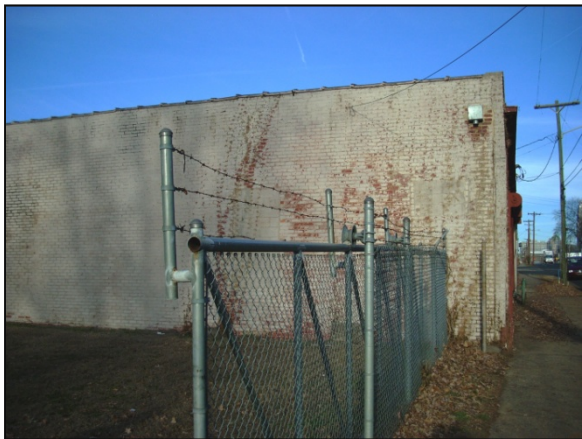
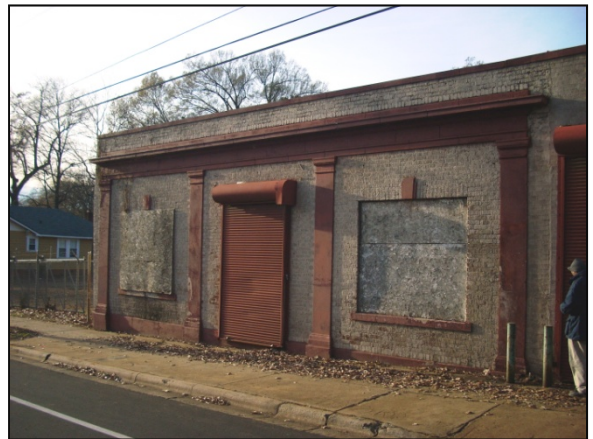
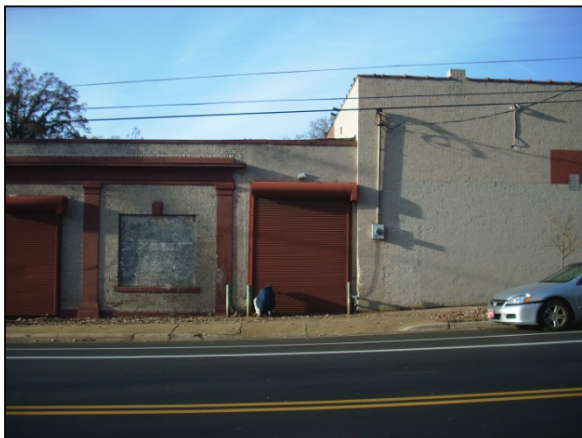
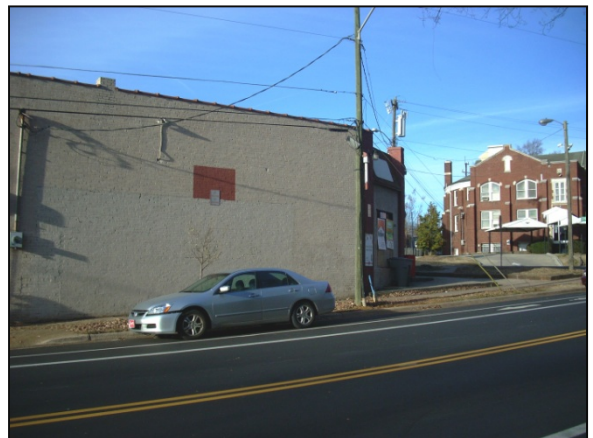
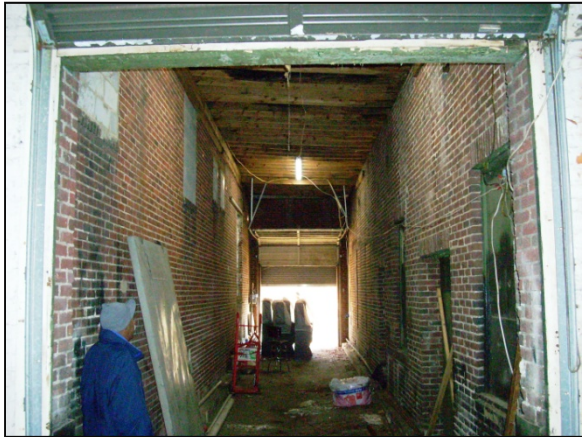
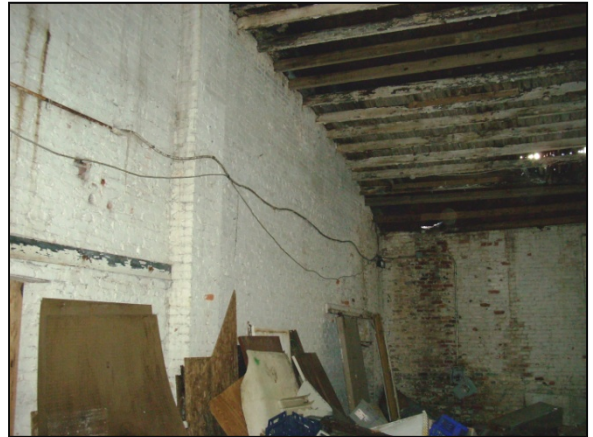
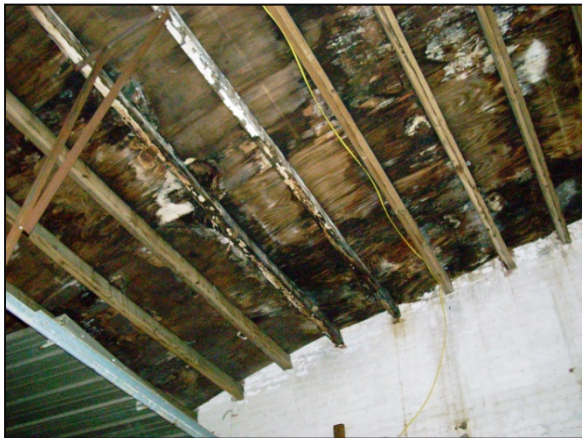
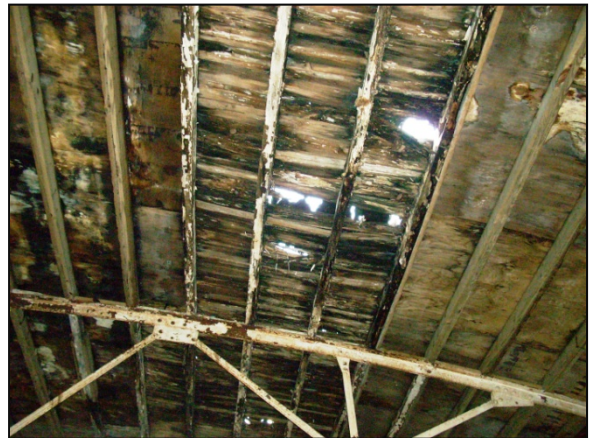
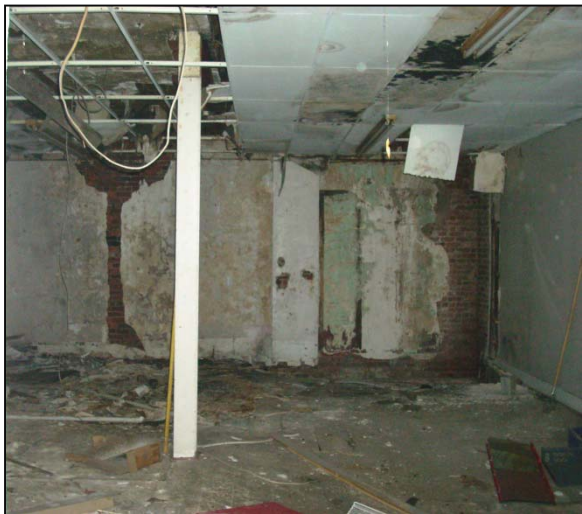
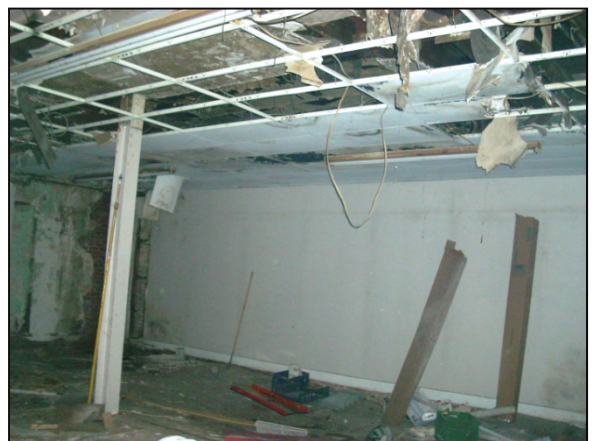
The sections of this proposed for demolition are in very poor repair, and are currently not in use. HDC Staff has toured the inside of these structures to the extent that the condition of the building allows. Photographs of the interior of these building are attached.

The roofs of these structures are in extremely poor condition, and provide no protection from the elements. Parts of the internal walls have collapsed. The buildings are currently secured, and accessible only through installed metal roll-up doors.

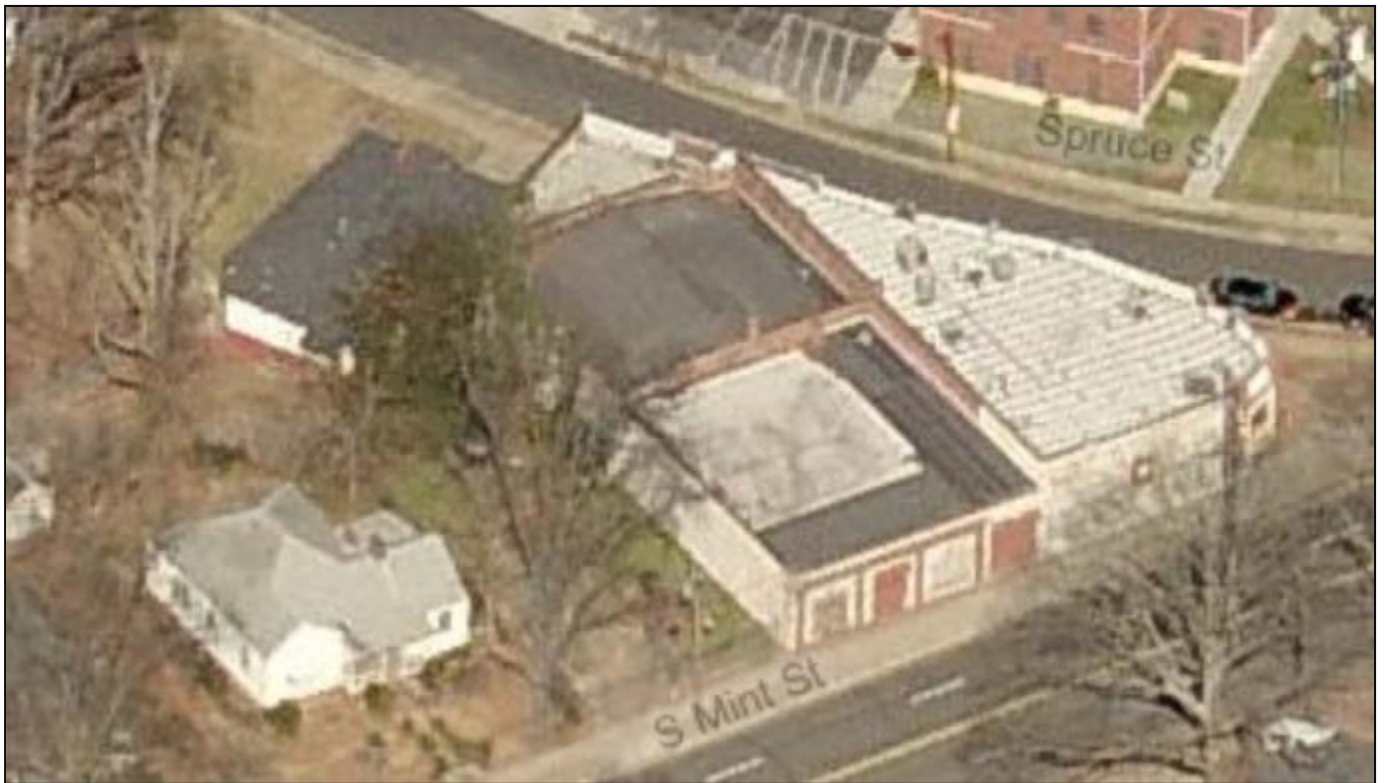
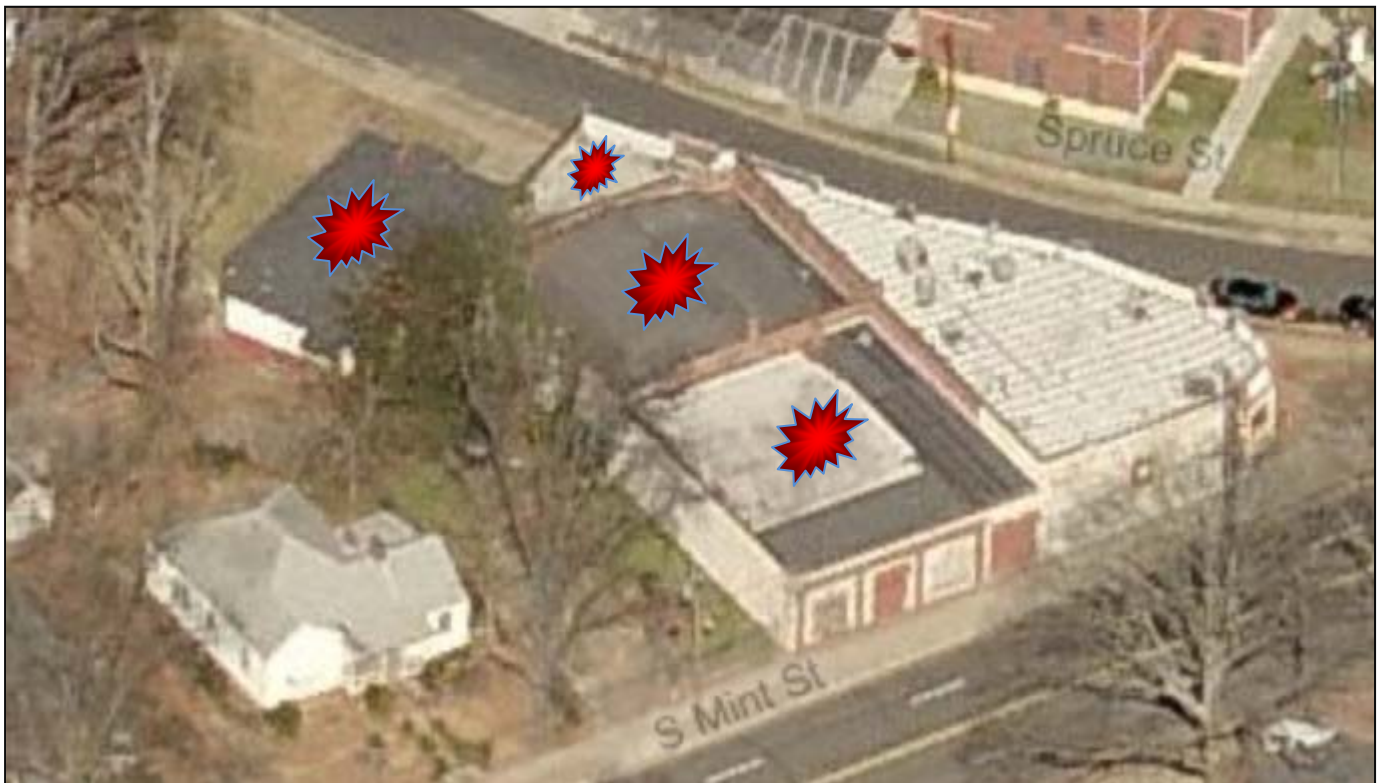
- Sections to be demolished
