# Charlotte Historic District Commission Application for a Certificate of Appropriateness

## April 13, 2011

ADDRESS OF PROPERTY	1715 Wickford Place, Wilmore Local Historic District	HDC 2011-036
SUMMARY OF REQUEST	Addition of Front Porch Columns & Railings	
OWNERS	Henry Ellis & Amber Ellis	
APPLICANT	Henry Ellis

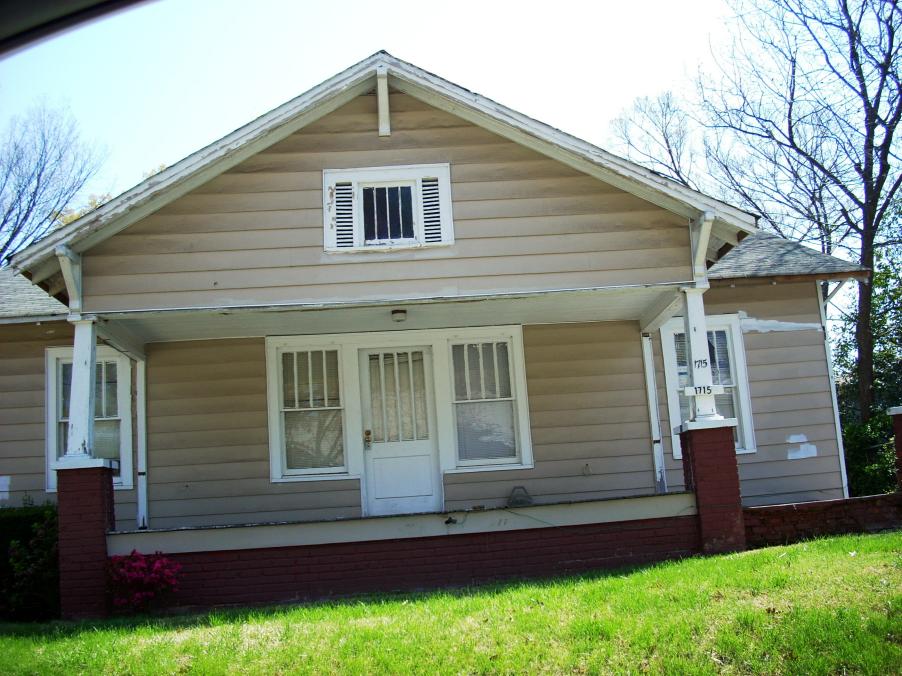
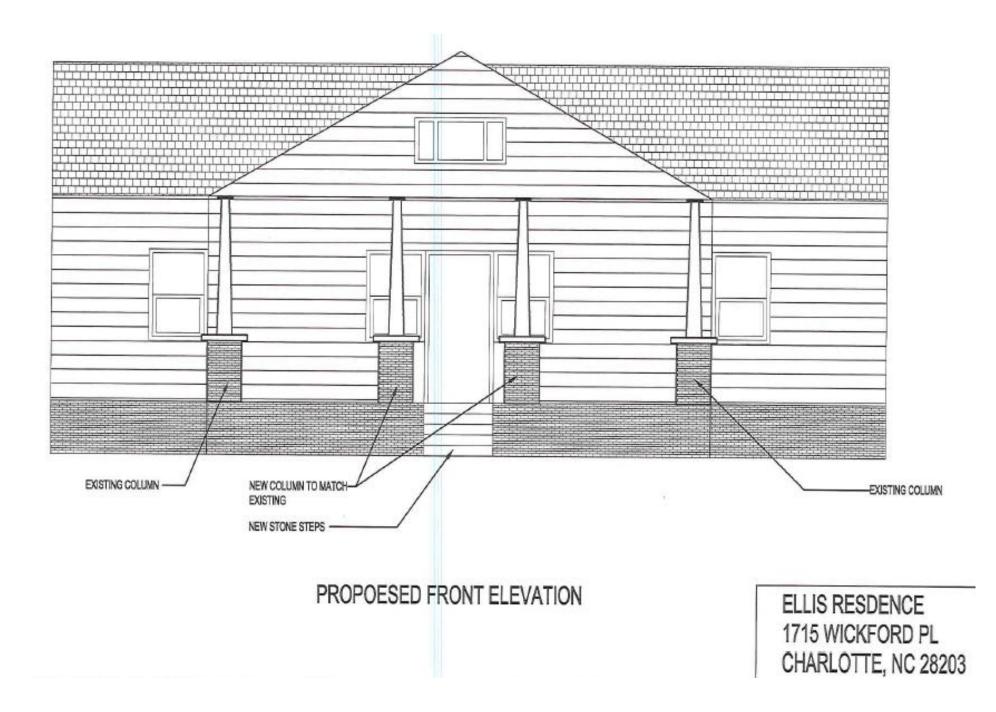
As shown on the attached drawing, the plans call for the installation of two new columns inboard of the existing corner columns on the front porch. The two existing columns are on brick bases that extend to the ground. In order to match the existing columns, the porch would have to be notched to accommodate the installation of two new bases of this design. An alternative approach would be to install two columns with smaller brick bases sitting on the floor of the porch, but this design would likely need to have additional foundation work done under the existing porch deck.

This application seeks approval for the addition of two front porch columns to this single family home in Wilmore. The porch currently has two columns at the outside corners, and the new columns would be inboard of those.

In the course of the restoration of the front porch, the owners have determined that the gable roof of the front porch is in need of additional support.
