2006 rear addition. Red tape marks are a *random* sampling of the abundance of inferior masonry work, including:inconsistent mortar joint widths (from 1/4"-1 1/4"); broken bricks; crooked bricks; uneven course; overfilled mortar joints; excess mortar drips

Substandard Masonry Work

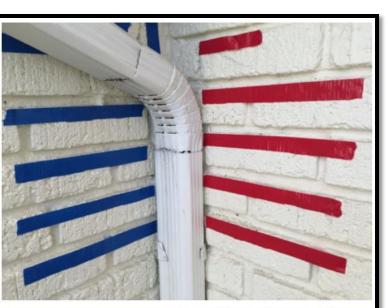
Uneven walls at butt joint between original house (left) and addition (right), NW side. Top several rows are up to 3/4" out of level.

The literal illustration of a poorly matched addition.

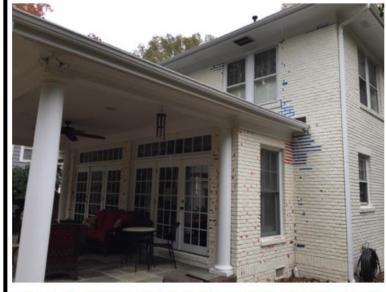
Southwest side of rear addition and original building, viewed from Worthington Ave walk. Tape below gutter illustrates a highly visible element of this poorly matched additionthe walls are uneven as much as 7/8" at the butt joint between old & new walls, and the mortar joints have been overfilled as much as 24" from the inside corner (blue tape)

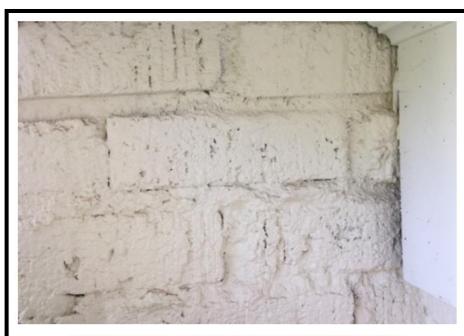
Shoddy and overfilled mortar joints, upper NW wall of 2006 addition

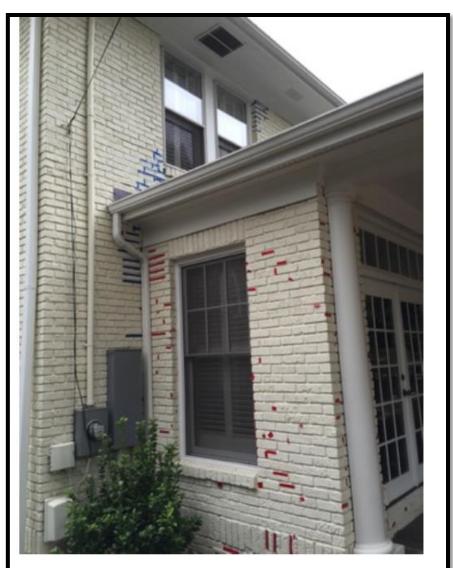
Northwest side of 2006 single story rear addition & original building. Settlement cracks around second floor windows carelessly repaired with blueish/gray mortar, instead of beige color used on rest of house. Tape below gutter illustrates uneven butt joint on this side of addition.

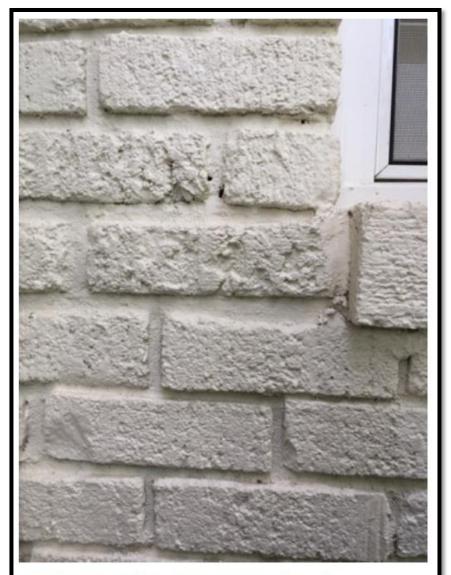
Northwest wall of 2006 addition, left side of window. Crookedly set bricks, broken bricks filled with mortar and inconsistent mortar joint widths.

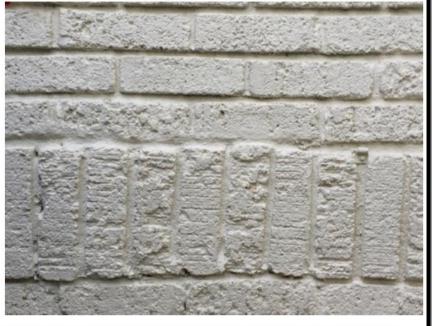
Crooked soldier course. NW wall of 2006 addition. Also note mortar overfill and drips

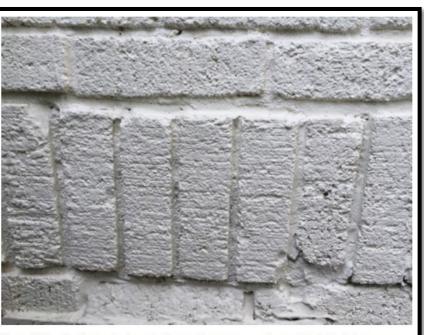
More NW wall with crooked, protruding soldier course and caved-in brick below.

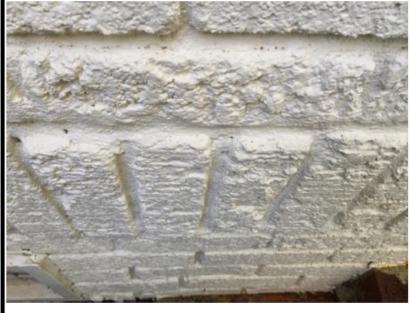
Top of crooked NW wall soldier course, protruding 1/4"-1/2" from rest of wallexposing it to standing water.

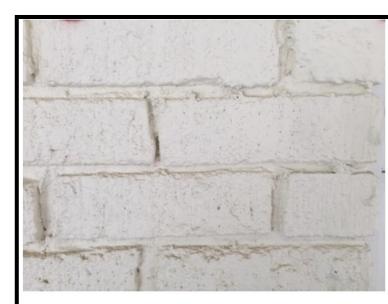
More inferior mortar work on *left wall* of addition: crooked, untooled joints and excess mortar drips indicative of substandard craftsmanship throughout.

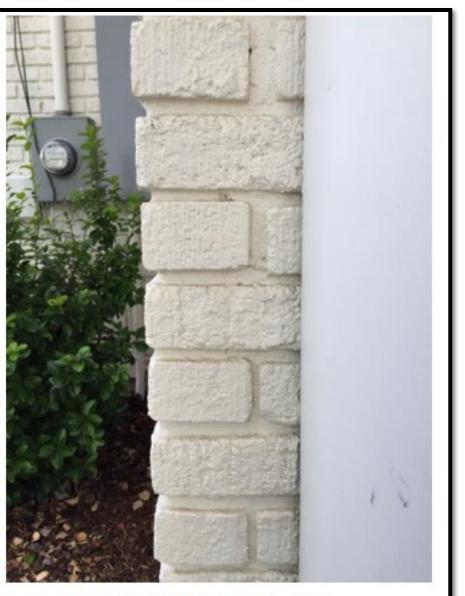
Left wall of 2006 rear porch addition.

Vastly inconsistent mortar head (vertical) joints, ranging from 1" at top to 3/8" at bottom. Bed joints also vary as well. Also note broken and crooked bricks, and excess mortar on brick faces & edges.

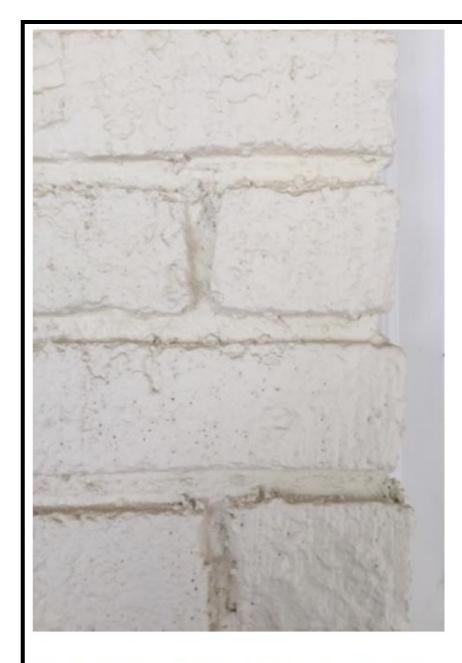
Shoddy brick & mortar installation, left wall of 2006 addition

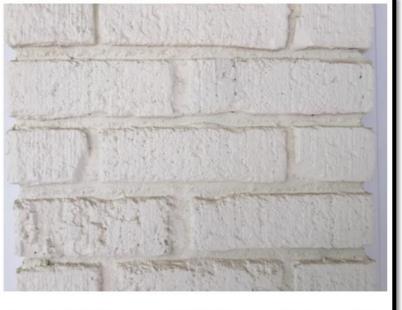
Inconsistent mortar joint widths; crooked and broken bricks; sloppy & excess mortar. Center wall of 2006 rear porch addition.

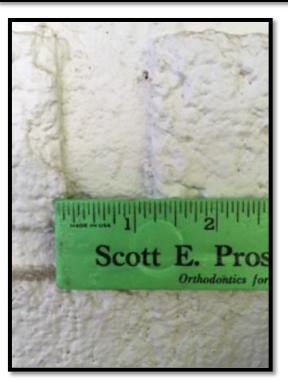
Center wall of 2006 addition

Mortar head joints in excess of one inch wide, common throughout all three sides of porch. (Industry standard is 3/8")

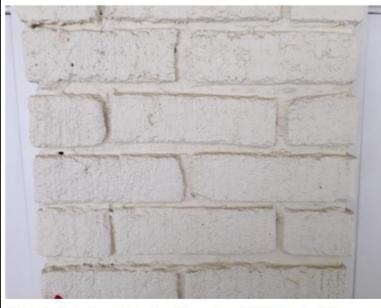
Substandard, shoddy workmanship on the *center wall* of 2006 porch addition: Crooked & broken bricks, uneven mortar joints, excess mortar not removed.

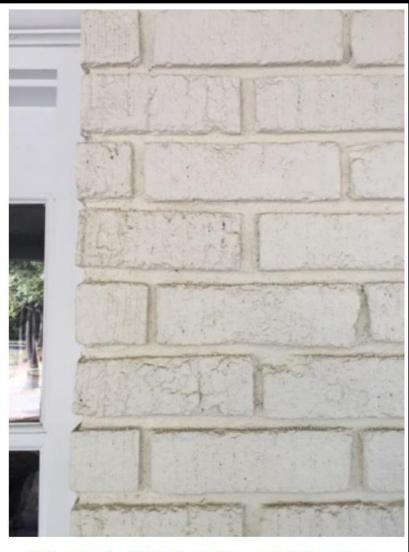
right wall of 2006 rear addition

Uneven head & bed mortar joints, crooked & broken bricks-

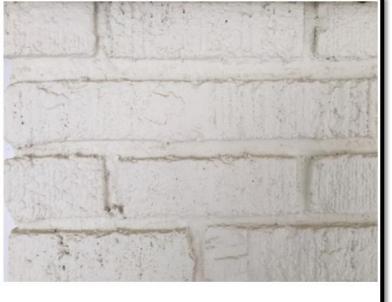
right wall of 2006 addition

More inconsistent & sloppy mortar joints-

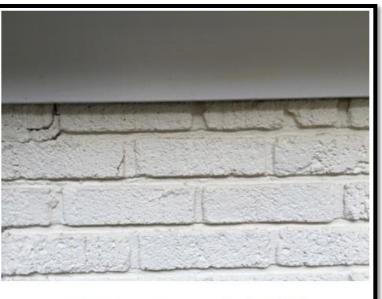
Broken bricks, uneven mortar spaces, sloppy mortar finish. Top of 2006 addition *SW wall* (facing Worthington Ave)

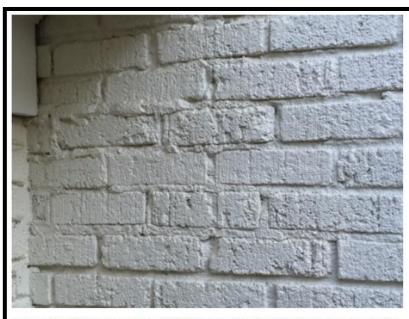
Same wall (higher up, w/o tape) of 1924 bldg. at *SW side* butt joint, facing Worthington. Unsightly-and problematic-overfilled and irregular mortar joints, inferior work all around.

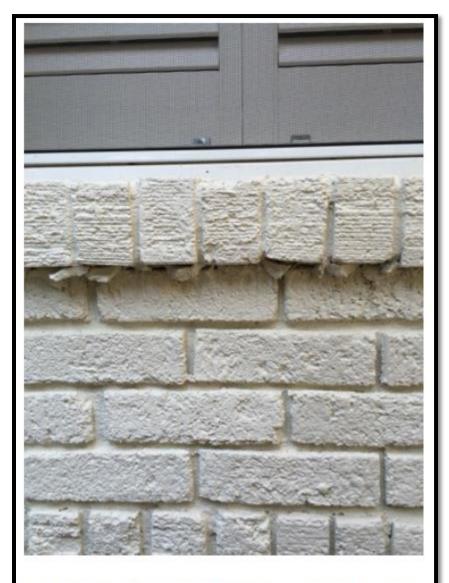
Crooked brick, irregular mortar joint spaces, sloppy mortar finish. *SW wall* below window of '06 addition, facing Worthington Ave.

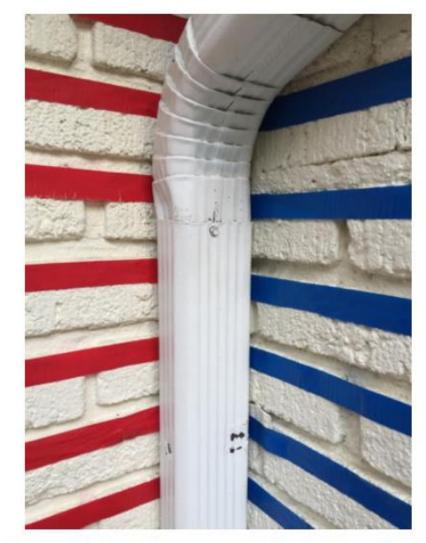
Greatly uneven brick courses at *SW side* butt joint facing Worthington Ave. of 2006 addition (left) and 1924 original structure (right), some as much as 7/8" Also note irregular mortar joints, as well as overfilled joints at top right.

The literal illustration of a poorly matched addition.

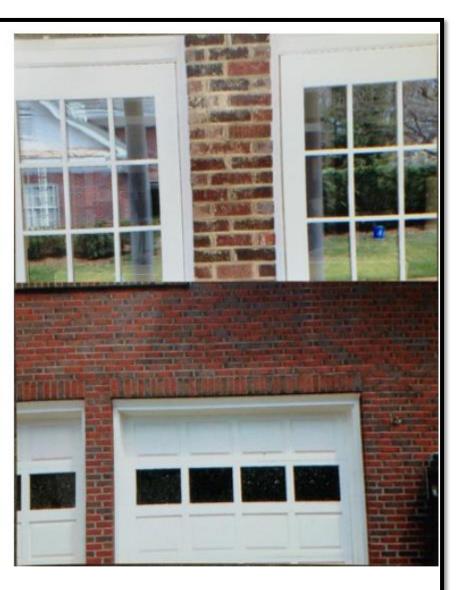
Photos of mismatched brick & mortar colors, between house (top) and garage (bottom). Also note mismatch in reflection on left side of top photo.

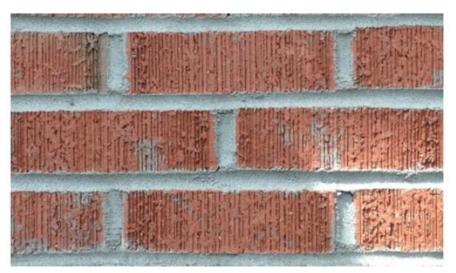
Mismatched brick texture and brick & mortar colors, between the 1924 house (top) and 2001 garage (bottom)

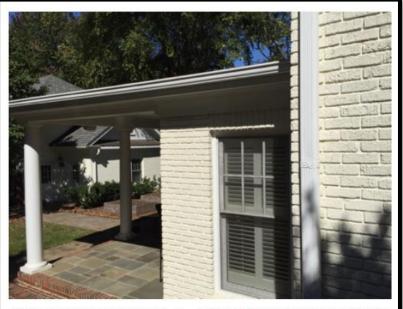
Inferior brick and mortar work on *South wall* of '06 addition (w/window) hidden by paint. Disparate elements of garage, addition and original house unified with neutral color.

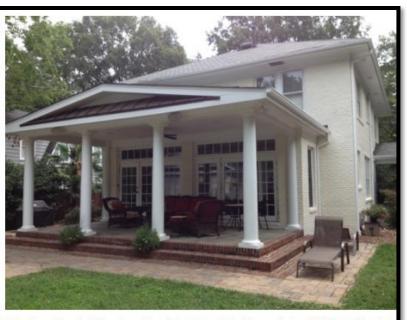
Poorly matched addition (porch) and repair work (2nd floor windows) hidden with paint, defects no longer visible from Worthington Ave.

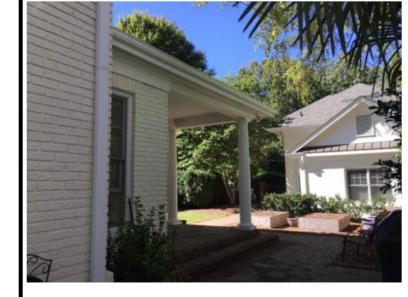
Inferior brick & mortar work on *North wall* of '06 addition (left w/window) hidden by paint. Disparate elements of garage, addition and original house unified with neutral color.

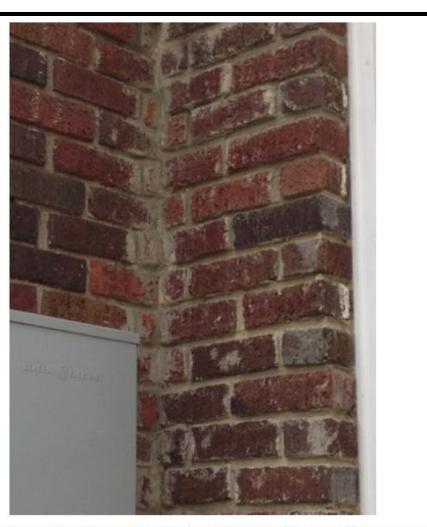
Inferior joint between original structure (left) and 2006 remodel (right). In addition to the obvious shoddy mortar work, note the mismatched brick and uneven brick courses and mortar joints, especially at the top. These photos of the *north side* of the 2006 addition are indicative of the error-filled workmanship throughout all three sides.

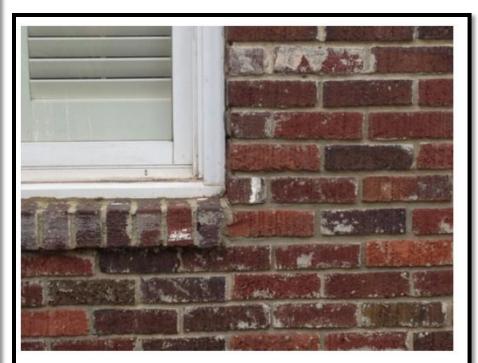
More sloppy, unsightly masonry work-north side wall of 2006 addition.

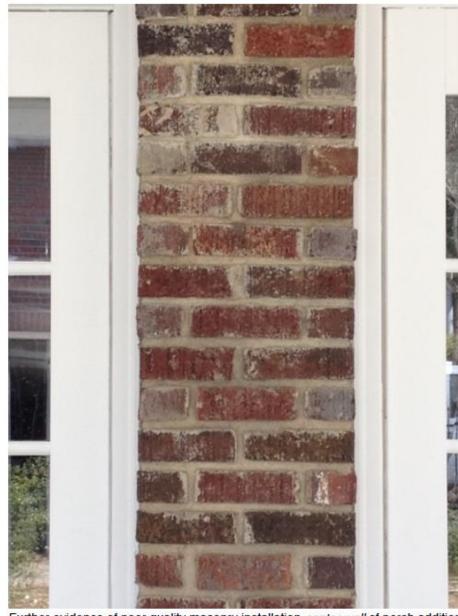
Further evidence of poor quality masonry installation-*center wall* of porch addition. Note the crooked bricks, excess mortar and inconsistent joint spaces. Also note the mismatched red and gray garage brick in the left reflection.

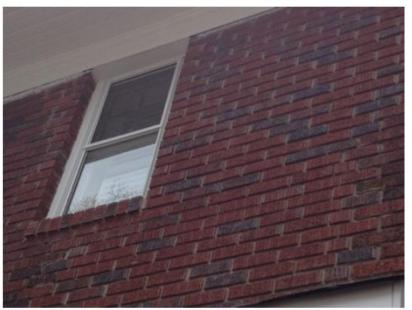
North side, second floor 6'w x 8'h brick wall of original house, visible from Ewing Ave.

Note mismatched brick & mortar, as well as brick texture, between old & new areas.

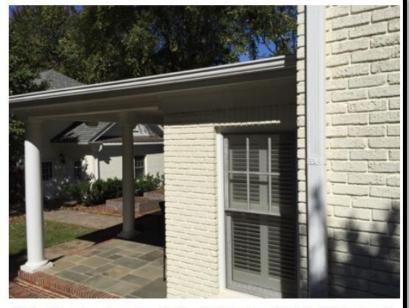
Inferior brick and mortar work on *South wall* of '06 addition (w/window) hidden by paint. Disparate elements of garage, addition and original house unified with neutral color.

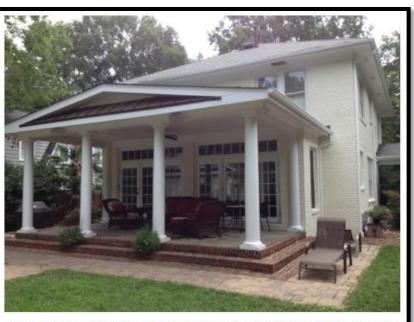
Poorly matched addition (porch) and repair work (2nd floor windows) hidden with paint, defects no longer visible from Worthington Ave.

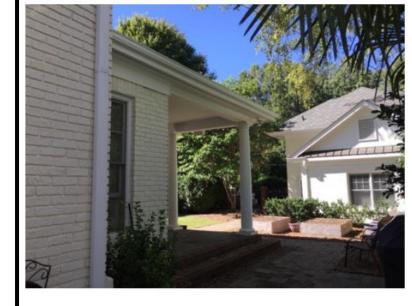
Inferior brick & mortar work on North wall of '06 addition (left w/window) hidden by paint. Disparate elements of garage, addition and original house unified with neutral color.

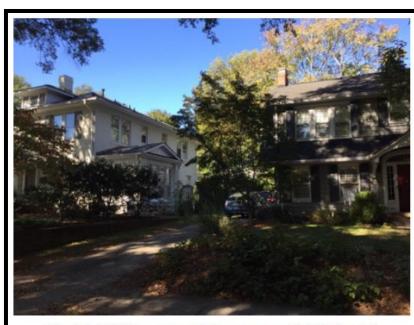
Mismatched brick & mortar on wall above sunroom gable hidden by paint. Disparate part of the building no longer visible from Ewing Ave.

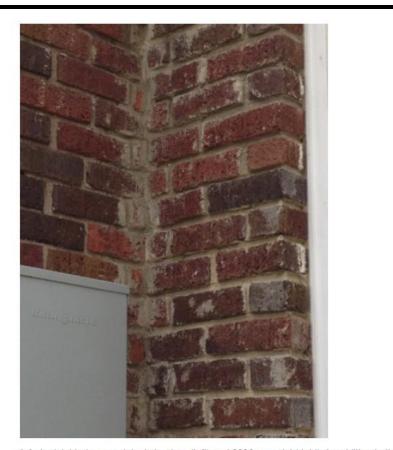
Inferior joint between original structure (left) and 2006 remodel (right). In addition to the obvious shoddy mortar work, note the mismatched brick and uneven brick courses and mortar joints, especially at the top. These photos of the *north side* of the 2006 addition are indicative of the error-filled workmanship throughout all three sides.

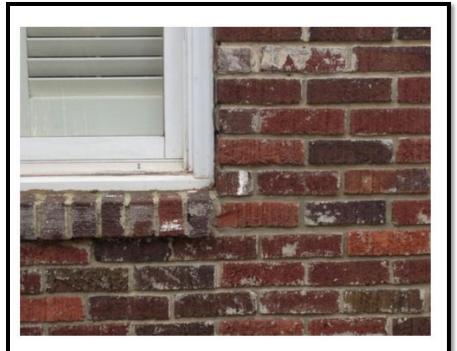
More sloppy, unsightly masonry work-north side wall of 2006 addition.

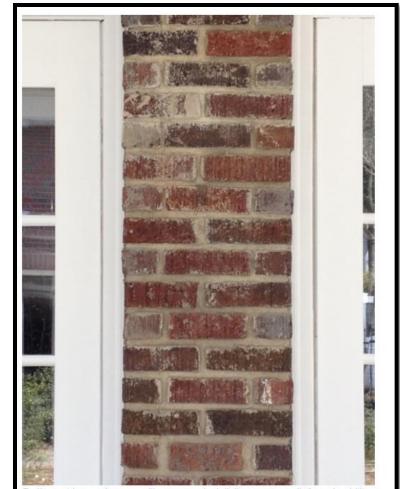
Further evidence of poor quality masonry installation-*center wall* of porch addition. Note the crooked bricks, excess mortar and inconsistent joint spaces. Also note the mismatched red and gray garage brick in the left reflection.

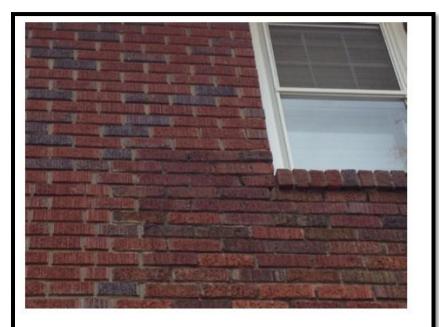
The bright red brick and gray mortar carelessly incorporated into the 2001 renovation came from the same batch of brick & mortar utilized in building the 2001 garage (left). Photo on the right is of the original 1924 brick & mortar.

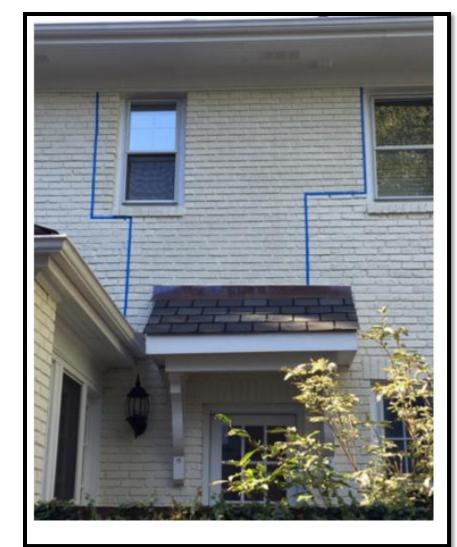
View from Ewing Ave. neighbor's property of *north side* 6' x 8' wall, where mismatched brick and mortar (area inside blue lines) were carelessly utilized during the 2001 conversion of the house from a duplex to a single family home.

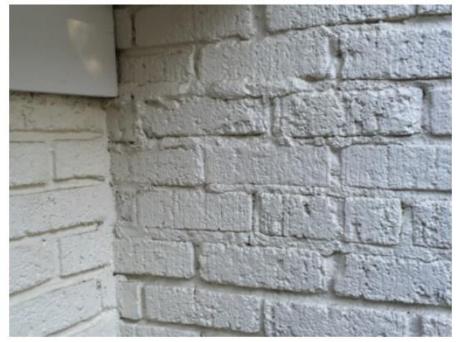
Despite being painted, this mismatched butt joint on the SW side, between the original house (right) and the 2006 addition (left), is clearly evident. Note once again the uneven rows of brick at the joint. The abundance of unsightly-and potentially damaging-mortar overfill on the upper right wall speaks for itself.

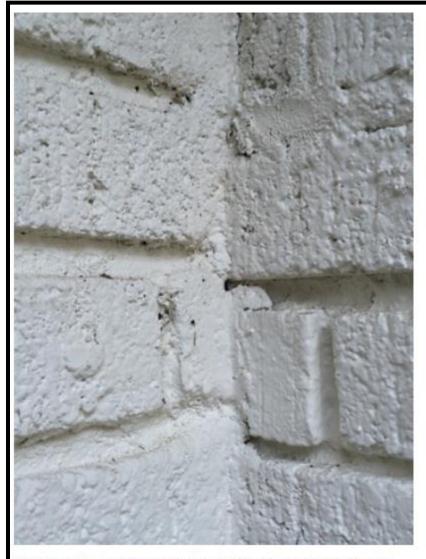
Uneven rows and sloppy mortar work-2006 addition south wall.

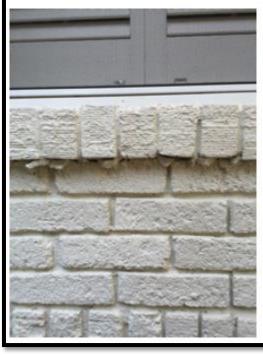
More examples of improper, unsightly mortar work on the 2006 addition

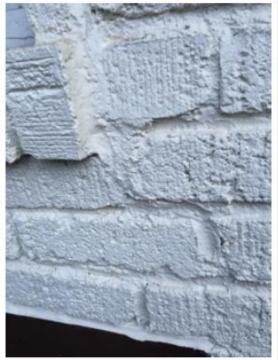
Poorly repaired settlement cracks around second floor rear window. The mortar color used was gray, despite the rest of the house having beige mortar. Probably done at the same time as 2001 renovation.

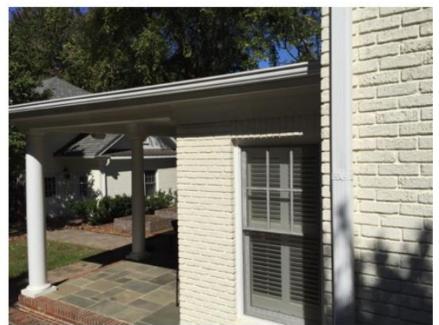
All of the substandard and disparate masonry areas hidden, and the unification of the garage (far left), 2006 addition (w/window) & original house (w/downspout) achieved with a neutral cream color. Note the proximity of the garage to the house.

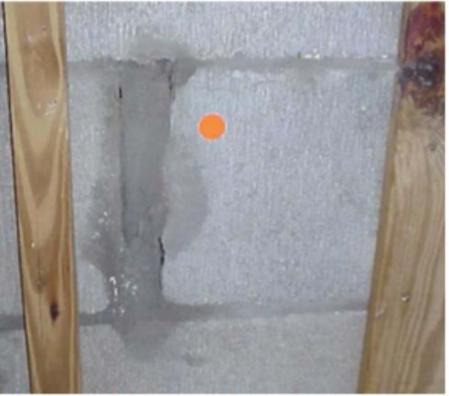
FIGURE 2: Improper mortar joint thickness.

Figure 2 shows the inside view of a poorly laid mortar header joint that well exceeds the allowable 3/8" width limit established by code. In fact, this vertical header joint measured more than 1" wide. As a result, the mortar will dry and shrink, leaving gaps which will allow water and cold air to penetrate through the wall.
