**LOCAL HISTORIC DISTRICT:** Dilworth

**PROPERTY ADDRESS:** 300 East Worthington Avenue

**SUMMARY OF REQUEST:** Addition, garage

***Charlotte Historic District Commission Case 2017-684***  
***HISTORIC DISTRICT: DILWORTH DEMOLITION***  
***ADDITION***

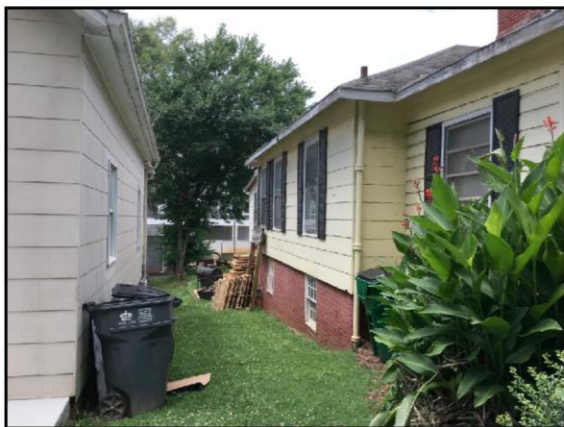
LEFT SIDE VIEW @ FRONT

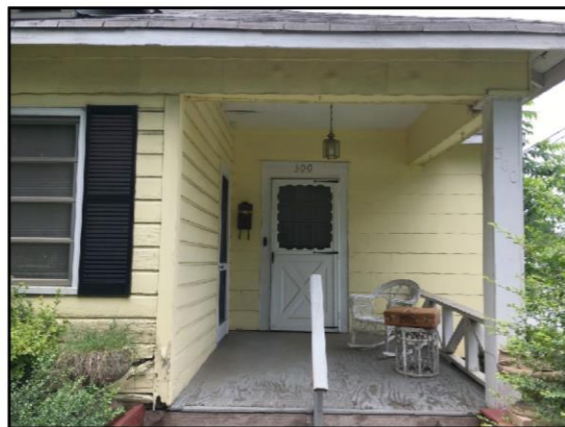
RIGHT FRONT @ PORCH

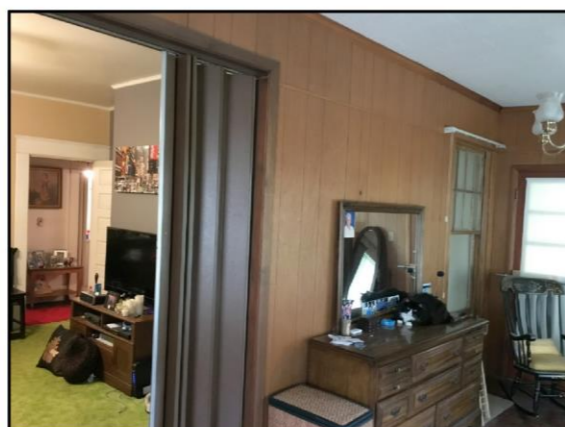
ENCLOSED FRONT PORCH

The project is an addition to create a single family house. The front elevation would be restored to an open front porch. The building addition would start behind the front dormer and continue to the rear of the property. Total height is approximately 23'-10". Design features include wood shakes, wood trim, exposed rafters and roof trim to match existing and a rear deck. The detached garage has design features that match the house. The height of the garage is approx. 24'-4".

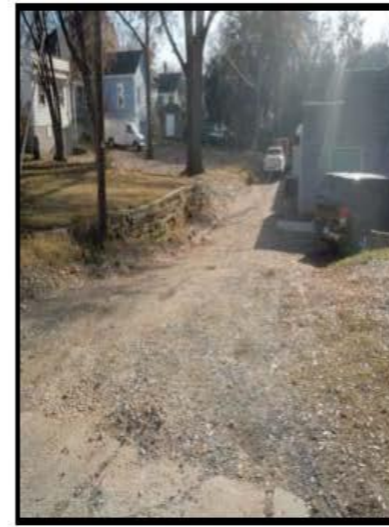
ALLEY SHOWING DESCENDING GRADE

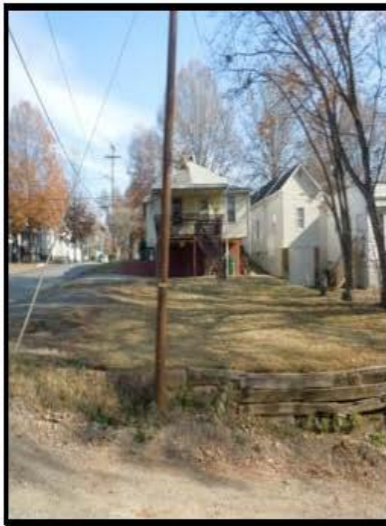
REAR OFF SUBJECT SHOWING GRADE DROP

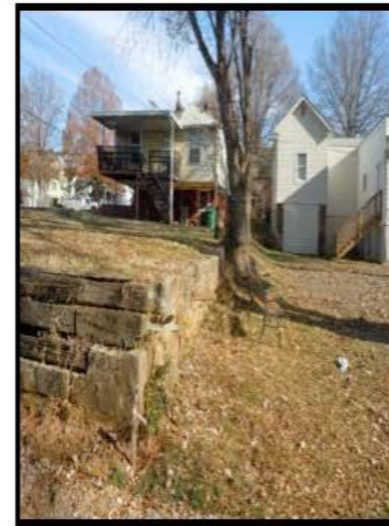
VIEW OF GRADE DIFFERENTIAL

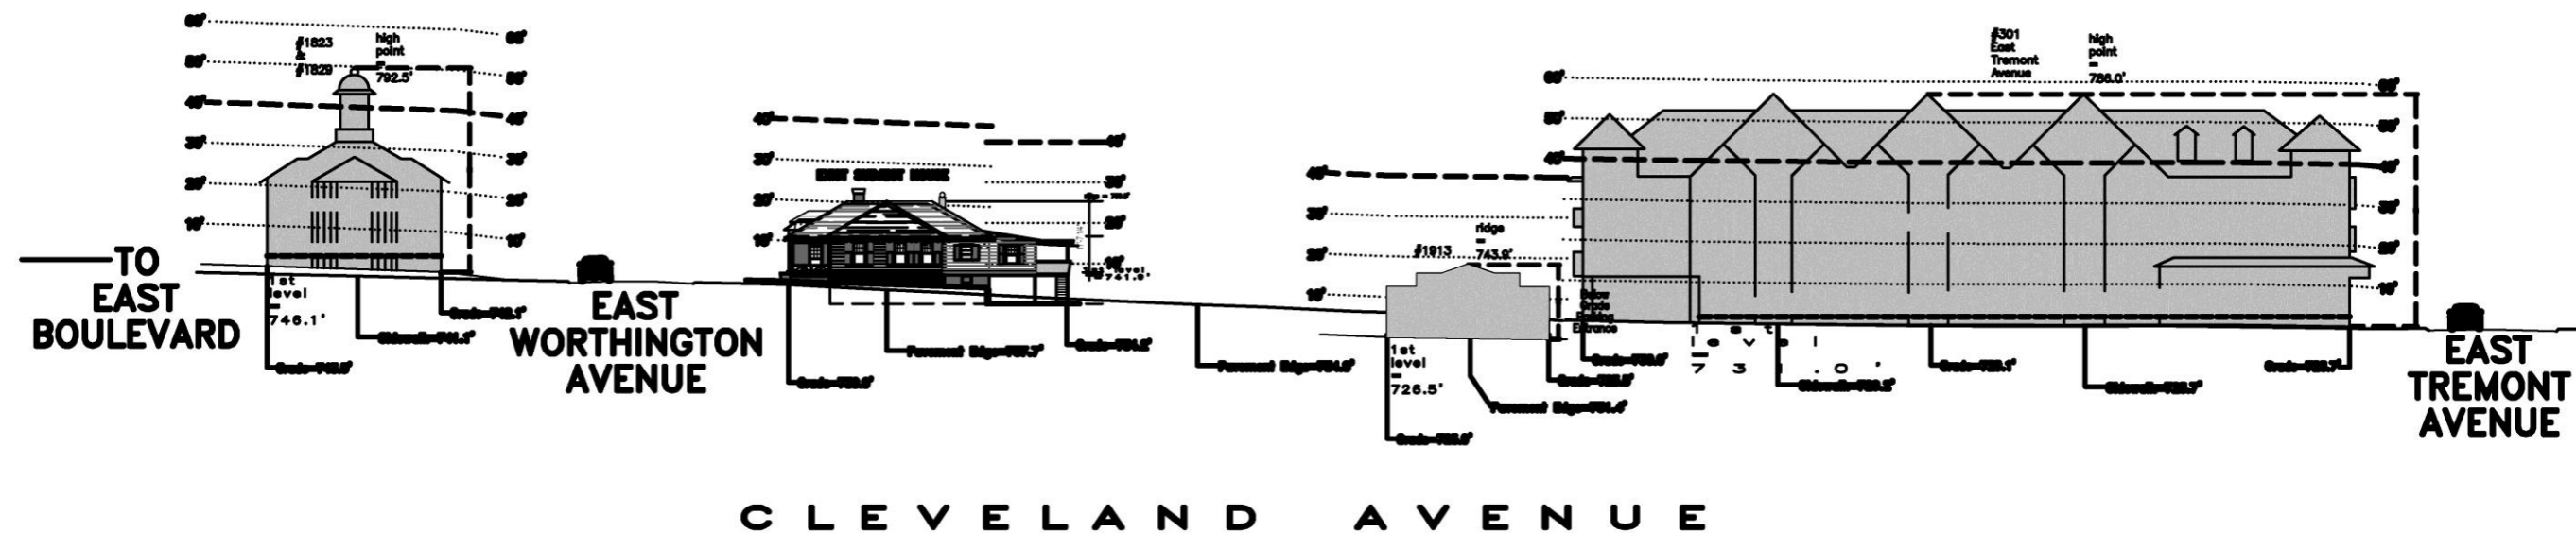
② EXISTING BUILDING HEIGHT SURVEY  
1/16" = 1'-0"

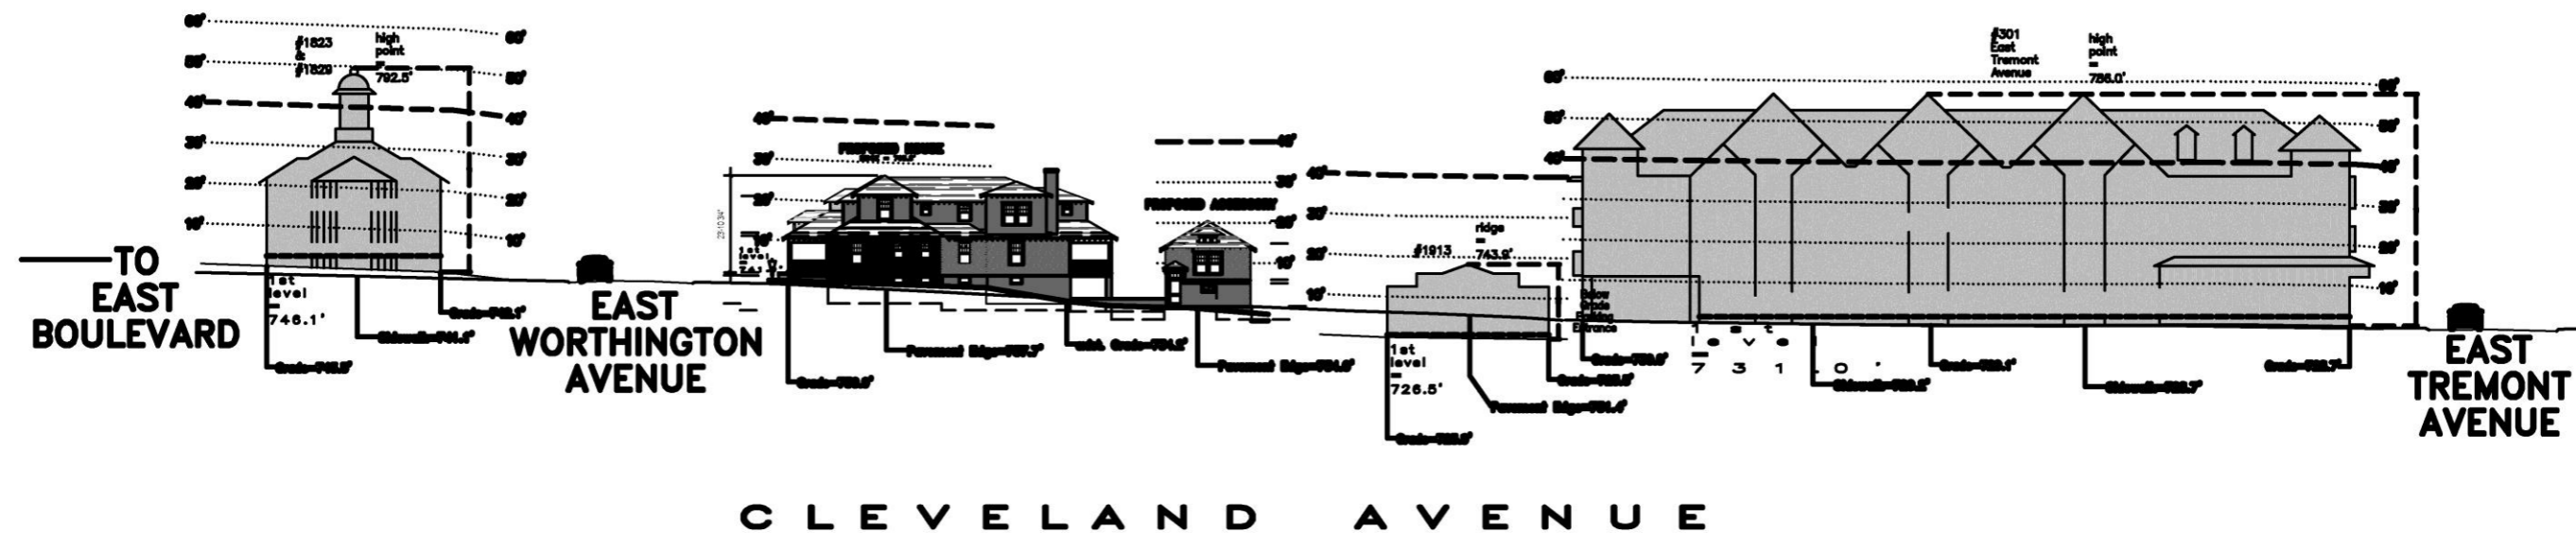
① PROPOSED BUILDING HEIGHT SURVEY  
1/16" = 1'-0"
