# Historical Committee Presentation

# 239 West Park Avenue Charlotte, North Carolina

PROPERTY ADDRESS:	239 West Park Avenue
SUMMARY OF REQUEST:	Addition
APPLICANT/OWNER:	Daniela Tomescu

# Charlotte Historic District Commission Case 2018-388 HISTORIC DISTRICT: WILMORE ADDITION

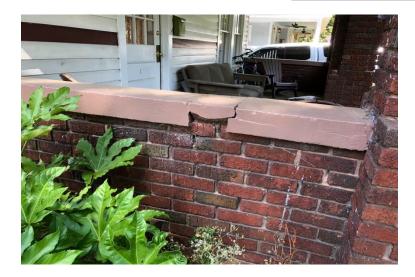
Condition of Existing Brick Rail

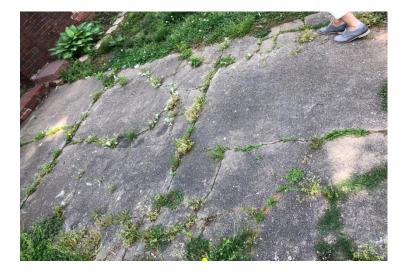
Condition of Existing Front Sidewalk

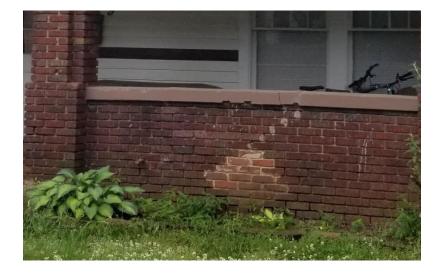
Condition of Existing Brick Rail

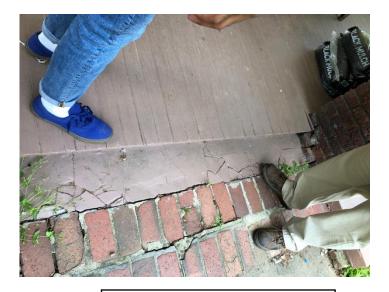
Condition of Existing Front Porch

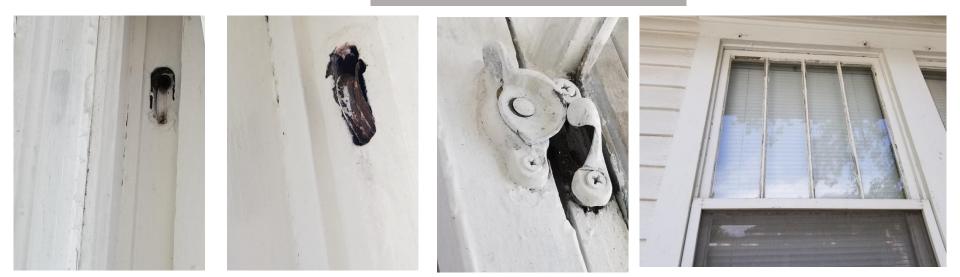
Most balances are missing

Closing Mechanisms Inoperable

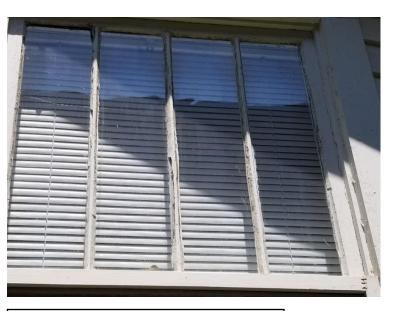
Wood Muntins will need replacement

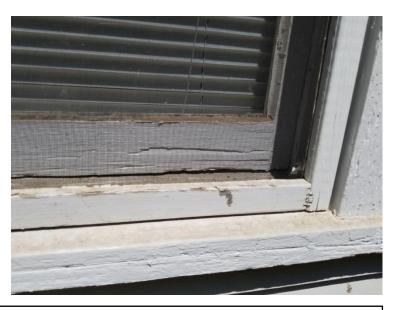
Sashes in bad condition and screens missing or damaged

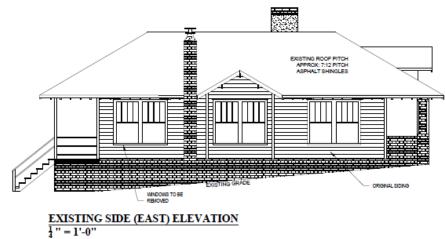
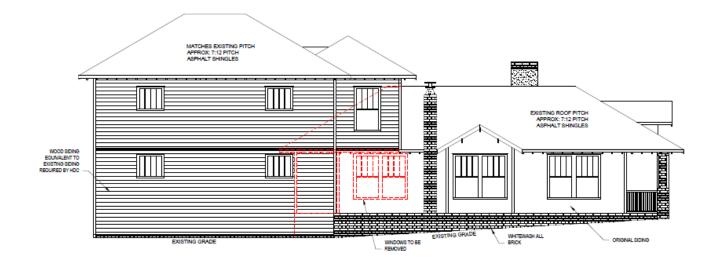
# Left Elevations-Existing and Proposed

NEW SIDE (EAST) ELEVATION

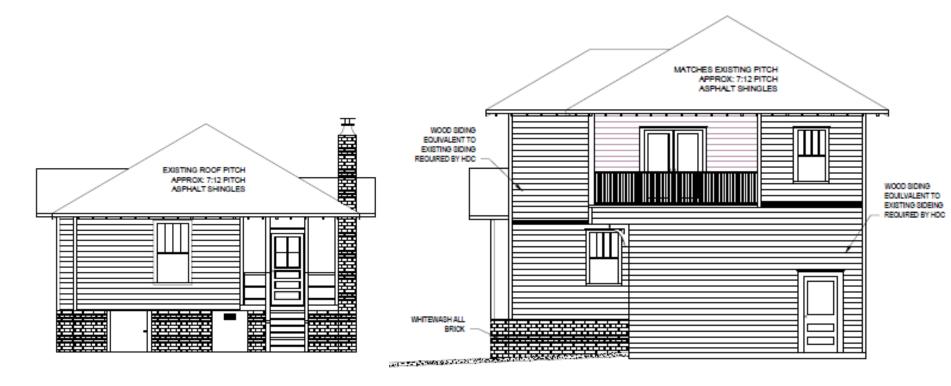
#### Rear Elevations-Existing and Proposed

$\frac{\text{EXISTING REAR ELEVATION}}{\frac{1}{4}" = 1'-0"}$

NEW REAR ELEVATION  $\frac{1}{4}$ " = 1'-0"

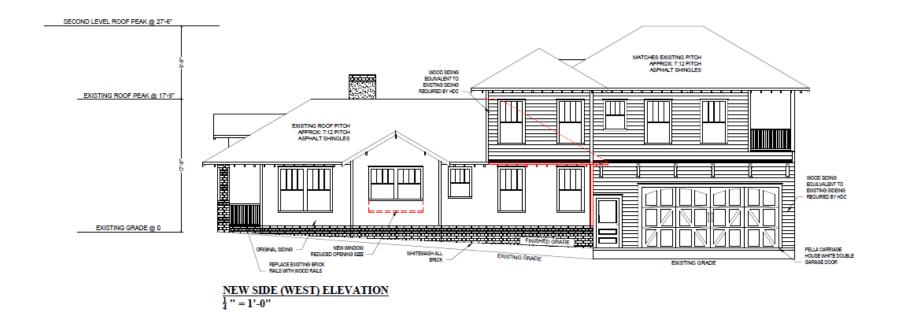
#### **Right Elevations-Existing and Proposed**

EXISTING SIDE (WEST) ELEVATION  $\frac{1}{4}$ " = 1'-0"

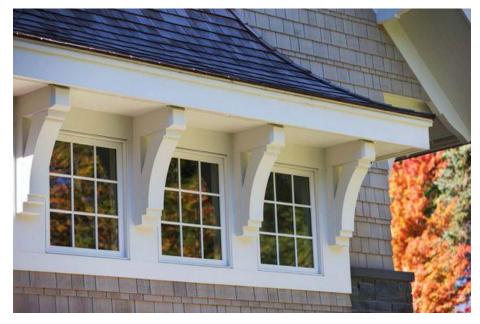
#### Example of Proposed Brackets over Garage Door

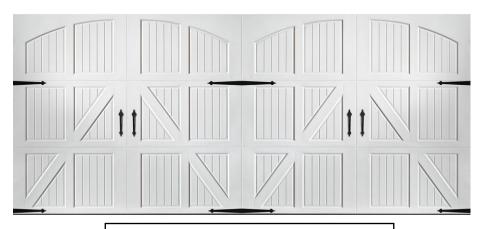
Example of Proposed Garage Door

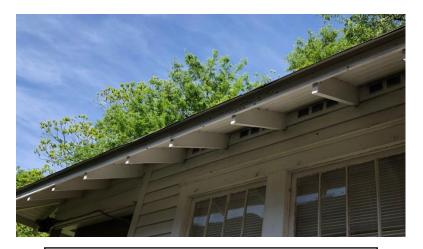
Existing Eave Detail to be replicated on Addition

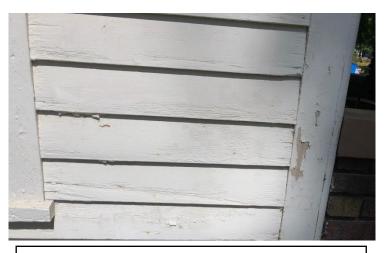
Existing Wood Siding to be repaired and Repainted

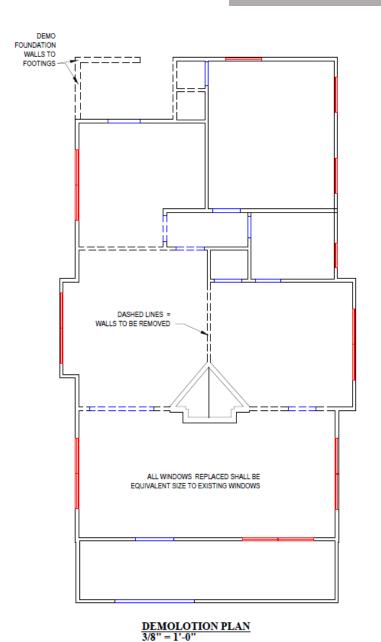
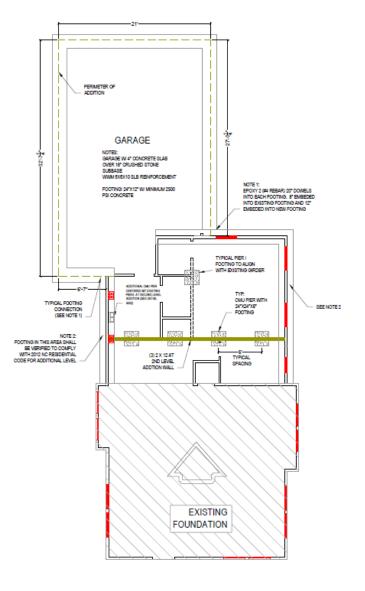
#### Proposed Demolition and Foundation Plans

$\frac{\text{FOUNDATION PLAN}}{\frac{1}{4}" = 1'-0"}$

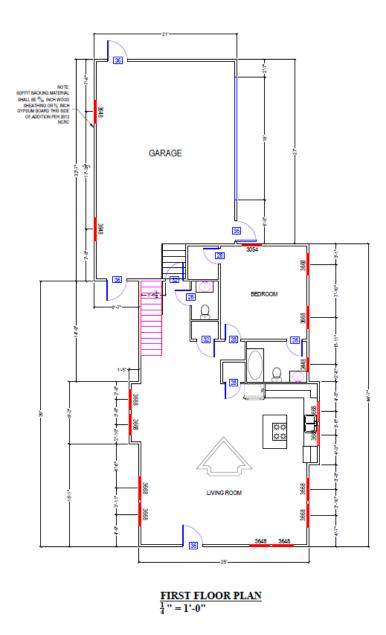
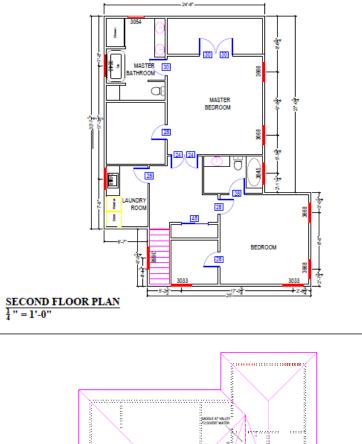
# Proposed Floor Plans

$\frac{\text{NEW ADDITION ROOF PLAN}}{\frac{1}{4}" = 1'-0"}$
