LOCAL HISTORIC DISTRICT: Plaza Midwood

PROPERTY ADDRESS: 2101 The Plaza

SUMMARY OF REQUEST: Painted Brick

Paint Removal Test – November 2019

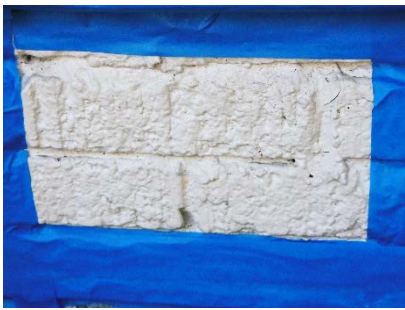
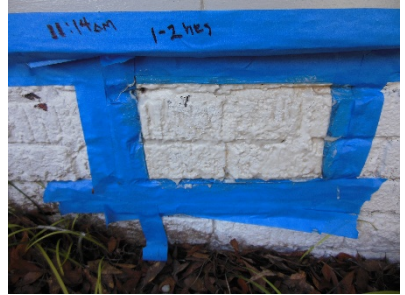
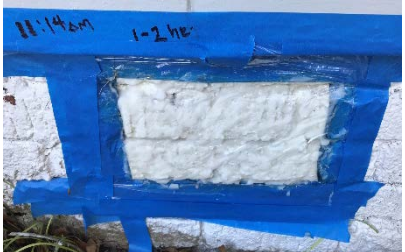
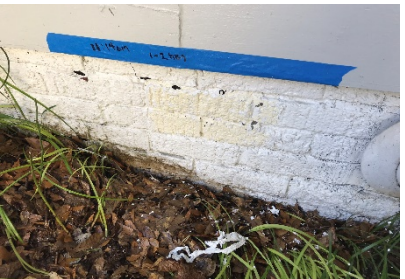
Sample Area 1

Homeowner selected two sample areas on the right-side of the main structure. One located on original foundation, and the second at the base of the front column.

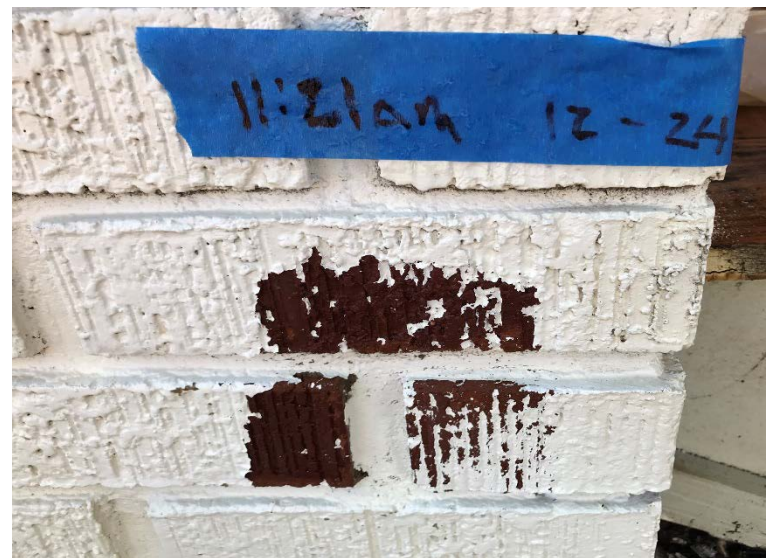
Sample Area 2: Before

Sample Area 2: After 20+hrs

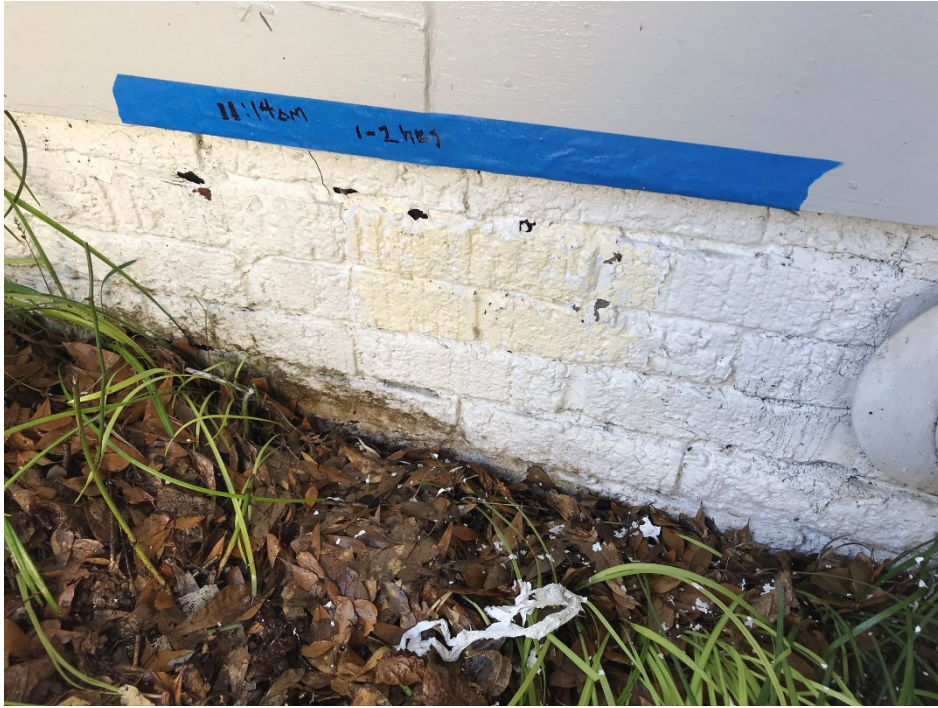
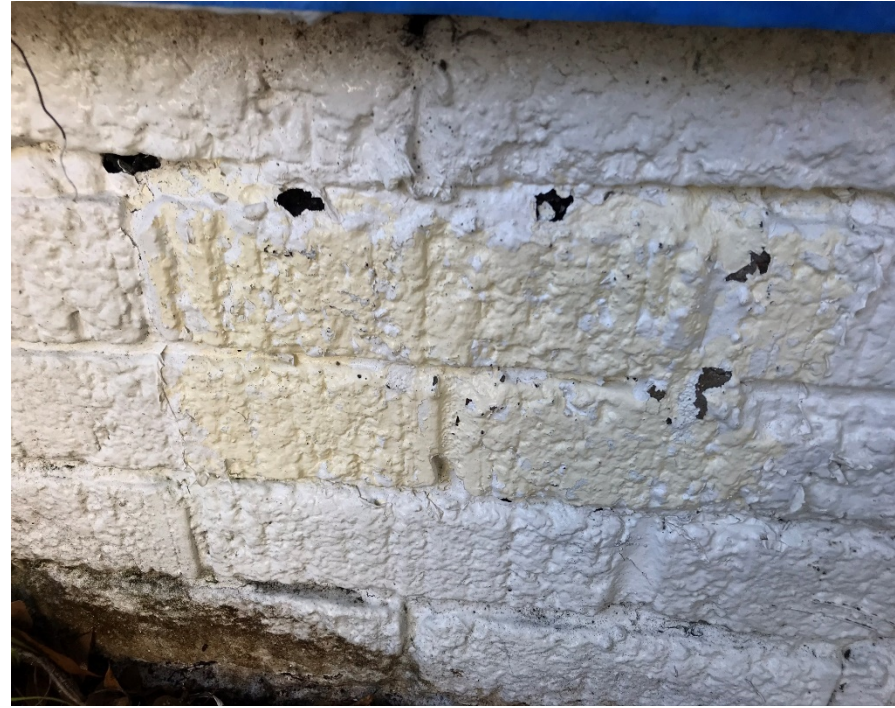
Sample Area 1 – 11:14am

Results

Right-side Original Foundation: After approximately 23hrs, the paint stripper was removed using a plastic scraper and a garden hose. As suspected an additional layer of paint was reveled. Additional applications, with long dwell times, and a low psi pressure washer will be needed to remove all the applied paint from the brick surface.

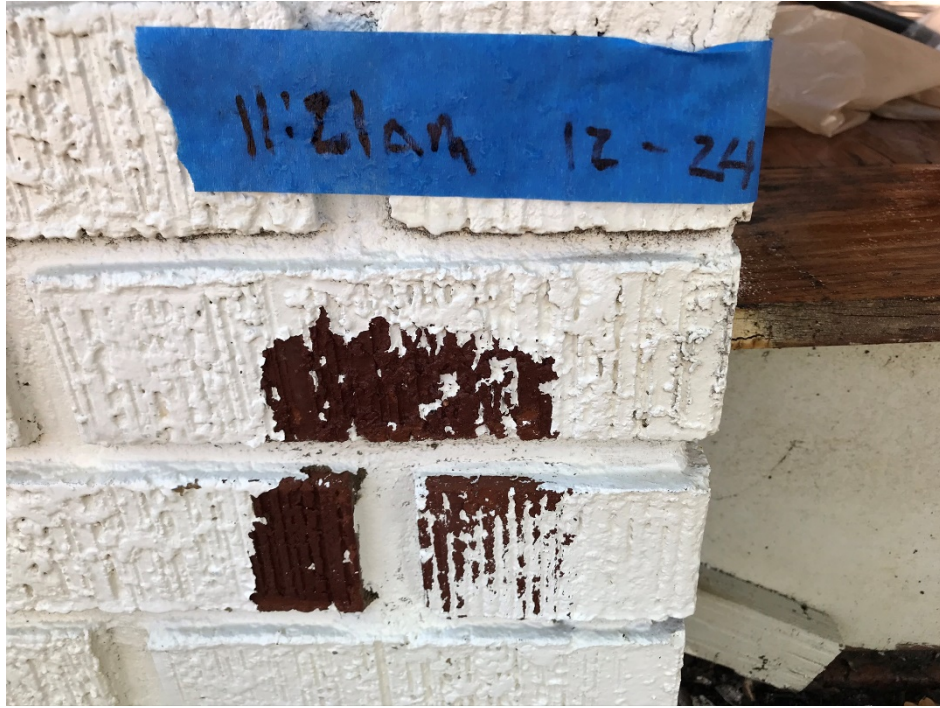
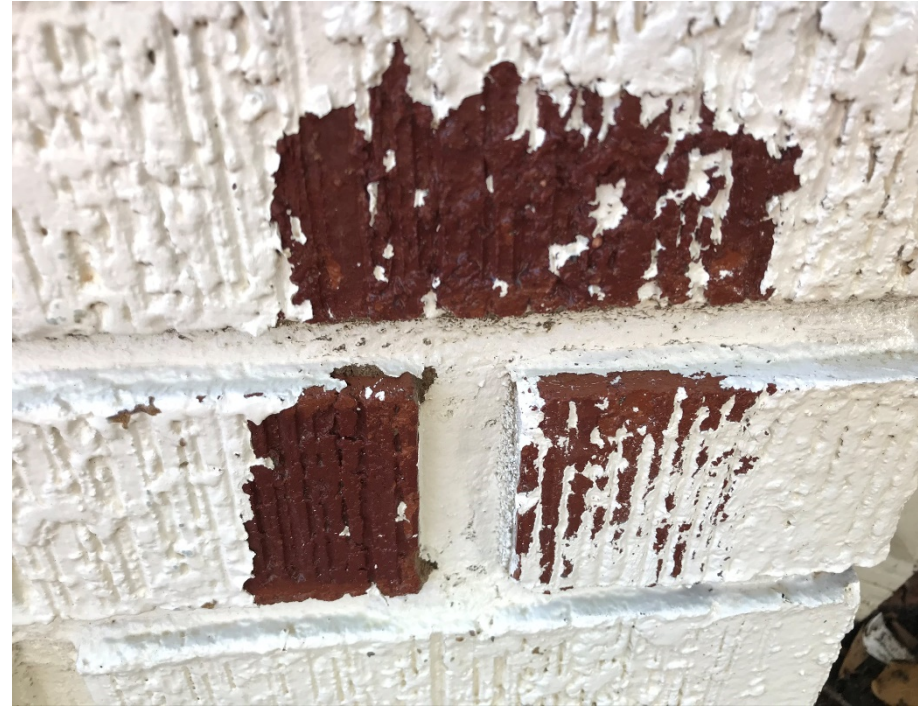
Sample Area 2 – 11:21am

Results

Right-side Front Column: After approximately 23hrs the paint stripper was removed using a plastic scraper and a garden hose. A low psi pressure washer and additional applications with long dwelling times should remove a majority of the paint.

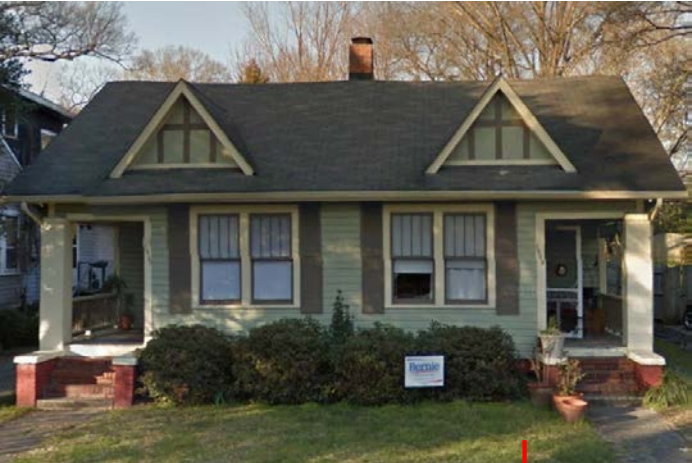
1537-1539 Belvedere

Single family houses with red/brown painted brick foundations + porch columns located within 1 block of 2101 The Plaza

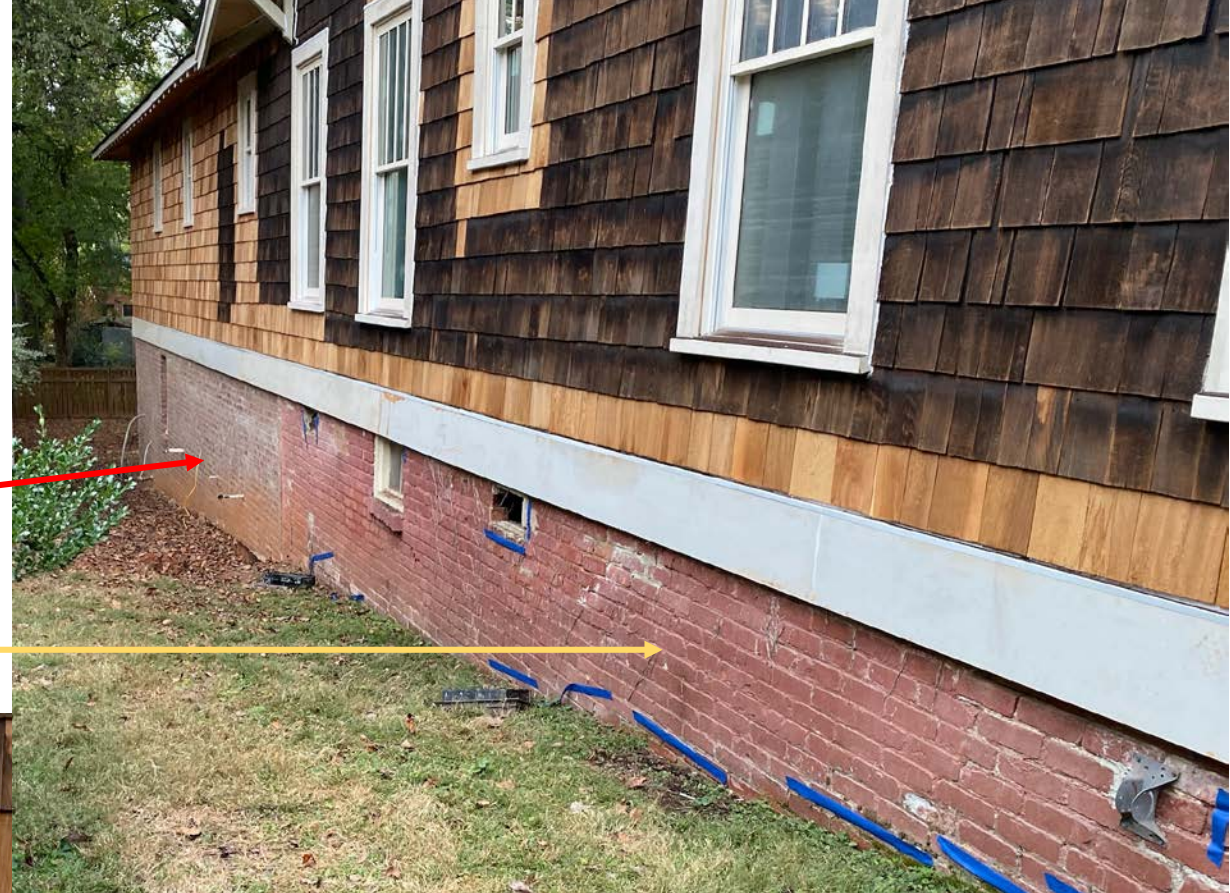
Staff recommended foundation paint color

New Brick

Original, painted brick

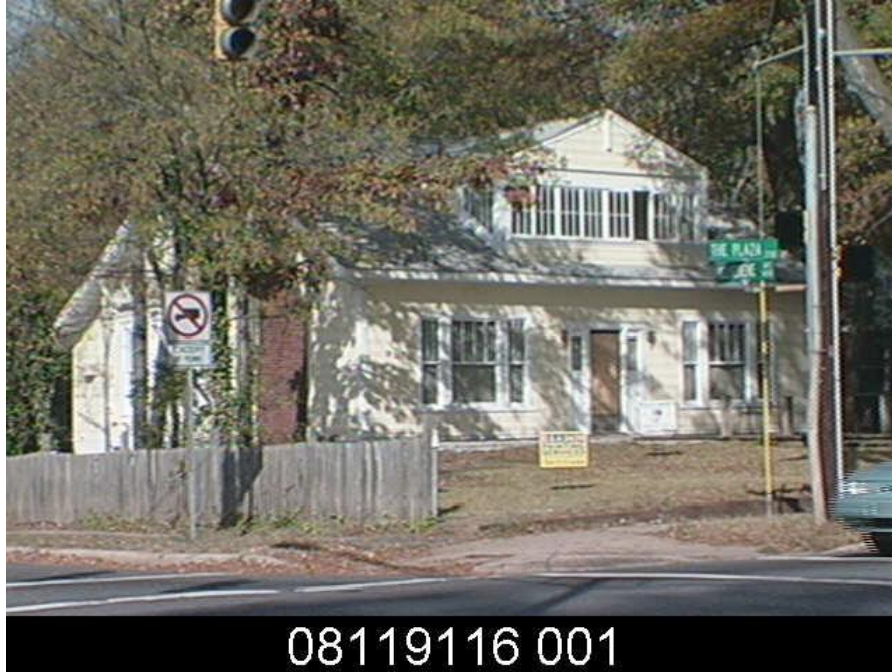
This is 2101 The
Plaza before c.2000

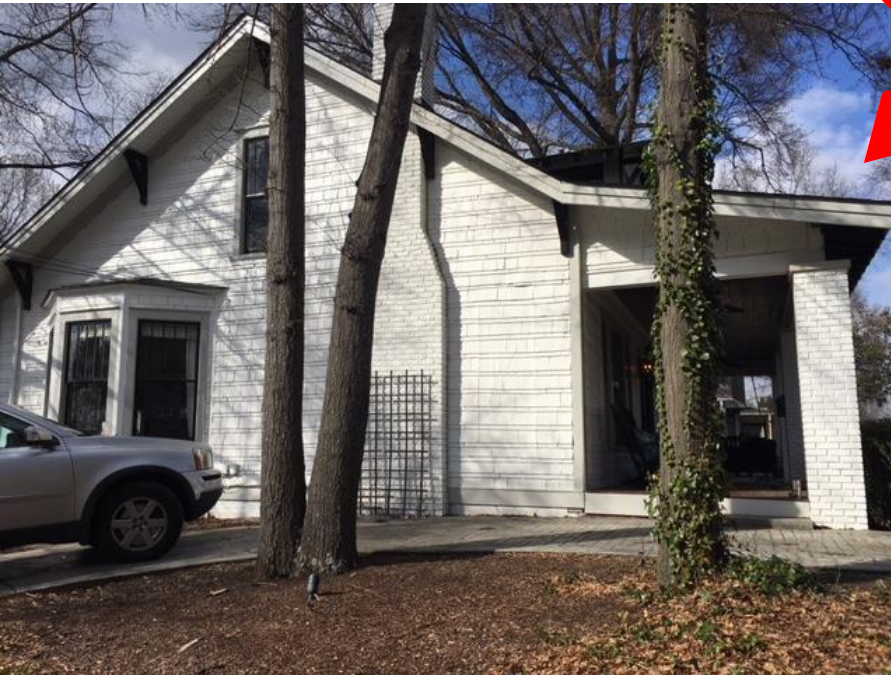
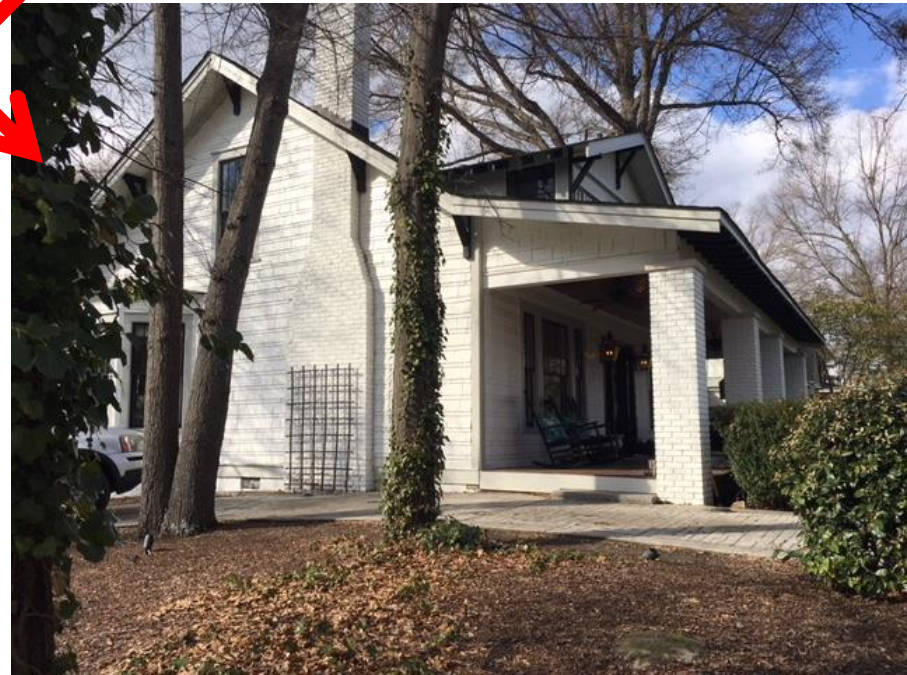
Painted Brick

The brick columns and chimney were painted without a COA by the owner. The owners are requesting to keep the painted brick. The applicant states the porch brick was different in color and texture than the original brick.
