<b>LOCAL HISTORIC DISTRICT:</b>	Dilworth
<b>ADDRESS OF PROPERTY:</b>	325 East Boulevard
<b>SUMMARY OF REQUEST:</b>	Demolition
<b>OWNER:</b>	Gary West, Max Maintenance Company
<b>APPLICANT:</b>	Gary West, Max Maintenance Company

# Charlotte Historic District Commission - Case 2014-021

**325 East Blvd.  
Charlotte, NC 28203  
Limited Structural Observations  
Photo Narrative  
for  
Gary West  
Dwelle Property Management  
and Real Estate Inc.  
756 Tyvola Road, Ste 119  
Charlotte, NC 28217  
by  
A. Wynn Yates, PE  
Yates Structural Engineering, PA  
3300 Elstree Drive  
Charlotte, NC 28226  
704-650-5541  
wyates@yseng.com**

**August 29 and September 5, 2013  
(Revised) January 8, 2014**

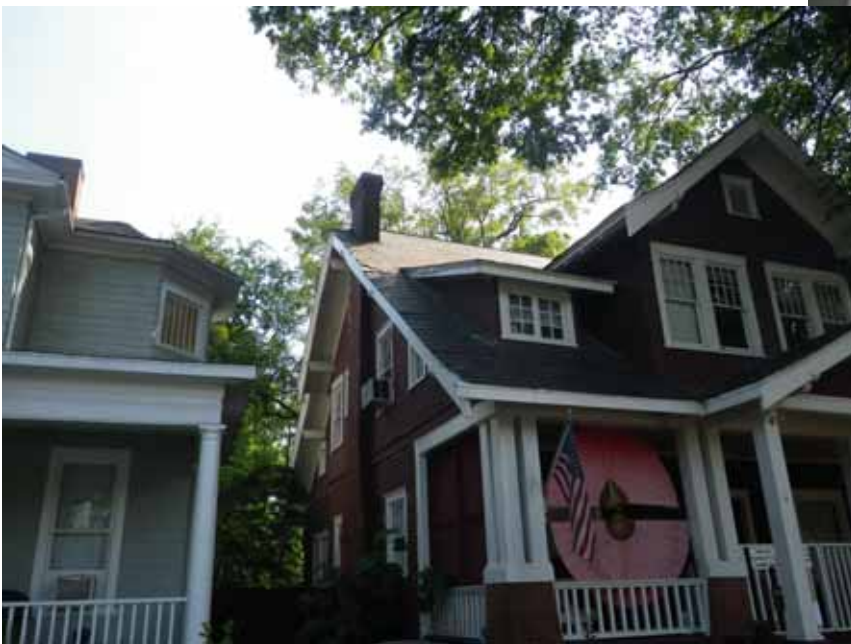
Photo #3

These pictures show the overhanging roof extensions to the left of the house, with a flying barge board supported with intermediate braces. There is a significant bend in the roof due to the inadequacy of the supporting buttress and the roof sheathing. The slate roof covering has responded to the bend by falling off the house as best seen in Photo #5.

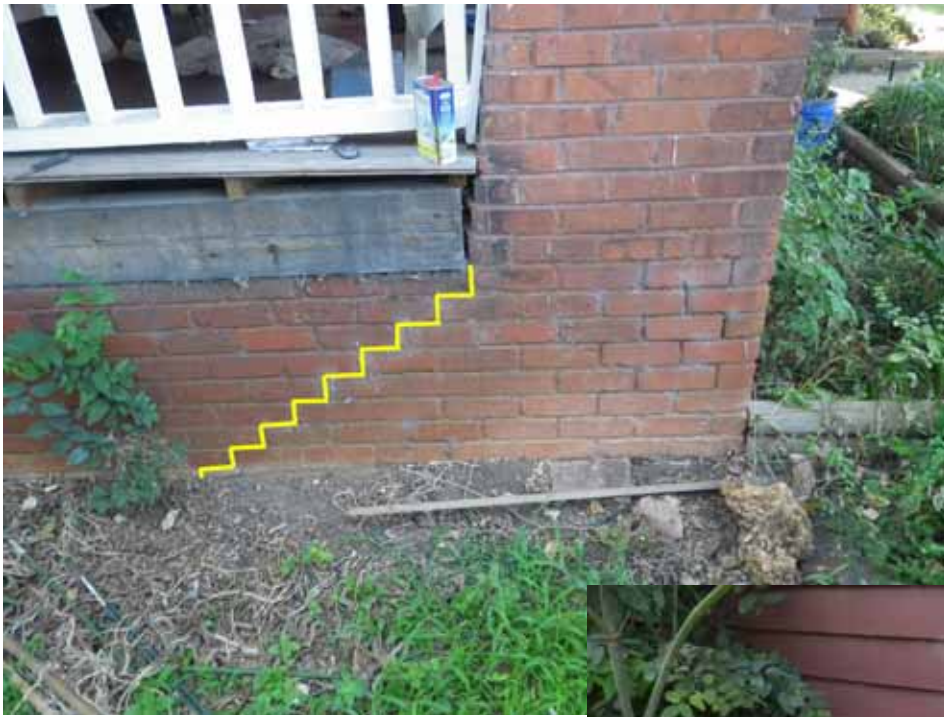
Stair-step cracking of the front porch brick (highlighted in yellow) seen in Photos #8 and #9 are not related to the proximity of living trees. On the other hand, the stair-step cracking seen in Photo #9 at the left foundation wall just below the left/front corner of the house is the result of tree root heave and or deterioration and decay of dead roots of the tree stump seen in Photo #6.

This picture and Photo #8 show exposed wood porch framing at the left/rear corner of the covered front porch. Vermin are free to enter the crawl through the gaps seen in these pictures.

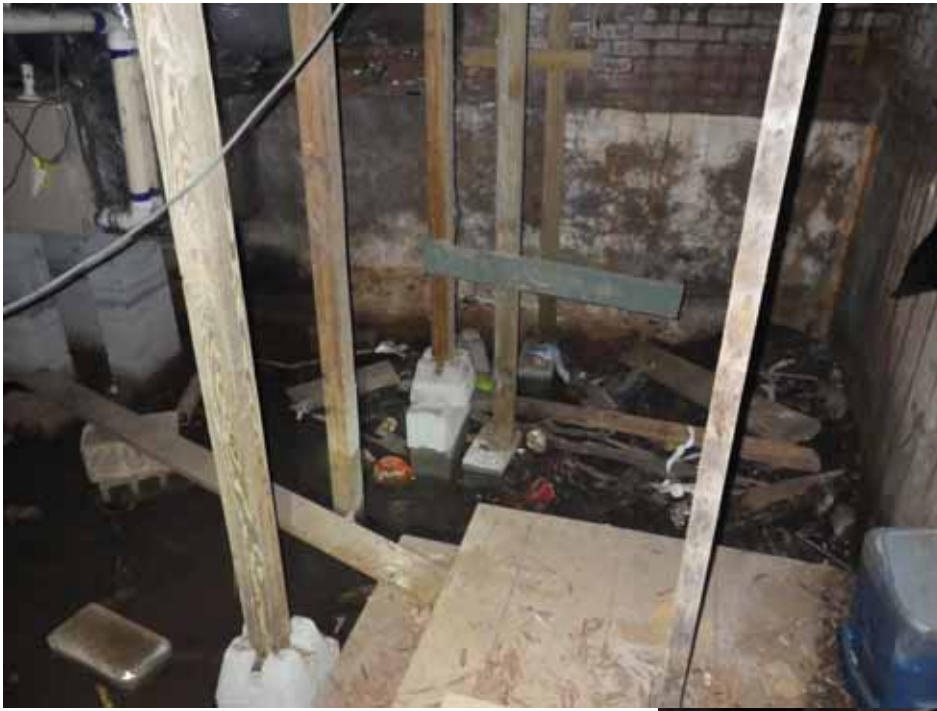
Photo #27

These pictures show the partial basement located under the right/rear corner of the building. A number of vertical 4x4 posts have been added in an effort to support deteriorated first and second floor framing above. They are too tall and are improperly supported at both ends; top and bottom. There is considerable water in the basement where no provisions for removal exist. Photos #54, #55 and #56 show more views of the right/rear partial basement.

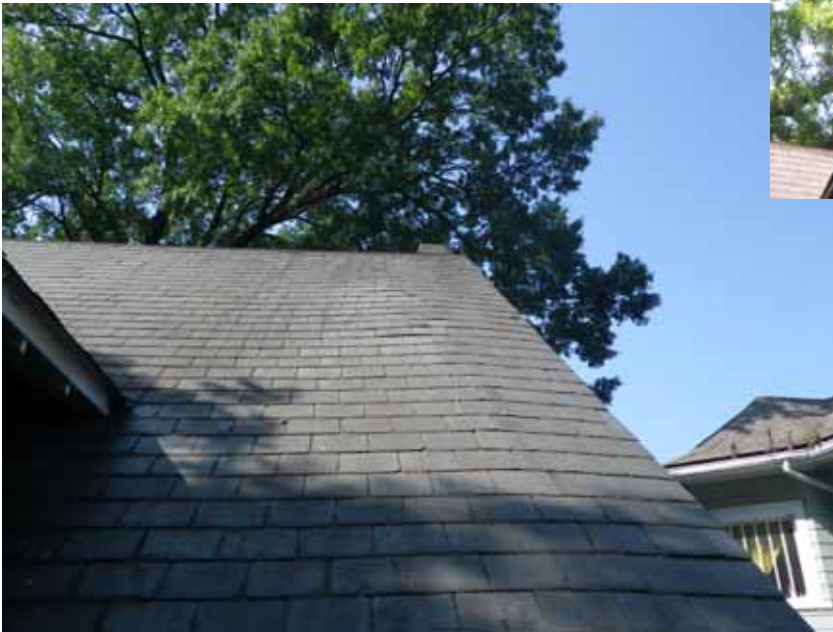
These pictures were taken atop the two-level rear deck looking back across the slate covered, left/rear quadrant roof. Even though the overhang seen to the right in Photo #35 is not properly supported, there is not the same loss of shingles as seen at the left/front corner of the house.

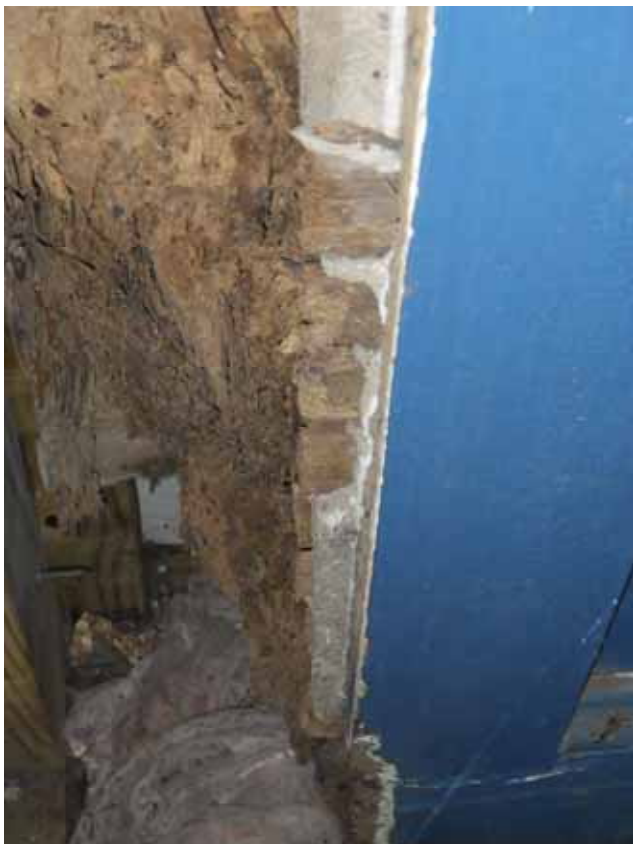
Photo #44

These pictures and those that follow were taken on September 5, 2013. As seen in Photos #44 and #45 there is extensive damage at the rear portion of the left/rear, first floor room and to the rear wall adjacent to the deck as seen in Photo #41. Not seen in these pictures is the damage to the rim band below, which not surprisingly is extensive as well.

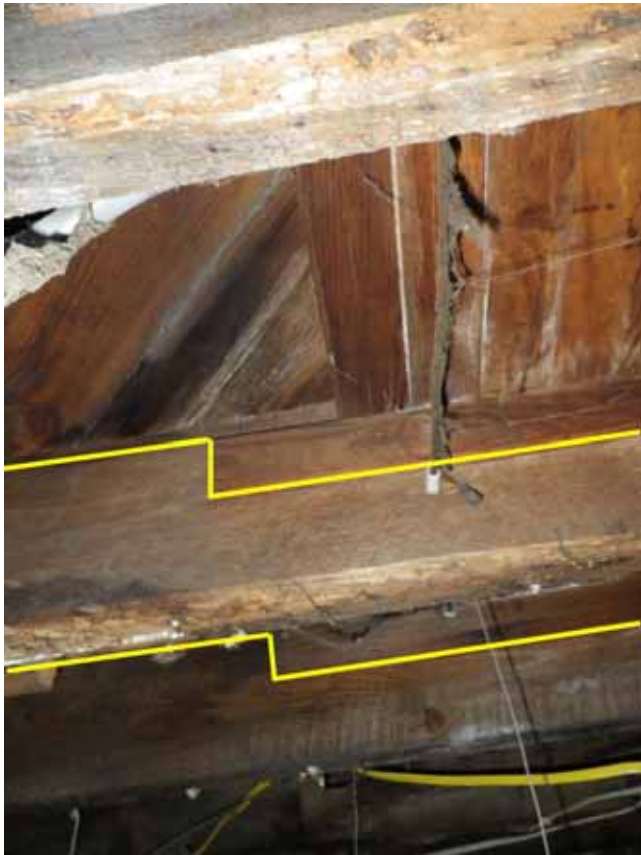
Photo #60

This picture shows joists that were notched down probably to accommodate a deep setting bed for bathroom tile floor covering in the bathroom above. The notching greatly reduced the capacity of the joists as well as violated accepted engineering practices. The notching is but one of several reasons the bathroom floor and clerestory rear wall are so dramatically tilted as seen in Photos #61 and #62.

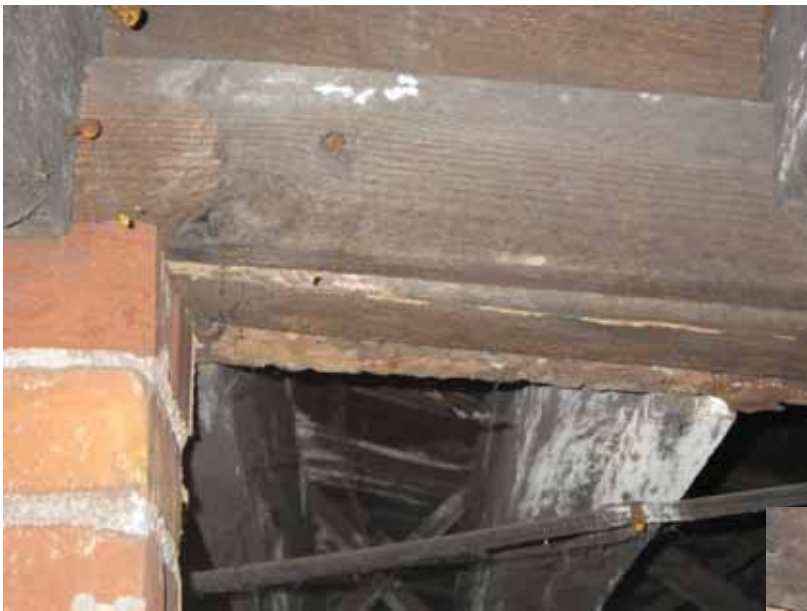
Photo #65A

The most significant floor deflections occur around the stair openings at the first, second and third floors. The right rear quadrant of the house has deflections so extreme, safety is a concern. Photos #65A through #65G show a broken front-to-back girder that is so compromised, it has contributed to the much of the 2" (+/-) sagging seen at all three of the supported levels near the center of the house.

These pictures show the 4x10 girder that runs from front-to-back under the left wall of the corridor that aligns with the front entry vestibule. The girder has failed completely and is one of the areas that first made us fear for our safety. The most dramatic picture is Photo #65G, which was taken looking right-to-left and shows the girder broken and sagging under the wall above. In fact, the floor above has a 3"-4" dip in it and is at risk of catastrophic failure.

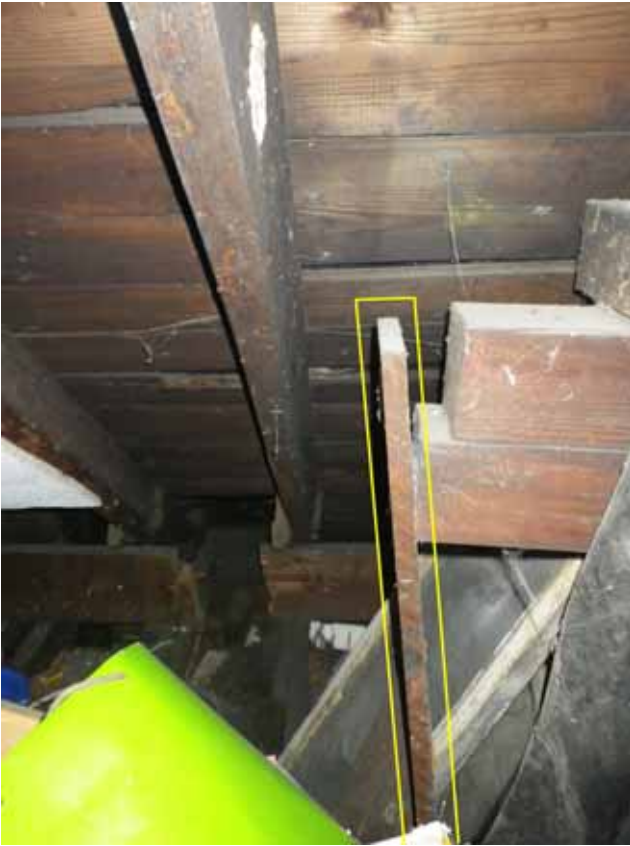
Photo #76

These pictures address the condition and support of the cantilever roof support brackets seen in Photos #77 and #78. There is insufficient back-span length to the 2-ply, vertically stacked 4-by cantilevered horizontal brackets. In addition, the only tie-down at the end of the brackets is a single 1-by as seen in Photos #76 and #79.
