LOCAL HISTORIC DISTRICT: Dilworth

PROPERTY ADDRESS: 300 East Worthington Avenue

SUMMARY OF REQUEST: Demolition

Charlotte Historic District Commission - Case 2016-235
Demolition
HISTORIC DISTRICT: DILWORTH

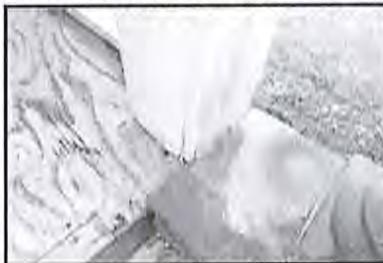
2.1 Picture 2

2.1 Front porch: There are areas of damage to flooring and the front right post is/has settled into the wood flooring. This is a safety hazard, recommend repair by a qualified contractor.

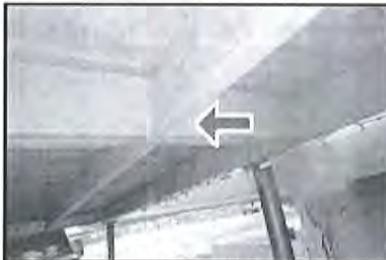
2.4 Picture 2

2.4 The following concerns were noted with the deck during the inspection. Further review and repair as deemed appropriate by a licensed contractor: Areas of deterioration noted at base of at least one post. (Picture 1)

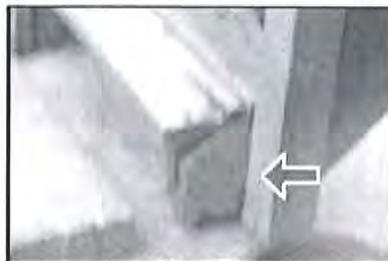
2.4 Picture 4

Areas of deterioration noted in step stringers and railings. (Picture 4,5)

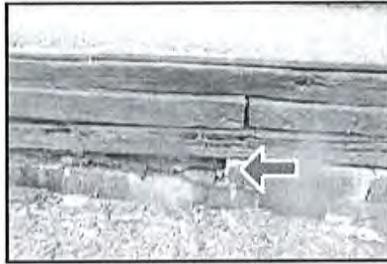
2.5 Picture 2

2.5 (1) Retaining wall at rear of site has areas of deterioration in wood, has been non typically

patched/repared over the years. There are pieces missing in the wall at rear. At left side there are loose block and metal bands/anchors in wall.

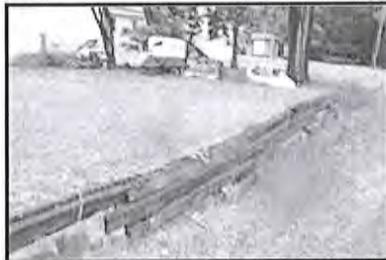
2.5 Picture 5

(2) A guard rail and pickets should be considered to prevent children from accidental fall at driveway/sidewalk area.

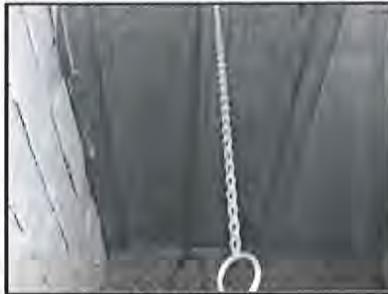
3.5 Picture 1

3.5 The attic access is the pull down stairs over the stairs leading to the basement. The attic was not accessed during the time of inspection.

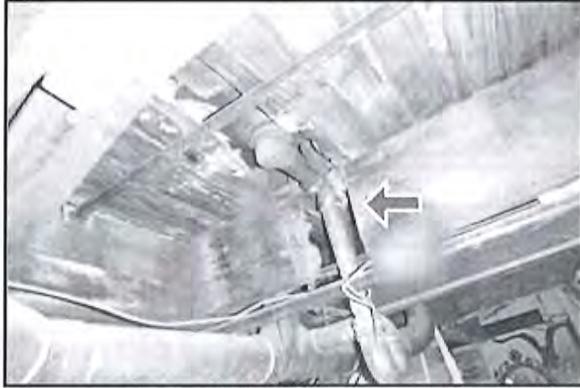
5.2 Picture 1

**5.2 (1)** A floor joist has been cut through for a drain line under the bathroom area. (Picture 1)

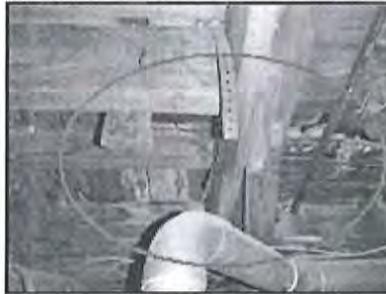
5.2 Picture 4

🏠 (2) Evidence of moisture stains and or moisture damaged at floor joists and or the sub-structure in the basement underneath the hall bathroom and kitchen. Recommend further investigation of all floor framing and repair recommendation by a qualified engineer.

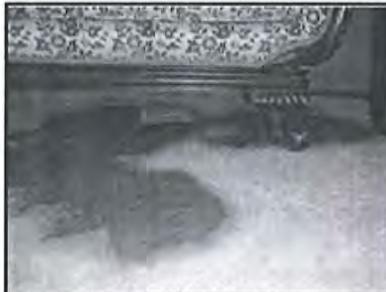
5.4 Picture 2

🏠 5.4 (1) Evidence of water/moisture present inside the basement foundation area. The basement ground was wet at the time of inspection. The basement is open to the crawl space under the front porch, this is a least one water entry point. This water/moisture entry needs to be eliminated to reduce dampness in the structure/foundation that may lead to deterioration of the building components.

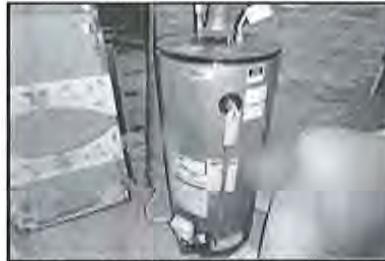
7.2 Picture 1

7.2 (1) View of water heater(s) in basement (for your info).

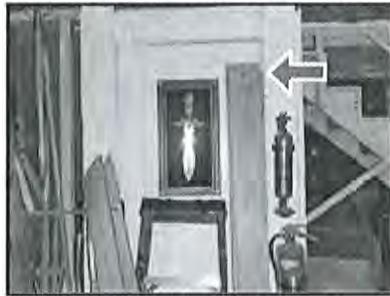
7.3 Picture 1

7.3 Note: Two bathrooms in the basement were not accessible and or not functional at the time of inspection.

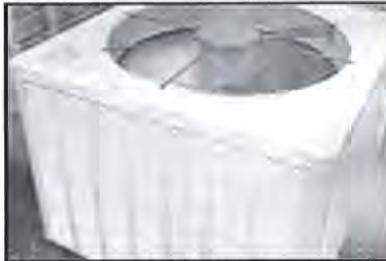
8.0 Picture 1

8.0 (1) View of heating/cooling system air handler outside (for your info). This is a Rheem model # 13AJL36A01, built in 2009.

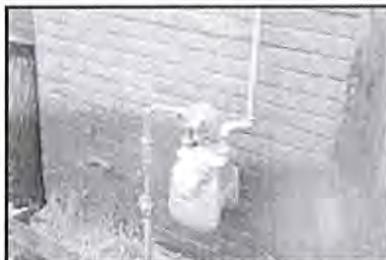
8.8 Picture 1

8.8 The main fuel cut off is at the gas meter located at right side side of the building. It may be cut off by turning the valve 90 degrees to the pipe.

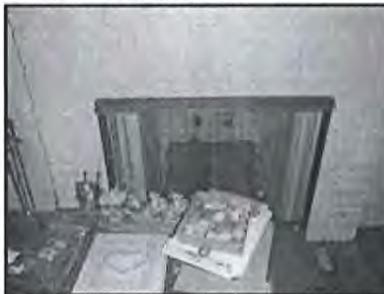
9.6 Picture 1

9.6 Fireplace inaccessible during the time of inspection; not inspected for operation and chimney not inspected.
