PROPERTY ADDRESS: 804 East Kingston Avenue

SUMMARY OF REQUEST: Tree removal

Charlotte Historic District Commission Case 2017-429
HISTORIC DISTRICT: DILWORTH
TREE REMOVAL

RE: Risk Assessment of 42" Willow Oak (*Quercus phellos*)

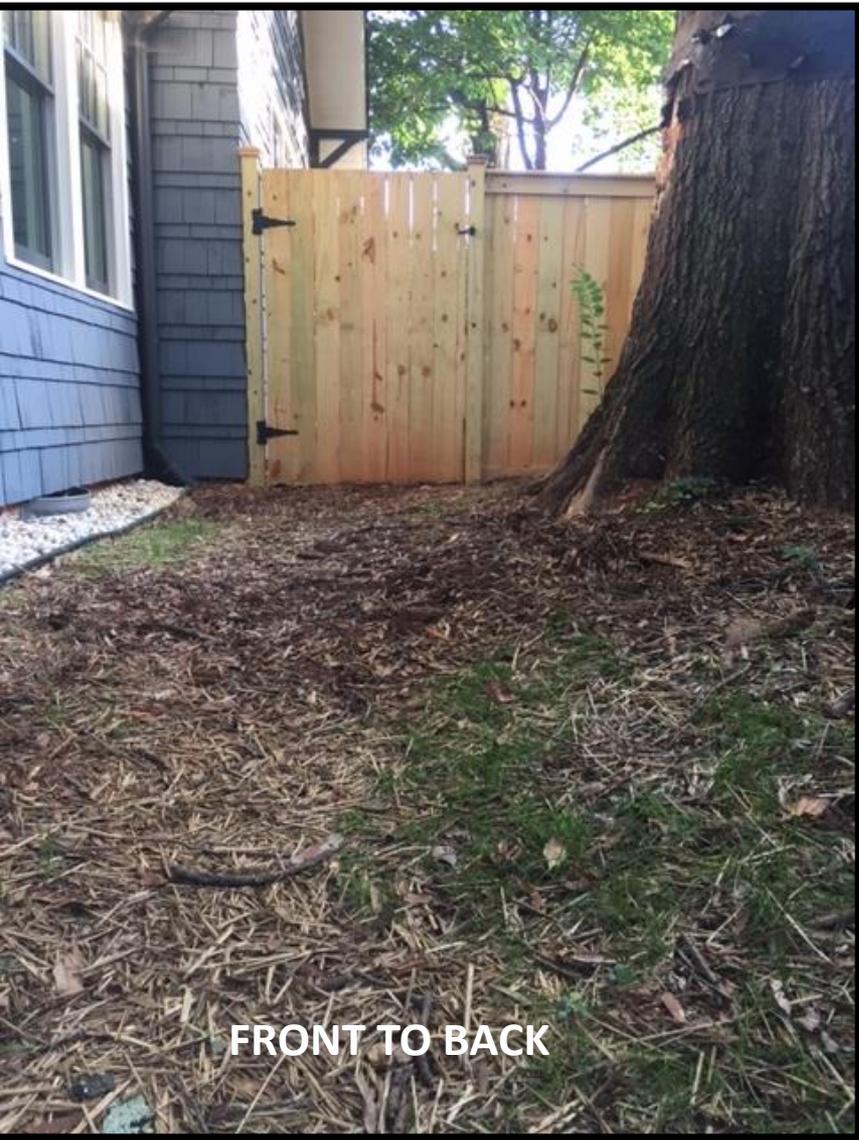
FRONT TO BACK

The property is the site of a single family house with a large, mature tree in the right side yard and partially on the adjacent property. There is second large maturing tree located in the rear yard. A one car driveway apron is located on the right side to provide access to a detached garage that has been demolished. A new detached garage was constructed on the rear left side of the property.

The project is the request to remove the large, mature tree in the side yard to provide clear access to the garage in the rear yard and the installation of a new driveway.

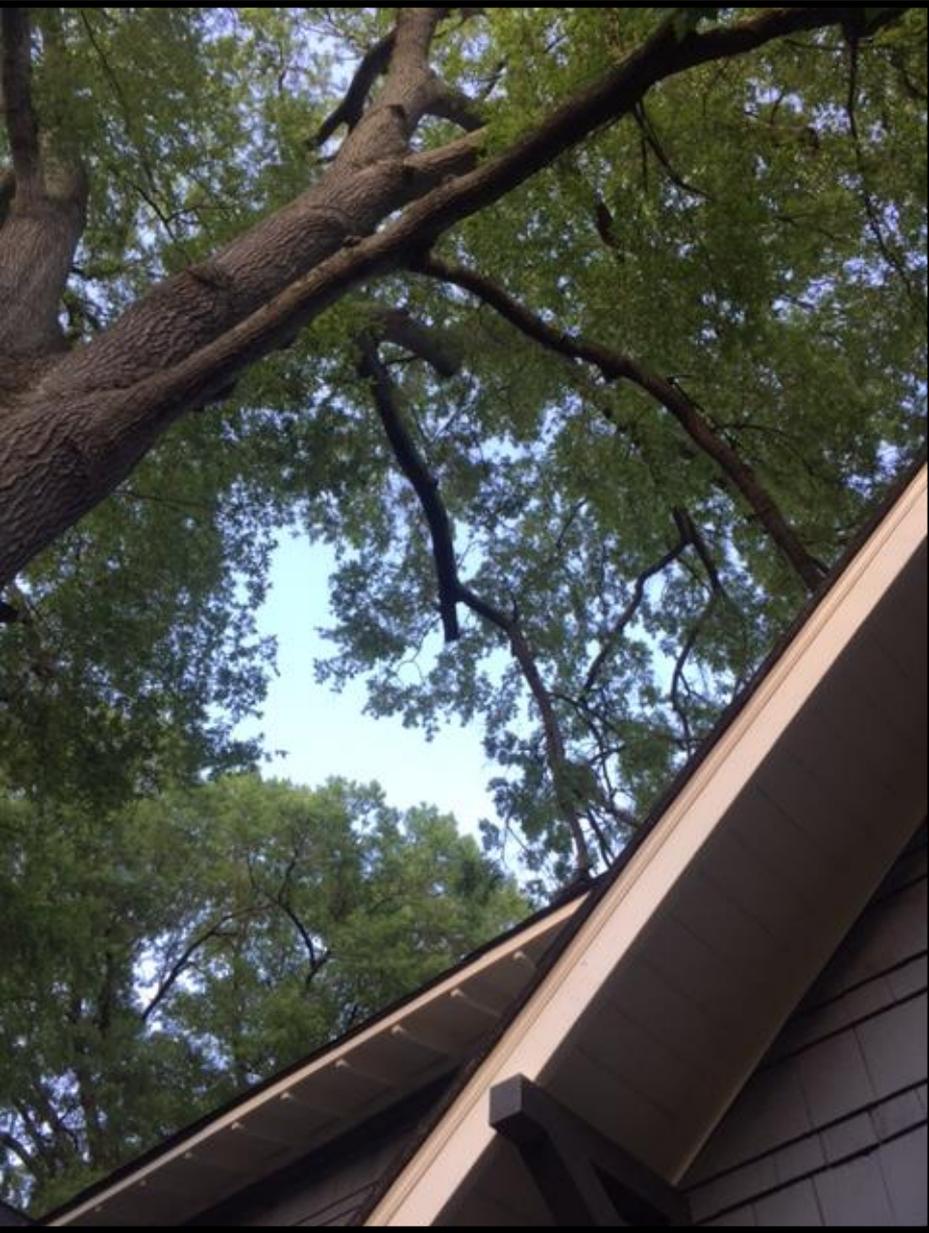
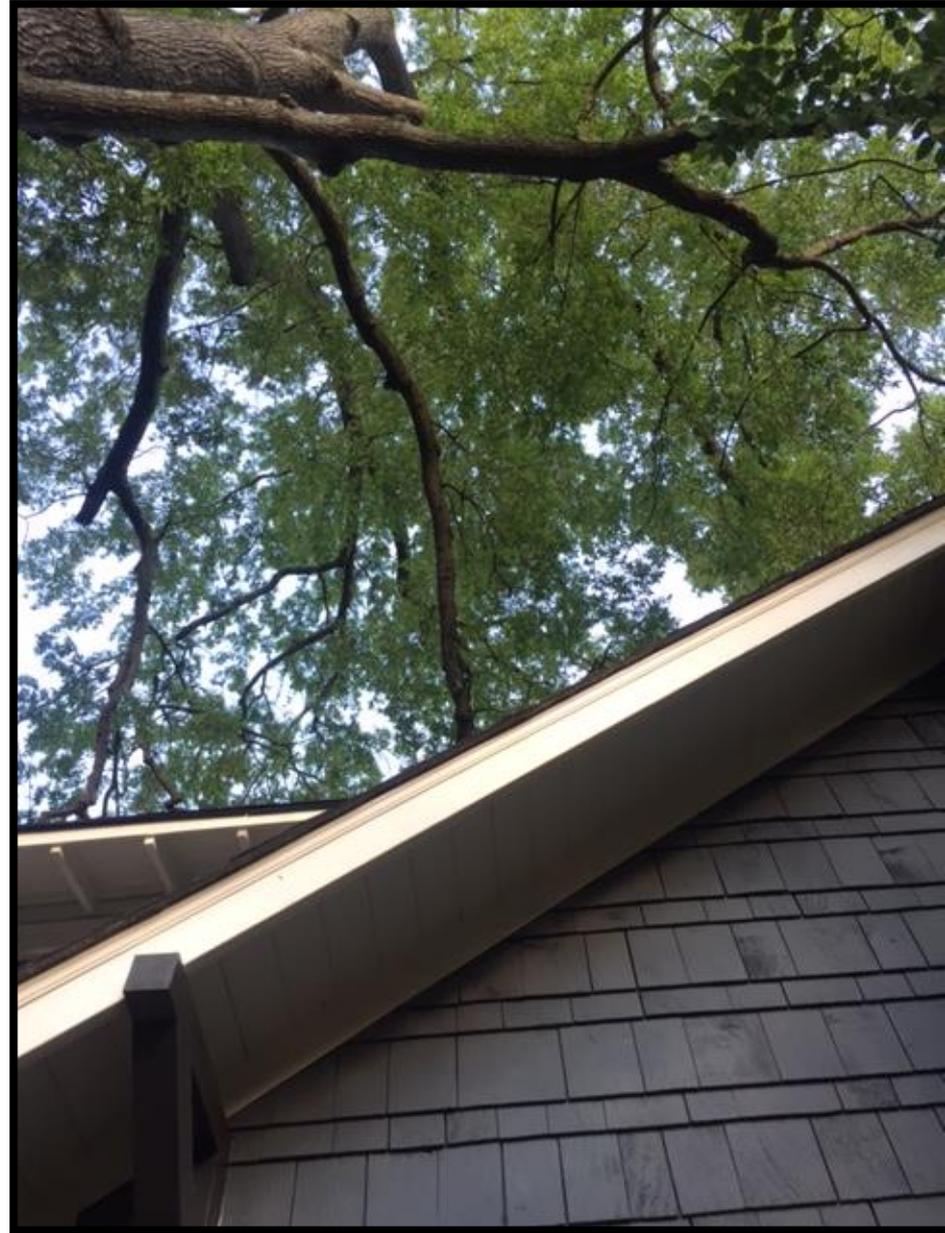
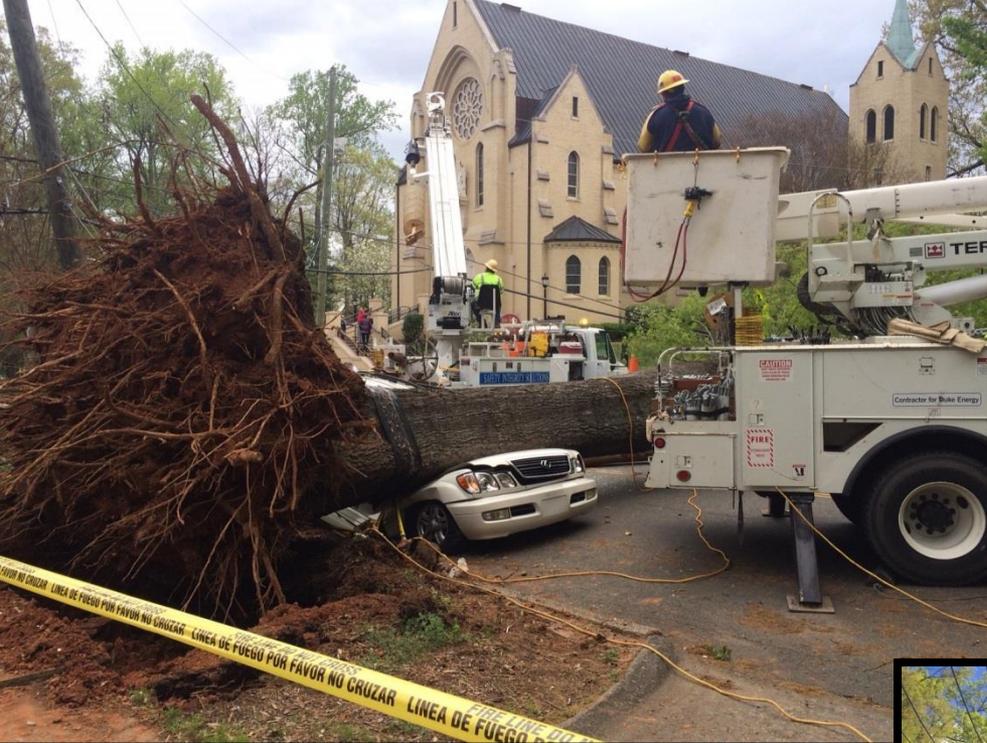
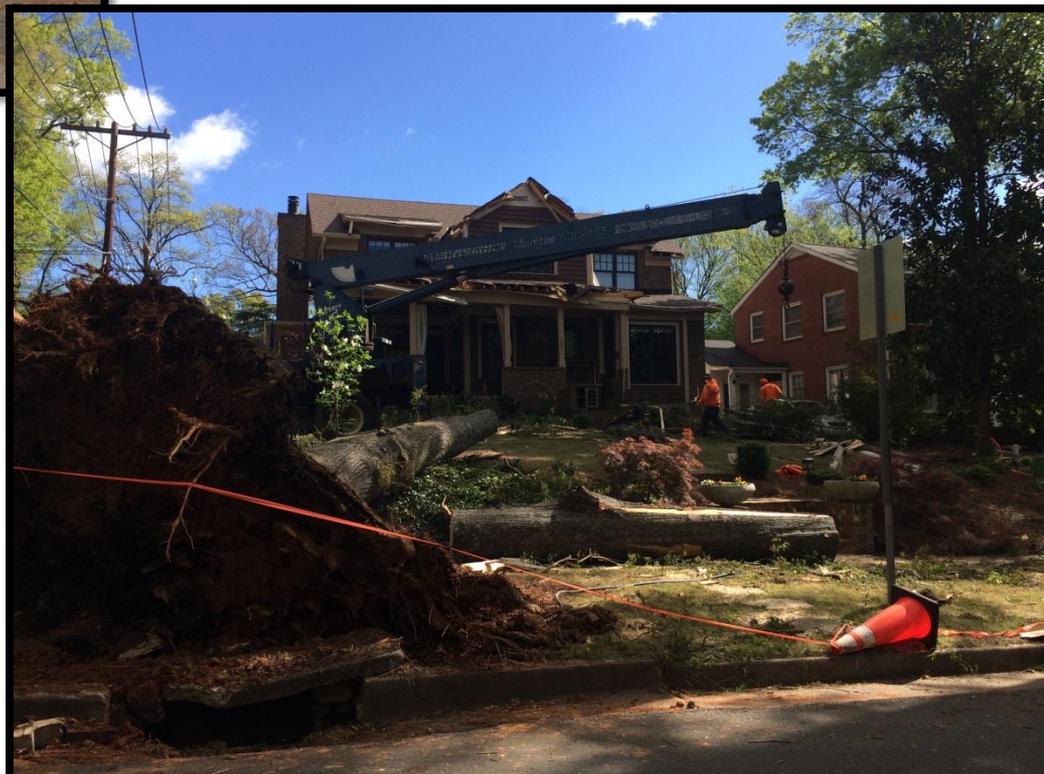
UP VIEW

- The drilling analysis revealed a 32% approximate strength loss at 30' in right lead
- The drilling analysis also revealed a less than 5% strength loss in lower trunk
- Co-dominant stems with included bark at 30'
- Soil compaction and approximate 80% pavement over critical root zone
- Construction damage to approximately 15% of cambium of lower trunk

- Based on the inspection results, your tree does present a high risk of failure at this time and should be removed.
