LOCAL HISTORIC DISTRICT: Dilworth

PROPERTY ADDRESS: 304 East Worthington Avenue

SUMMARY OF REQUEST: Demolition

Charlotte Historic District Commission - Case 2016-235
Demolition
HISTORIC DISTRICT: DILWORTH

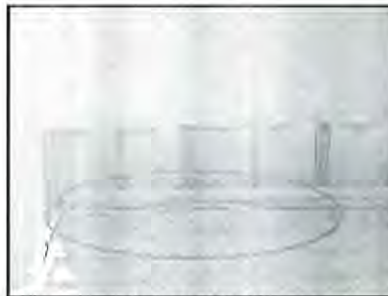
4.0 Picture 1

4.0 (1) Evidence of warped siding at the top rear corner on the left side of the building. This may have been from a previous building fire.

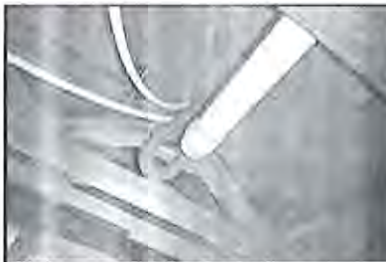
7.1 Picture 1

**7.1** At rear left garage ceiling area there is a non typical drain pipe and connection, a grey flexible pipe is installed through the floor and connected to PVC. This pipe does not appear to have a proper trap built into the drain line.

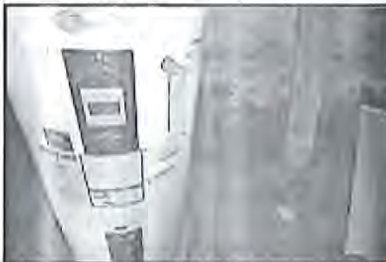
7.2 Picture 1

7.2 (1) View of water heater(s) in the right crawl space (for your info). This is a Whirlpool model # ES50R92-45D built in 2008.

📷 (3) Both units: The overflow pipe that extends from the T&P (Test and Pressure) valve on the water heater is missing, this pipe should be properly installed so that it extends to within 6 inches of floor for safety. This is typically an easy repair, using common industry standards.

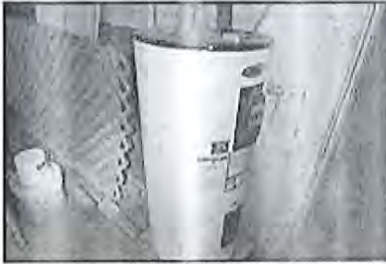
7.2 Picture 2

(2) View of water heater(s) in the left crawl space (for your info). This is a Whirlpool model # ES50R92-45D built in 2014.
