LOCAL HISTORIC DISTRICT: Plaza Midwood

PROPERTY ADDRESS: 1513 Belvedere Avenue

SUMMARY OF REQUEST: Replacement windows

Charlotte Historic District Commission Case 2017-519
HISTORIC DISTRICT: PLAZA MIDWOOD
REPLACEMENT WINDOWS

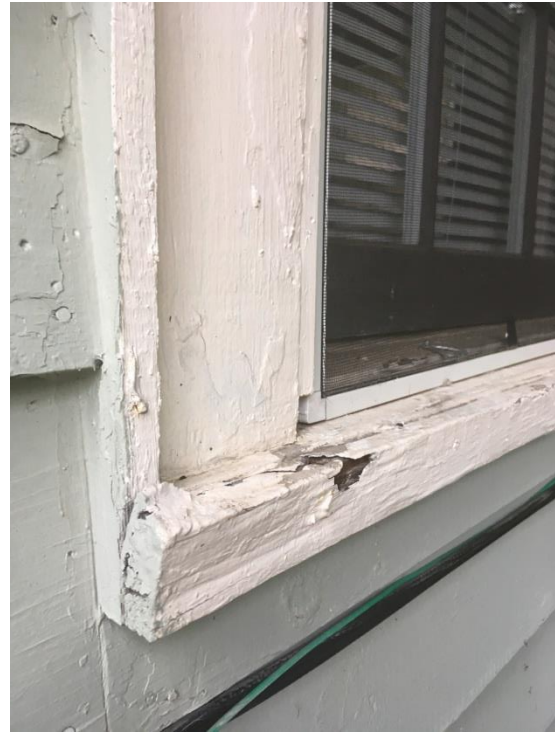
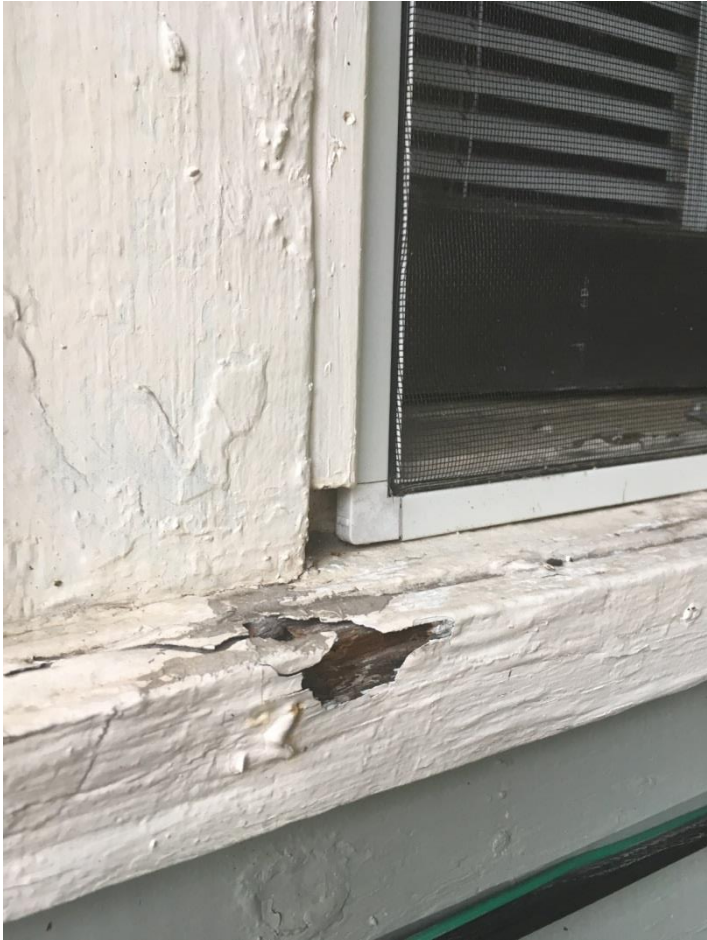
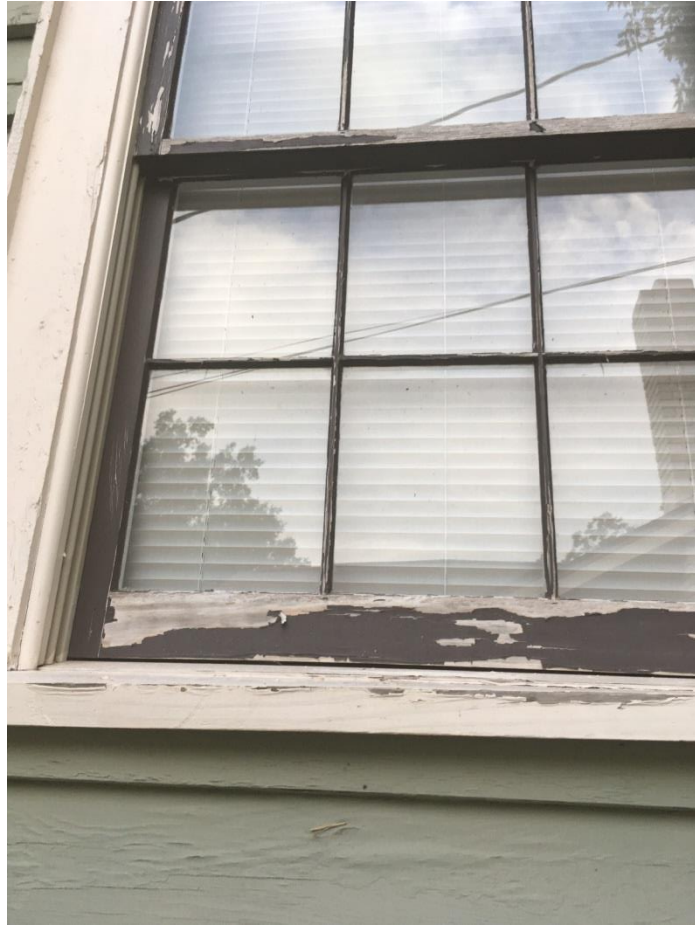
- 21 total windows, with 9 not visible from the street
- 6 windows part of a recent addition. All 6 are not visible from the street.
- All windows are wood single pane windows.
- Window panes are cracked in several windows (master bedroom and living room)
- Several windows were painted shut by the last owner and cannot be opened
- Almost all windows that can be opened require more effort than they should and need to be propped open in many cases
- Several of the inoperable windows are in the master bedroom (addition) on the second floor and are therefore a safety hazard
- Exterior trim has severe wood rot
- Many windows are missing glazing.

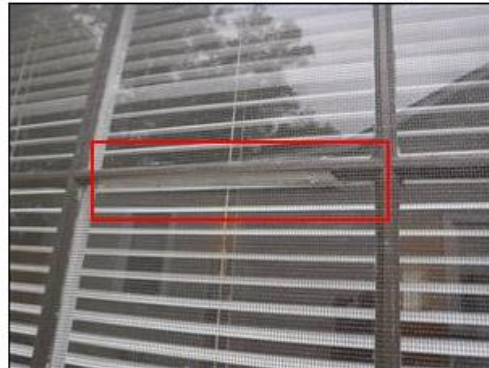
3.0 Picture 1

Various window(s) have missing/peeling glazing. Recommend re-glazing to increase comfort levels inside home and prevent glass from falling out.
