LOCAL HISTORIC DISTRICT: Dilworth

PROPERTY ADDRESS: 1508 Dilworth Road

SUMMARY OF REQUEST: Detached garage addition, tree removal and tree replacement

Charlotte Historic District Commission Case 2018-024
HISTORIC DISTRICT: DILWORTH
ACCESSORY BUILDING

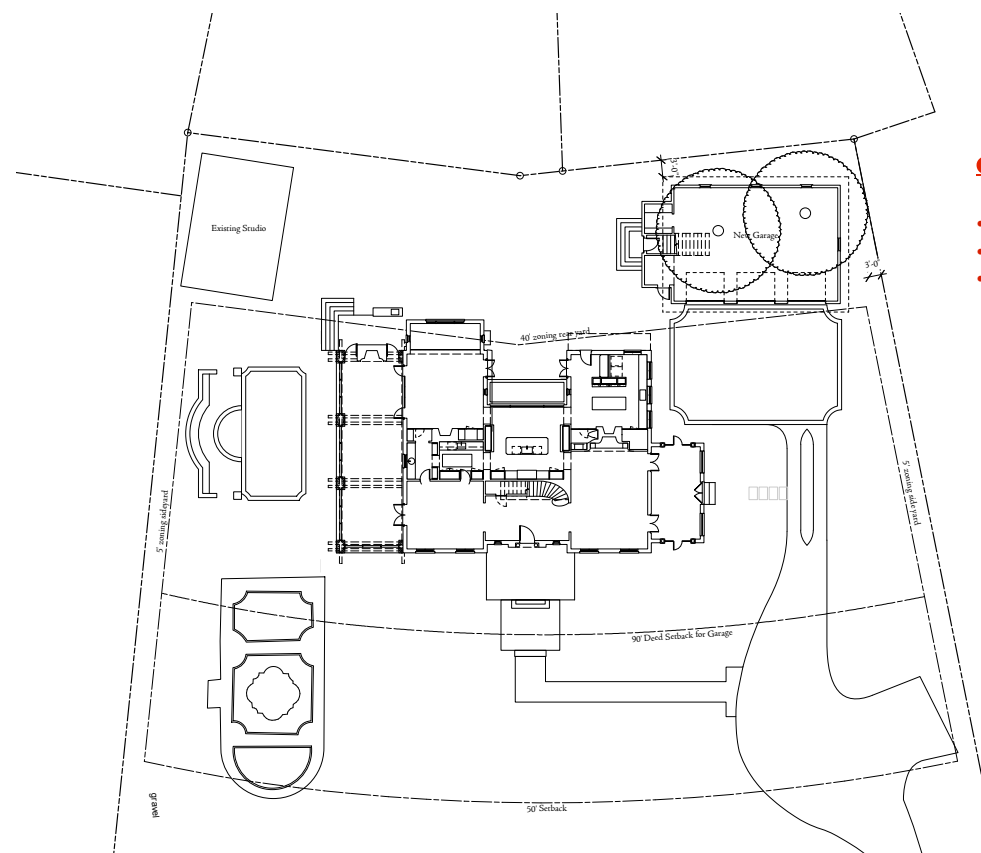
Original Proposed Garage Location

- Meets all required setback and required separation
- Appropriate distance from house to avoid crowding
- Places motor court in a less visible location

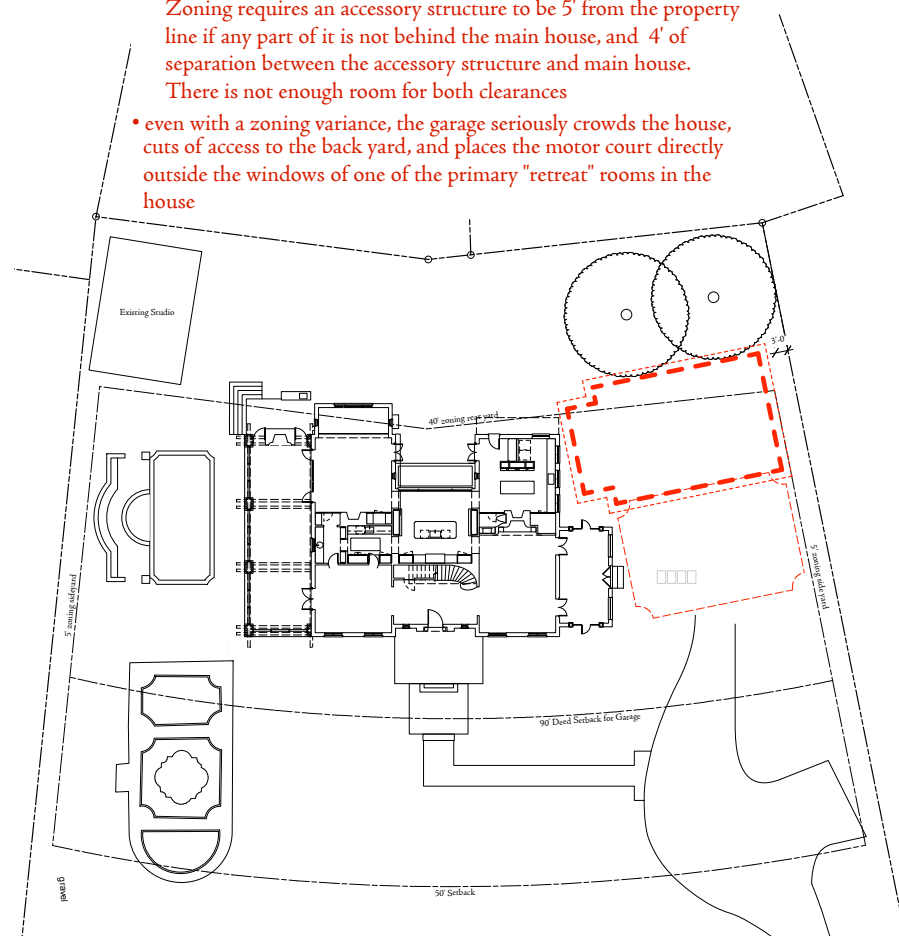
Alternate Location 1

This is the only alternate location that physically fits on the site. However, it is not a feasible solution for several reasons:

- too close to house
Zoning requires an accessory structure to be 5' from the property line if any part of it is not behind the main house, and 4' of separation between the accessory structure and main house. There is not enough room for both clearances
- even with a zoning variance, the garage seriously crowds the house, cuts of access to the back yard, and places the motor court directly outside the windows of one of the primary "retreat" rooms in the house

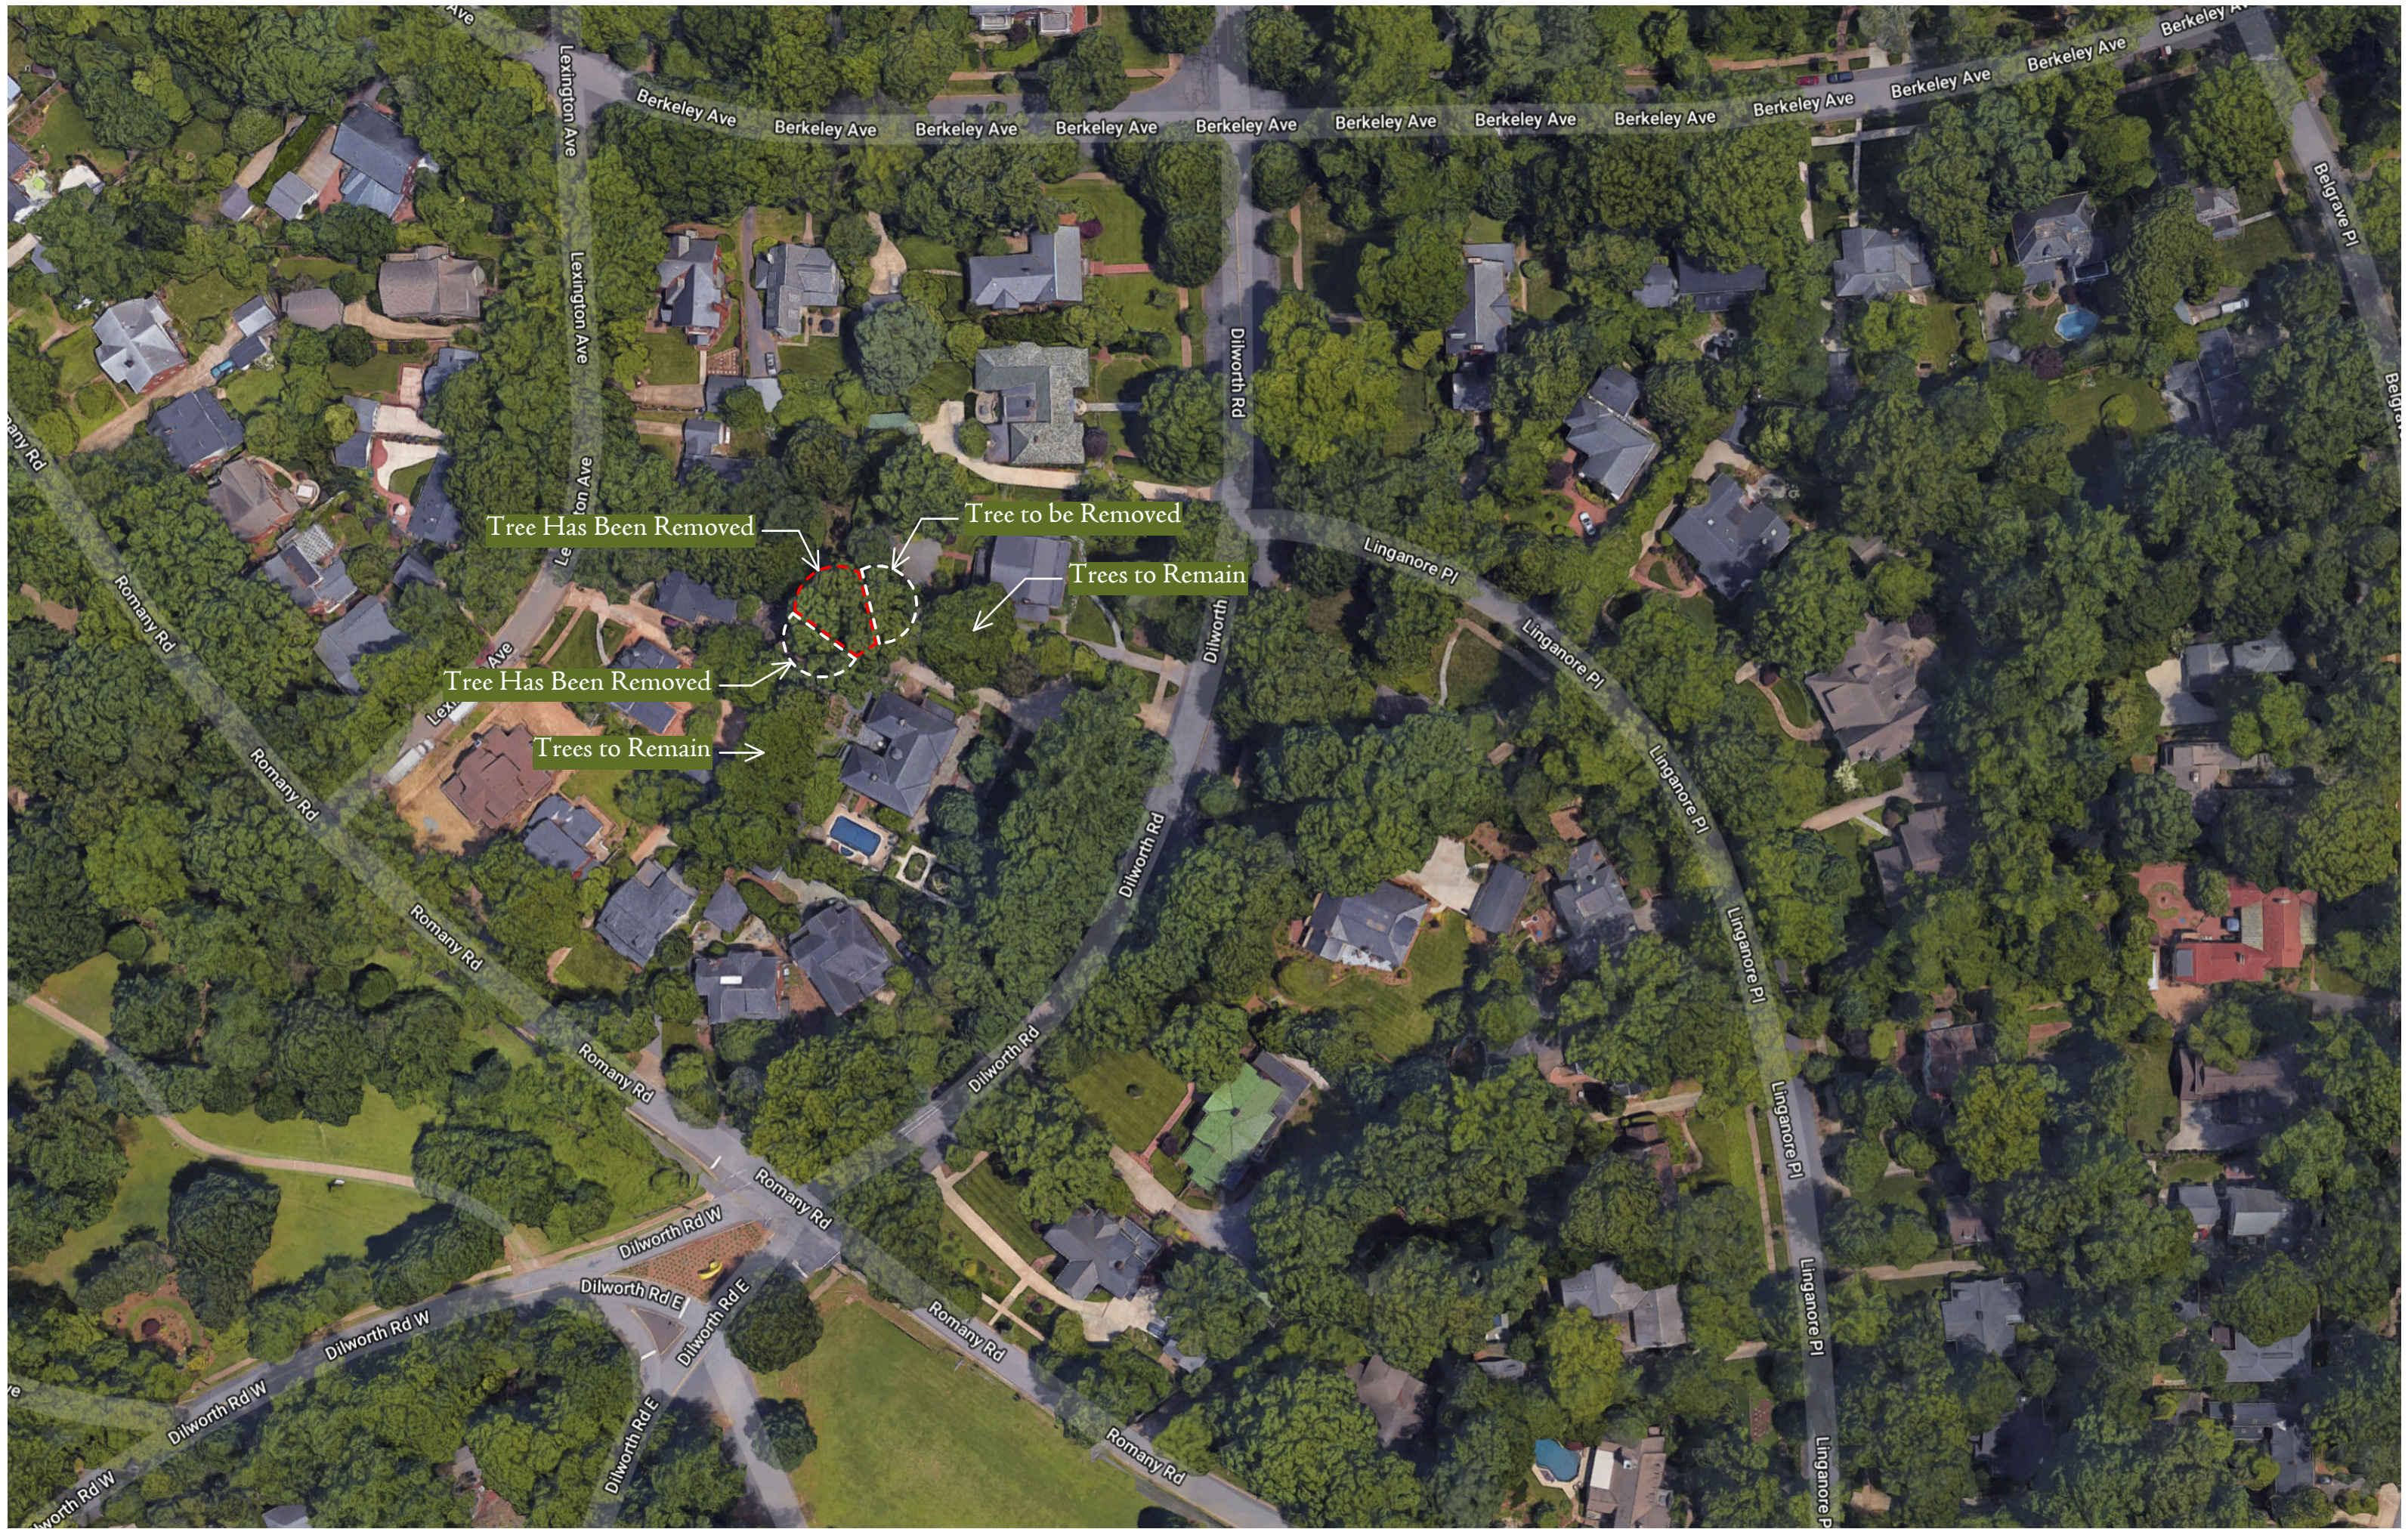
30" Oaks in Question are leaning dangerously, with unbalanced crowns due to repeated trimming for utility clearance, as well as the loss of a 3rd tree between them
