**LOCAL HISTORIC DISTRICT:** Wilmore

**PROPERTY ADDRESS:** 1740 Wilmore Drive

**SUMMARY OF REQUEST:** Siding Changes

# HDCRMI 2019-00517

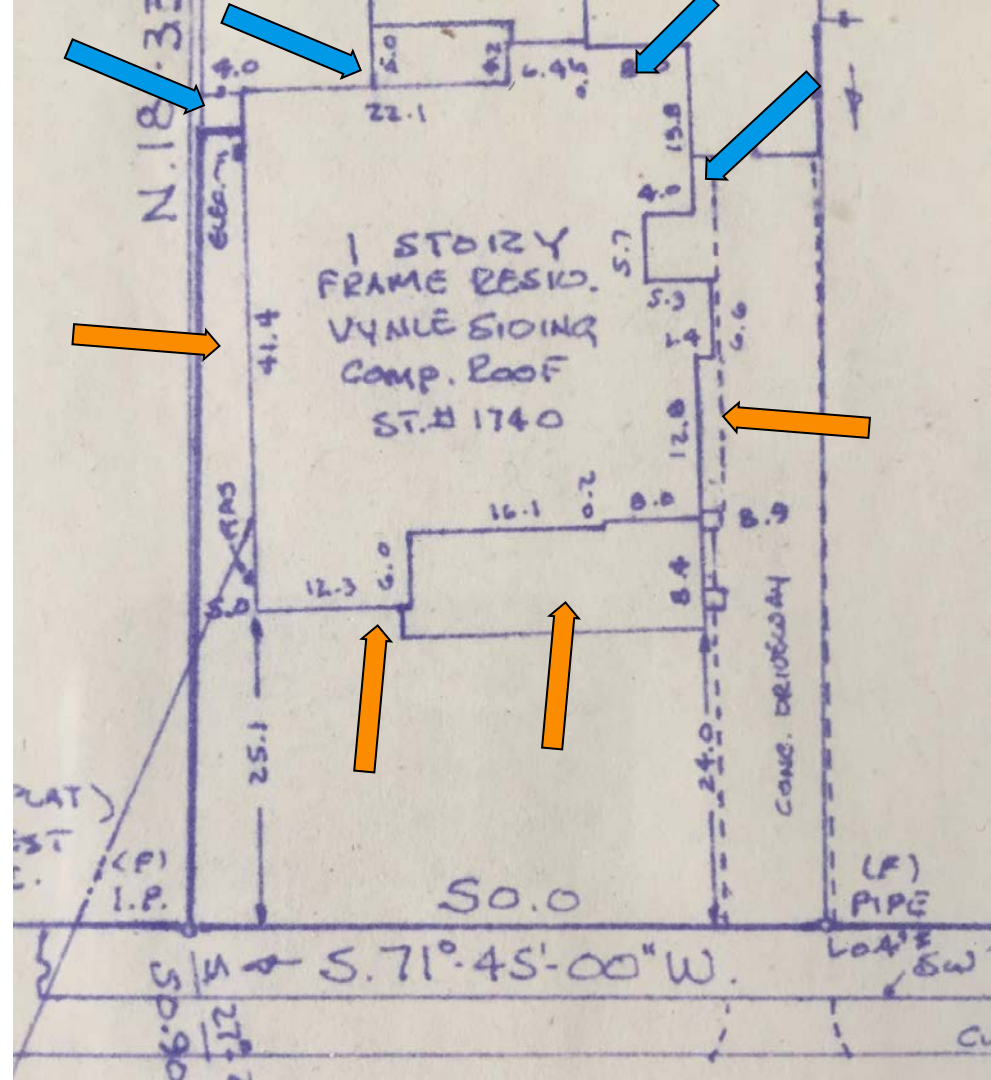
To the right is the property blueprint, including both the original structure and addition which was later added, to **1740 Wilmore Drive**. The blue arrows indicate areas which are already rehabilitated, while the orange arrows indicate areas in need of rehabilitation. Since there is no new construction, updated drawings are not applicable.
